Building Inspection Report

MB/LC/20096

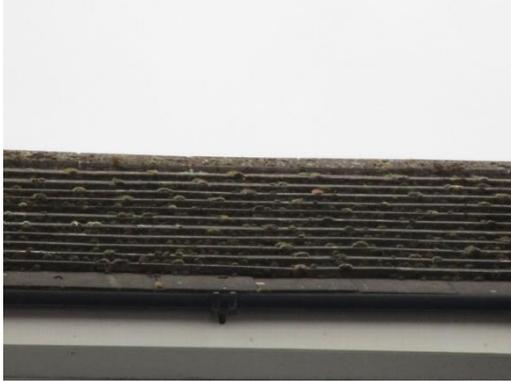
Where ridge tiles could be inspected we did note some minor deterioration of mortar pointing which would benefit from repointing and rebedding work in the short term.

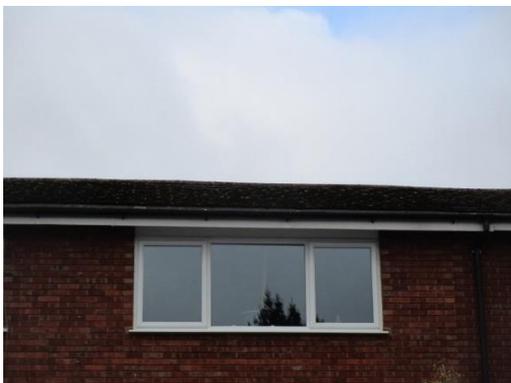
Where the main pitched roof covering could be inspected this largely appeared to be in a satisfactory condition without any slipped or damaged roof tiles. There is some minor undulation to the center of the roof however this would appear to have been the case for a significant period of time.

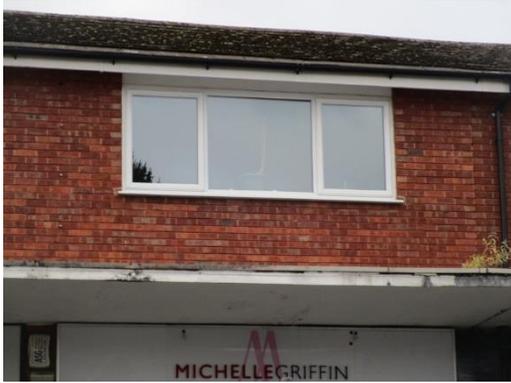
Where the brickwork could be inspected at first floor level this was in a satisfactory condition. No evidence of significant deterioration to brickwork or pointing was noted.

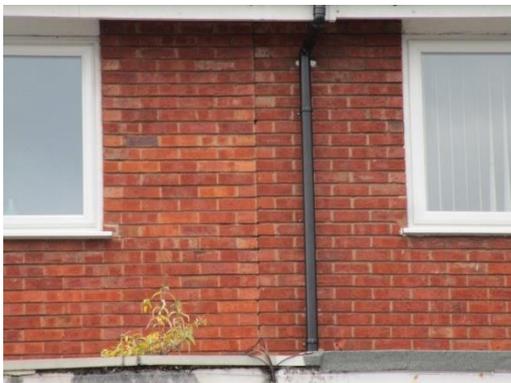
Windows at first floor level have been replaced with PVCu double glazed units. Should they have been replaced post 2002 we advise you obtain the FENSA or Building Regulation Certificate regarding their installation.

There is minor deterioration of mastic at the junction between the PVC window frame and brickwork which will benefit from isolated renewal in the short term to prevent damp penetration at this junction.

The separation between brickwork associated with this property and the right hand property is showing some signs of deterioration to mortar pointing which would benefit from repointing in the short term.

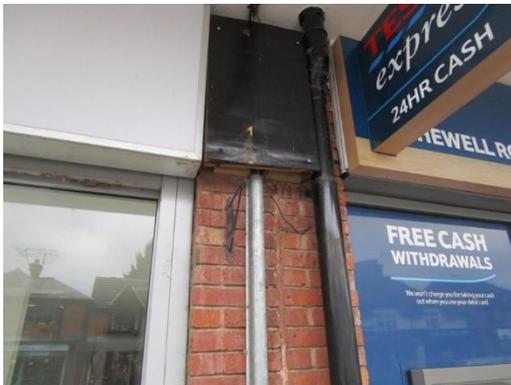
Damp staining to brickwork adjacent the right hand rainwater pipe would suggest that the rainwater pipe is leaking and requires repair.

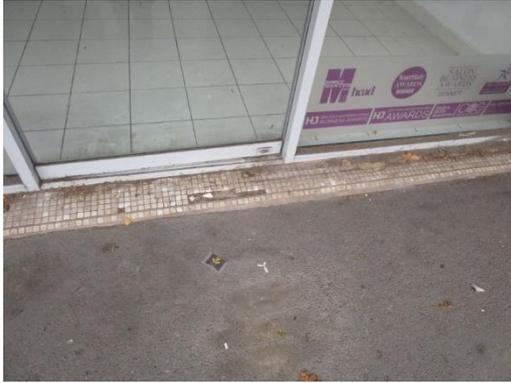
It is comparatively unusual to find a fully glazed entrance door swinging out onto the pavement and it would be of benefit to consider this as part of a health and safety risk assessment for the property to ensure there is no potential for impact damage to anybody using the pavement when people are exiting the building.

The mosaic threshold adjacent the main entrance door is in a dilapidated state and requires partial replacement.

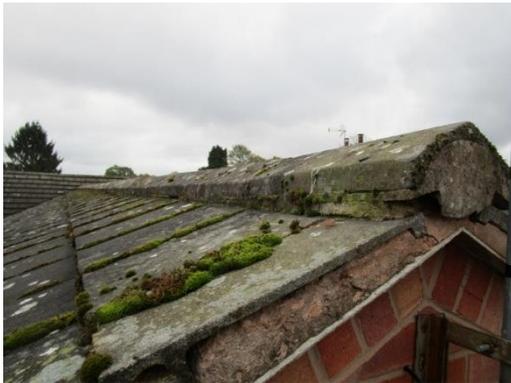
No ridge tiles to the main pitched roof could be inspected. They were largely in a satisfactory condition however there is clearly deterioration of mortar pointing which will require attendance in the short term.

We did note areas of deteriorated mortar pointing to valleys and to ridge tiles and would set aside a figure of £800 for repointing work in the short term.

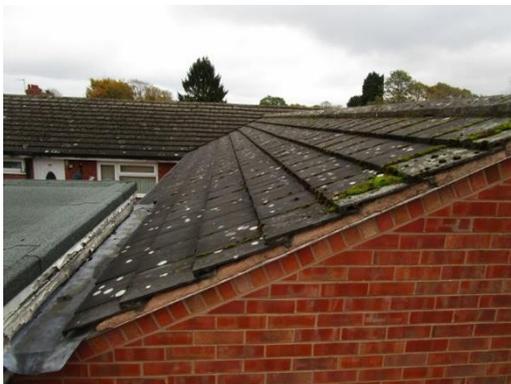
Where roof tiles could be inspected there is again some slight undulation however no slipped or damaged roof tiles were noted on the day of the survey only it appeared to be in a generally satisfactory condition.

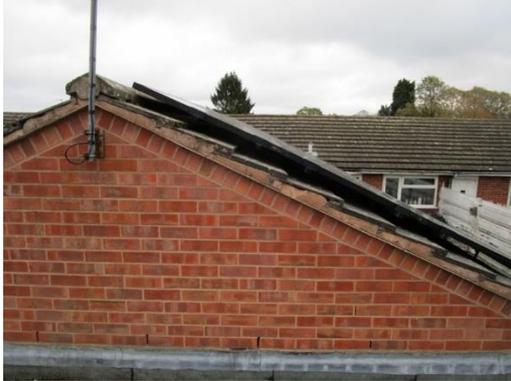
To the left hand facing pitch a PV installation has been installed to the pitched roof. You should confirm whether you have any liability for repair and maintenance of this installation. Should there be any liability we recommend you obtain all instructions and ensure it is left in good working order. Additionally you should confirm that an engineer has assessed the roof and whether it is suitable to sustain the additional load from the PV installation.

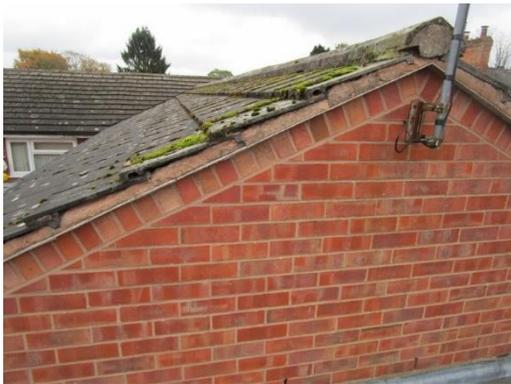
Mortar pointing to verge tiles to the rear facing gable are in need of complete repointing in the immediate term.

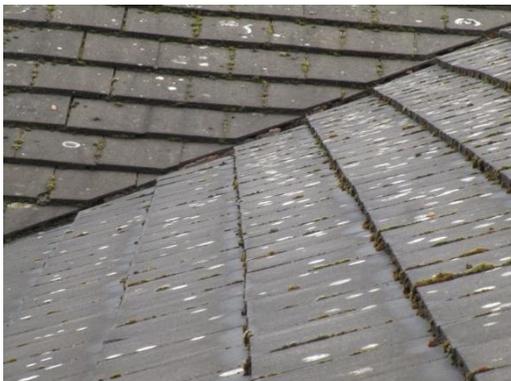
There are valleys to the main pitched roof area which require repointing to the verge. No detailed inspection of the valley lining is possible and this should be inspected as part of gutter clearance work and repointing work to identify the extent of any repair or maintenance necessary.

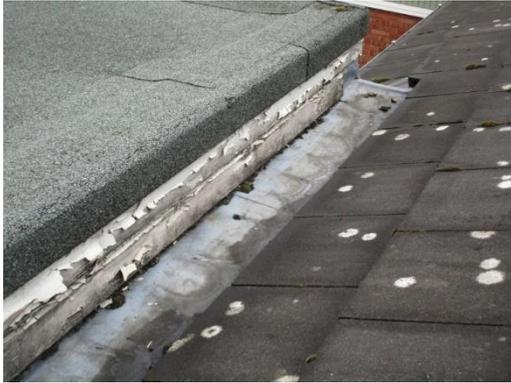
The lead lined valley at the junction between Tesco and this building has a number of splits which will require repair in the immediate term to prevent issues of water ingress internally.

Where a single lead lined valley to the rear could be inspected we noted splits and tears and would suggest that this is repaired as part of other roof work already recommended.

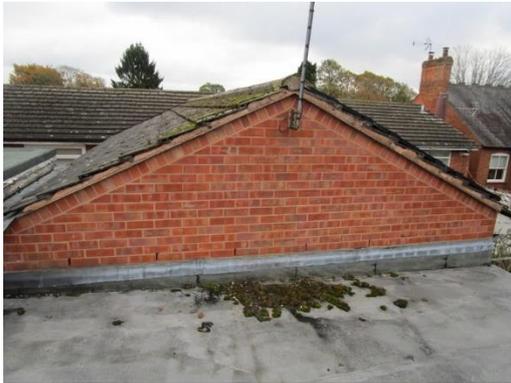
Ranging over brickwork at first floor level to the rear facing gable this all appeared to be in a generally satisfactory condition without any evidence of significant deterioration to brickwork or pointing noted.

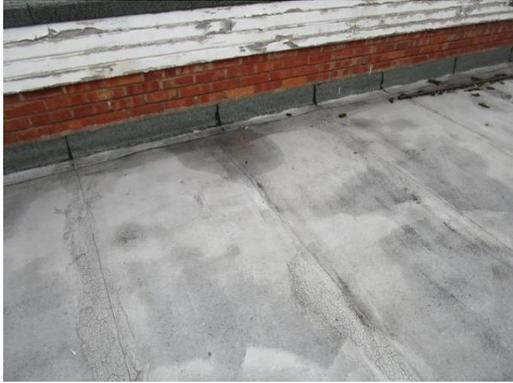
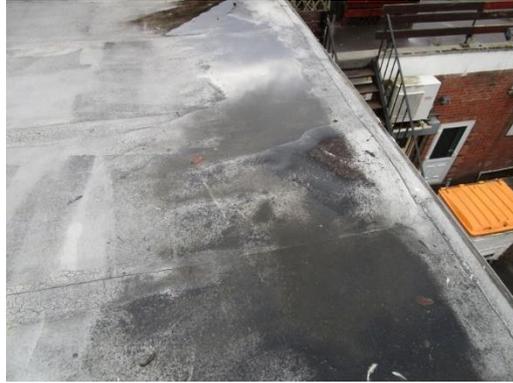
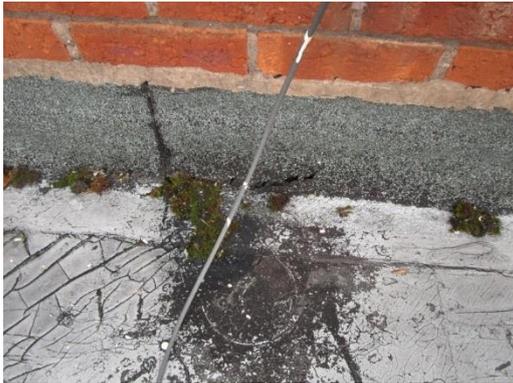
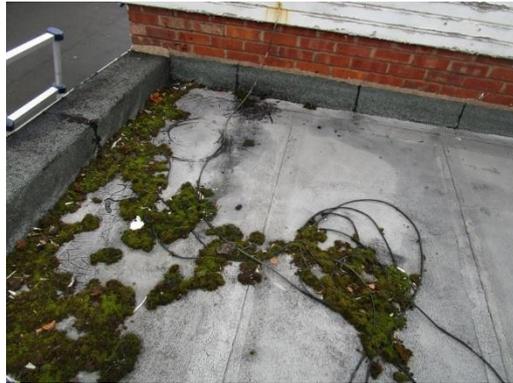
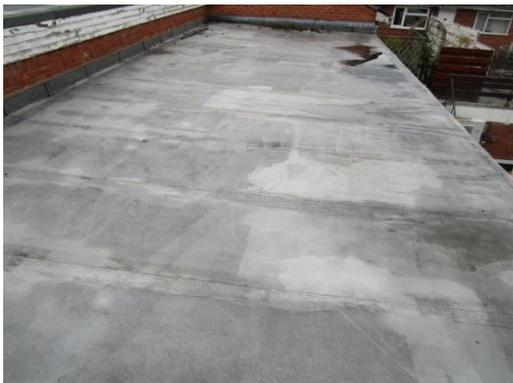
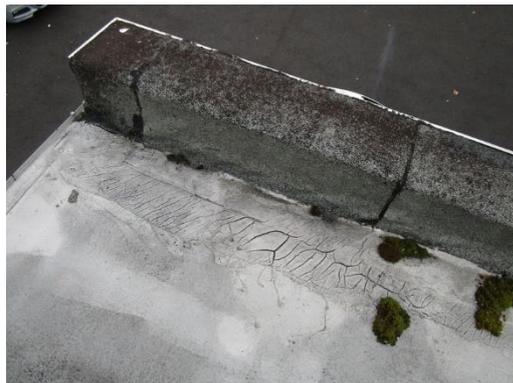
The main flat roof utilises a bitumen built up felt. This has received a reflective coating at some point in the past although this has now deteriorated.

Crossing the roof we note numerous areas of undulation suggesting bubbling of the substrate which may well be an asphalt stock. In any case there are numerous areas of cracking particularly to the perimeter upstand which will require complete renewal in the immediate to short term.

The roof covering is deteriorated and given the undulation noted we anticipate there is water to the underside of the felt which will likely result in issues of water ingress internally. It would be our recommendation that budgets are set aside for repairs to this roof covering in the immediate term with complete replacement required in the short term.

The built up flat roof to the rear of the property is showing significant signs of deterioration. We would set aside a provisional sum of £1,000 for repairs in the immediate term.

We have anticipated it will require complete replacement in the short term and we would set aside a provisional sum of £8,000 for recovering the roof. This excludes any upgrade and installation that may be required in order to satisfy Building Regulation Approval.

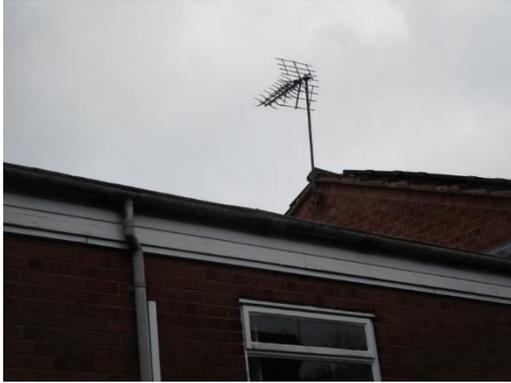
Timber fascias were without substantial rot or decay but will benefit from redecoration in the short term. There is some suggestion that elements of the fascia have been over clad which may be concealing previous issues of rot and decay.

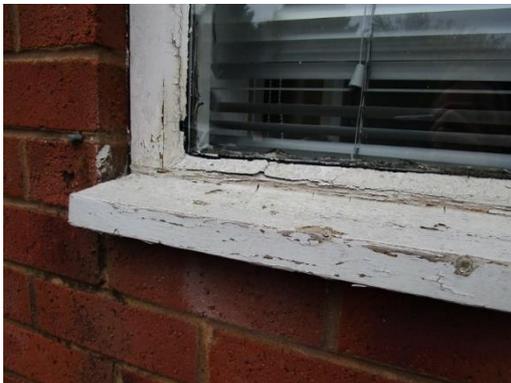
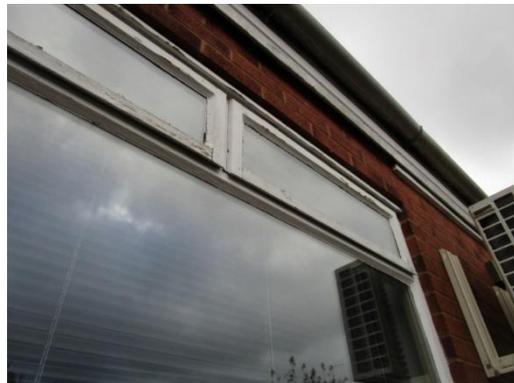
Timber windows at first floor level are again showing significant signs of deterioration. There is rot and decay particularly at cill level. Putty to glazing requires complete removal. Opening lights to windows did not appear to close fully against the frame. Timber repairs prior to redecoration are required to windows in the immediate term.

Timber windows to the rear of the property are in a dilapidated state. We would set aside a provisional sum of £1,000 for timber repairs and renewal of deteriorated putty prior to redecoration in the immediate term.

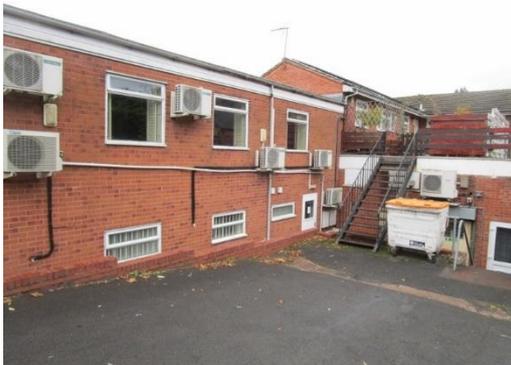
The AC condensers to the rear elevation largely appear to utilise an R22 gas which is now obsolete. As a result it will be our opinion that the AC installation in its entirety will require complete replacement.

The air conditioning installation at the property is clearly of some significant age. We noted a significant number of the AC condensers utilised an R22 refrigerant which can no longer be re-charged. As a result we would suggest that the AC installation requires licenced de-gassing and disposing off.

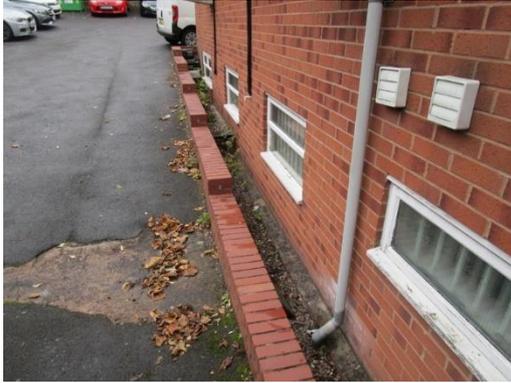
Elements of the building are below ground. We would recommend enquiries are made as to any details on the presumed tanking system that must have formed part of the construction to prevent issues of penetrating damp internally.

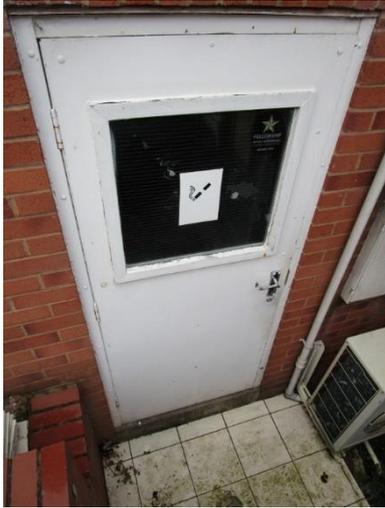
The timber exit door leading from the rear of the property to the emergency exit adjacent the WC is showing signs of rot and decay. Should it be retained it will require timber repair prior to redecoration in the immediate term.

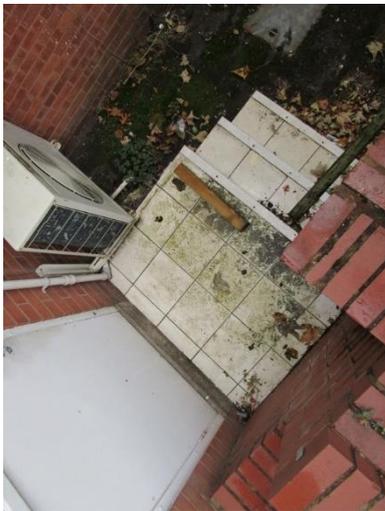
The stepped access leading from the emergency exit does not utilise a non-slip tile and is considered dangerous. There is also an unprotected ledge.

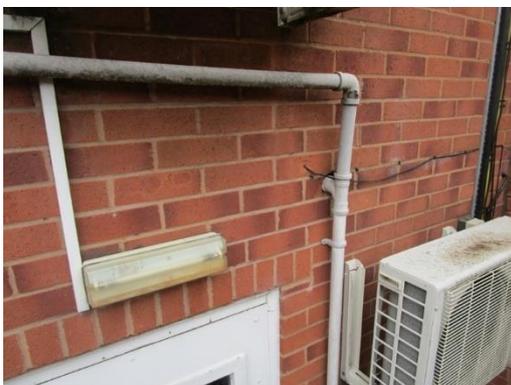
Small bore waste pipes leading from the first floor are aged and brittle and should they be required they will likely require replacement.

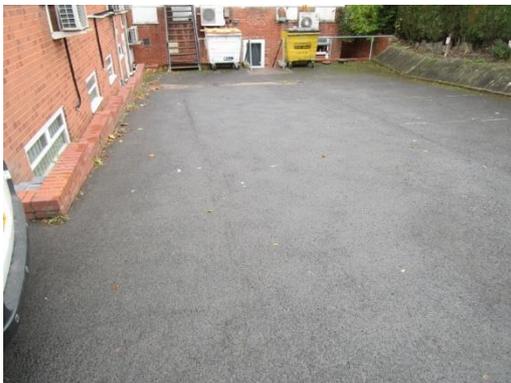
The macadam driveway slopes toward the rear of the building. Although this appears largely to fall toward the adjoining owner's property it would be imperative that the drainage is maintained in good order to prevent issues of pooling water adjacent the fire exit.

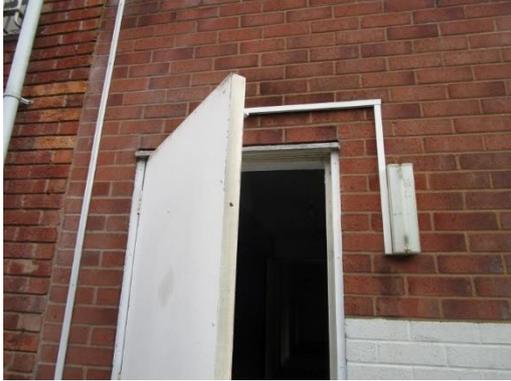
The rear exit door at first floor level is in need of redecoration. There is a lack of mortar pointing to the head of the door which will likely result in issues of damp penetration internally.

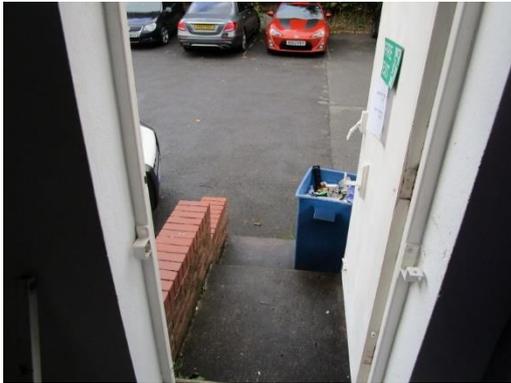
The stepped access from the first floor fire exit into the car park requires careful management as the emergency exit leads directly onto a frequently used access road.

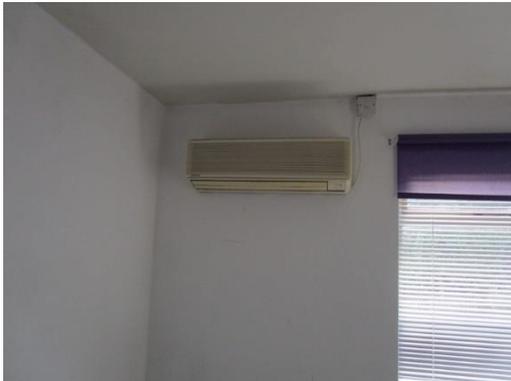
Heating and cooling at first floor level appear to be provided by isolated areas of AC cassettes. These are of some significant age showing signs of water staining and we note that a number of the condensers externally utilised an R22 gas which is no longer available. As a result we would suggest that the AC installation at the property in its entirety will require removal and disposal. Clearly any replacement of the AC installation will attract a significant cost.

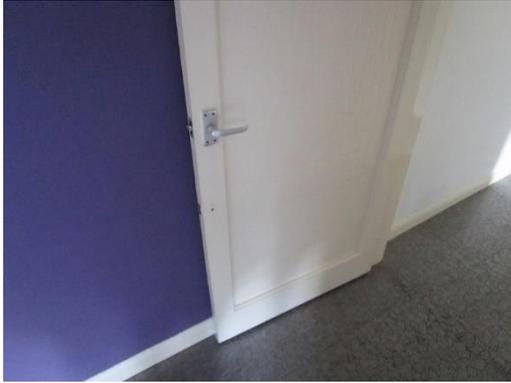
The doors at first floor level which appear to have been painted over a previous glazing. The glazing by modern day standards should be a safety glass or having a safety film applied should these be retained.

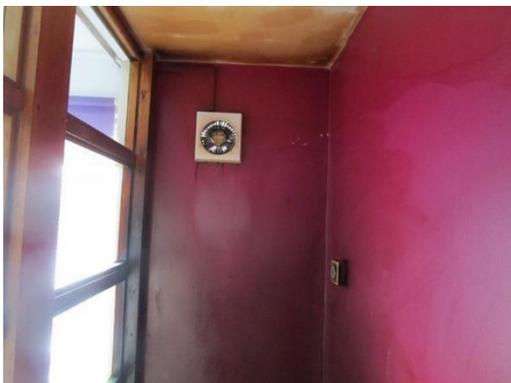
Mechanical extractor in the rear left hand corner of the first floor should it be required requires complete replacement.

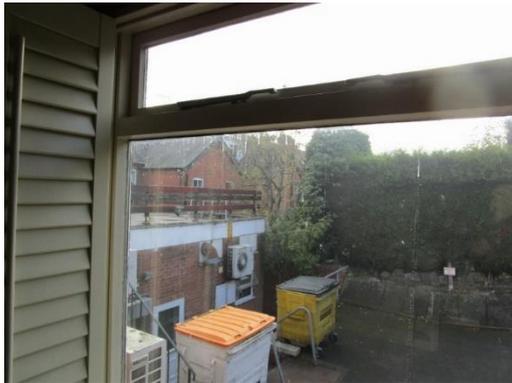
There are numerous areas of damp staining to windows. This appears to be on the inner side of the glazing. This would suggest water ingress at the junction between the glazing and the frame externally.

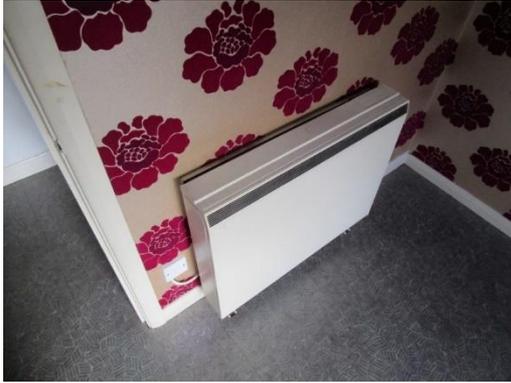
Elements of the first floor heating utilising electrical storage heaters. These are clearly of some significant age and require testing to ensure they are left in good working order.

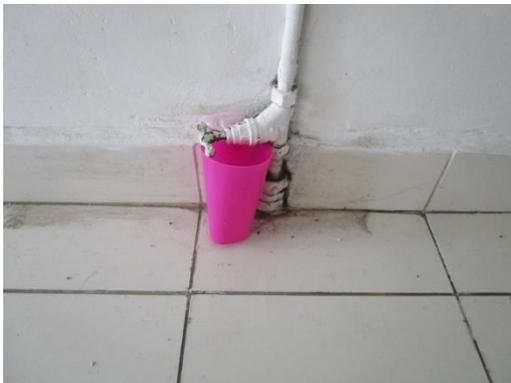
The incoming water supply would appear to be within the room. The evidence on site would suggest that this is leaking. We would recommend that this is repaired by an appropriate qualified plumbing in the immediate term.

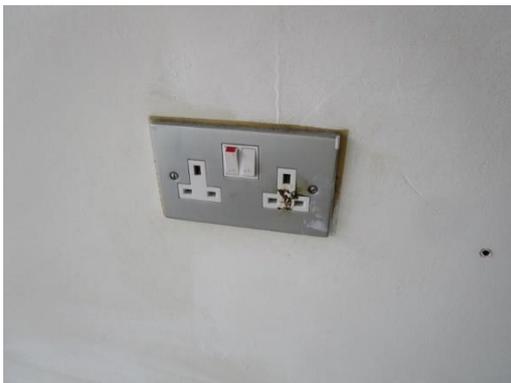
We note evidence of some heat staining to an electrical socket point. This is considered dangerous and we would recommend that the electrical installation at the very least is subject to inspection and testing by an NIC EIC Electrical Engineer. We would anticipate that complete electrical rewire will be necessary.

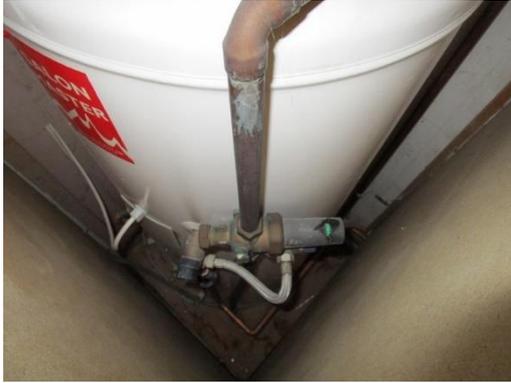
Within the small boxed-in area is a hot water cylinder. This was not operating on the day of the survey. We note numerous areas of damp staining at low level adjacent the cylinder which may suggest that this leak when in use. Should it be retained it should be subject to inspection and testing by a competent plumber.

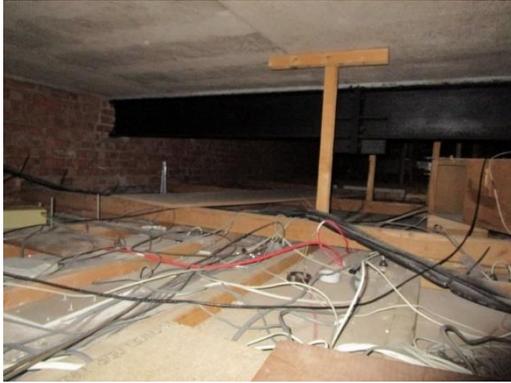
When inspecting within the void there is some suggestion that the signage to the front of the property forms part of the external wall. This is likely inadequate and we would suggest that upon renewal of the signage to the front of the property construction of a small partition above the shop front will be necessary.

Given the size of the void above the suspended ceiling and the services passing through the void it would be our recommendation that independent smoke detection is installed within the void.

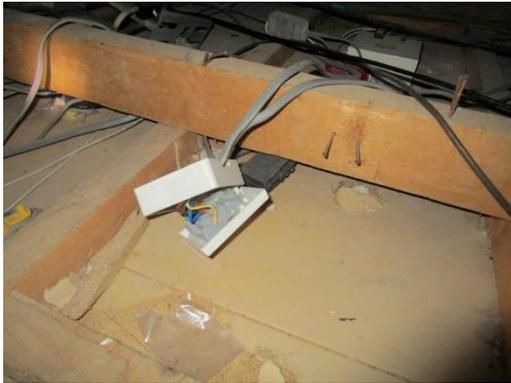
There are electrical connections which are of some concern. We would recommend that these are stripped out as part of the refurbishment work.

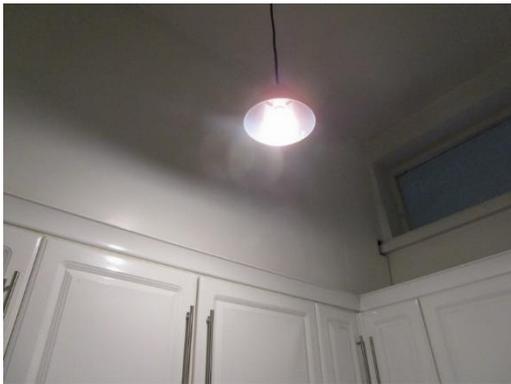
There is a large partitioned area to the head of the kitchen wall units to the left hand wall. We presume that there are services contained within this partition. No inspection is possible but we would recommend that the partition is removed as part of the refurbishment work to identify what is behind this section of boxing.

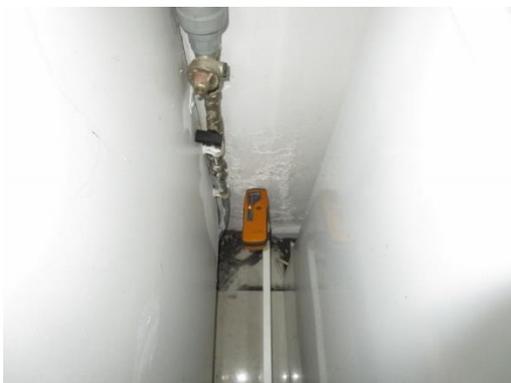
Further blistering of paint finishes is noted at low level toward the rear wall. Testing this with a damp meter did identify raised levels of dampness. Further areas of the main cause of dampness may become apparent once kitchen units are stripped out.

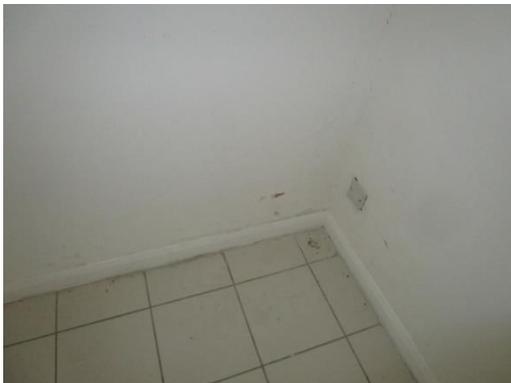
There is some damp staining to the rear left hand corner of the room. Testing this with a damp meter did identify some raised levels of dampness which would suggest it is progressive. The walls are in part below ground and again we recommend that you obtain any details in regard to the tanking system used at the property.

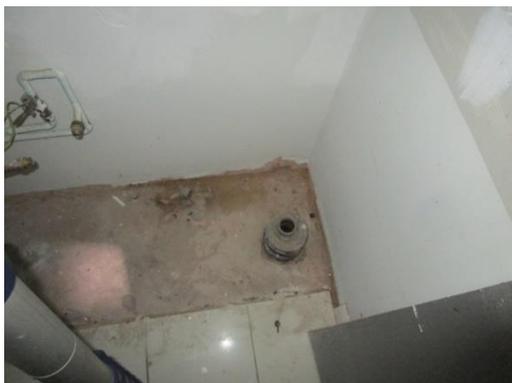
There appears to be an open soil pipe within the small store area off of the room which we would recommend is appropriately capped.
