# Structural Feasibility Report

Relating to: Modifications at  
XXXX  
XXXX  
XXXX

Report date: XXXX 2021

**Job reference:** JB/XXXX

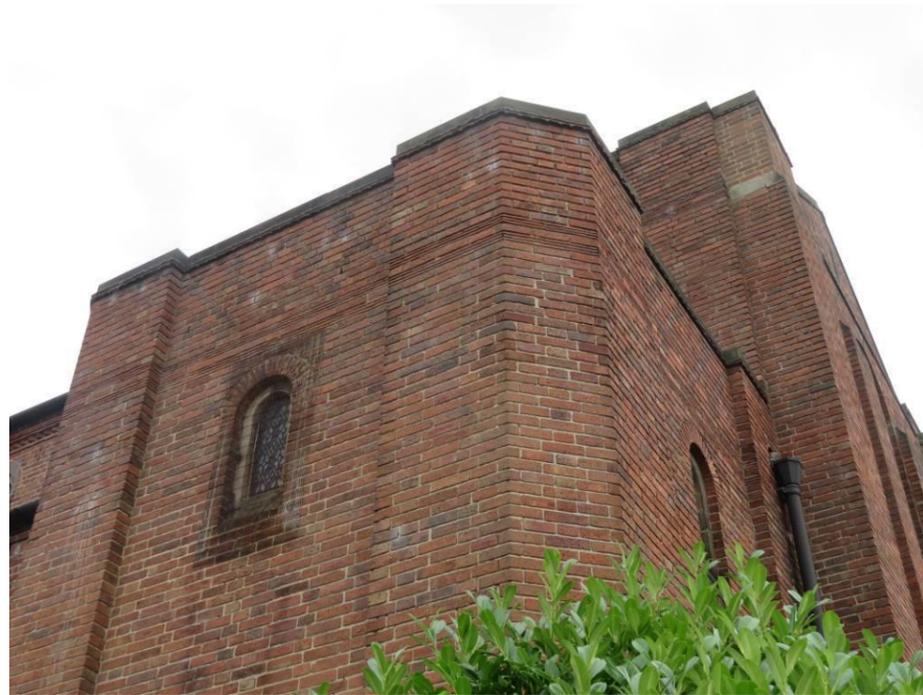
To the north elevation of the northwest tower there were no signs of significant cracking to the facing brickwork. A possible slight bulge was noted close to the top of the wall on the northwest corner, corresponding with the level of the roof deck.

**Northwest corner of northwest tower at high level**

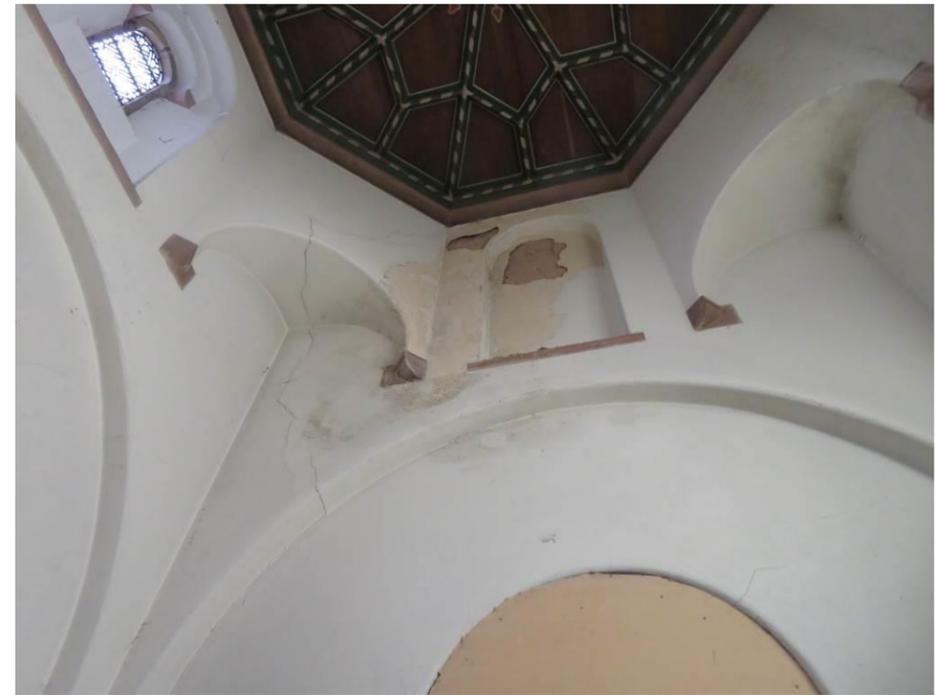
**Vertical crack in northeast corner of northwest tower**

The crack is located at the junction with the main north wall to the Nave. It was noted to be slight, measuring approximately 3-5mm in width. At low level there was evidence of previous decorative repairs to the crack, suggesting it is not recent. Signs of previous water ingress were noted to the walls at high level.

The vertical nature and constant width of the cracks seen in the northwest and southwest towers suggests that the cracking is most likely to be associated with expansion and contraction of the brickwork, rather than movement in the ground. Thermal movement cracks in walls are usually vertical and a constant width, and they can open and close as the temperature, moisture and humidity levels change throughout the year.

In accordance with BRE Digest 251 *Damage to Low Rise Buildings*, Where the observed cracks are less than 5mm wide this would be categorised as Category Two damage. In this case the suggested remedial works are to undertake decorative repairs only internally and to repoint mortar as required externally.

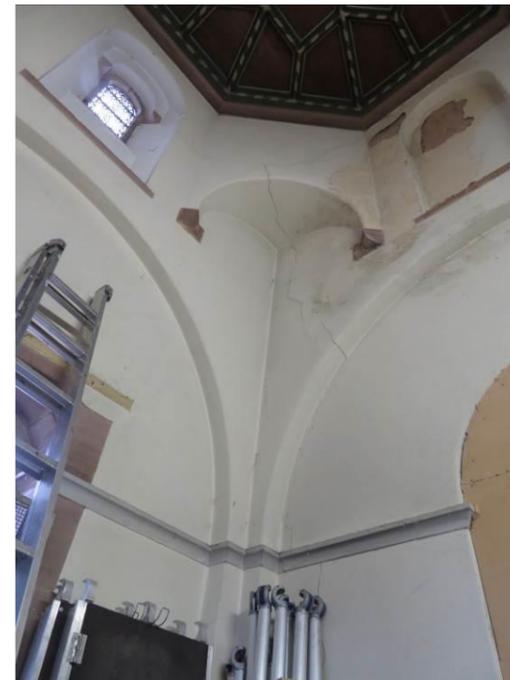
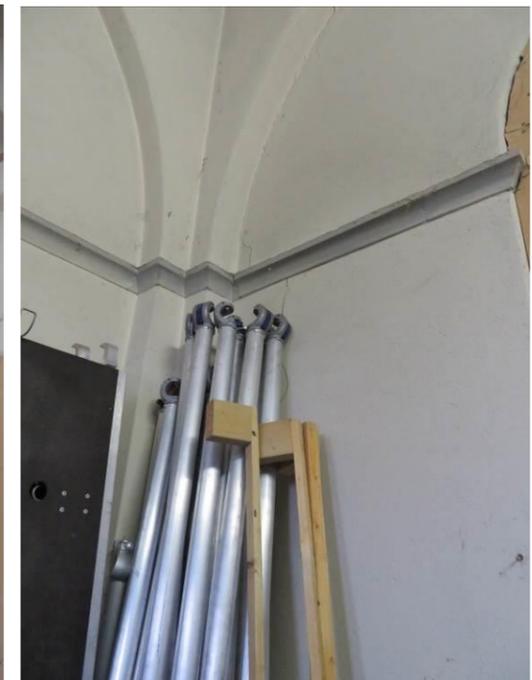
Internally, the tower is currently a single storey space with no upper floor levels. An approximately vertical crack is present in the northeast corner of the tower, running through the plaster to the inset arch below where the crack runs down to ground.

**Vertical crack in northeast corner of northwest tower**

Where cracks are 5mm wide or more, the cracks fall into Category Three damage in accordance with BRE Digest 251. In these locations it is recommended that crack stitching is undertaken with helical bars across the cracked areas, to both the internal and external faces to stabilise the brickwork. This would typically involve disc cutting a 40-55mm deep chase into the bed joint across a crack. An epoxy resin mortar is then pressure grouted into the open joint, and stainless steel rods are set into place. The following should be noted:

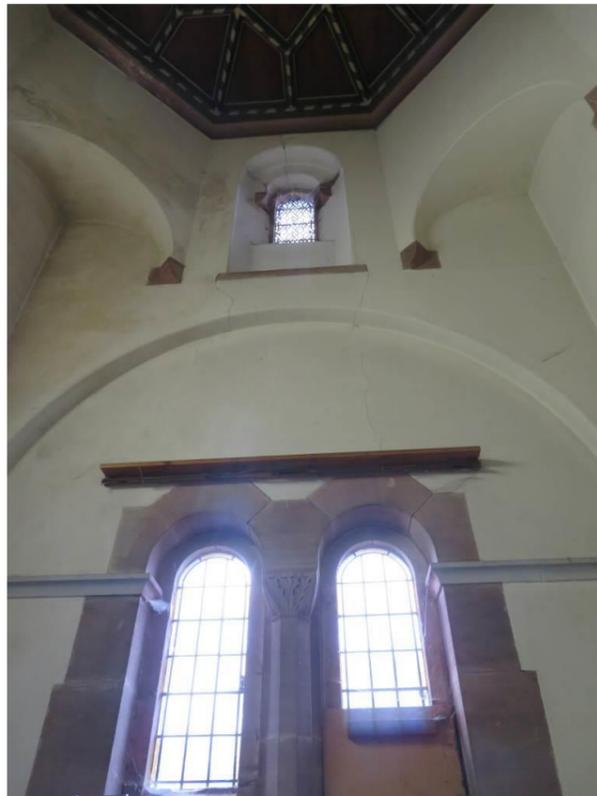
To the west elevation, slight approximately vertical cracks were noted between the upper and lower windows. A single crack was noted running above the upper window to roof level.

*Vertical cracks to west elevation of northwest tower*

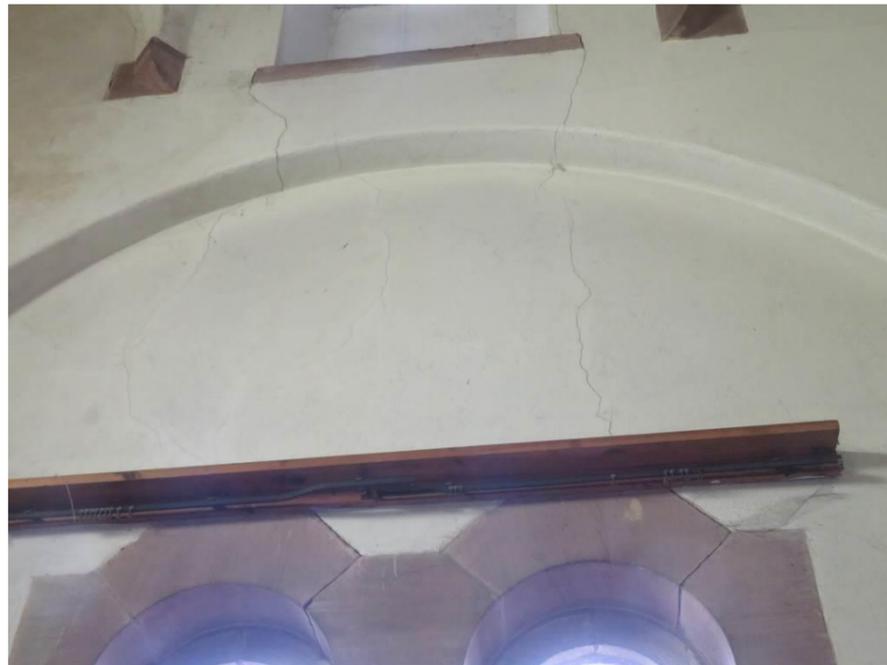
*Vertical cracks to west elevation of northwest tower*

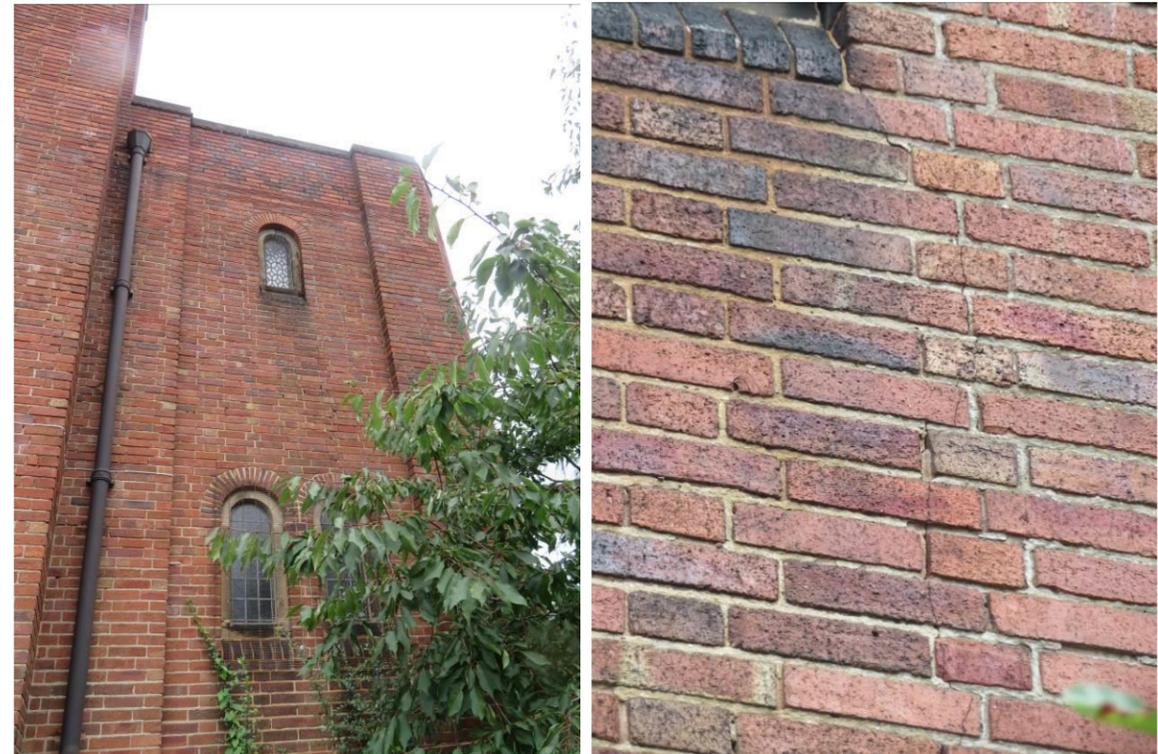
To the southwest tower, a very slight to slight approximately vertical crack was noted in the brickwork between the upper and lower windows on the west elevation.

*Vertical crack to brickwork on the west elevation of the southwest tower*

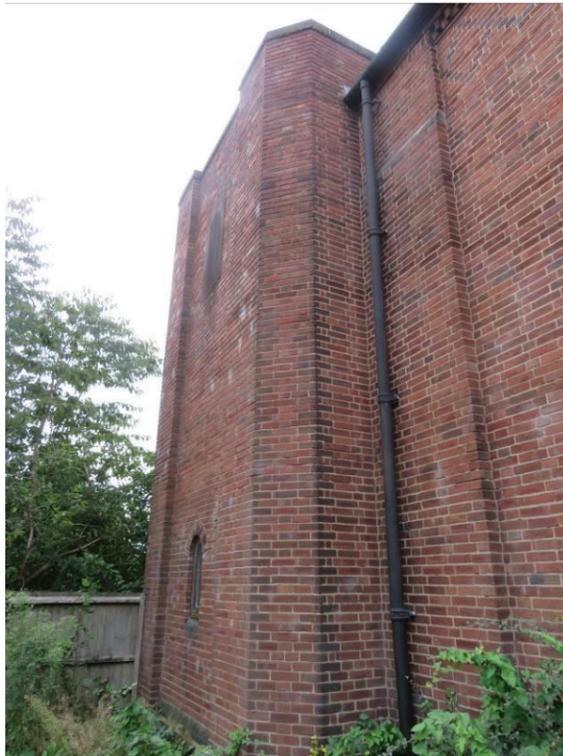
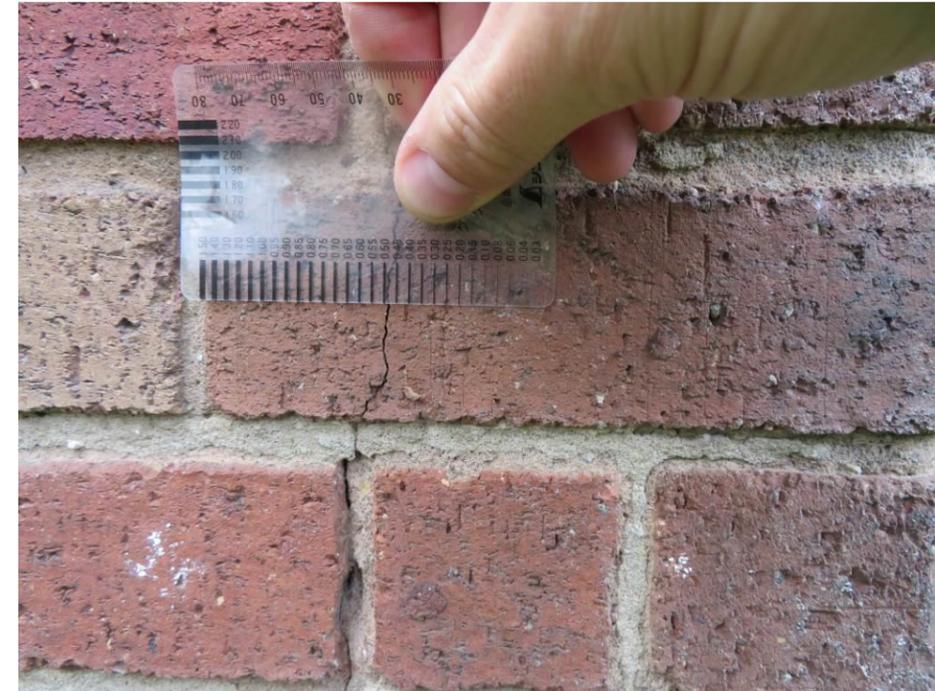
On the southern elevation, very slight cracks were noted to the external face of brickwork both beneath the ground floor window and to the eastern corner. In each case, the cracks were noted to be less than 1mm wide.

*Measurement of diagonal crack to the eastern corner*

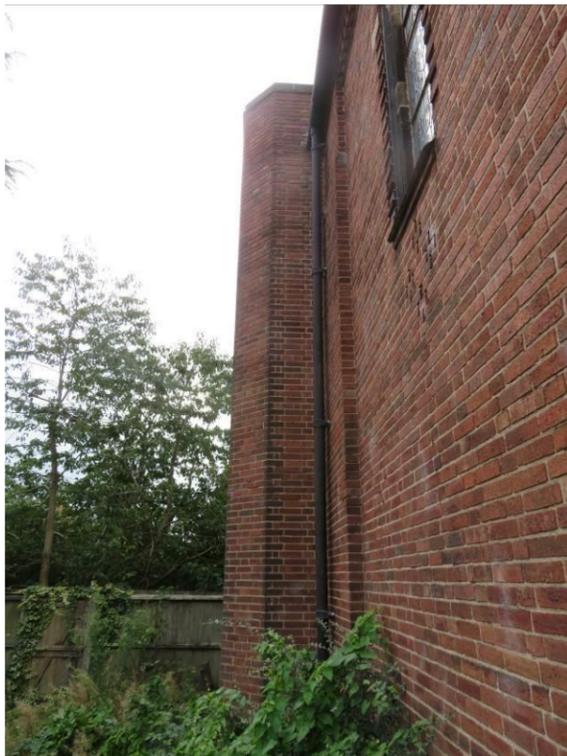
*Diagonal crack to the eastern corner of the southwest tower*

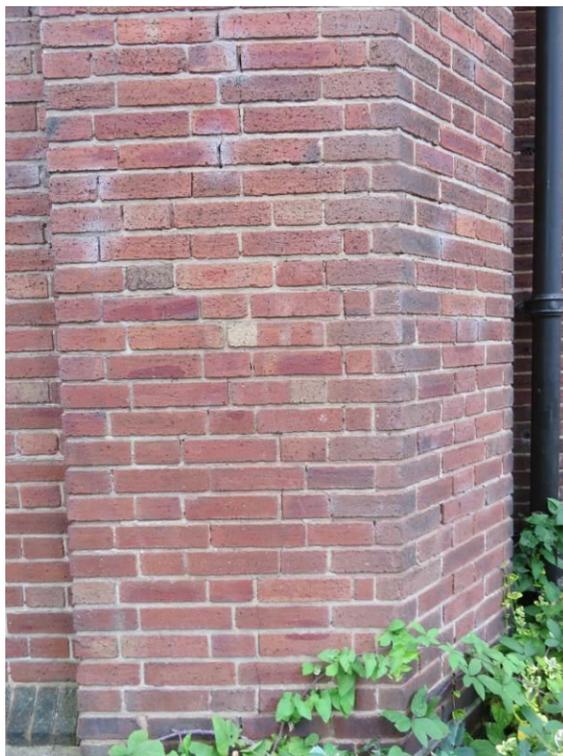
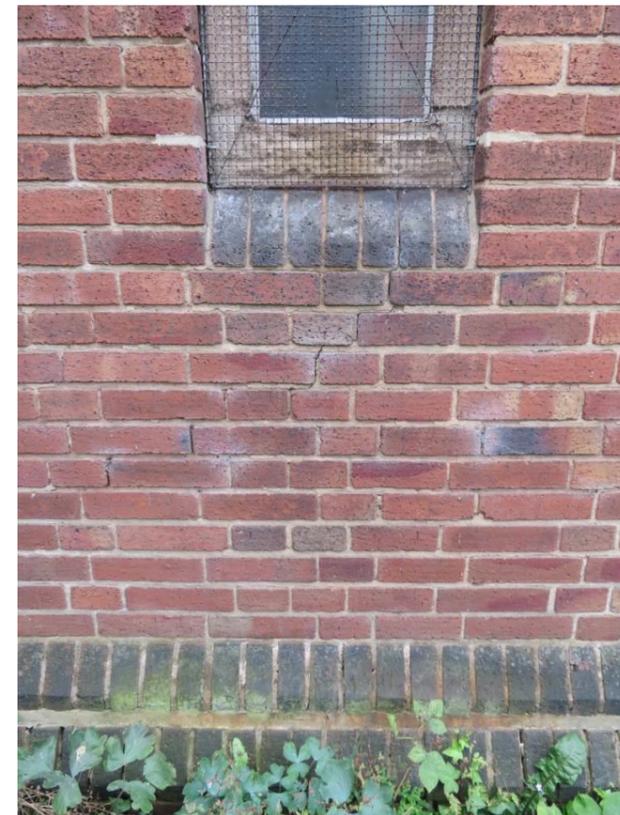
The crack beneath the window was noted to run diagonally down towards ground level. It did not appear to continue through the brickwork at ground level, however due to weathering of the mortar joints in the brickwork, this was not confirmed.

*South elevation diagonal crack beneath ground floor window*

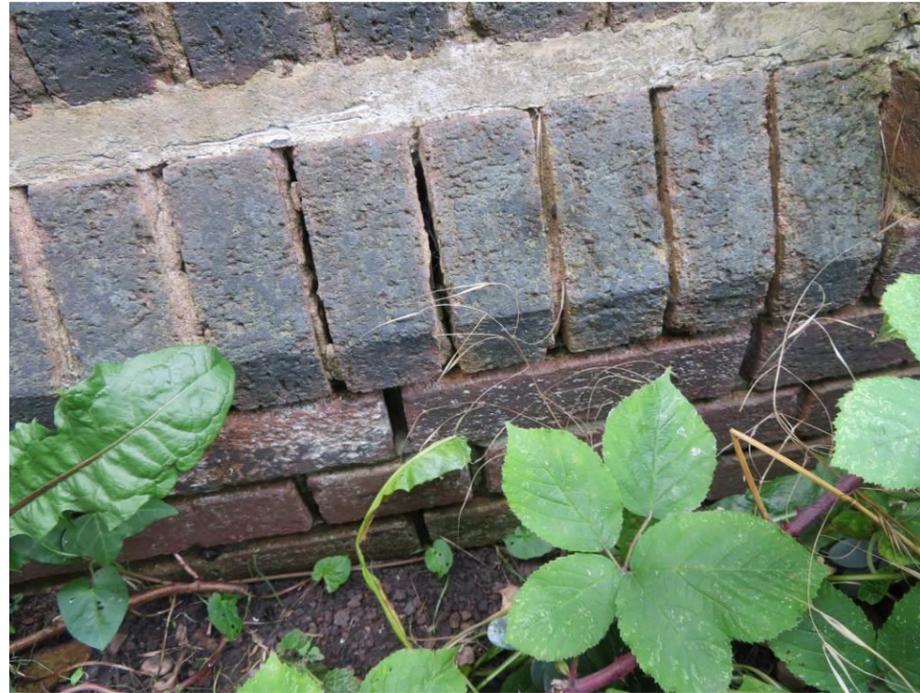
***Weathered mortar joints to brickwork at low level on south elevation***

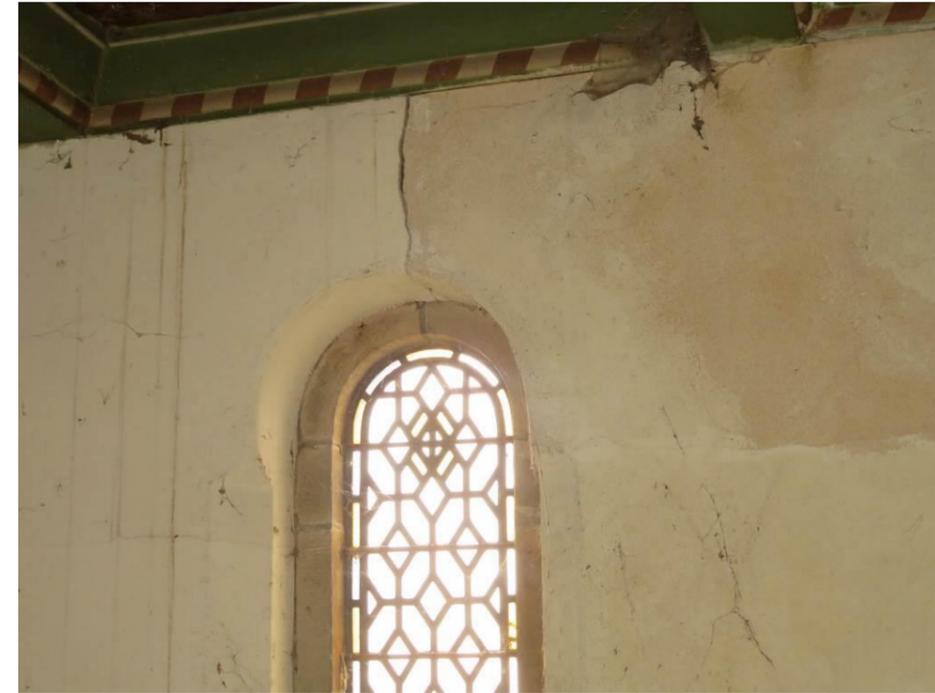
Internally, an approximately vertical crack was noted in the west elevation between the upper and lower windows, reflecting that observed on the external elevation. The crack appeared to be slight, approximately 5mm in width.

***Vertical crack to west elevation of southwest tower***

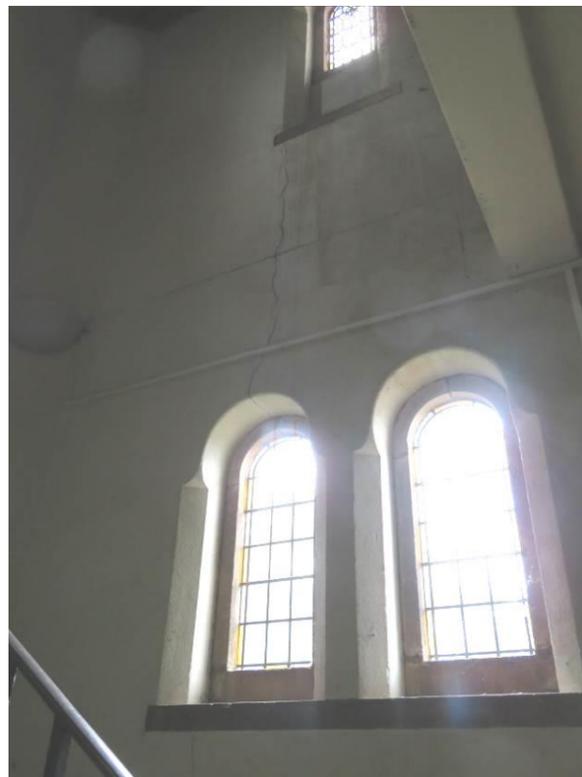
***Vertical crack to west elevation of southwest tower***

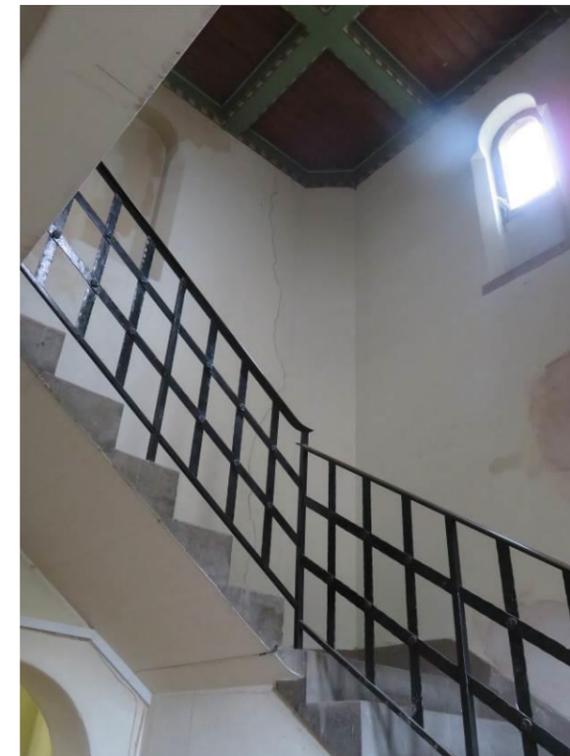
A slight to moderate vertical crack was noted full height of the tower in the eastern corner. In the understairs cupboard, it was measured as 5mm wide.

***Full height vertical crack in east corner of southwest tower***

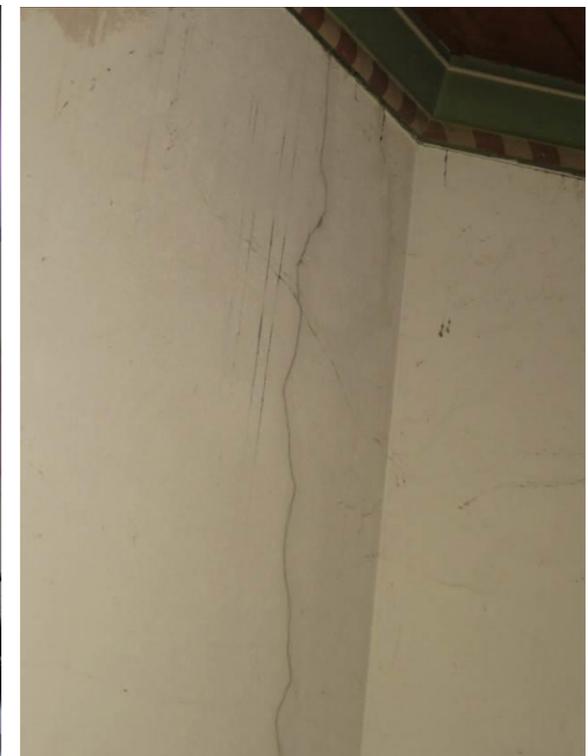
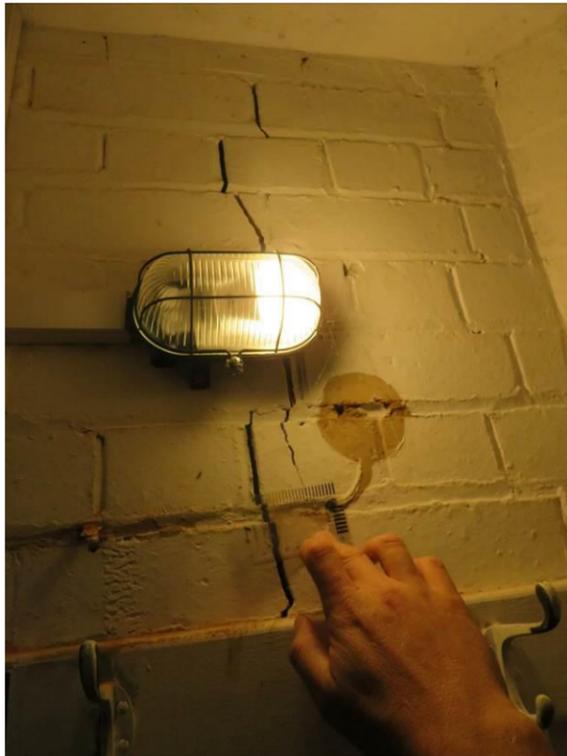
*Vertical crack in east corner of southwest tower*

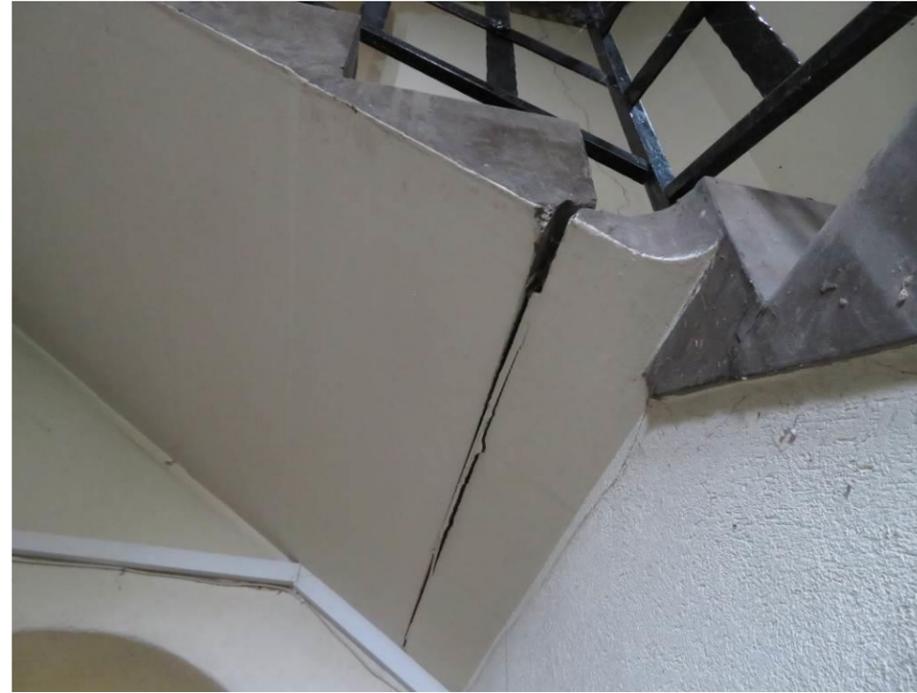
In the same corner of the tower, a gap of approximately 5-10mm has opened up between the quarter landing and the upper flight of concrete stairs. The gap appears to correspond with the crack in the wall, which each part of the stair having moved with the wall it is built into.

*Movement between concrete stair treads associated with vertical crack in east corner of southwest tower*

Simialrly, following the brickwork repairs to the southwest tower, a lightweight concrete repair mortar or resin shall be injecting into the gap between the concrete stair elements to reinstate the bearing between them.

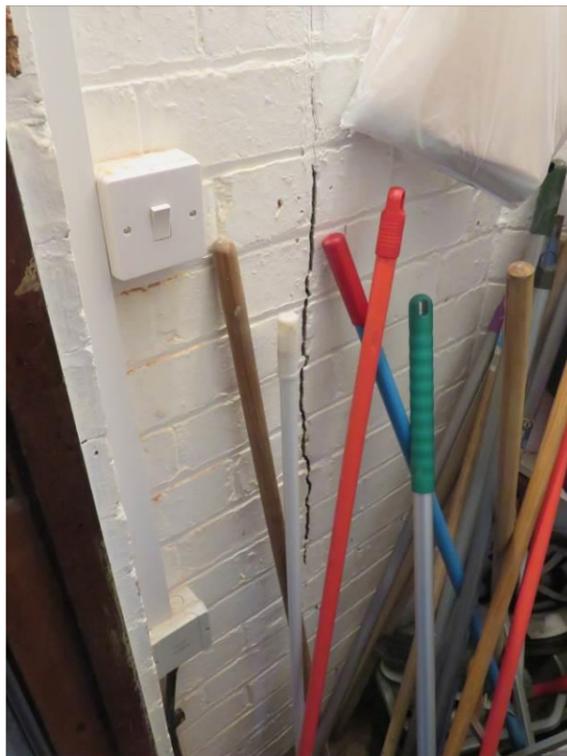
*Vertical crack in east corner of southwest tower*

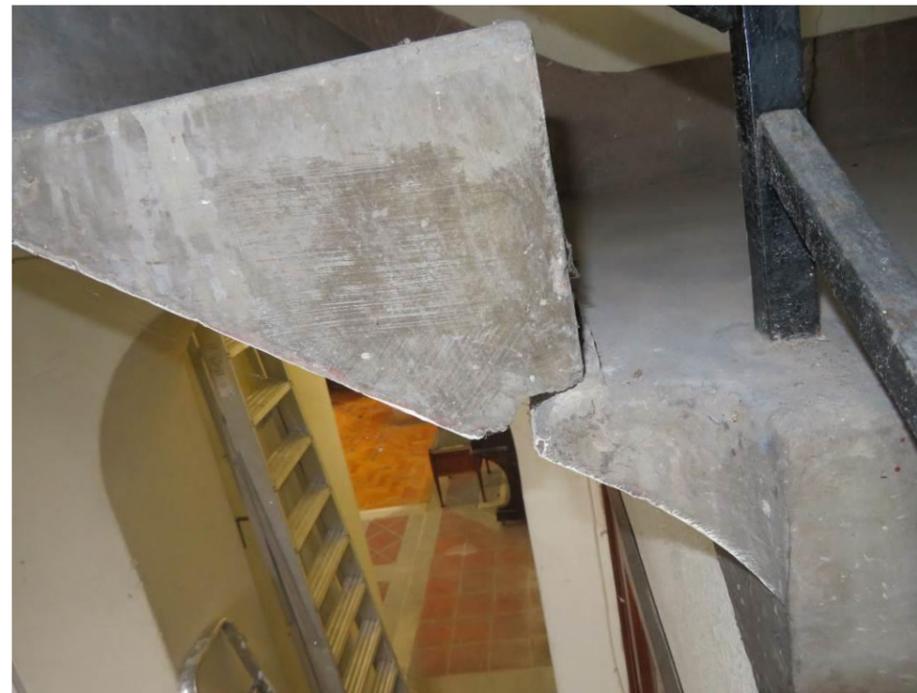
*Movement between concrete stair treads associated with vertical crack in east corner of southwest tower*

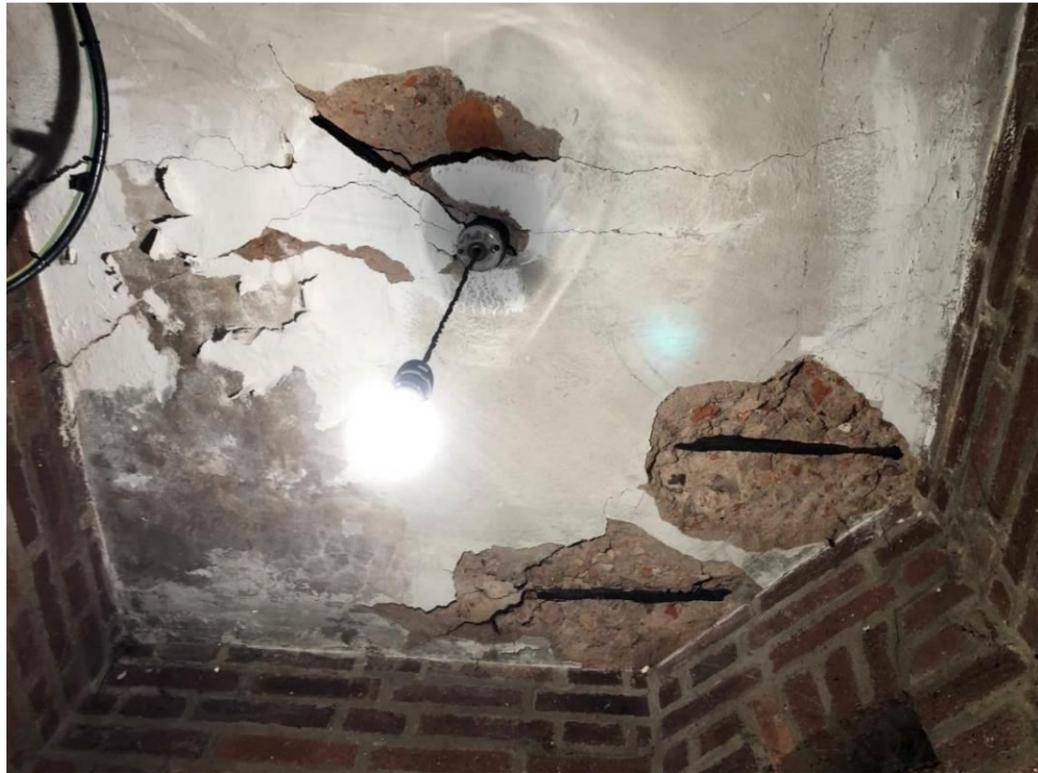
The roof to the tower is noted to comprise a concrete slab. The reinforcement in the slab has corroded, resulting in cracking and spalling of the concrete to the soffit.

*Spalled concrete and corroded reinforcement to soffit of roof slab in the southeast tower (photo taken from Quinquennial Inspection report by XXXX, dated October 2019)*

The spalling to the soffit of the southeast tower roof slab is the result of water ingress causing carbonation of the concrete, enabling corrosion of the reinforcement. This has been able to develop over a long period of time, but structural repairs will need to be undertaken at the earliest opportunity to maintain the integrity of the roof slab.

The soffit of the slab to the southeast tower is to be repaired using a lightweight high build concrete repair mortar. A detailed specification for the repair shall be prepared during the next stage of design, however a summary of the requirements for preparation and repair is set out in the following typical details.

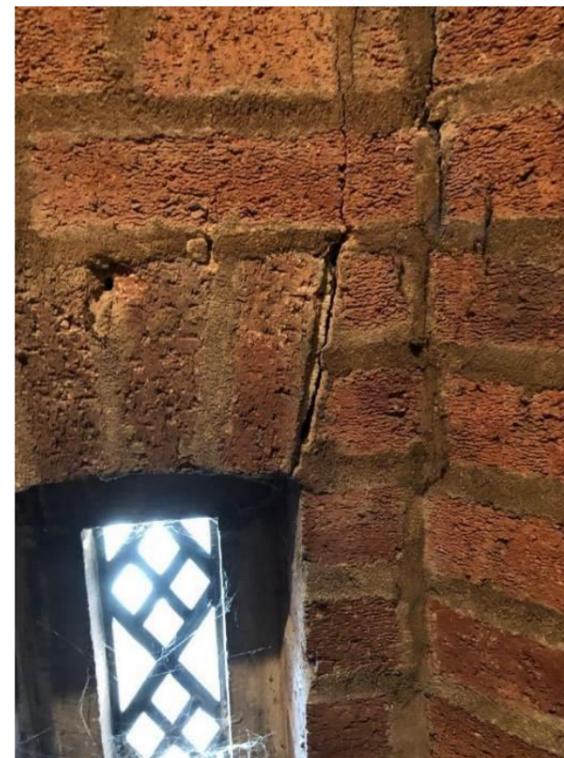
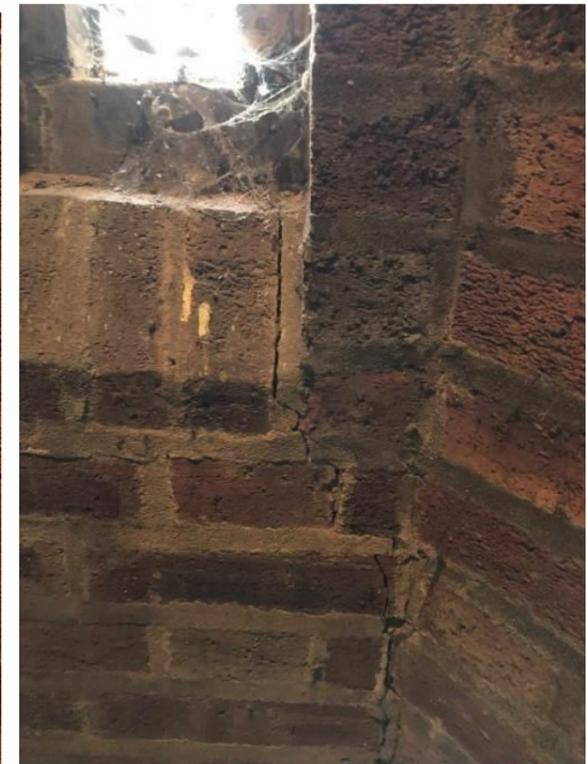
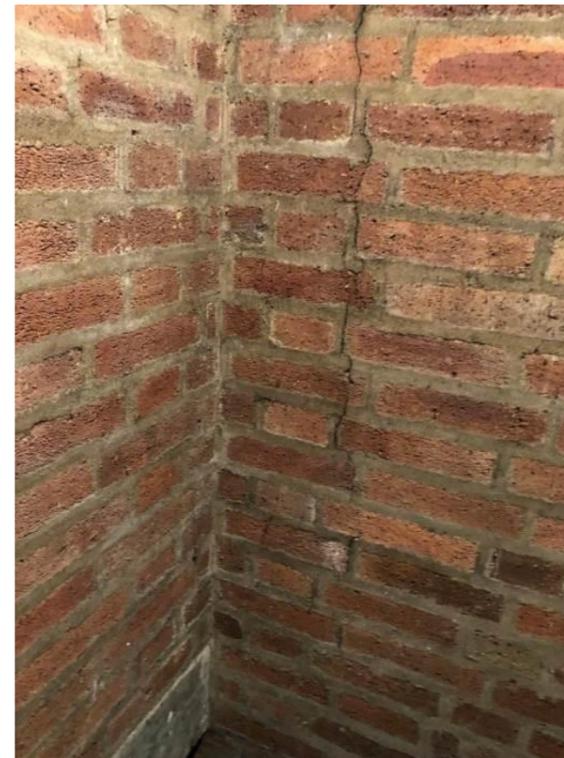
In addition, vertical cracks were noted in the brickwork to the external elevation of the tower. Cracks were noted to be slight, with a width of approximately 2mm.

*Vertical Cracks in southeast tower (photos taken from Quinquennial Inspection report by XXXX, dated October 2019)*

The vertical cracks to the southeast tower as recorded by XXXX similarly appear to be the result of thermal movement of the brickwork.

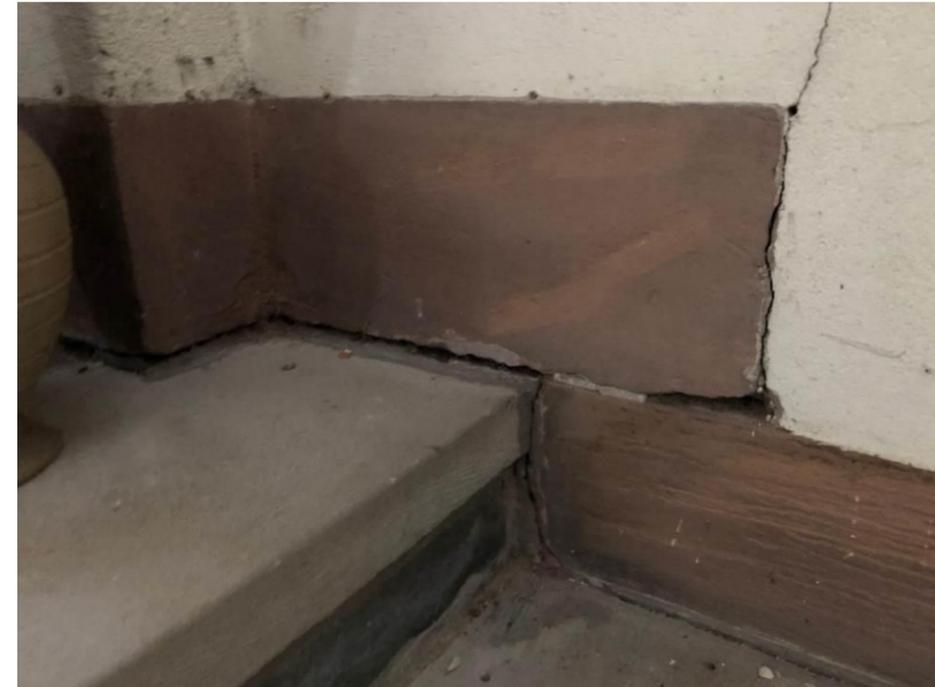
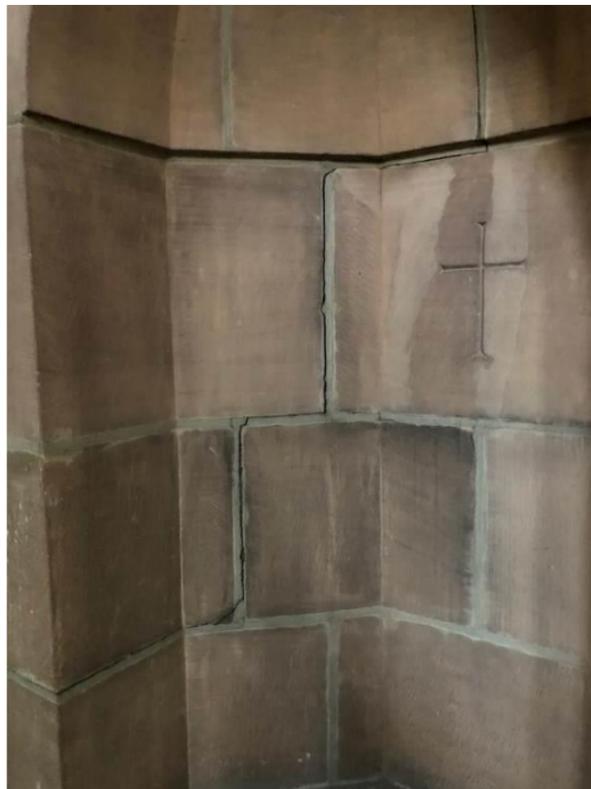
*Cracking was recorded to the east wall to the Chancel Stone plinth behind the altar. Open joints at low level. Cracking to the rendered infill. A horizontal crack runs through to the right hand side of the stone plinth and to the right hand rendered panel and stone string at mid and high level. Clearly there is some movement occurring here. Note: there are some large trees just the other side of this wall which the church is considering felling in the not too distant future. They are taking advice from a tree specialist.*

**Cracking to masonry behind altar (photos taken from Quinquennial Inspection report by XXXX, dated October 2019)**

The cracking in the Chancel area as recorded by XXXX takes a different form, with diagonal cracks noted in masonry and above openings. The report suggests that ground movement due to the proximity of trees in this location is the cause and recommends a watching brief.

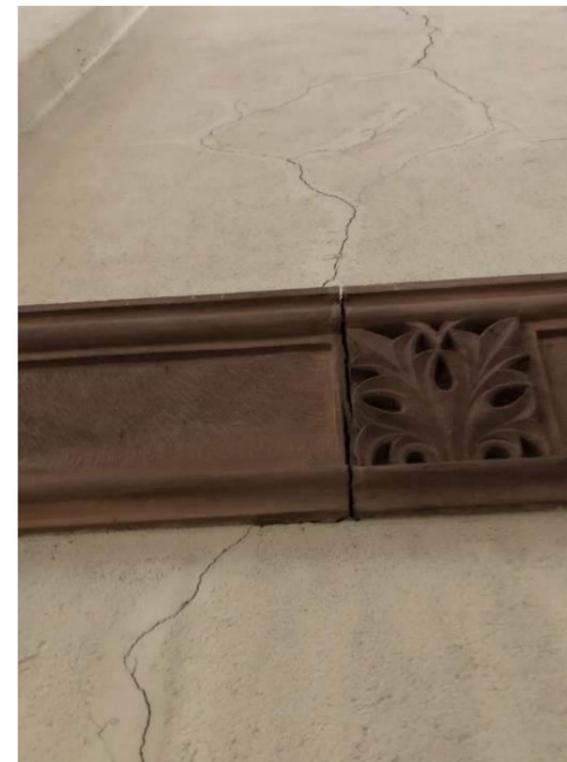
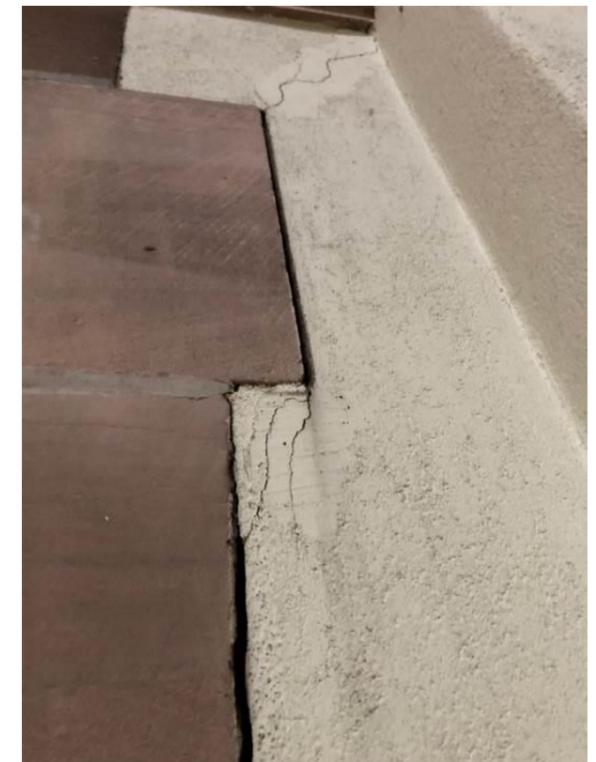
*Stone Lime Sedilia (Eastern of the two in the north wall) - Cracks between vertical stone dressing and adjacent the render. This has been mentioned in previous quinquennials and cracks in the render have been filled but are opening up again. A watching brief should be kept.*

**Cracking in Chancel (photos taken from Quinquennial Inspection report by XXXX, dated October 2019)**
