BRIEF: Carry out a full condition survey of three campus buildings in Oxfordshire.

Case Study

Full Building Condition Survey of Campus Buildings

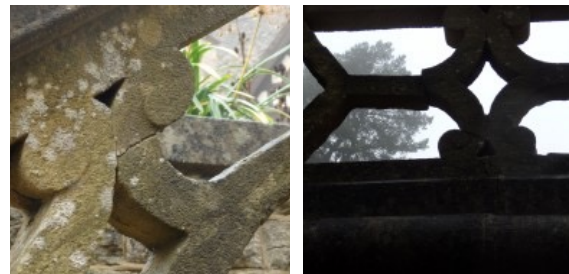
- We also noted some structural movement in several areas of the property, but the evidence we found on site suggested that this was historic and not likely to cause further problems.

STEPS AND BALUSTRADING SHOWED SIGNIFICANT DISTORTION, INDICATING HISTORIC MOVEMENT

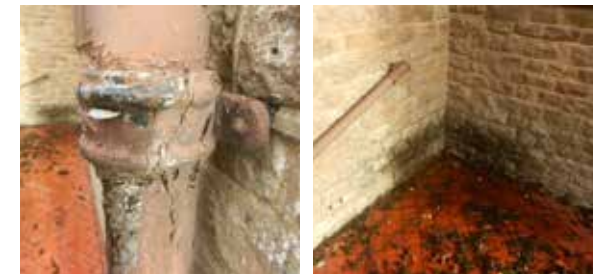
GUTTERS NEEDED TO BE REPAIRED. LEAKING FROM RAINWATER GOODS CAUSING INTERNAL DAMP STAINING

- We found 20 items that would benefit from attention in the short term, including gutter repairs and maintenance, repairing rot and decay in the timber windows, and repair of glazed doors to prevent the contravention of regulations and bring them up to current safety standards.
