**BRIEF:** Carry out a full building survey to highlight any issues or defects, and to support budgeting for repairs and maintenance.

**PROPERTY:** University college building and chapel, dating from the early 19th century.

## Case Study Full Condition Survey of a University Hall Building

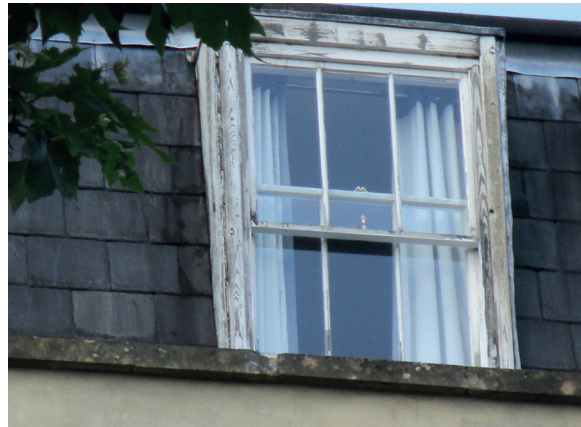
- In the immediate term, the windows were clearly in need of significant repair. We costed the repairs and redecoration works at approximately £60,000.

**THE WINDOWS WERE CLEARLY  
IN NEED OF SIGNIFICANT REPAIR**

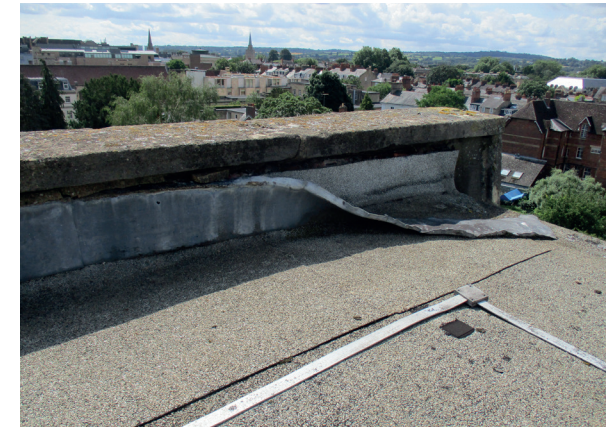
**THE FLAT ROOF WAS ALSO  
IDENTIFIED AS AN AREA OF CONCERN**

- In the medium term, the flat roof would need replacing (est. £70,000); however, in general the condition of the roof was commensurate with its age. Its lifespan could be increased by carrying out repairs to the flashings at the roof perimeter; we recommended doing this immediately to prevent water ingress. We advised that £3500 would be needed for this work.
