# Elements Survey Report

Report Date: 22<sup>nd</sup> May 2023

| <b>1.10</b> | <b>General Description</b> | Mid terrace retail unit comprising ground and basement accommodation in a retail complex |

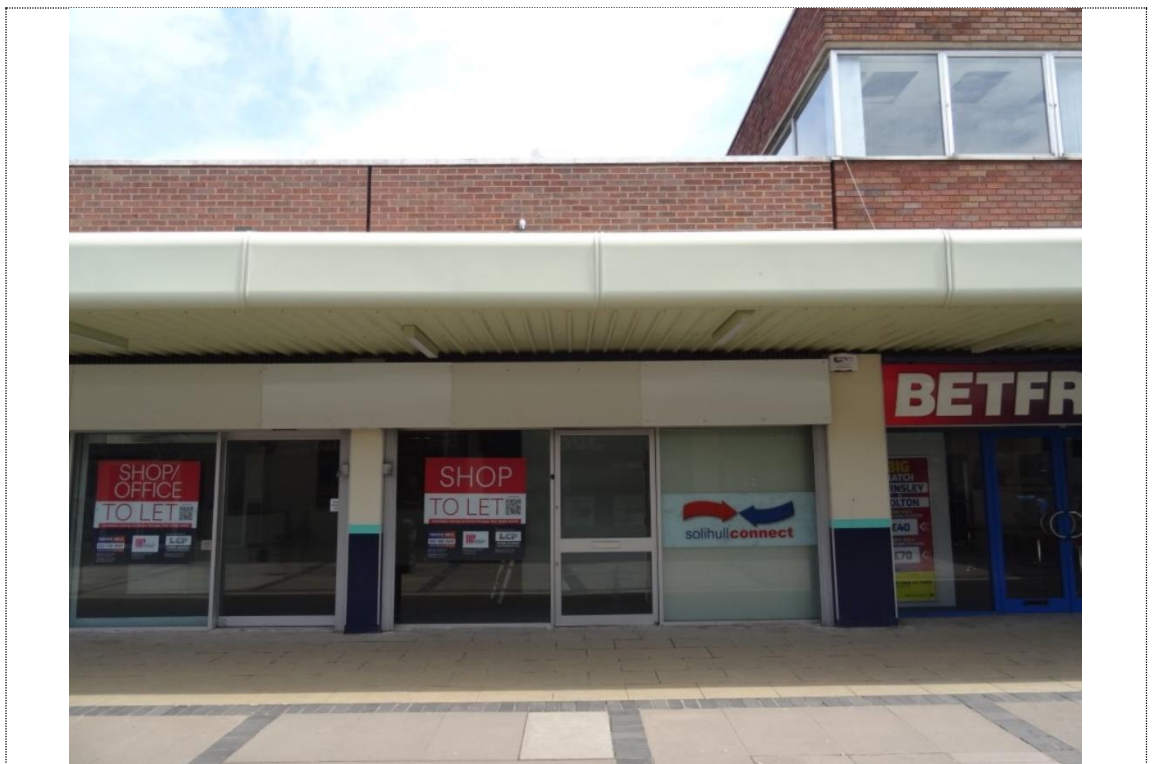
| Photograph | 2 |

| 2.02 | <b>Main External Walls - Front</b> | <p><b>Description/Photo:</b> Front parapet wall above canopy assumed cavity brickwork. No significant cracking, damage or deterioration noted.</p> <p style="text-align: right;">Photos 2 - 3</p> <p><b>Defect:</b> None</p> <p><b>Remedial Action:</b> None</p> |

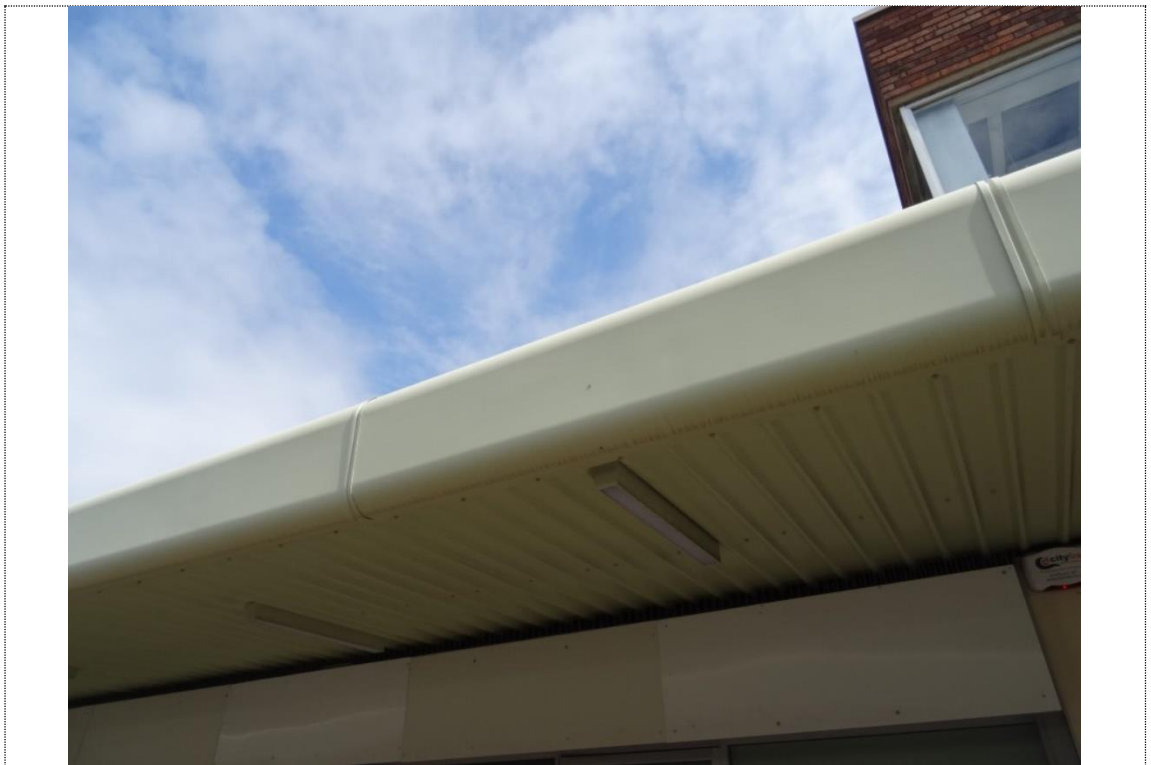
| Photograph: | 4 |

| <b>2.03</b> | <b>Canopy – Front</b> | <p><b>Description/Photo:</b> Metal profile sheet canopy. No impact damage or deterioration.</p> <p style="text-align: right;">Photos 3 - 4</p> <p><b>Defect:</b> Begrimed.</p> <p><b>Remedial Action:</b> Deep clean.</p> |

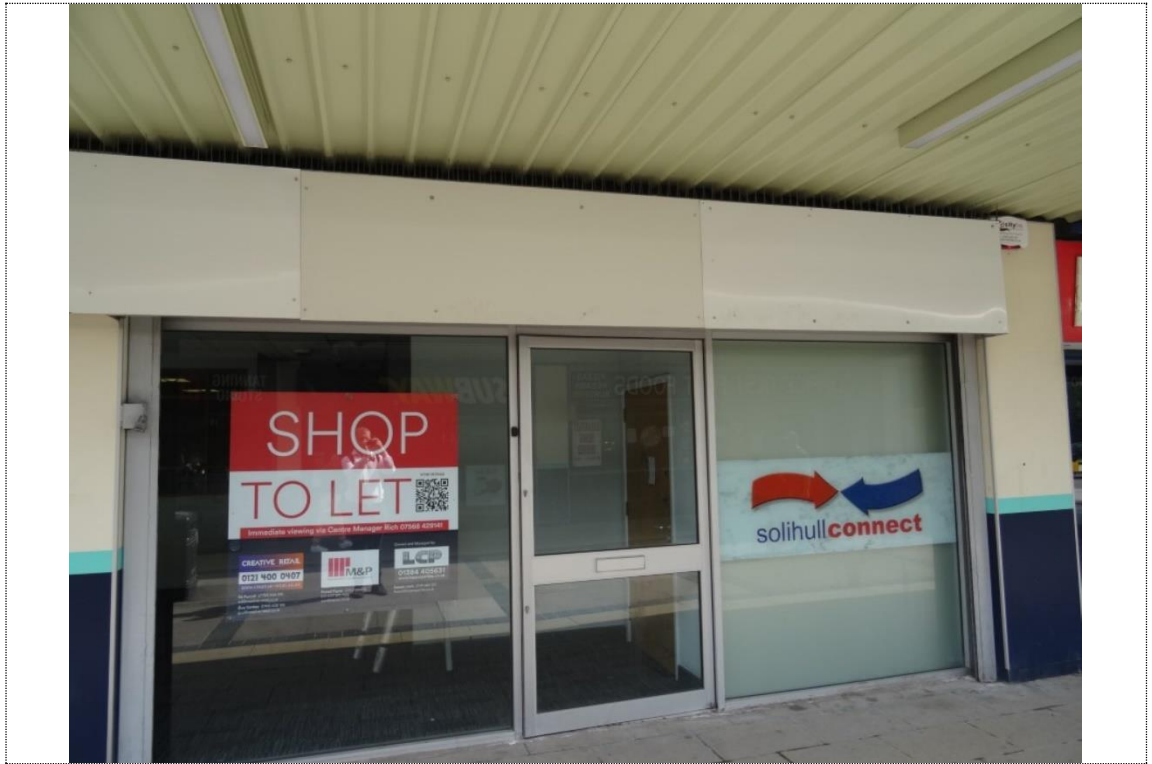
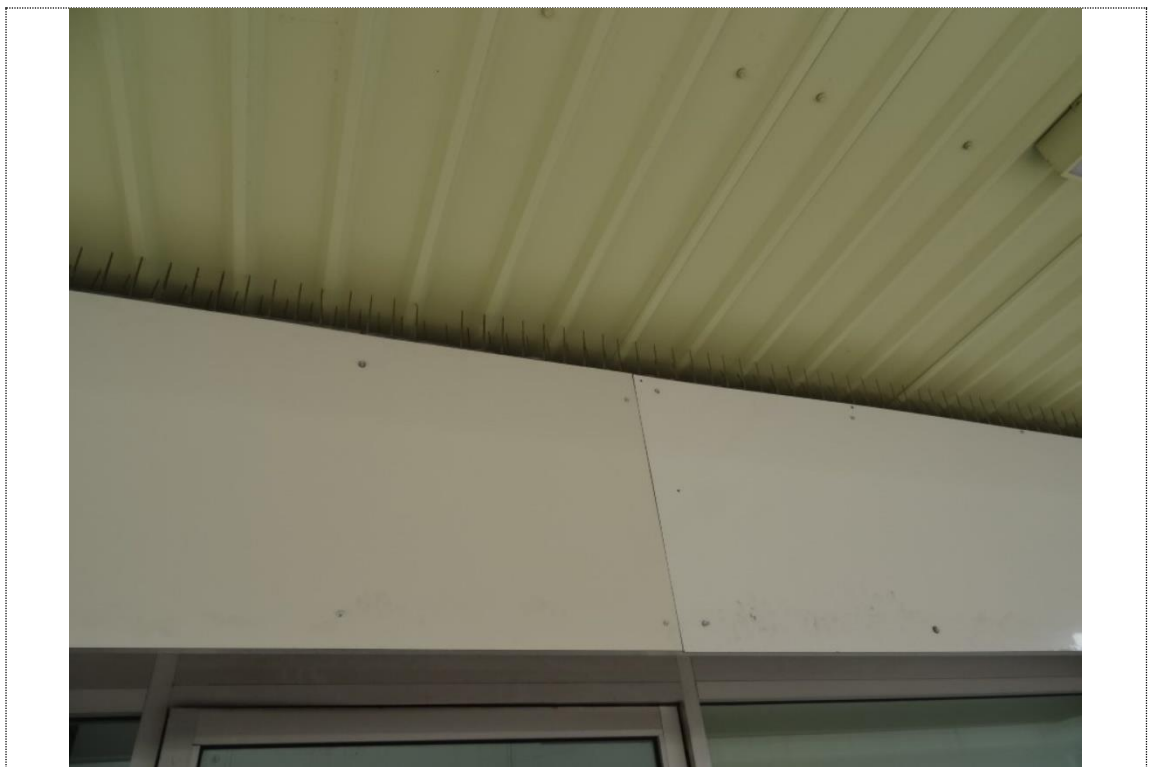
| <b>2.04</b> | <b>Shopfront</b> | <p><b>Description/Photo:</b> Blank signage installed. Roller shutter installed showing some minor corrosion. The entire shop front is single glazed within aluminium frames. No toughened markings noted to glass.</p> <p style="text-align: right;">Photos 5 - 7</p> <p><b>Defect:</b> Scuffed and begrimed.</p> <p><b>Remedial Action:</b> Deep clean.</p> |

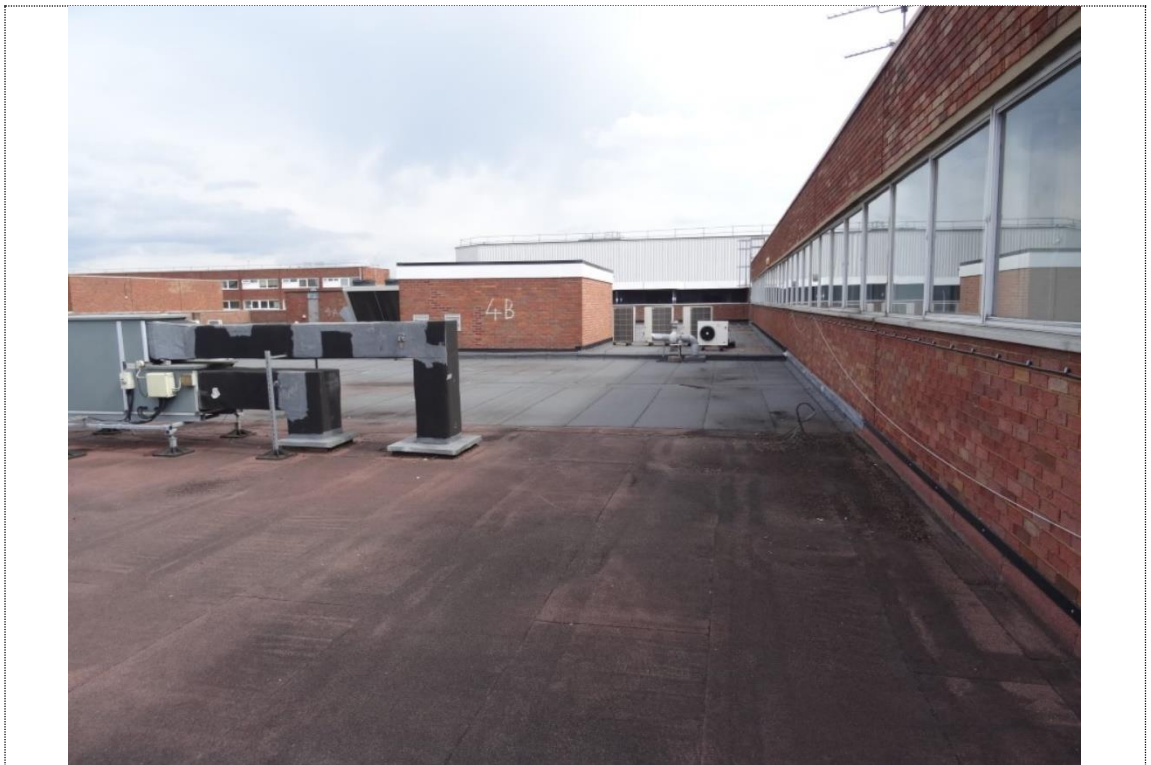
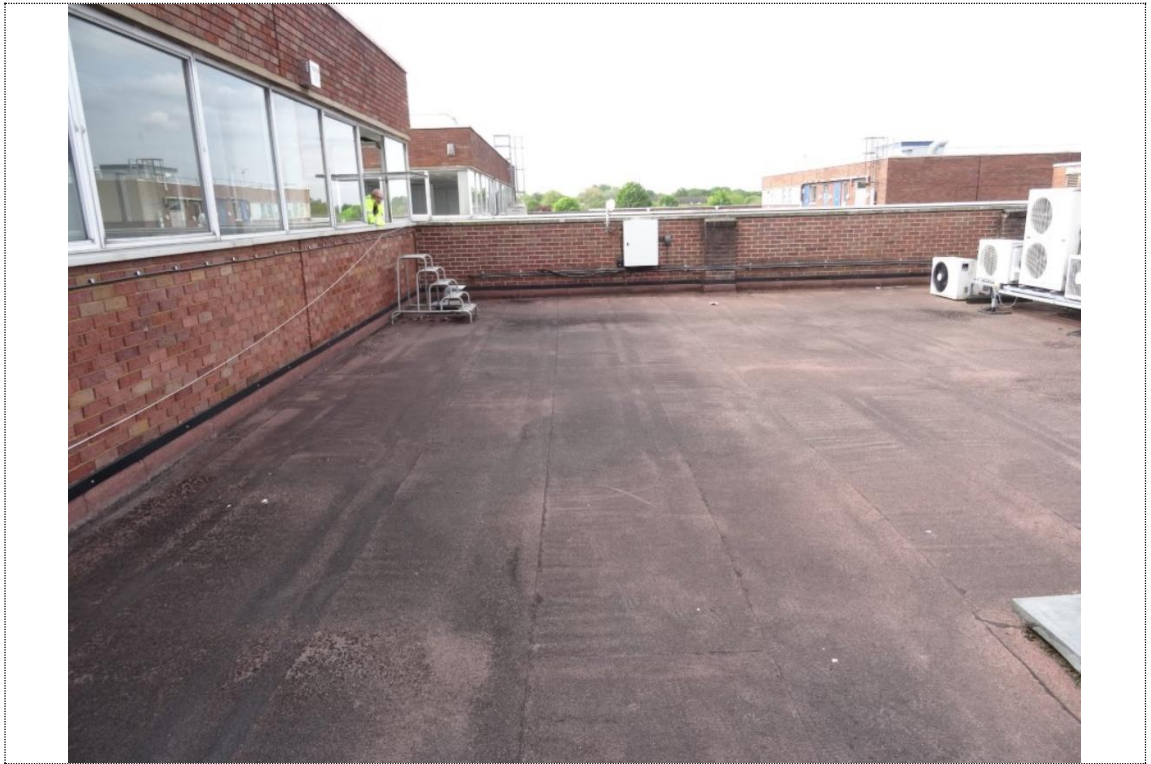
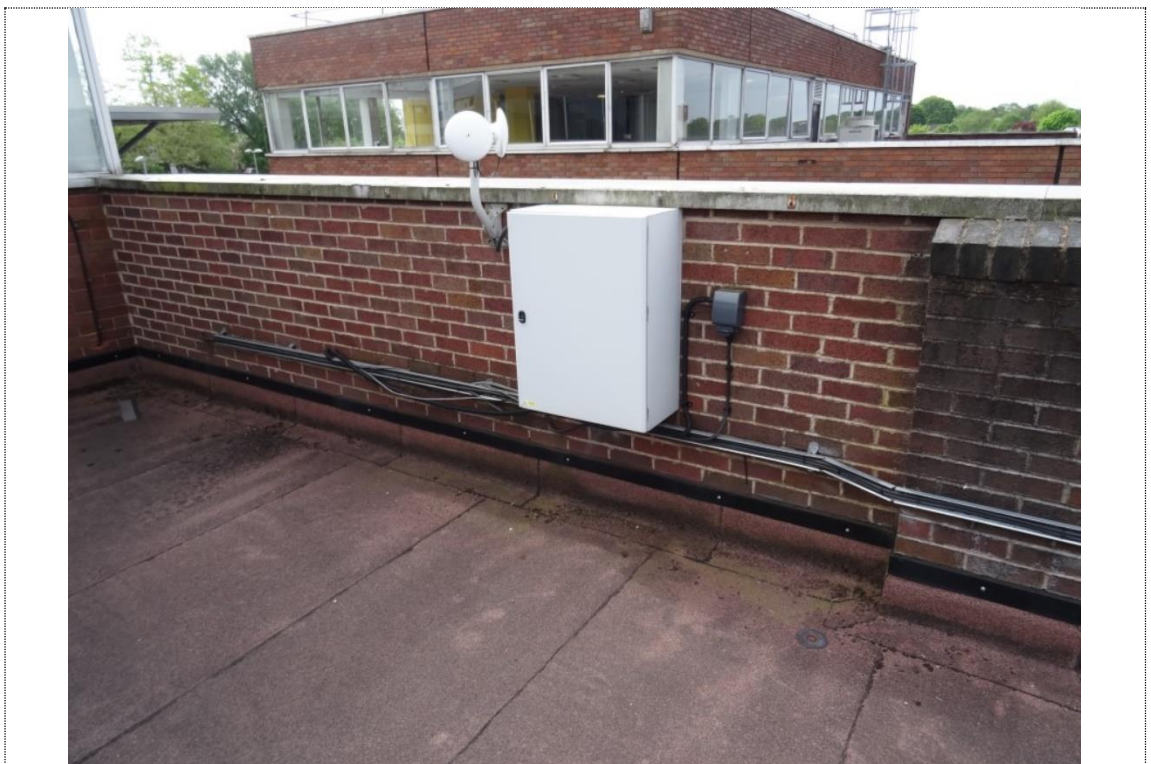
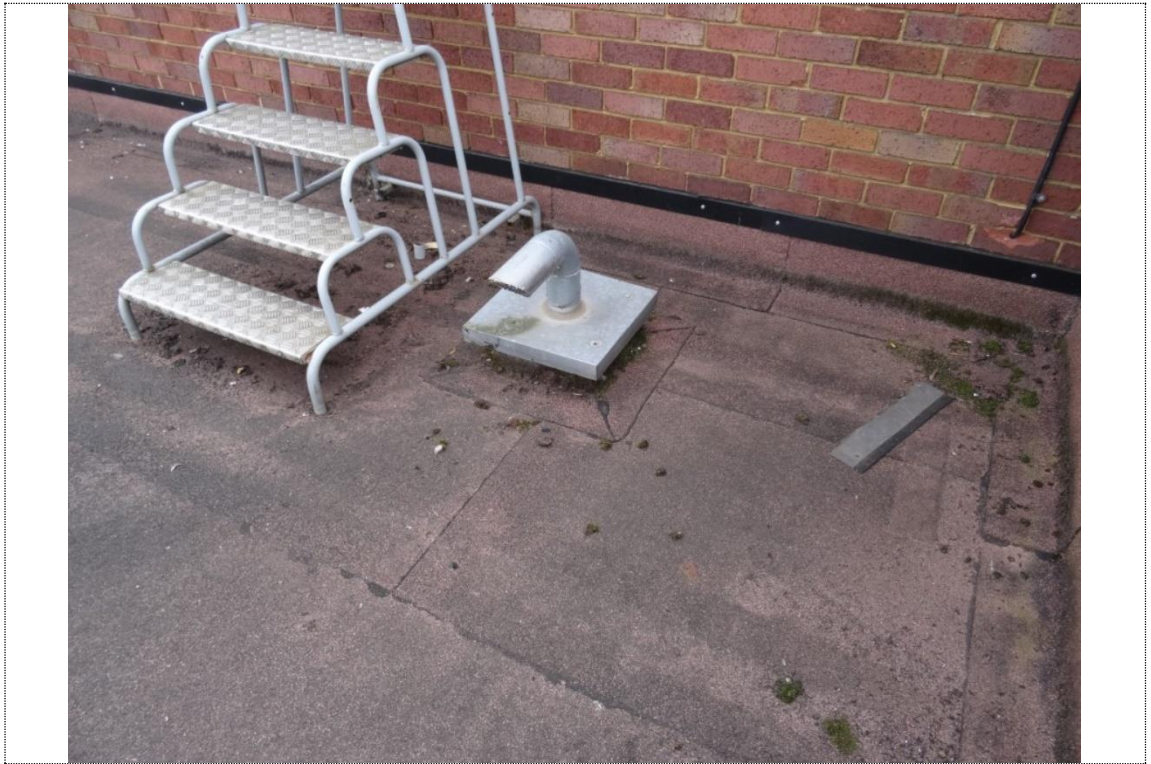
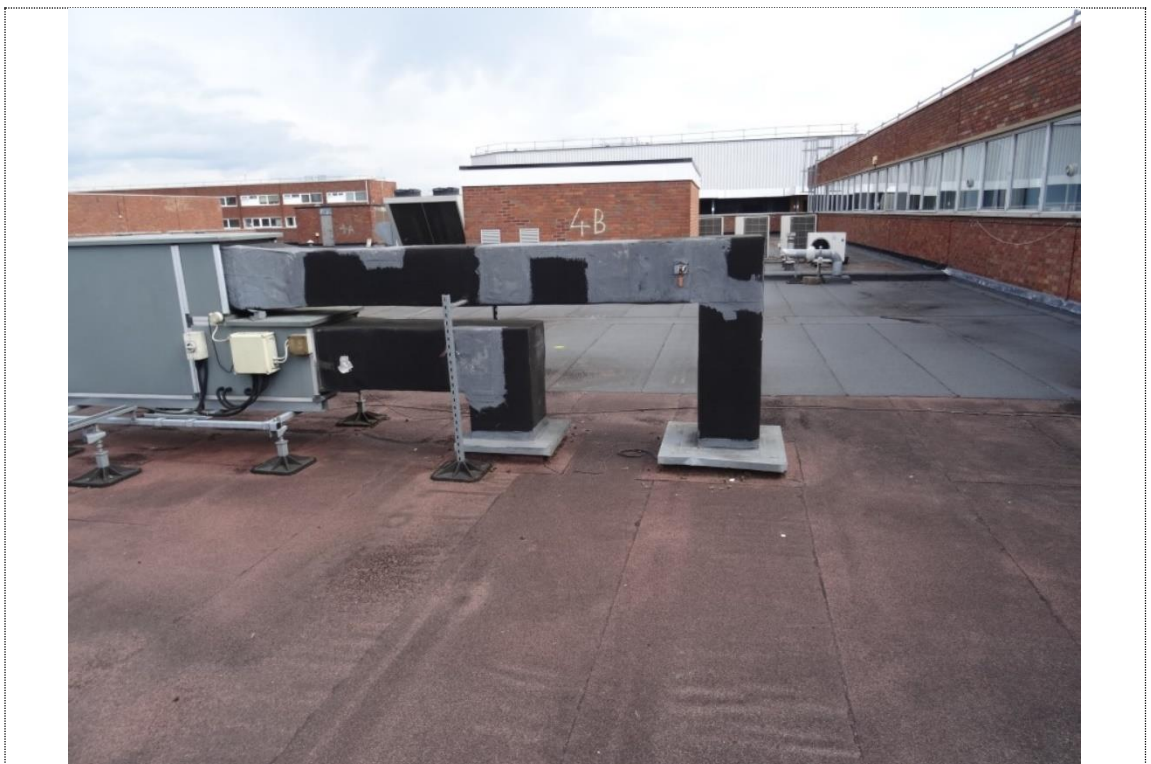
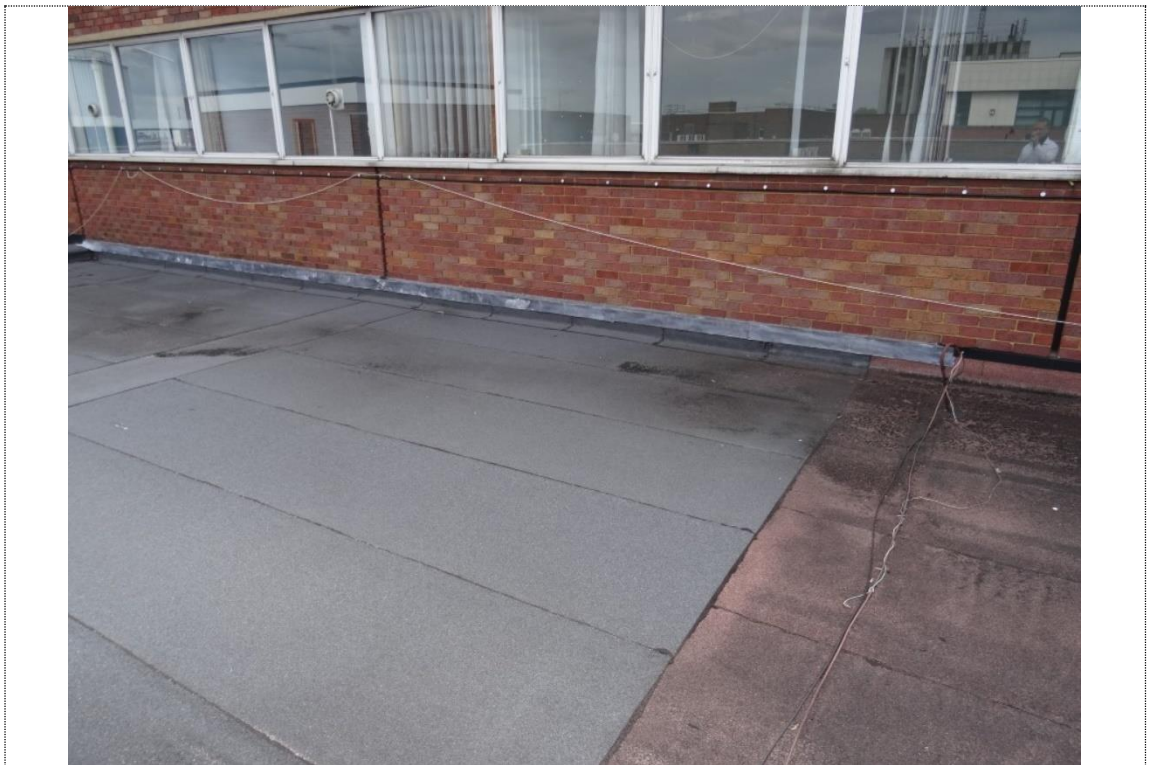
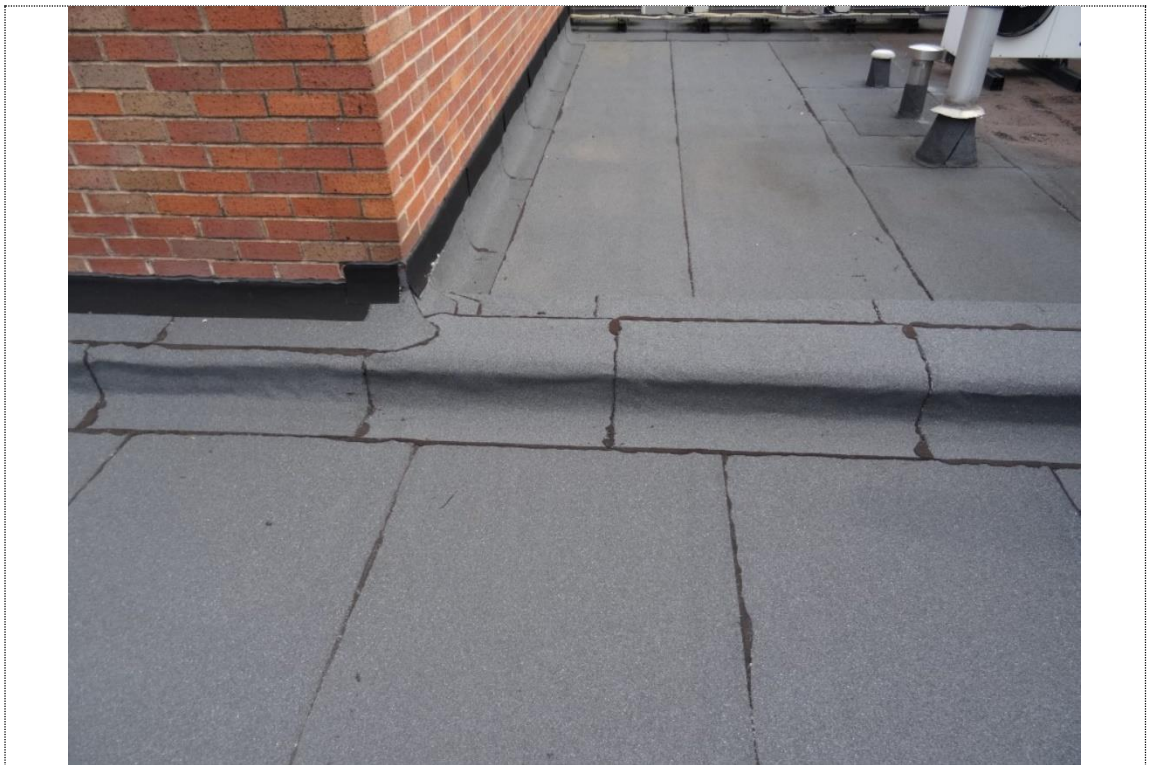
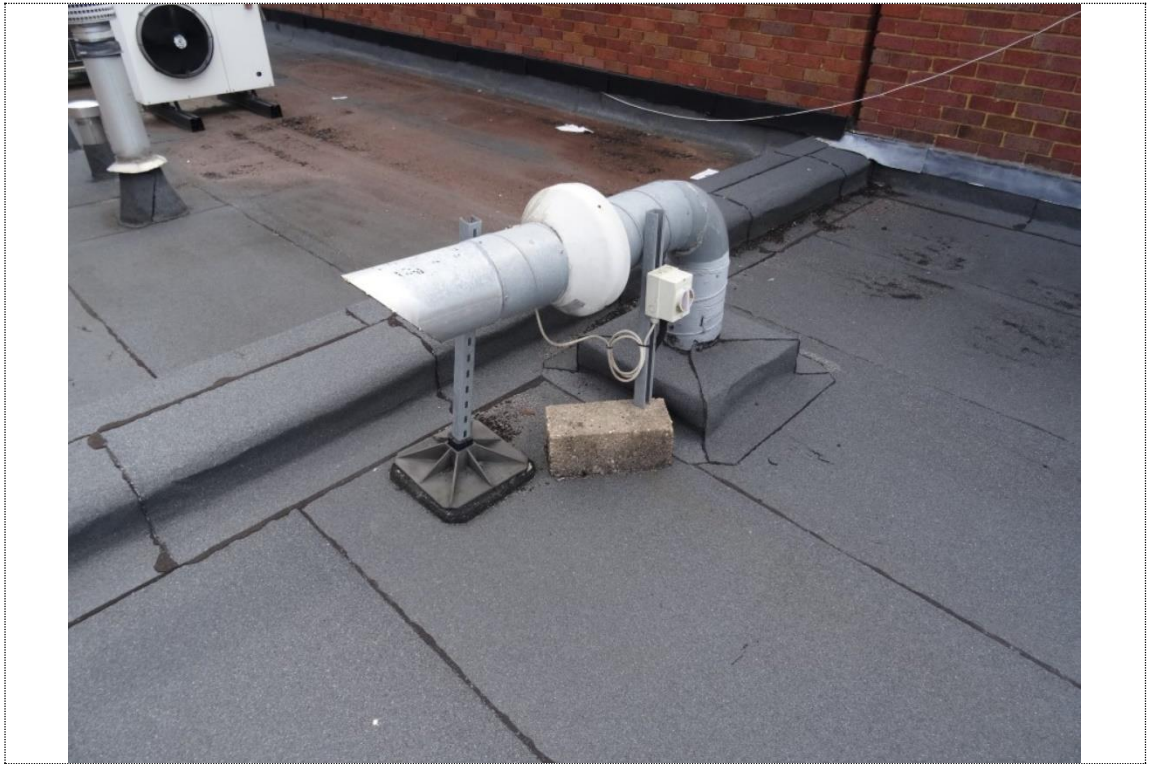
| 2.01 | <b>Flat Roofs</b> | <p><b>Description/Photo:</b> Covered with felt to the entire property. Vents/ducts provided for extractor fans and air conditioning systems and appear in a serviceable condition.</p> <p style="text-align: right;">Photos 8 - 17</p> <p><b>Defect:</b> No provision for rainwater management within curtilage of subject property. Lack of falls noted.</p> <p><b>Remedial Action:</b> Monitor and remedy if required however considered unlikely. Remedial work likely to be costly and problematic unless considered as part of the next re-roofing works.</p> |

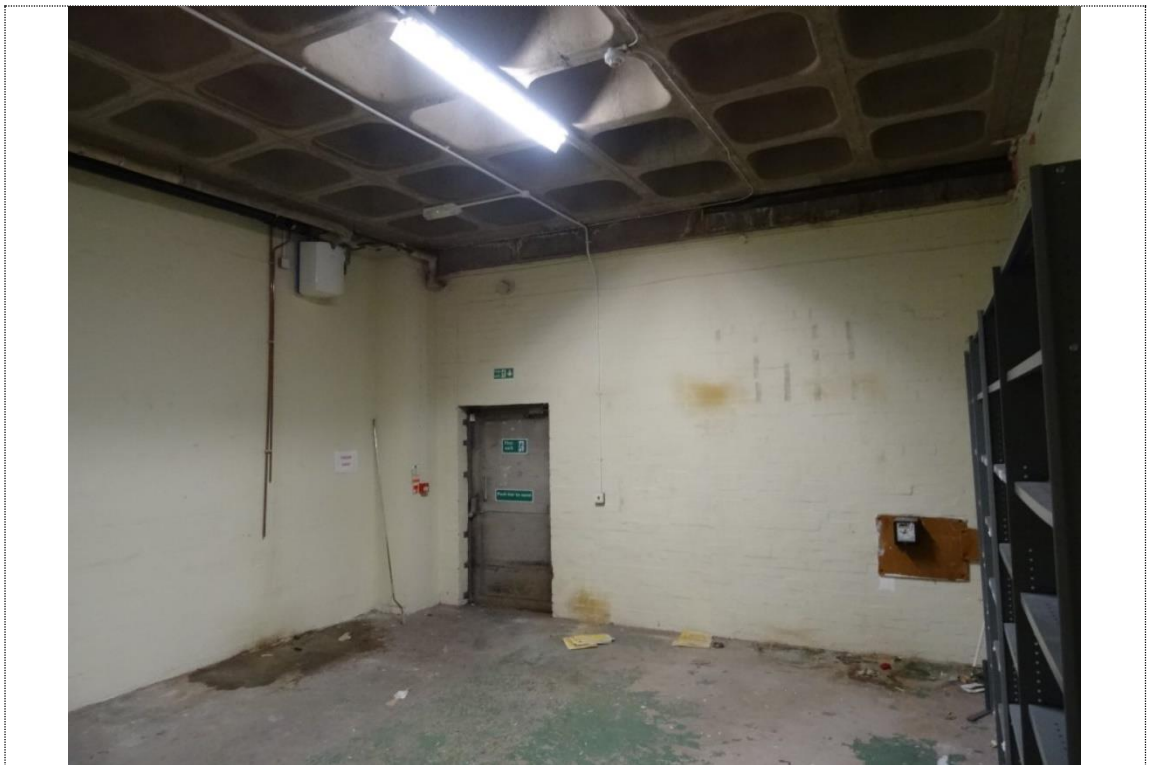
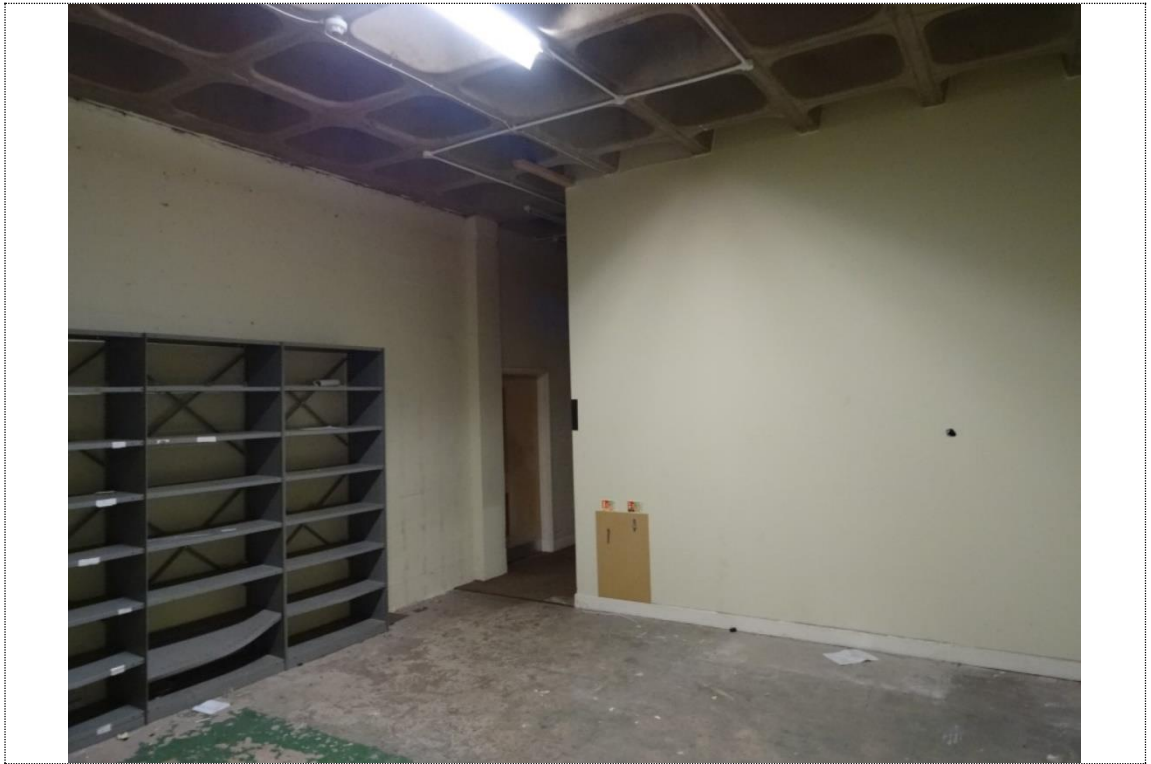
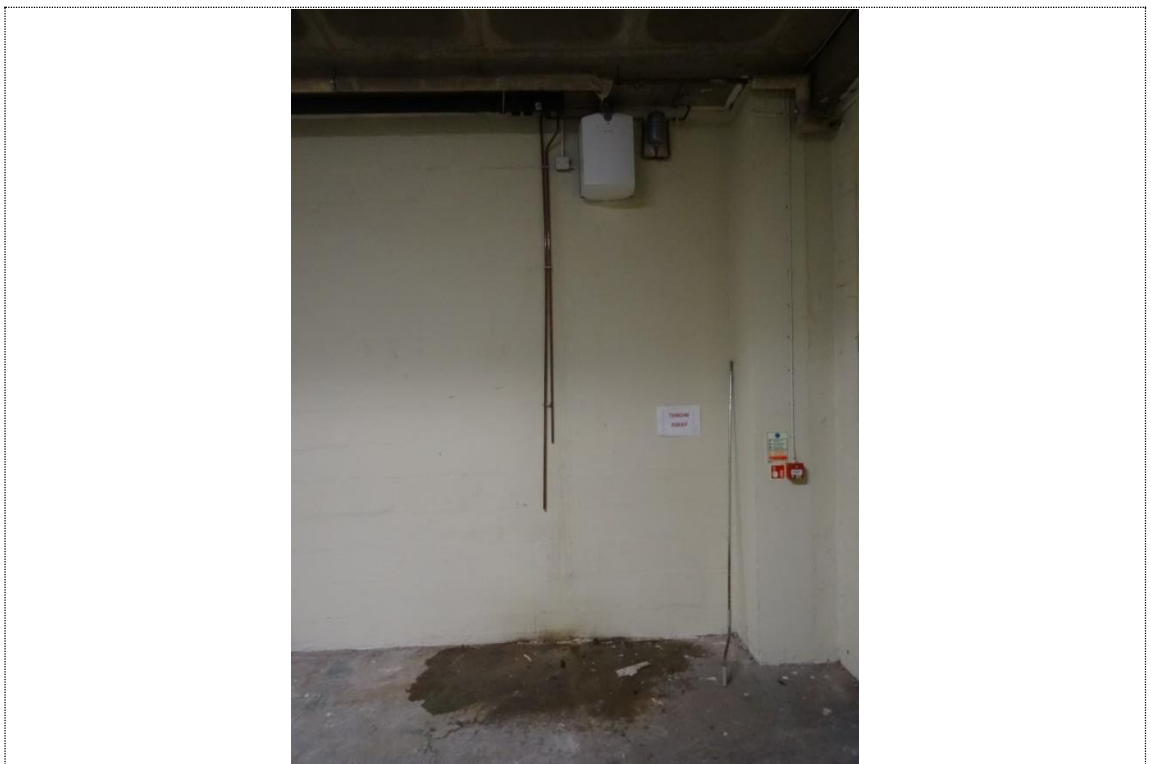
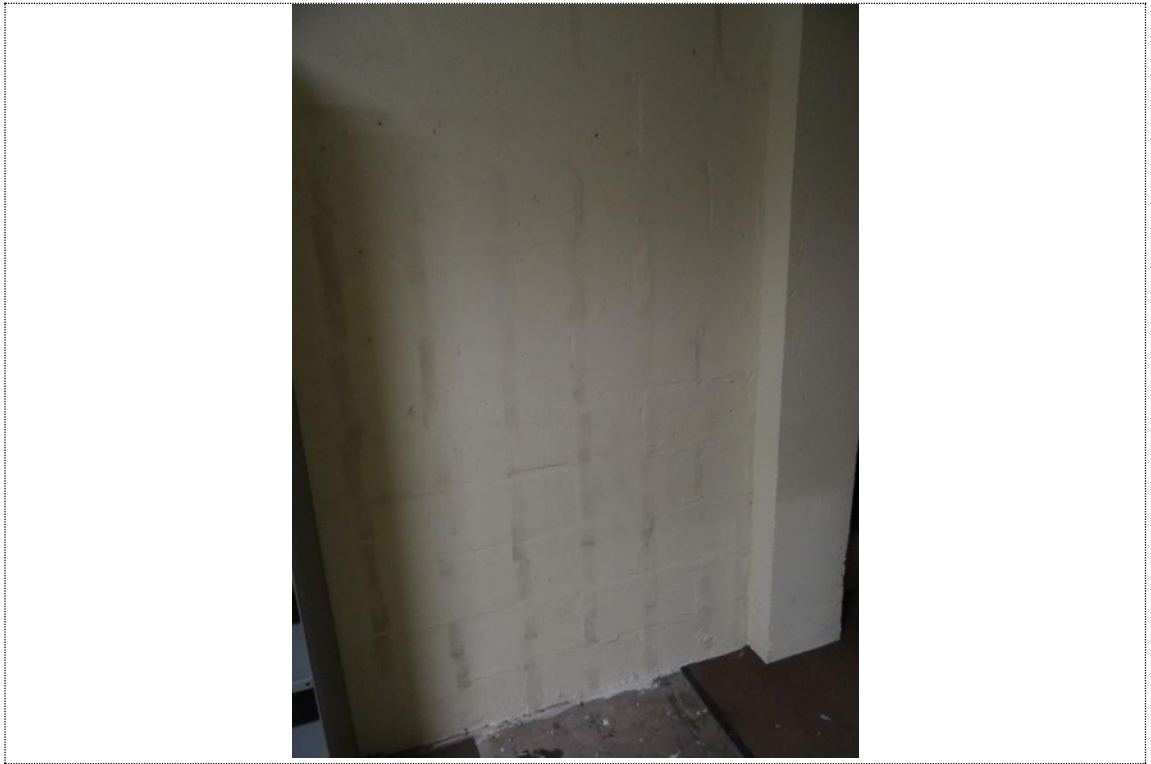
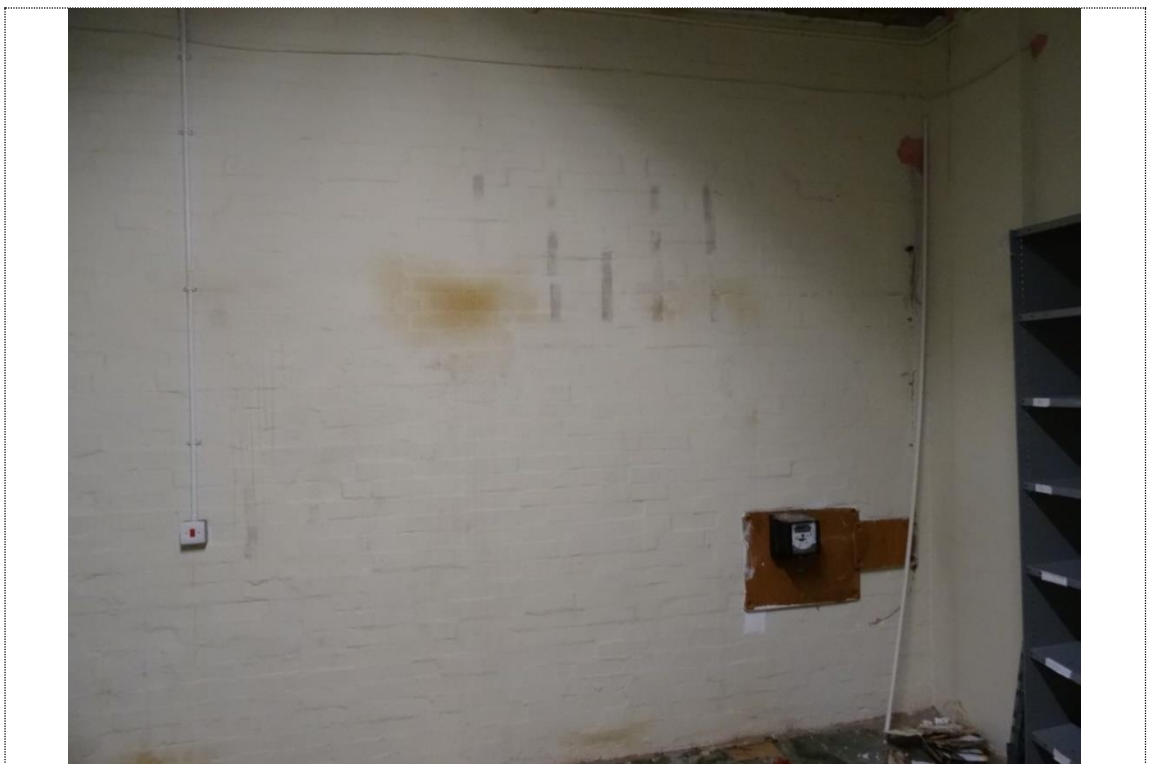
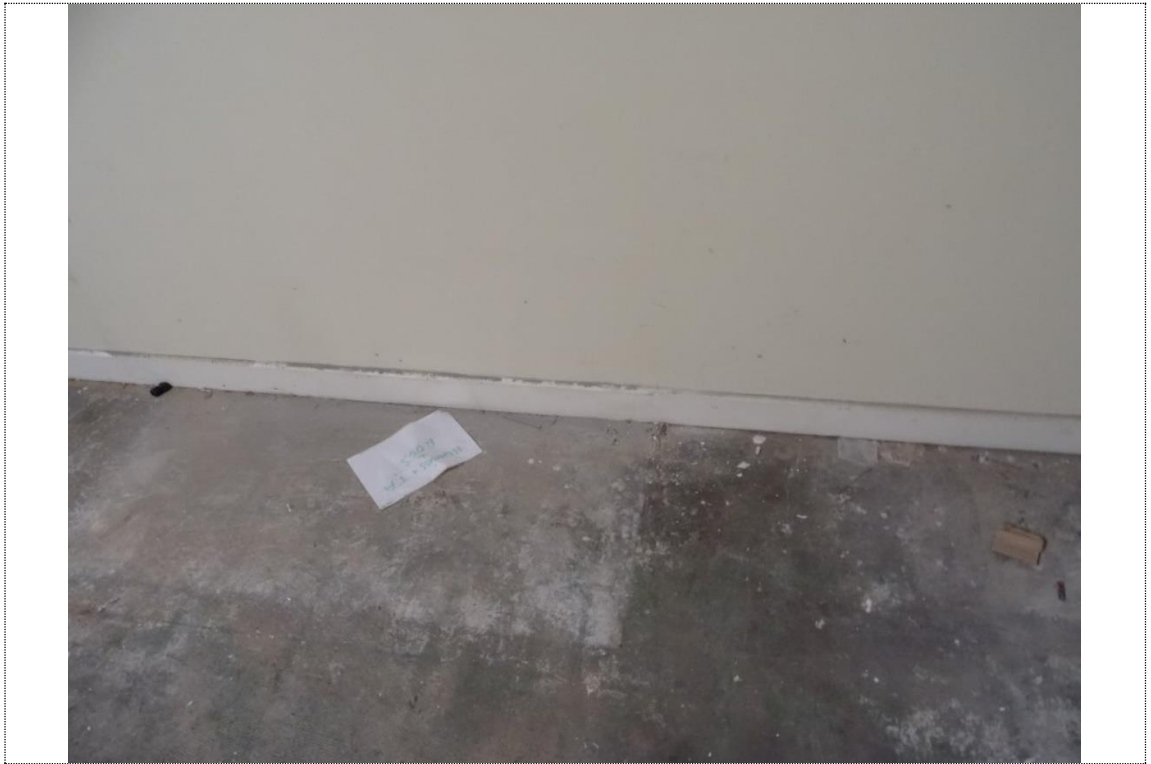
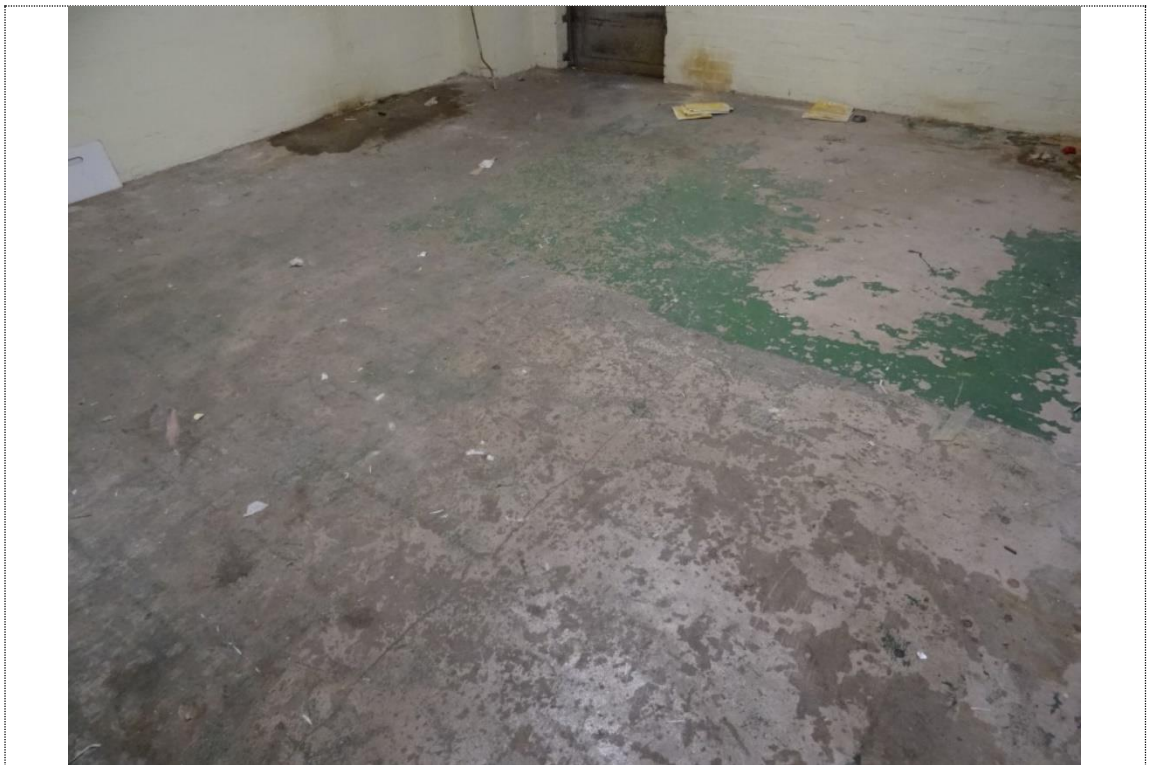
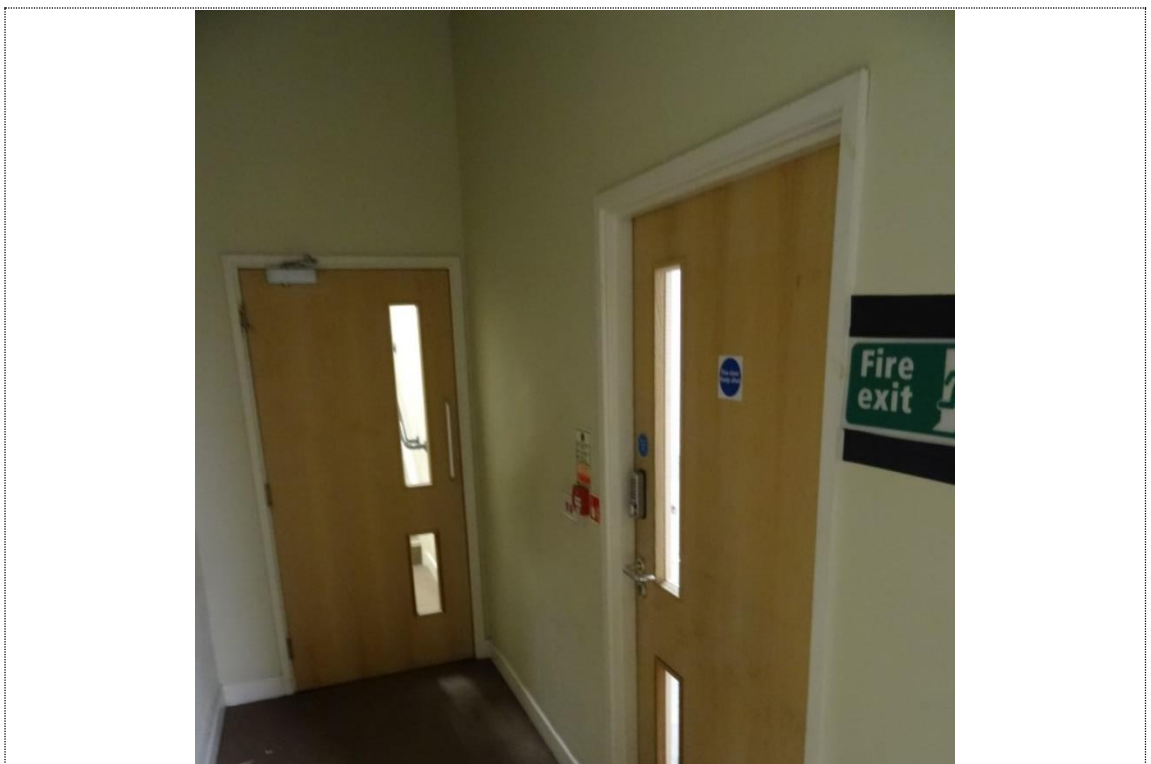
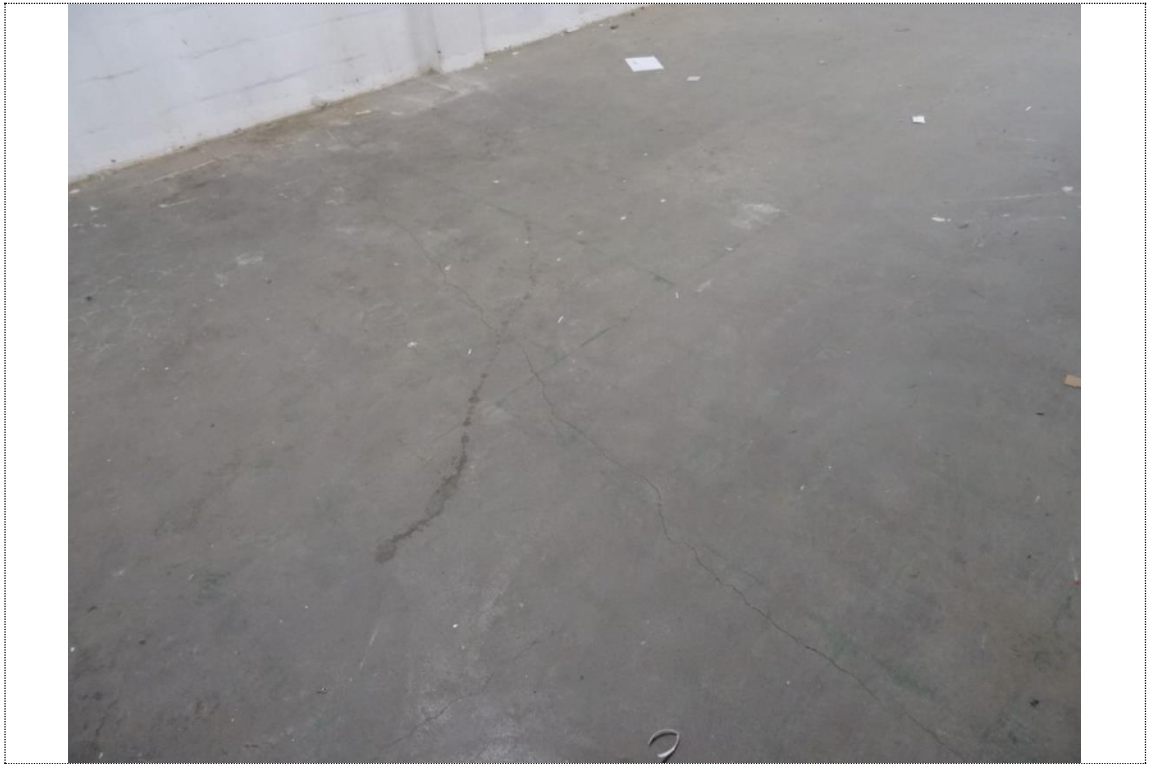
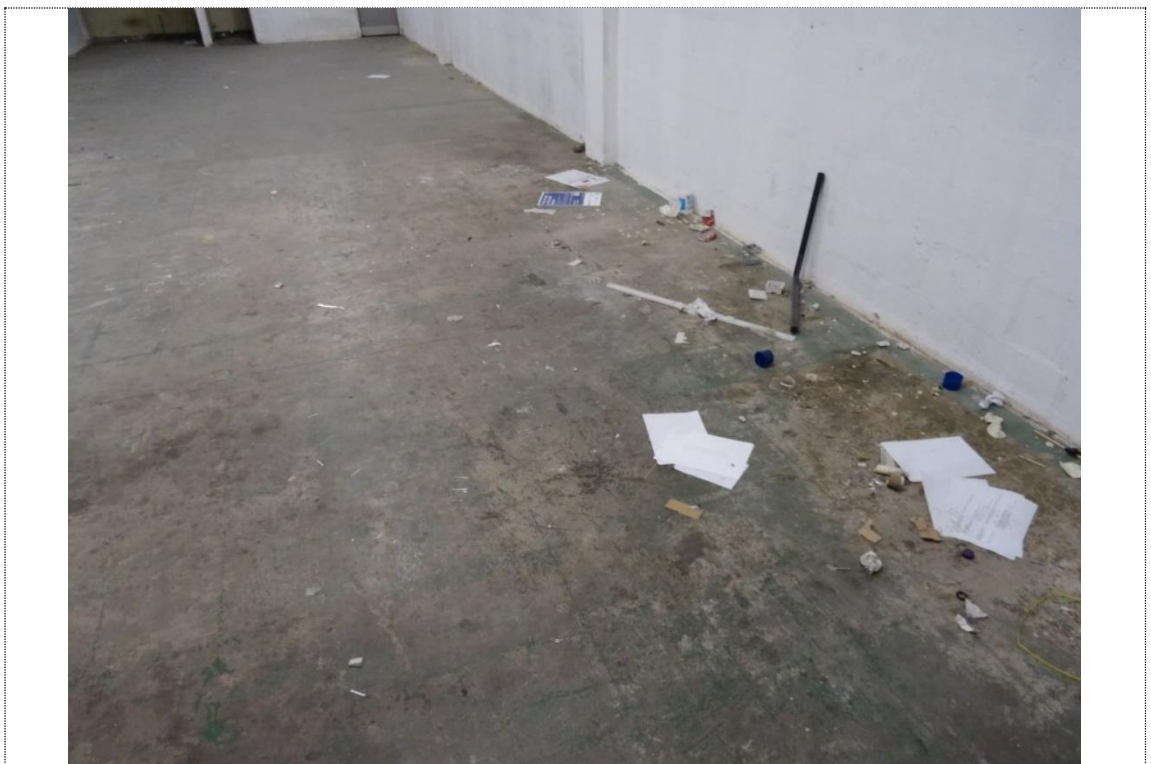
| 3.04 | Basement walls and floors | <p><b>Description/Photo:</b> Largely decorated brickwork and blockwork. Some decorated plasterboard walls adjacent to internal doors.</p> <p>Photos 18, 19, 22-26, 30-32, 35, 36</p> <p><b>Defect:</b> Decorative finish deteriorating in errors. Some impact damage to the right of the stairs.</p> <p><b>Remedial Action:</b> Redecorate and repair damage to provide adequate fire compartmentation.</p> |

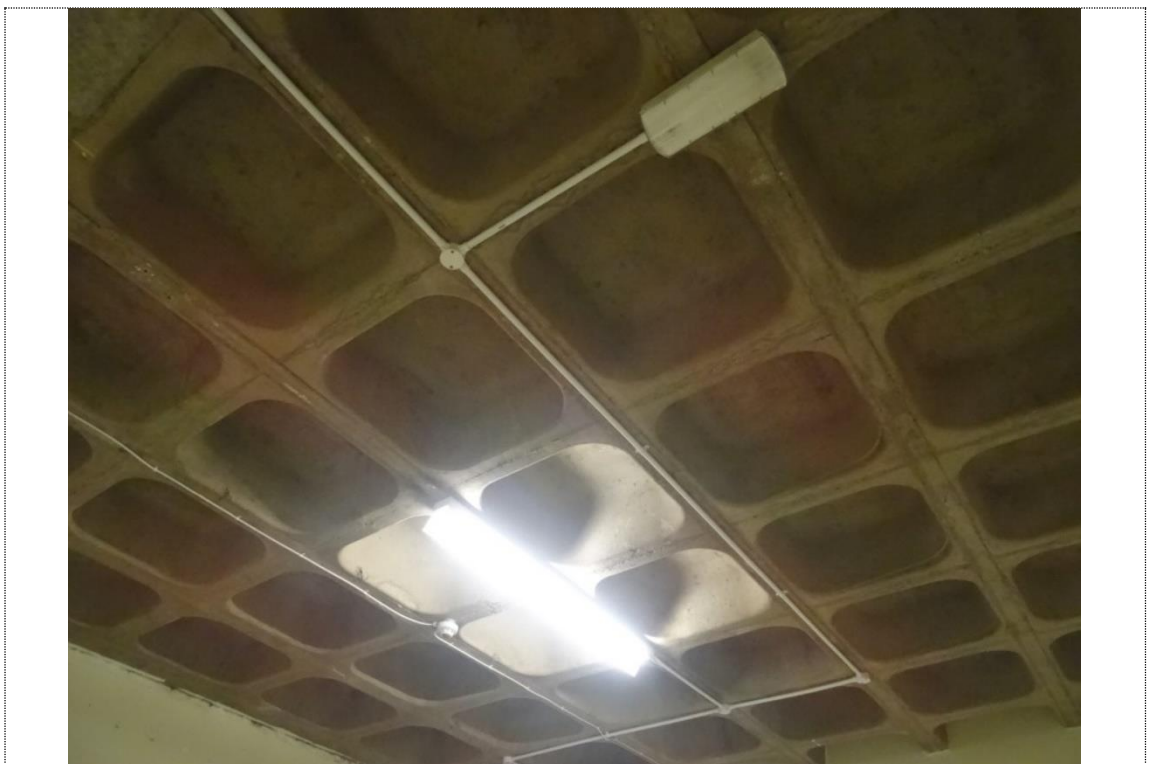
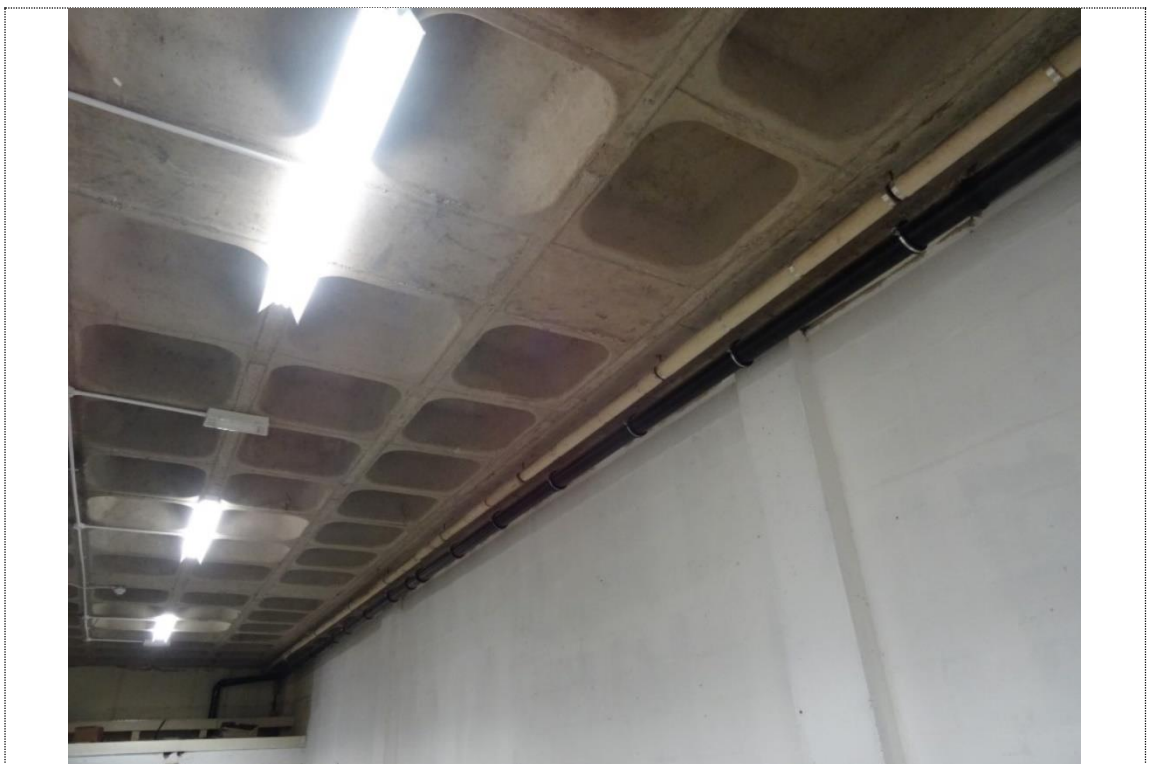
| <b>3.01</b> | <b>Basement Ceiling Structure (Ground floor structure)</b> | <p><b>Description/Photo:</b> Profiled concrete.</p> <p style="text-align: right;">Photos 20, 21, 33 and 34</p> <p><b>Defect:</b> Some minor cracking noted in areas, not considered significant. Repairs carried out to the front of the basement to suggest possible water ingress issues between the wall and ceiling.</p> <p><b>Remedial Action:</b> Monitor and carry out suitable watertight repair should water ingress become evident.</p> |

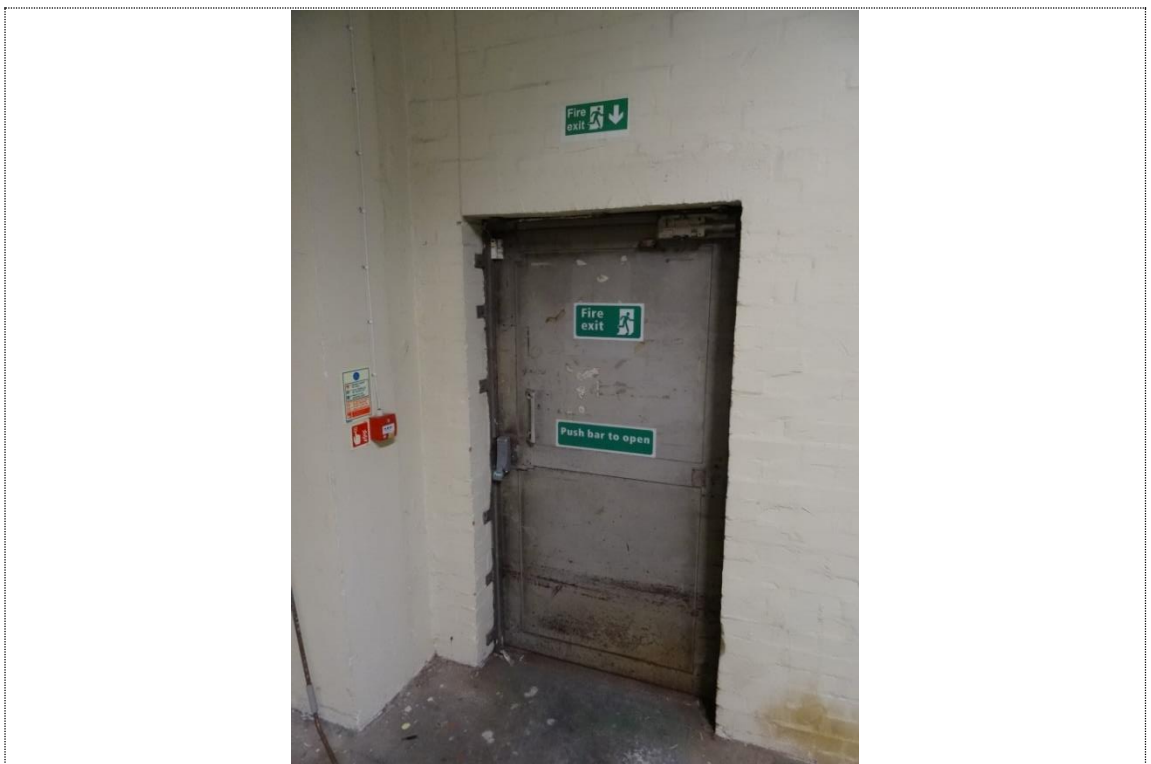
| <b>3.02</b> | <b>Basement Front wall and door</b> | <p><b>Description/Photo:</b> Brickwork showing no significant cracking or deterioration. Fire Exit door scuffed and dated however serviceable and operational.</p> <p style="text-align: right;">Photos 28 and 29</p> |

| | | <p><b>Defect:</b> Begrimed.</p> <p><b>Remedial Action:</b> Deep clean.</p> |
