# Elements Survey Report

Report Date: 22<sup>nd</sup> May 2023

| <b>1.10</b> | <b>General Description</b> | Mid terrace retail unit comprising ground and basement accommodation in a retail complex |

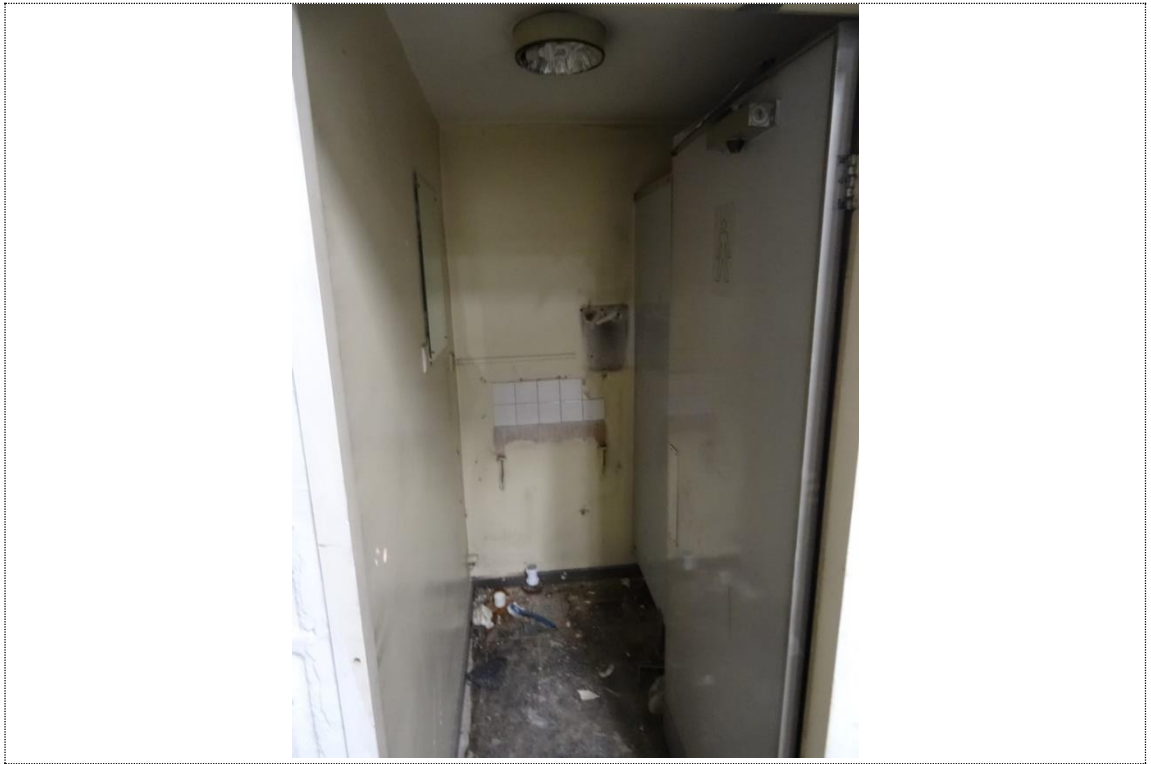
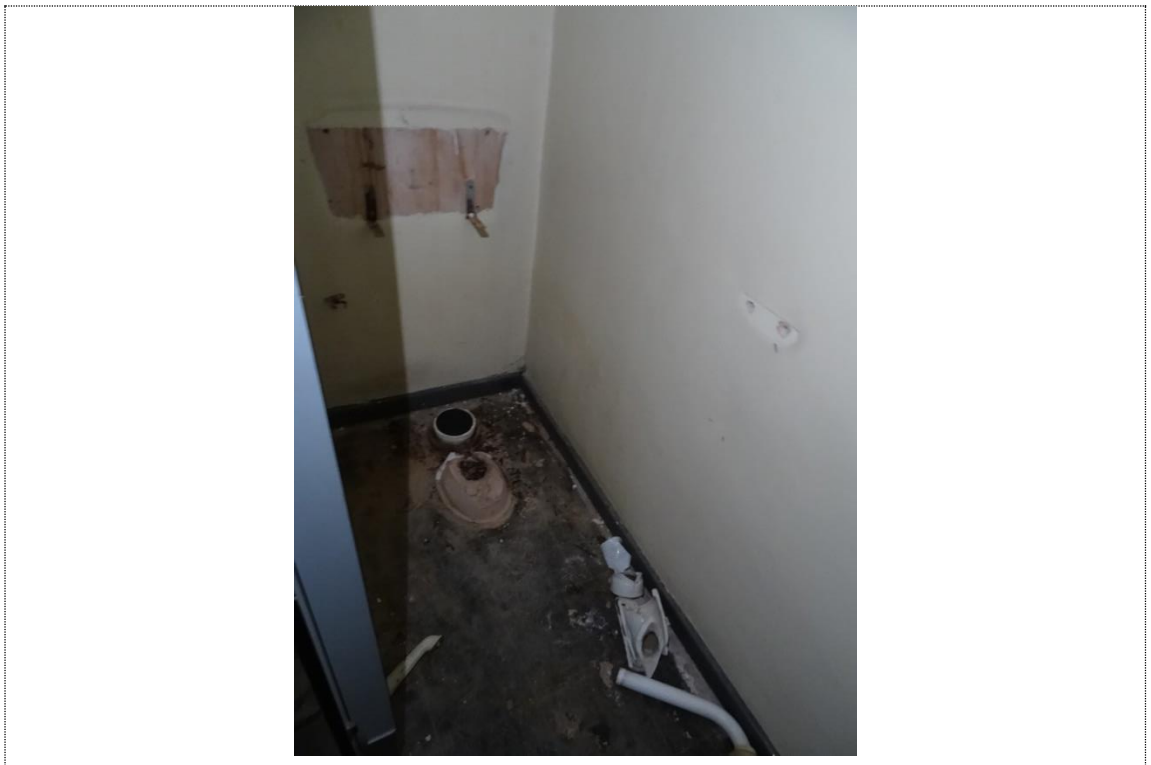
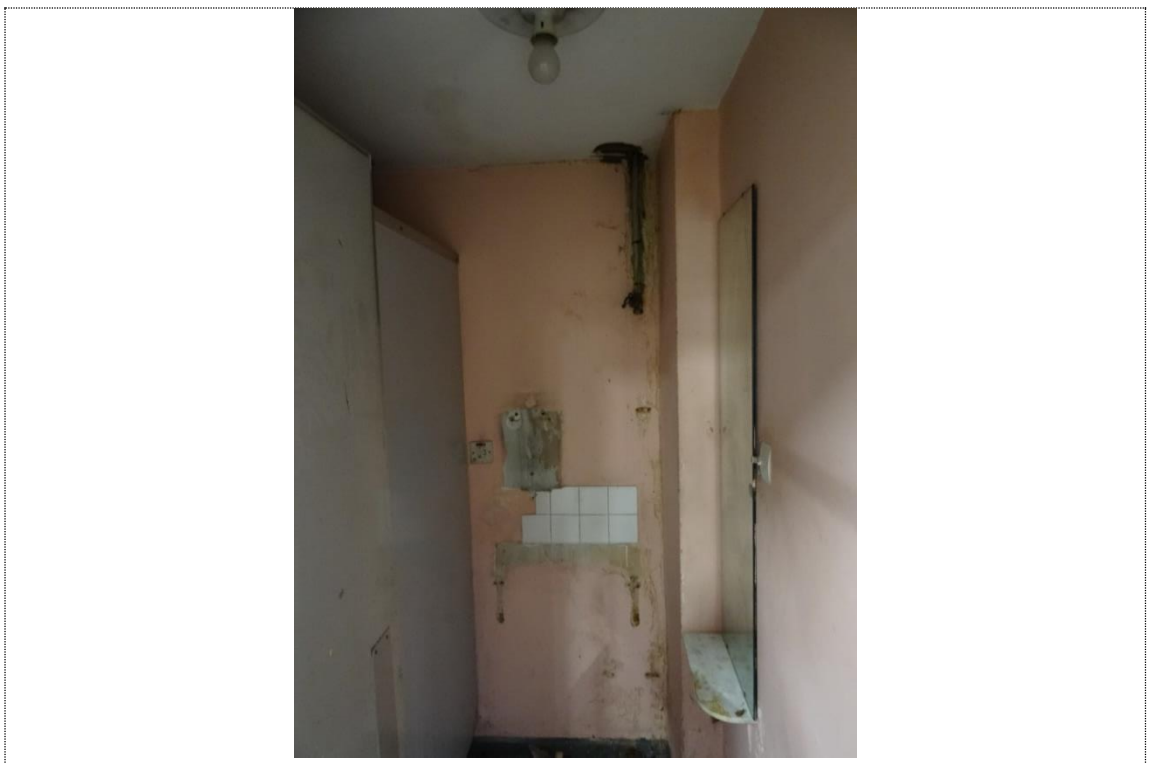
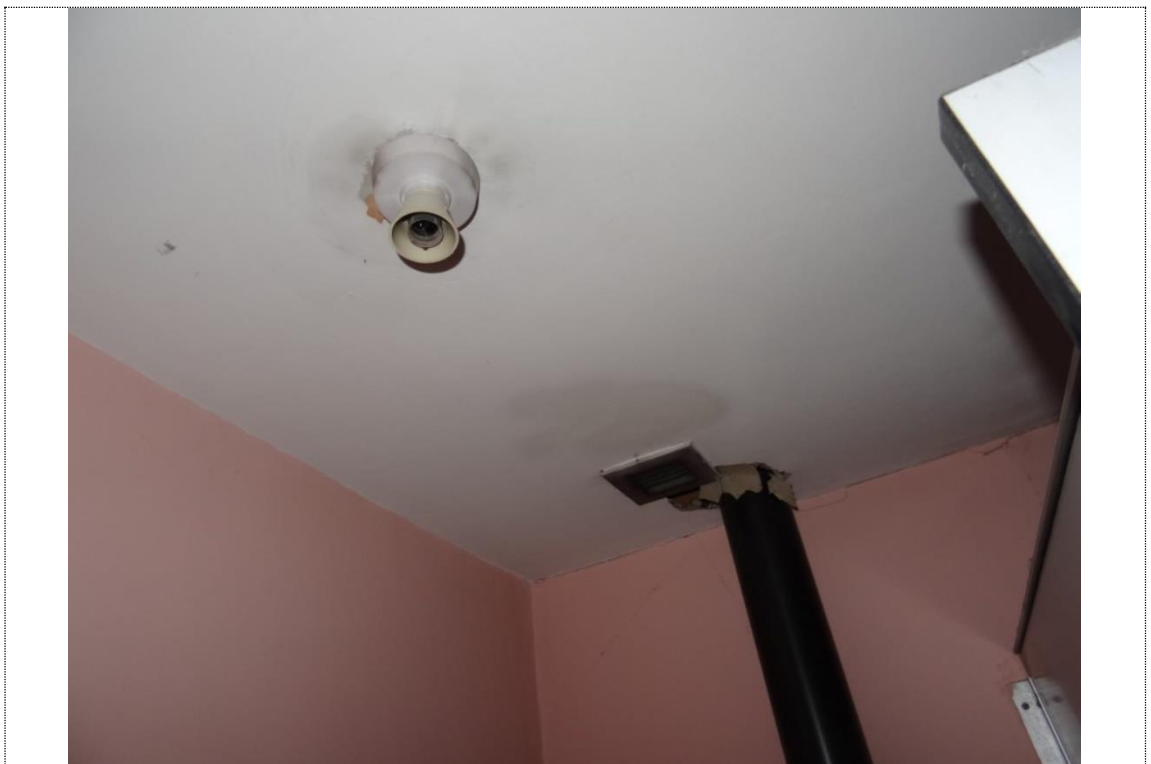
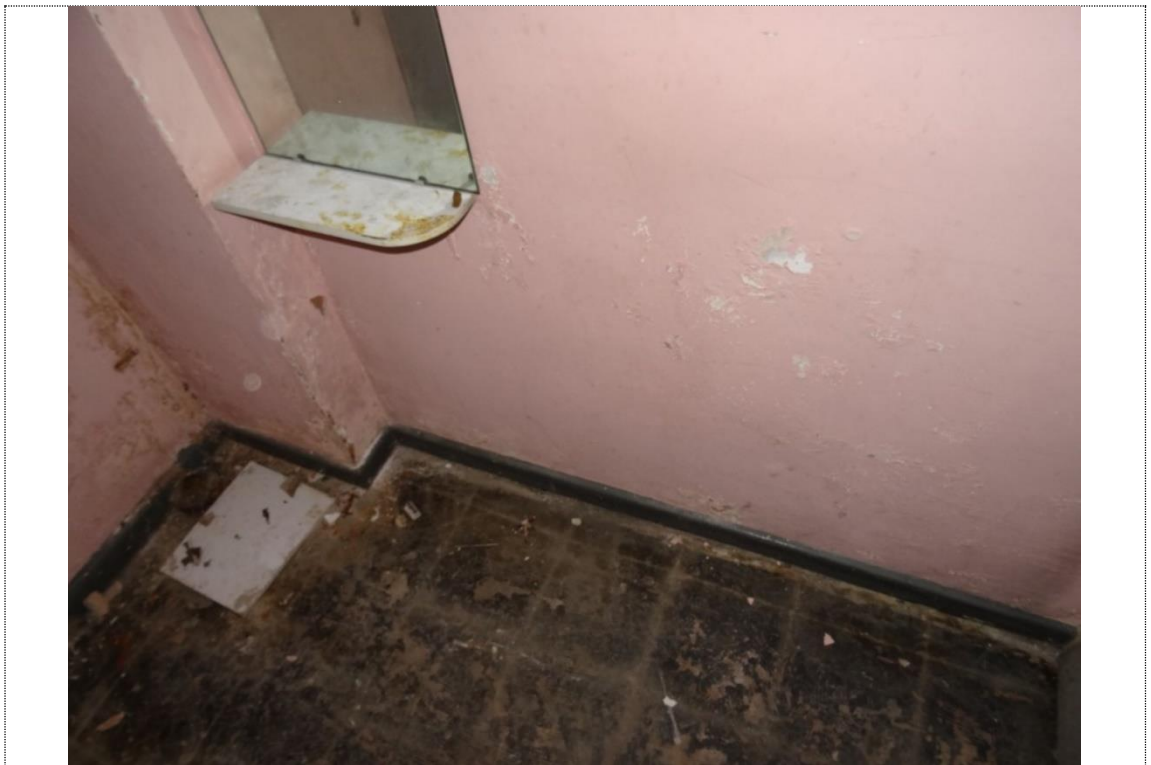
| 3.05 | Basement WC space | <p><b>Description/Photo:</b> Plaster/plasterboard ceiling and wall finishes. Timber internal joinery. Floor tiles removed. No sanitary appliances installed.</p> <p>Photos 37 - 44</p> <p><b>Defect:</b> Damaged wall and ceilings. Decorative finish poor. Staining where possible leakage occurred.</p> |

| | | <p><b>Remedial Action:</b> Consider demolition or entire reconstruction. Re-plaster where staining noted prior to redecoration. Should further leakage occur, investigate as required. Repair walls and ceilings prior to redecoration as required. Reinstate sanitary appliances as required.</p> |

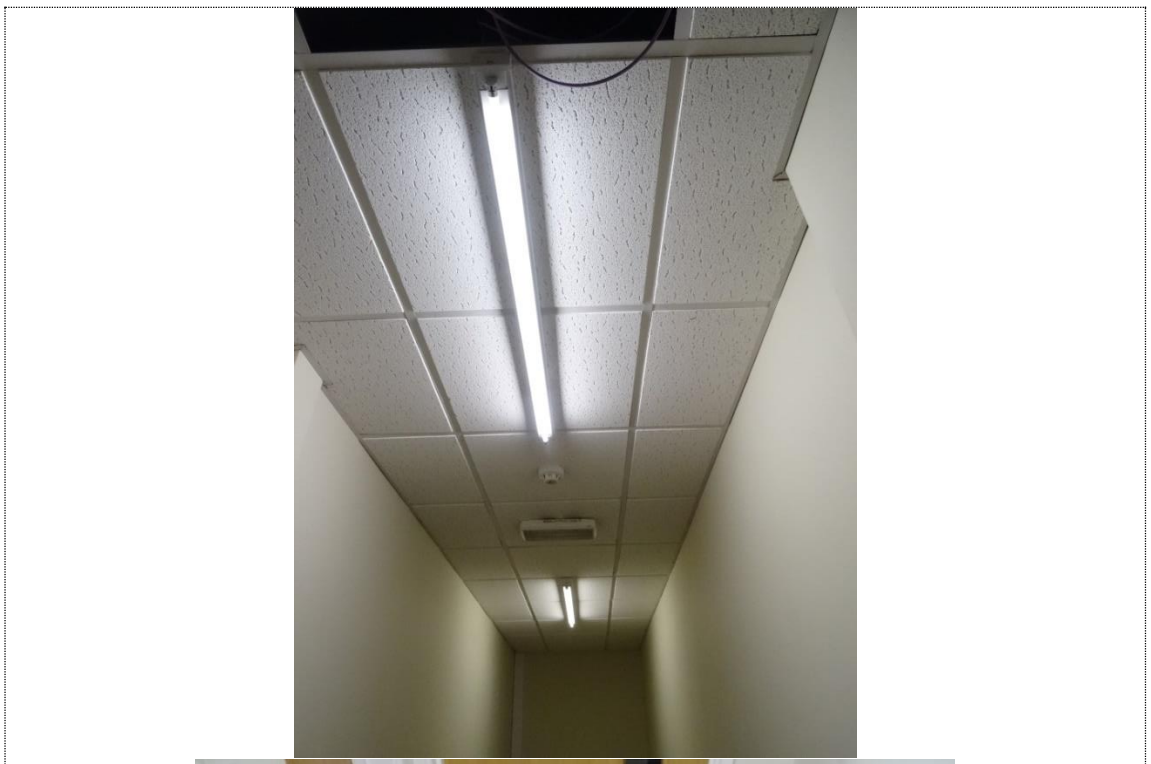
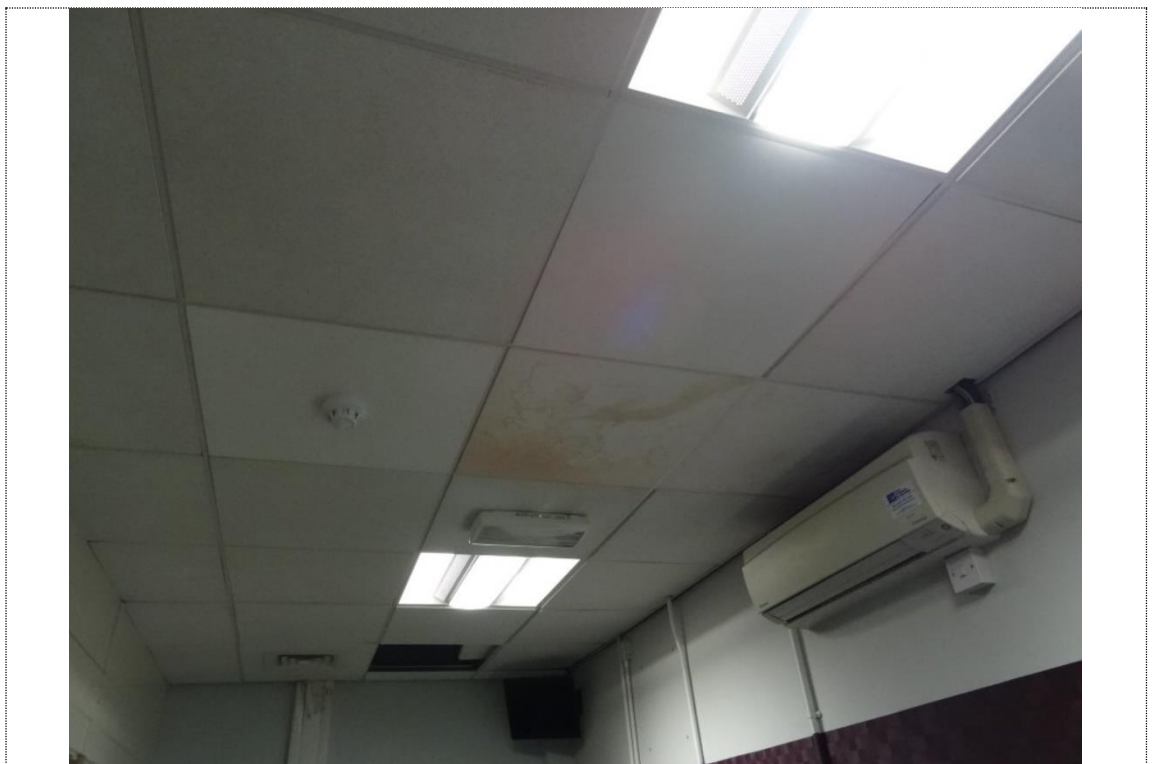
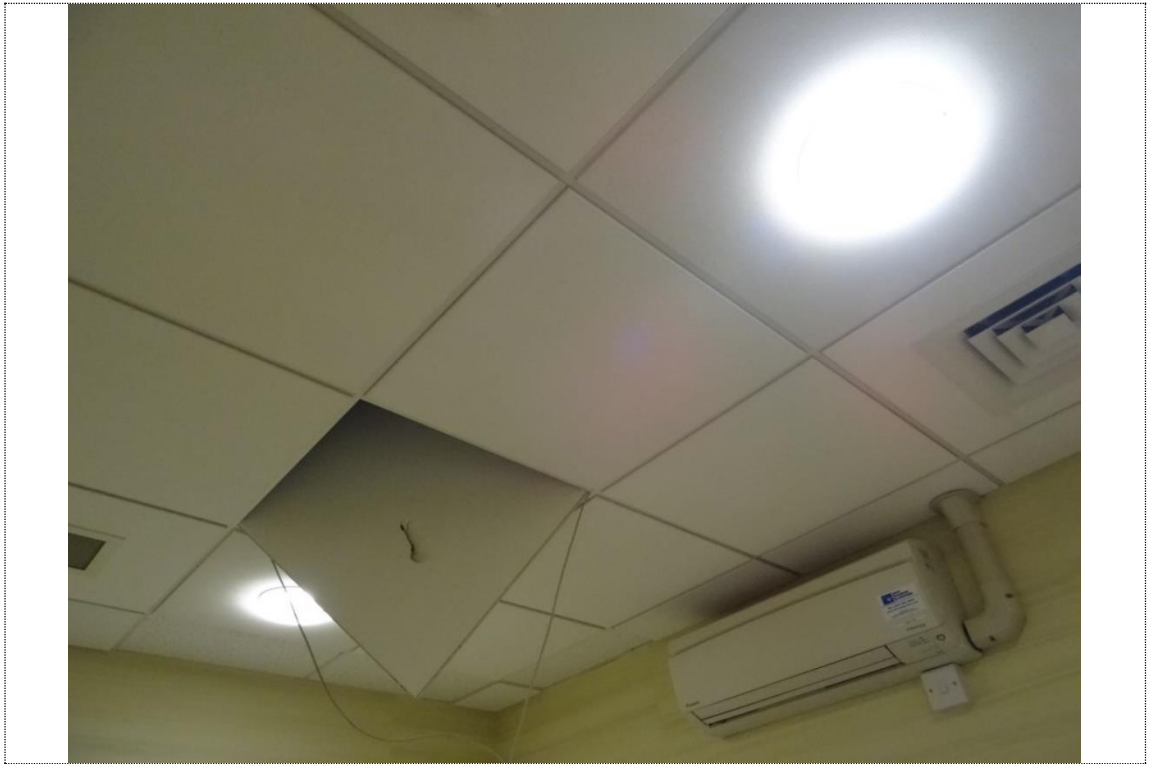
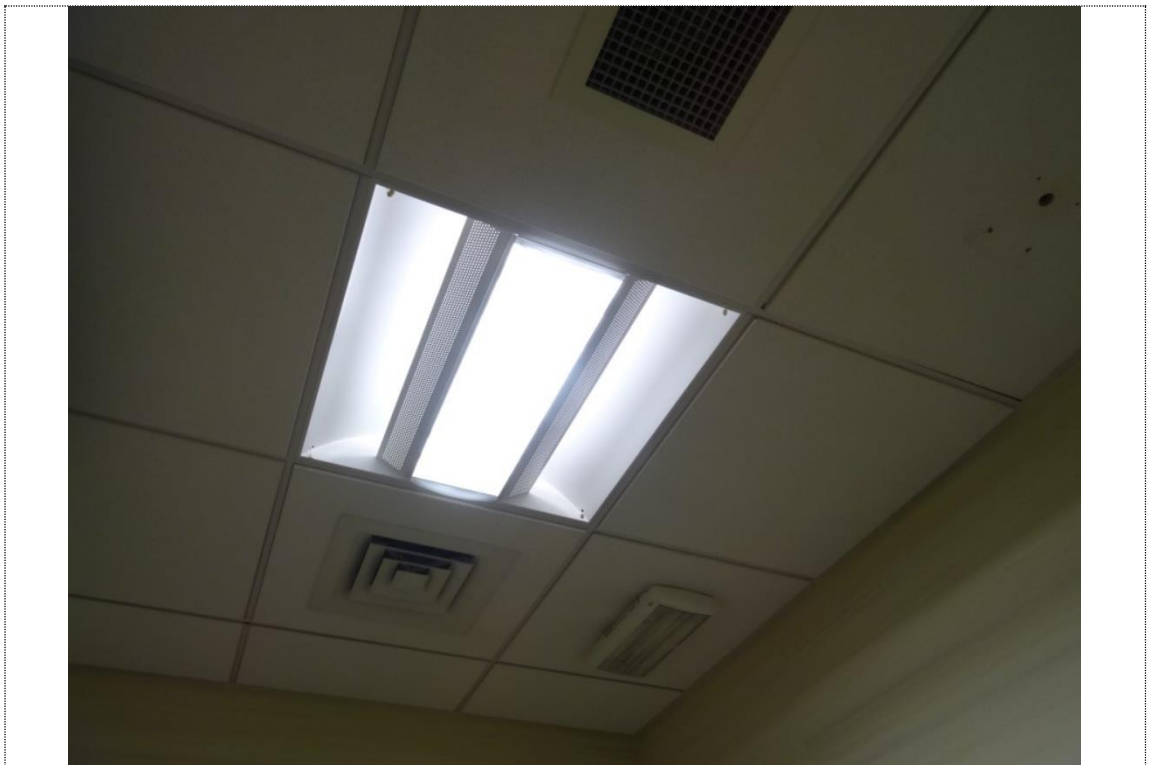
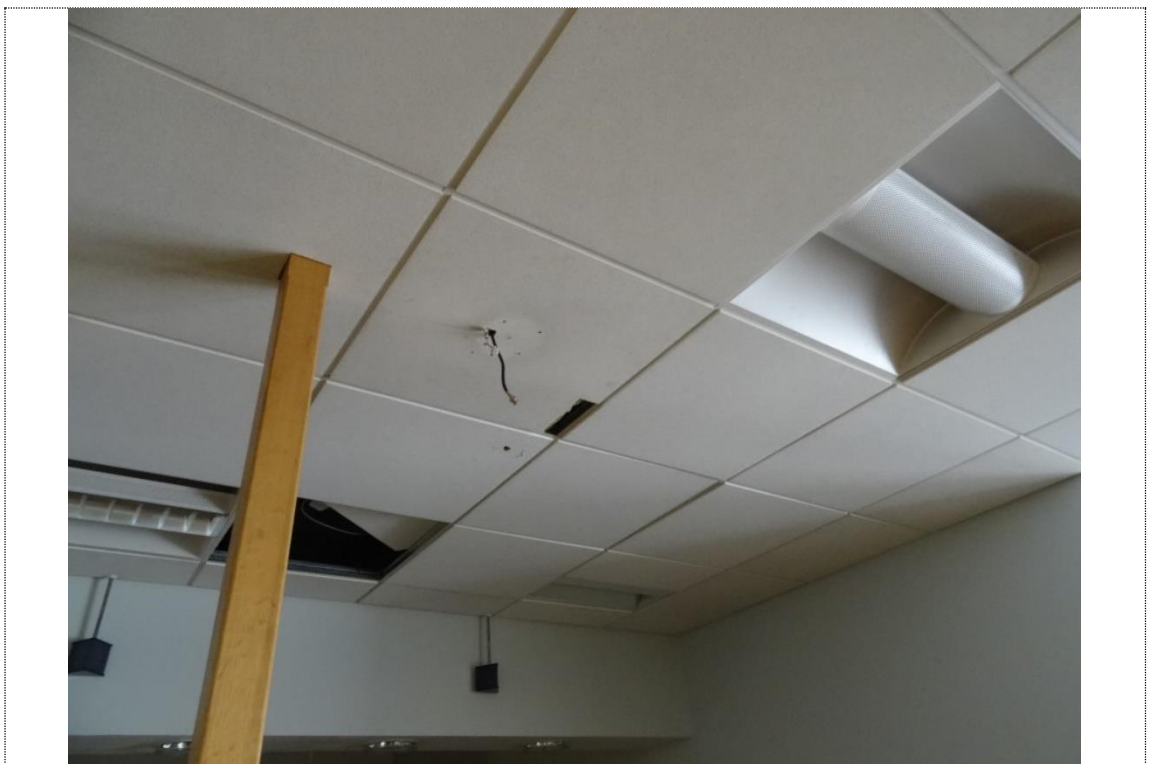
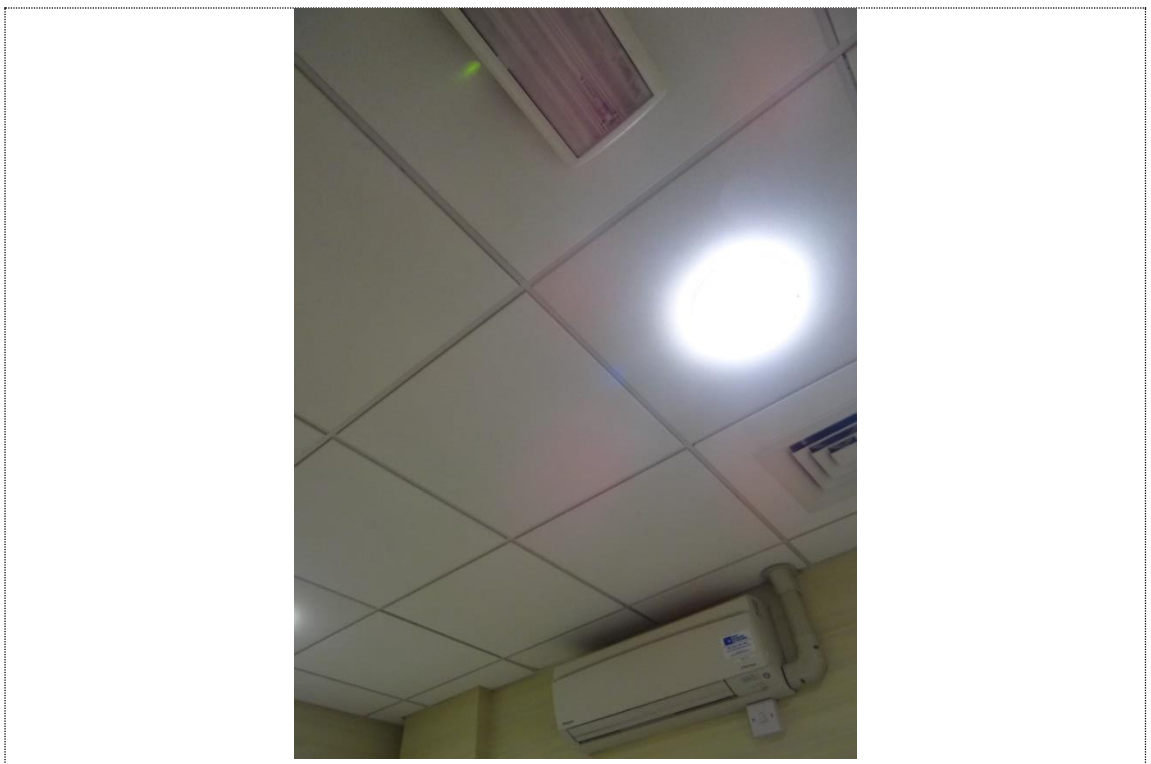
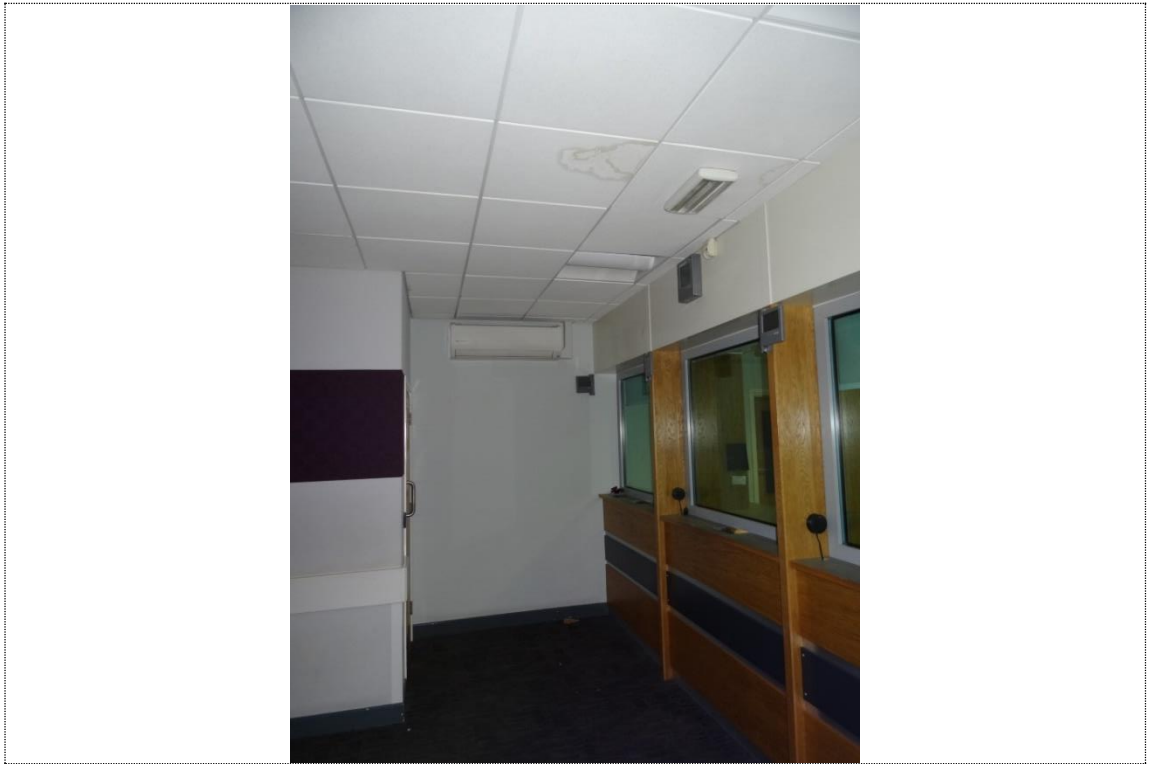
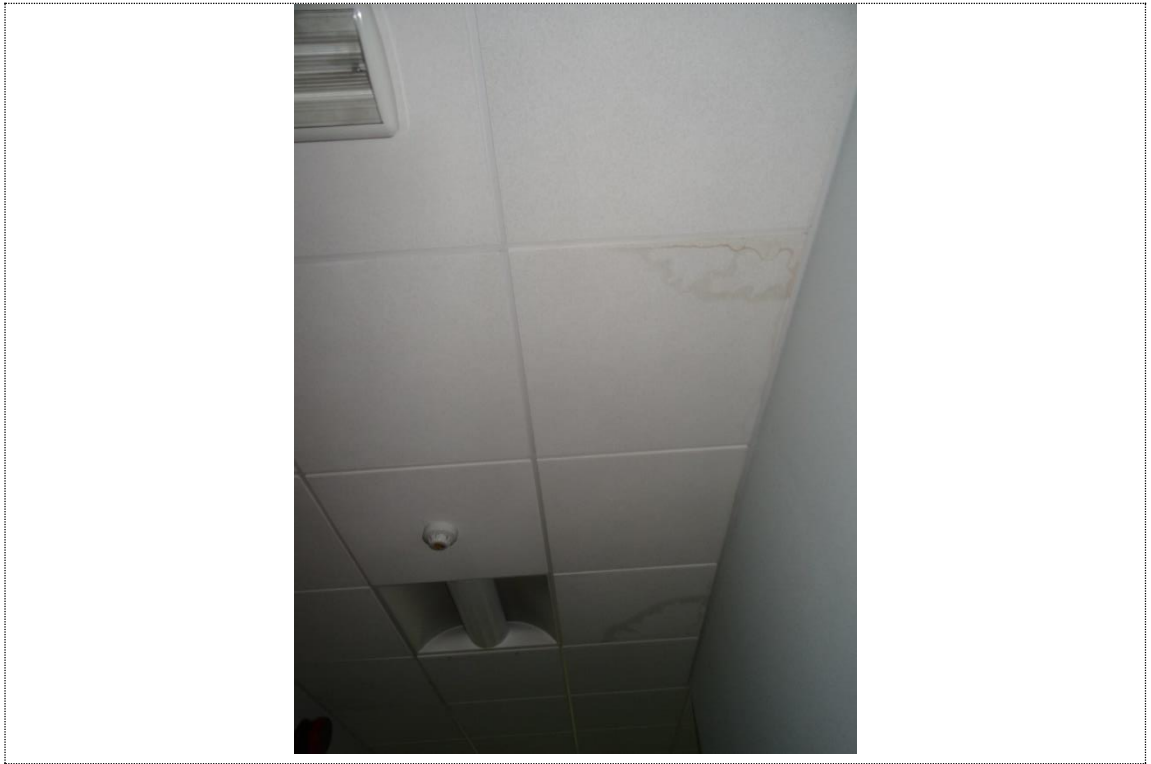
| 3.03 | Ceilings – Stairs and Ground floor | <p><b>Description/Photo:</b> Suspended metal grid with inset mineral fibre ceiling tiles. Emergency lighting and smoke detection provided.</p> <p>Photos 45, 52, 58, 63, 75, 78, 88, 94, 96-97, 103</p> <p><b>Defect:</b> Some tiles are damaged and stained. Staining assumed to be as result of leakage from the air condition system.</p> <p><b>Remedial Action:</b> Replace tiles where required stained or damaged. Should further staining occur, investigate to establish whether ducting is in need of repair.</p> |

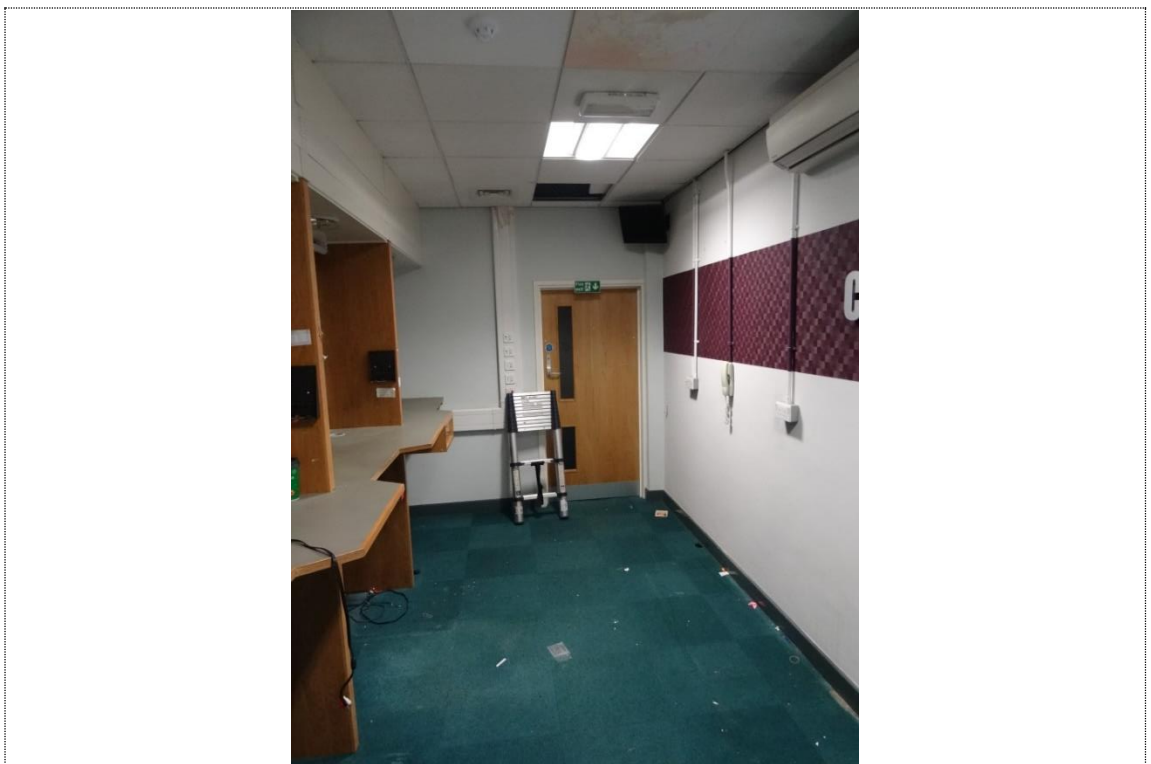
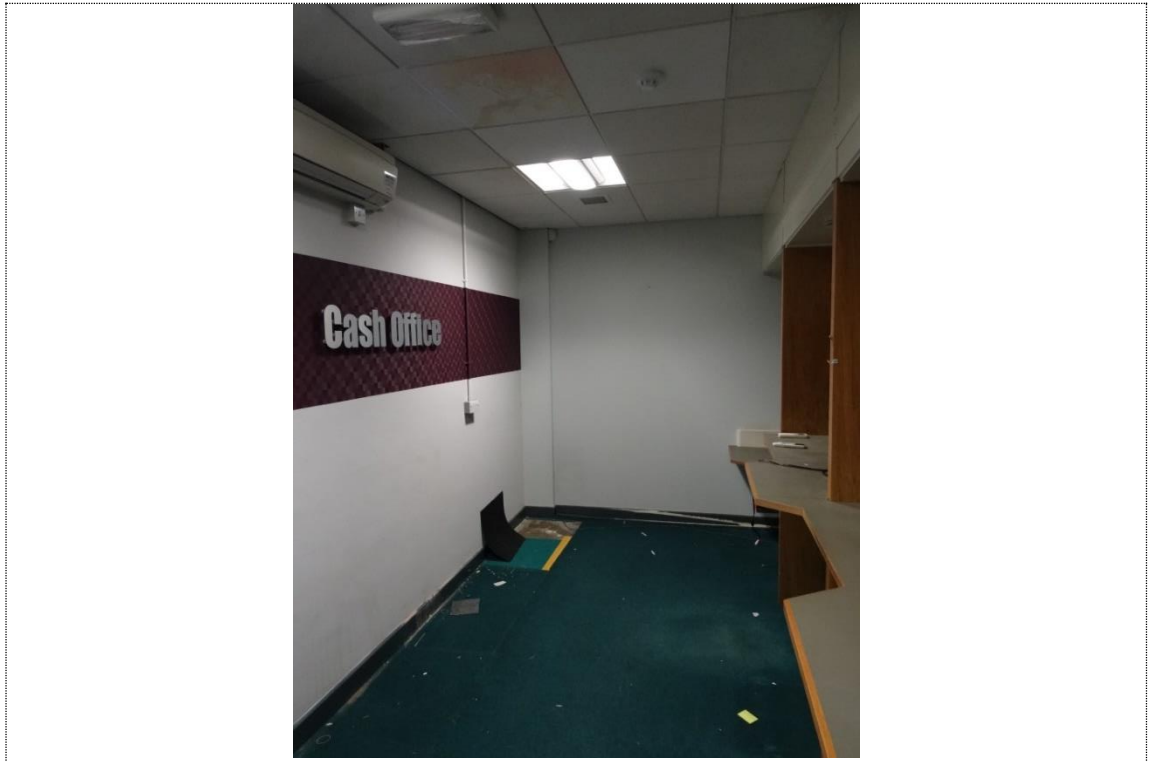
| | <b>Rear Staff Area</b> | <p><b>Description/Photo:</b> Suspended ceiling grid with mineral tiles. Walls are finished with textured wallpaper. Decorated timber skirtings and carpet floor tiles. Front features kiosk installation.</p> |

| | | <p style="text-align: right;">Photos 56-59, 61</p> <p><b>Defect:</b> The occasional ceiling tiles are stained. Some impact damaged and staining noted to the walls. Slight scuff marks to skirtings. Carpet floor tiles worn and begrimed.</p> <p><b>Remedial Action:</b> Replace ceiling tiles as required. Upgrade wall finishes and skirtings as required. Clean or replace floor tiles.</p> |

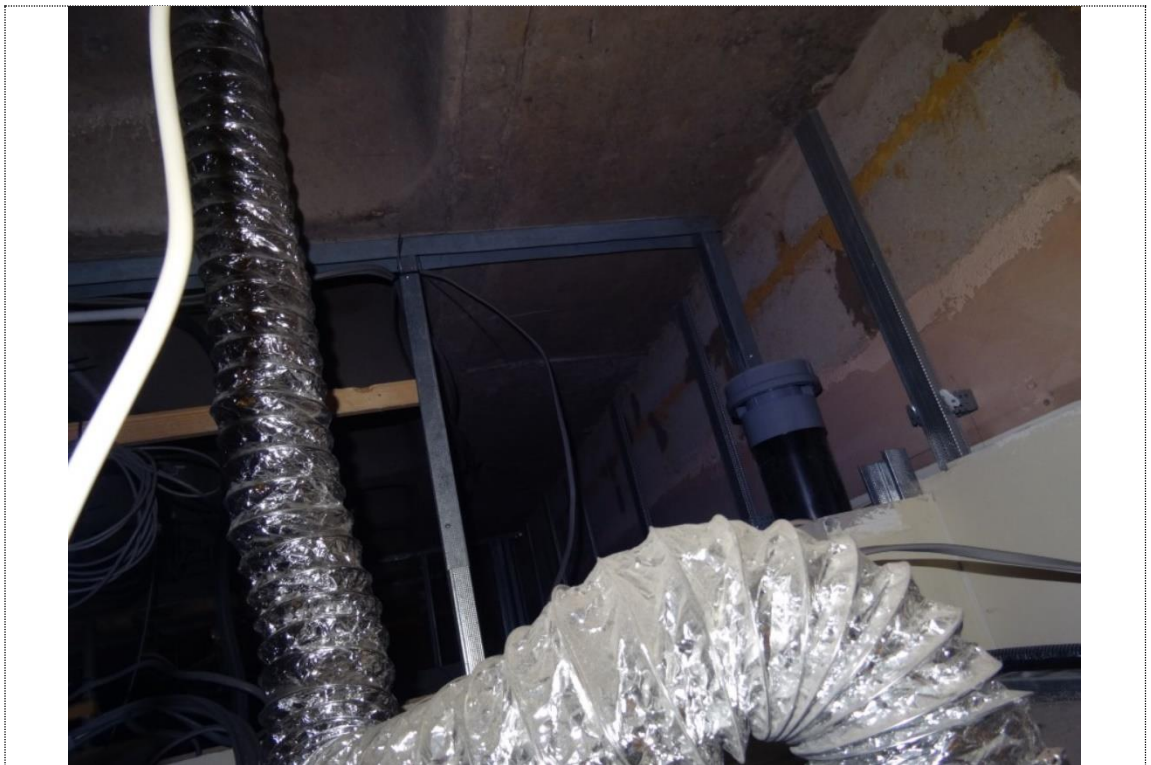
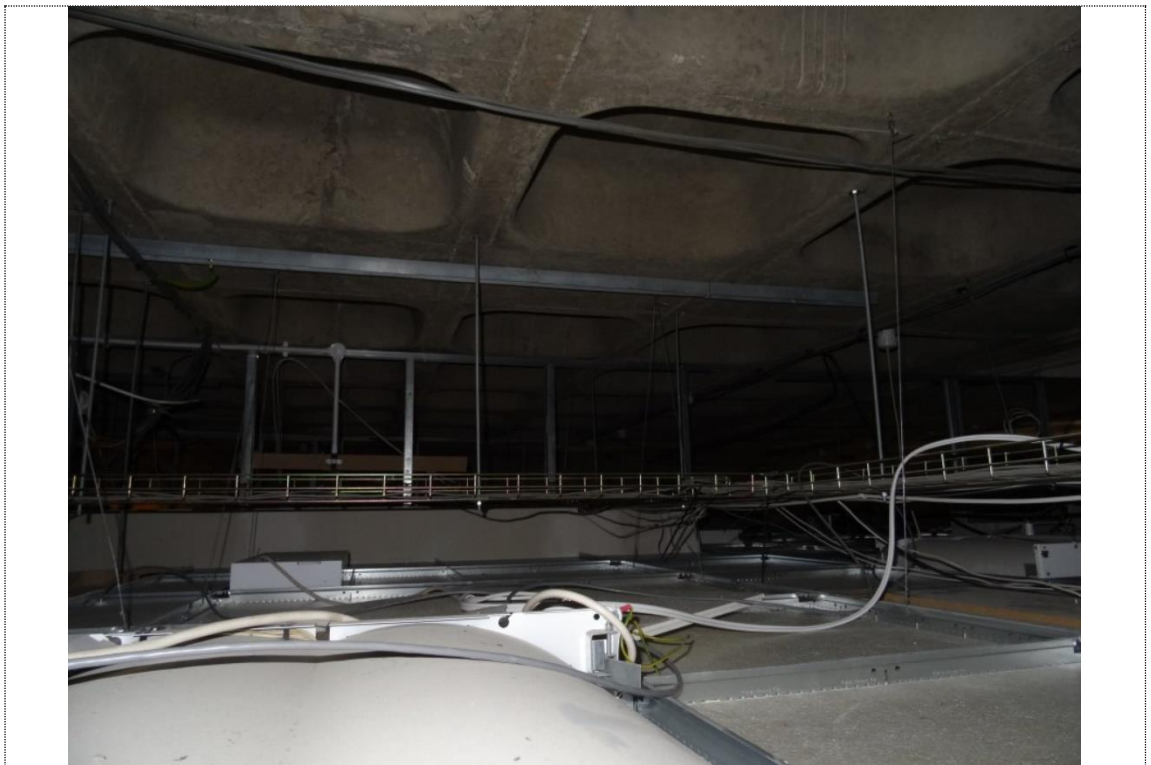
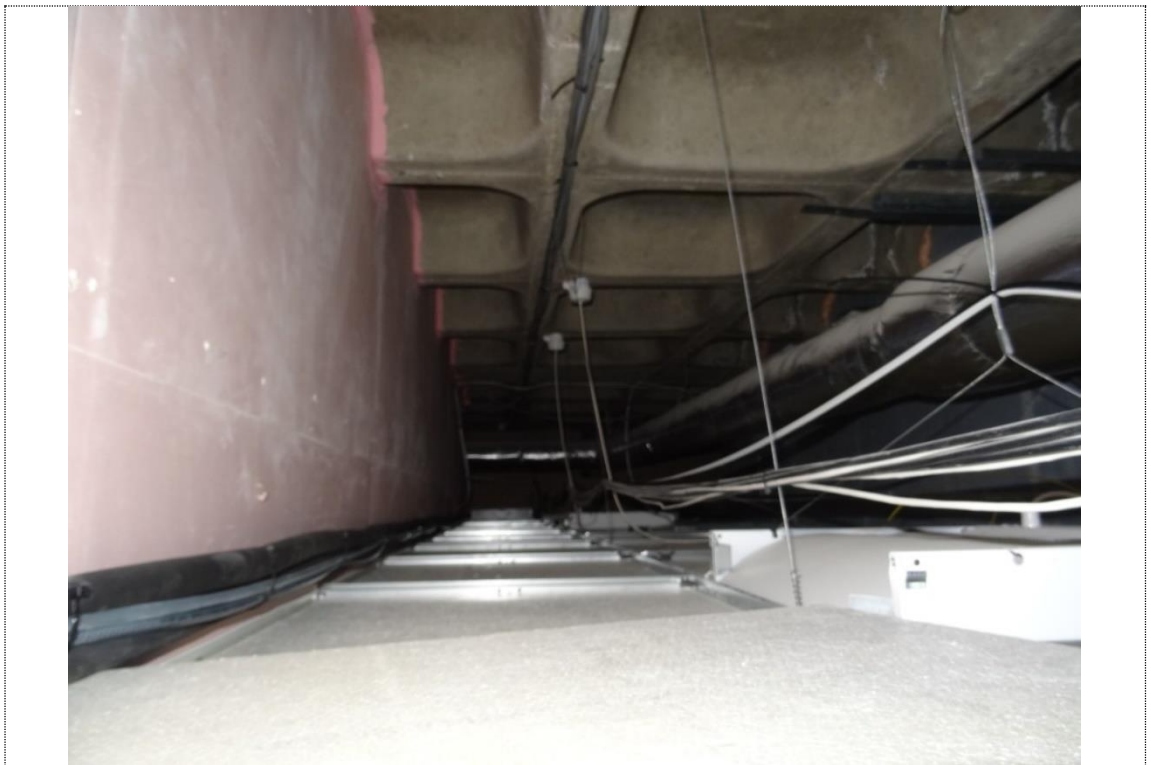
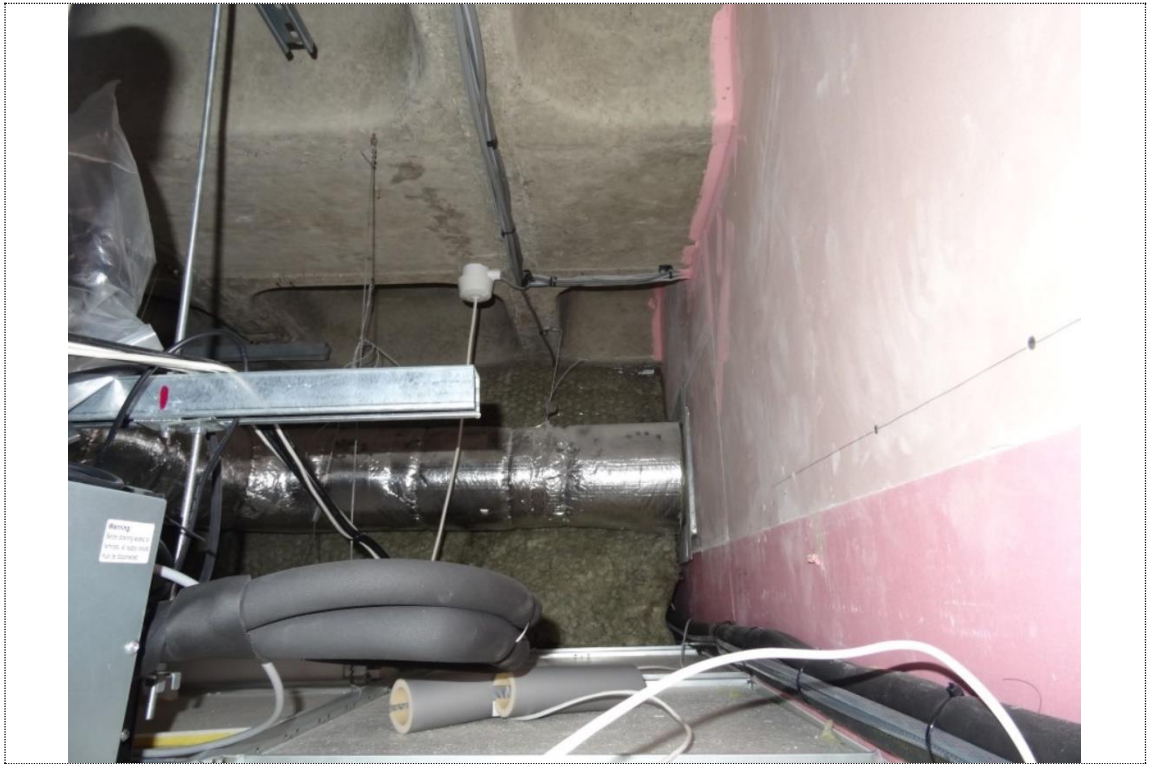
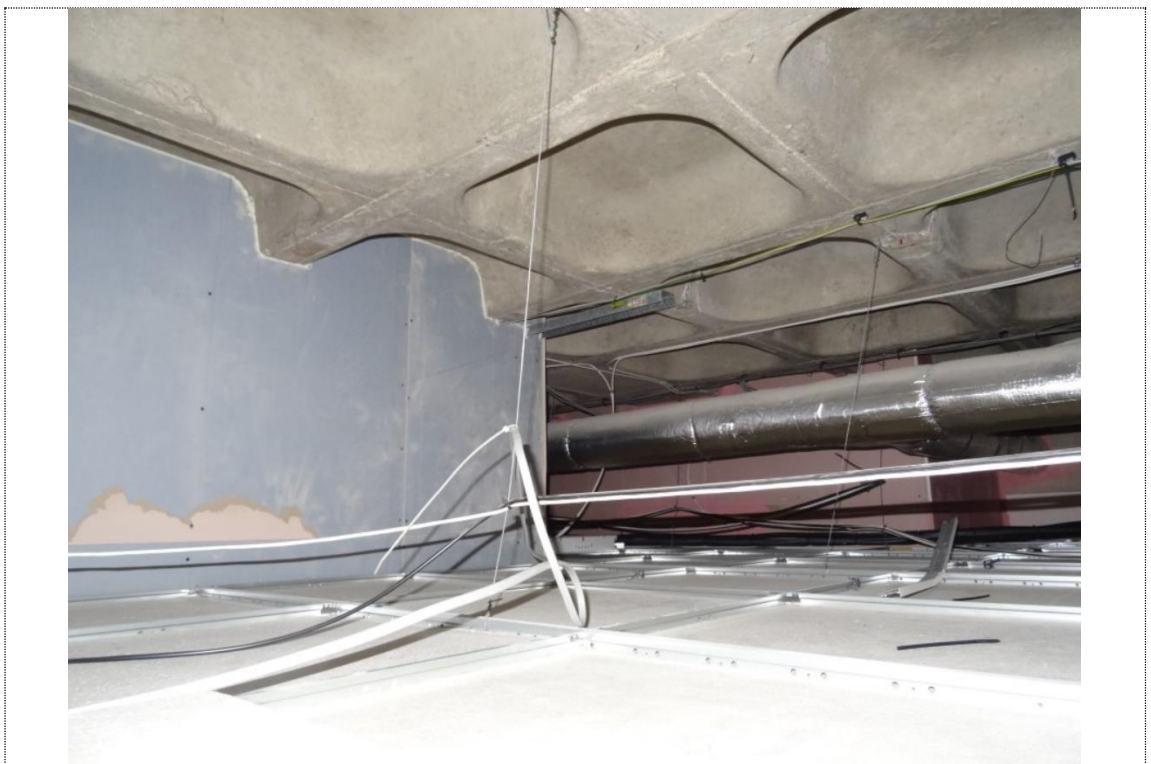
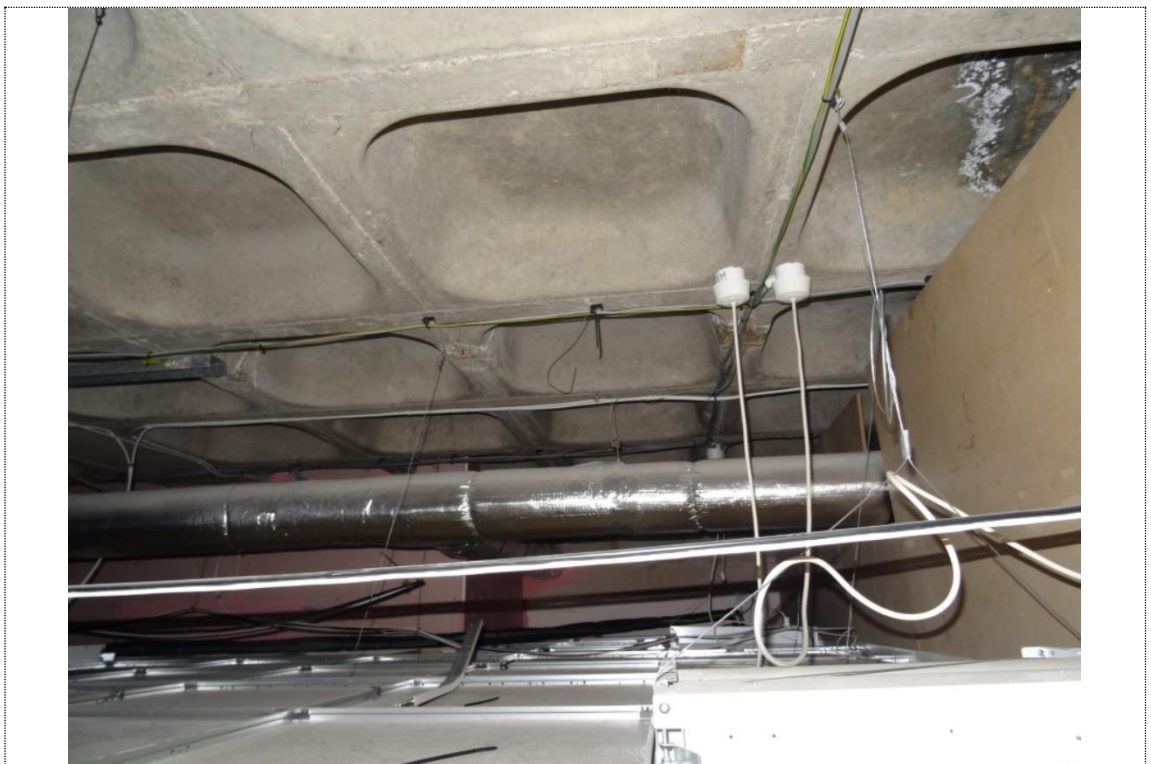
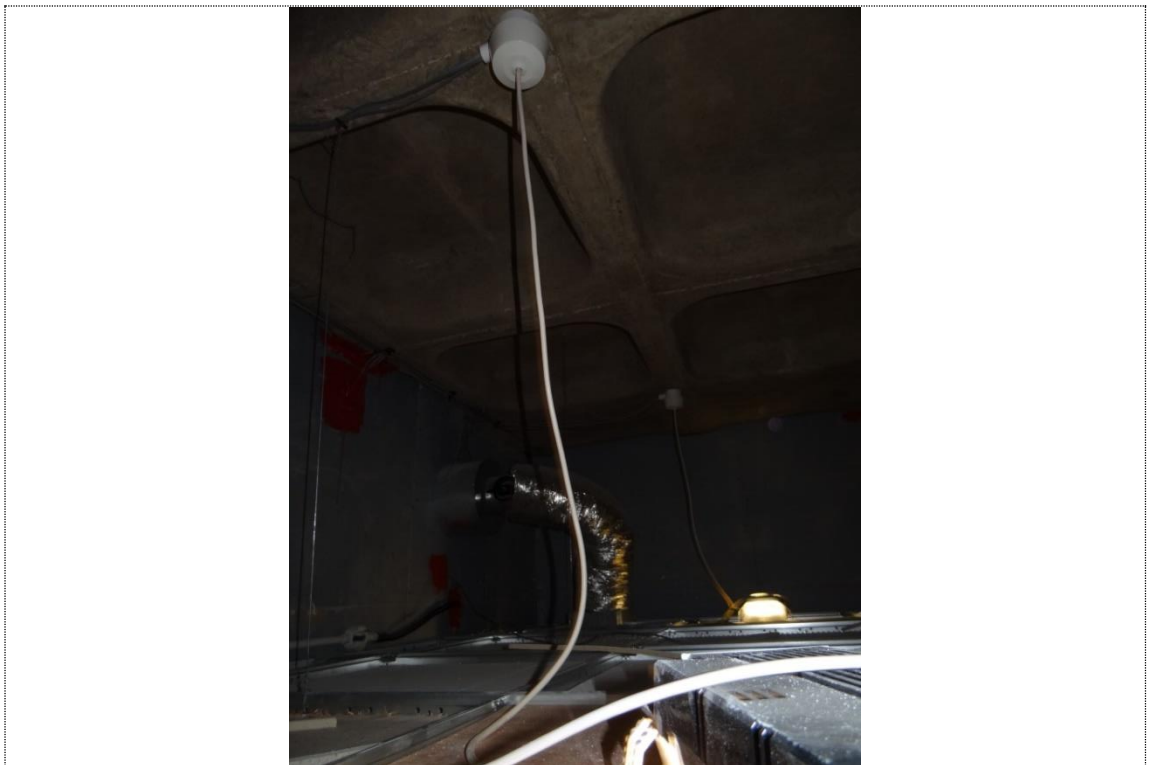
| 3.06 | <b>Ceiling Void (above suspended ceilings to ground floor and stairs)</b> | <p><b>Description/Photo:</b> Concrete roof structure moulded profile. No significant staining noted. Some compartmentation provided.</p> <p style="text-align: center;">Photos 47, 55, 60, 65-66, 106 - 115</p> <p><b>Defect:</b> No compartmentation noted where the current unit is to be split in two.</p> <p><b>Remedial Action:</b> Fire compartmentation to be upgraded in line with the recommendations of Fire Risk Assessment.</p> |
