# Elements Survey Report

Report Date: 22<sup>nd</sup> May 2023

| <b>1.10</b> | <b>General Description</b> | Mid terrace retail unit comprising ground and basement accommodation in a retail complex |

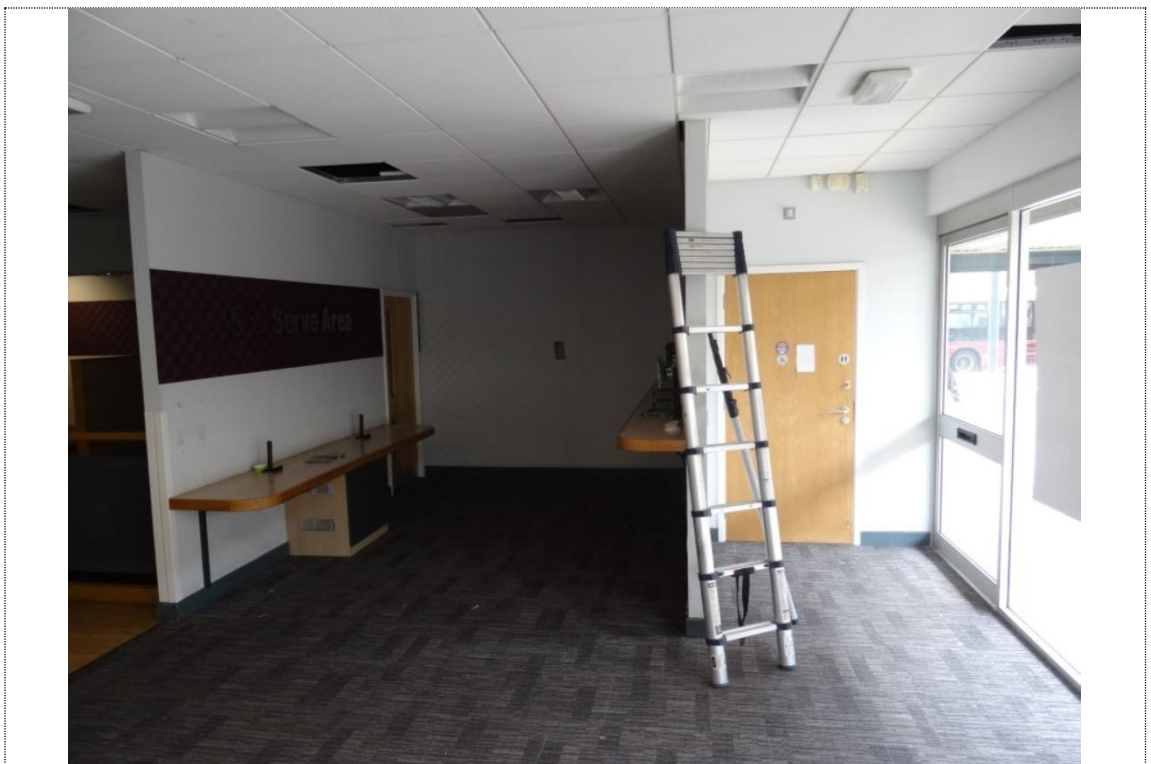
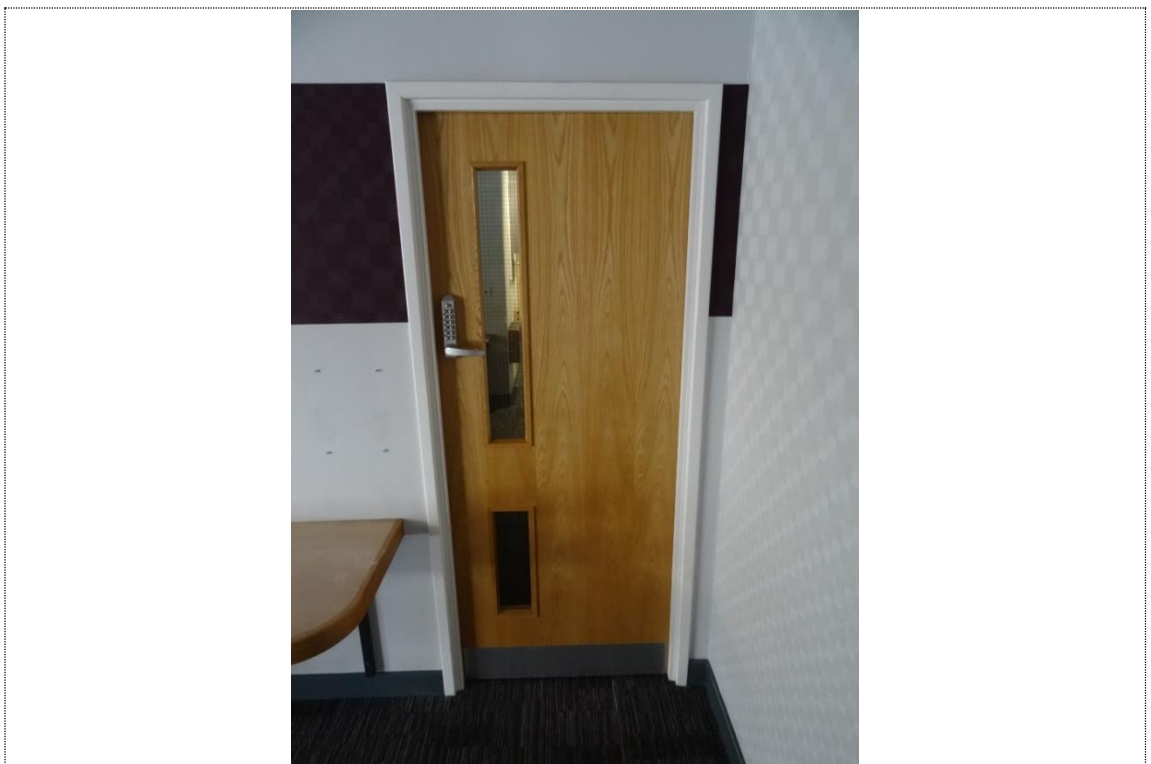
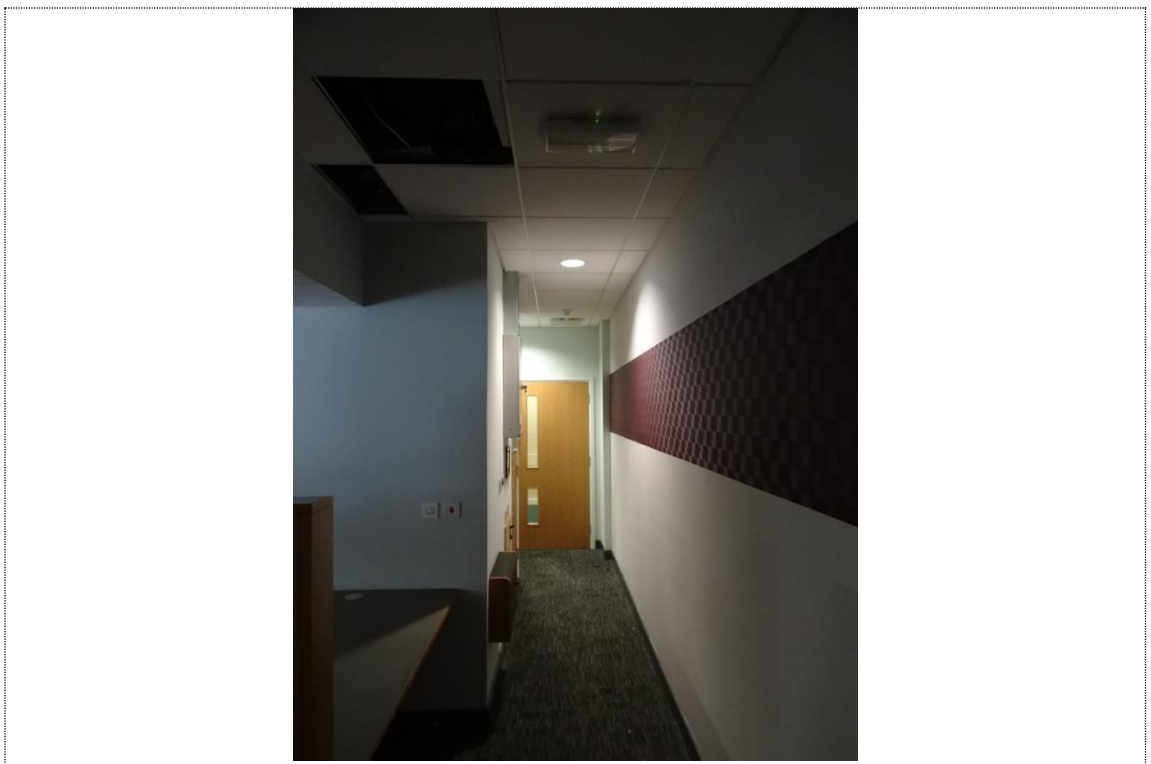
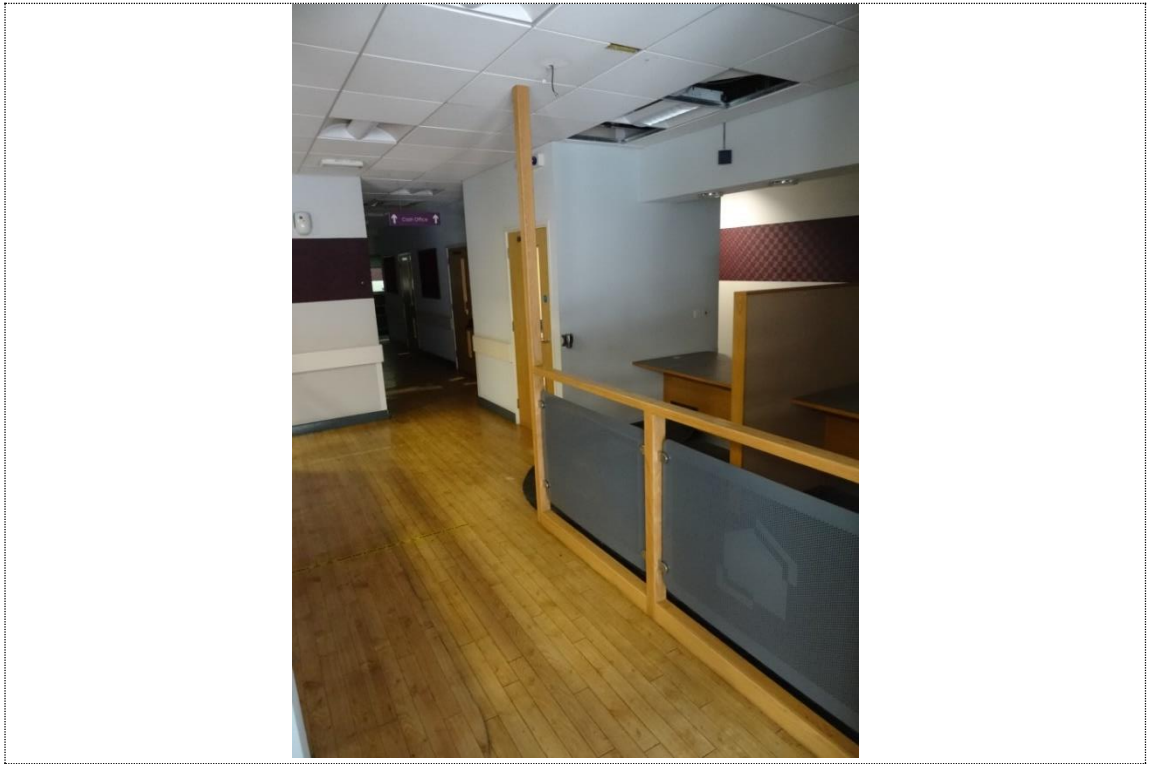
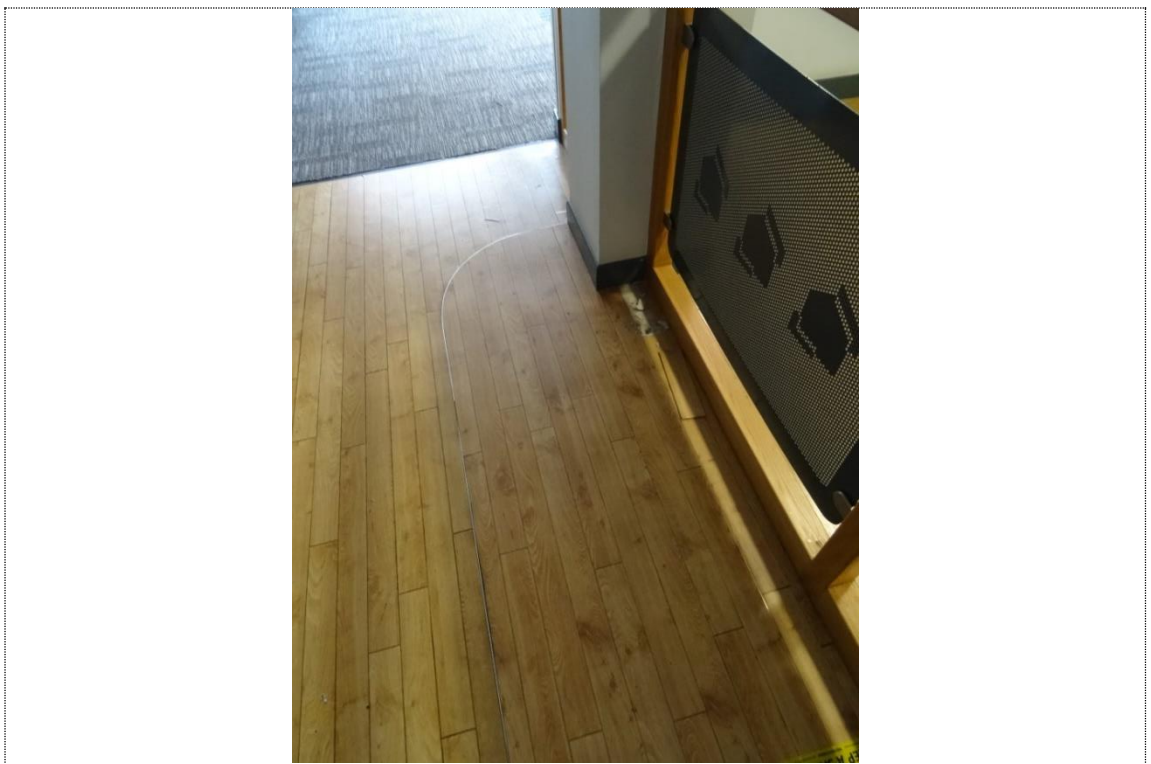
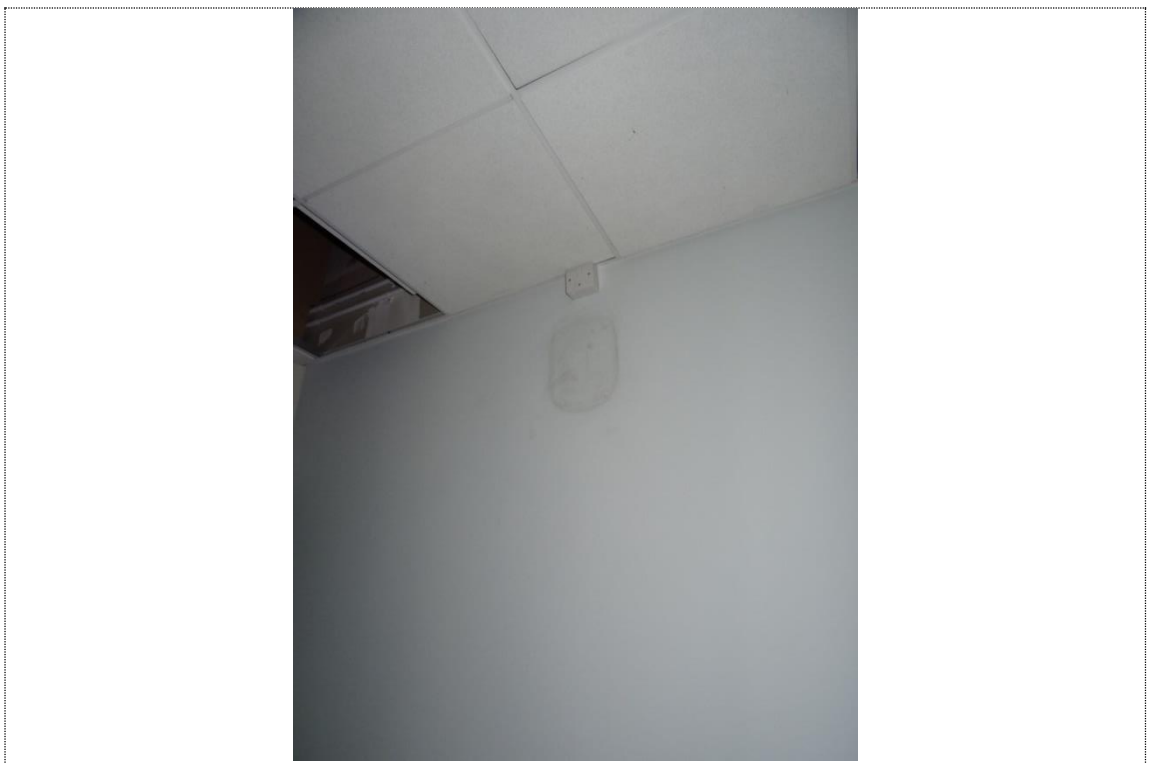
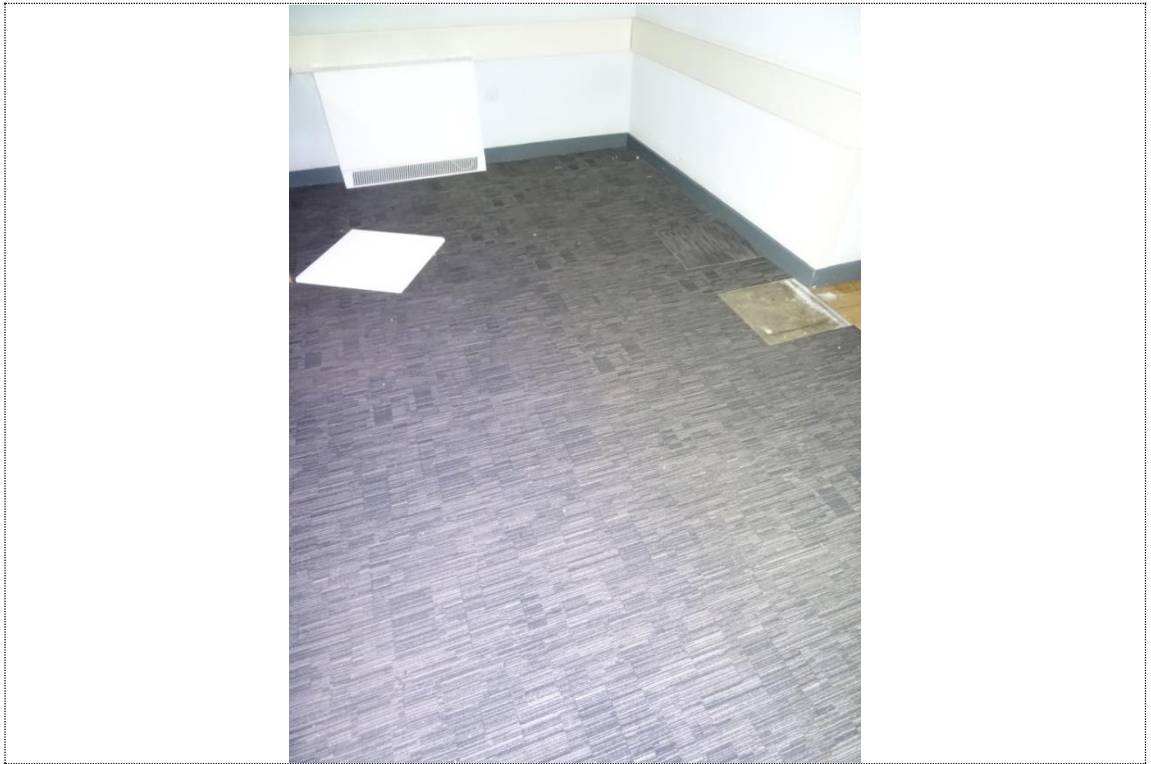
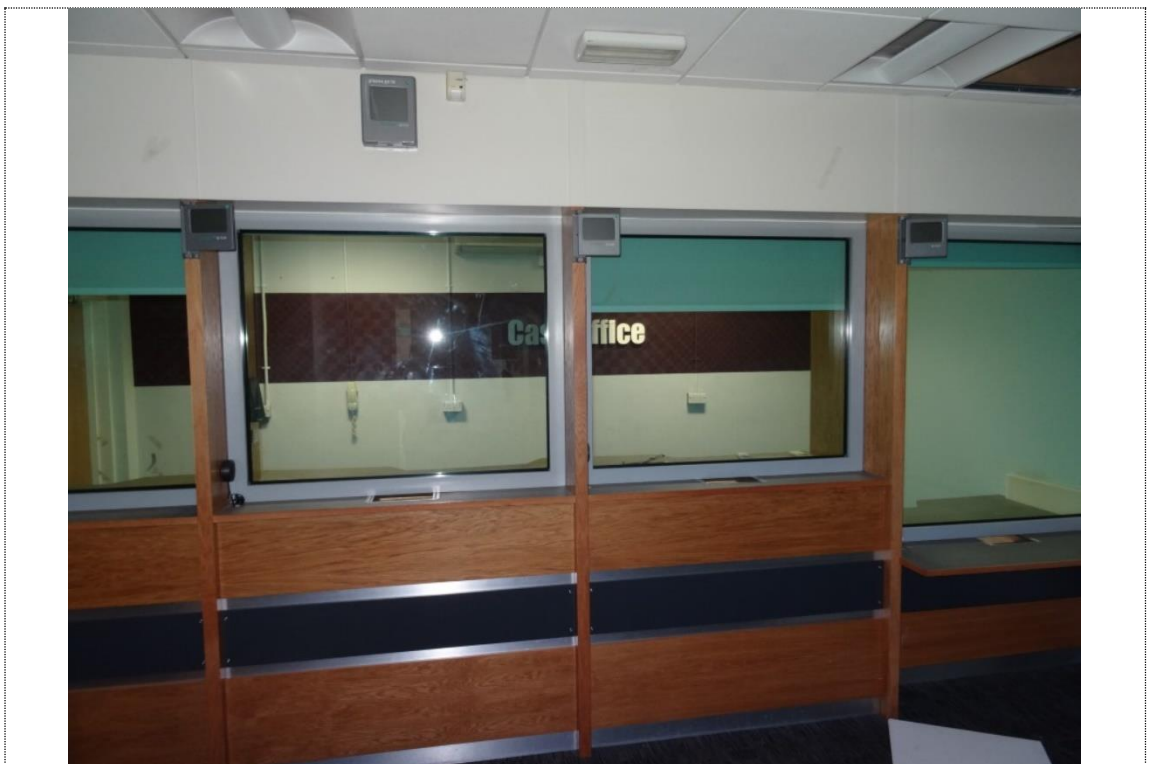
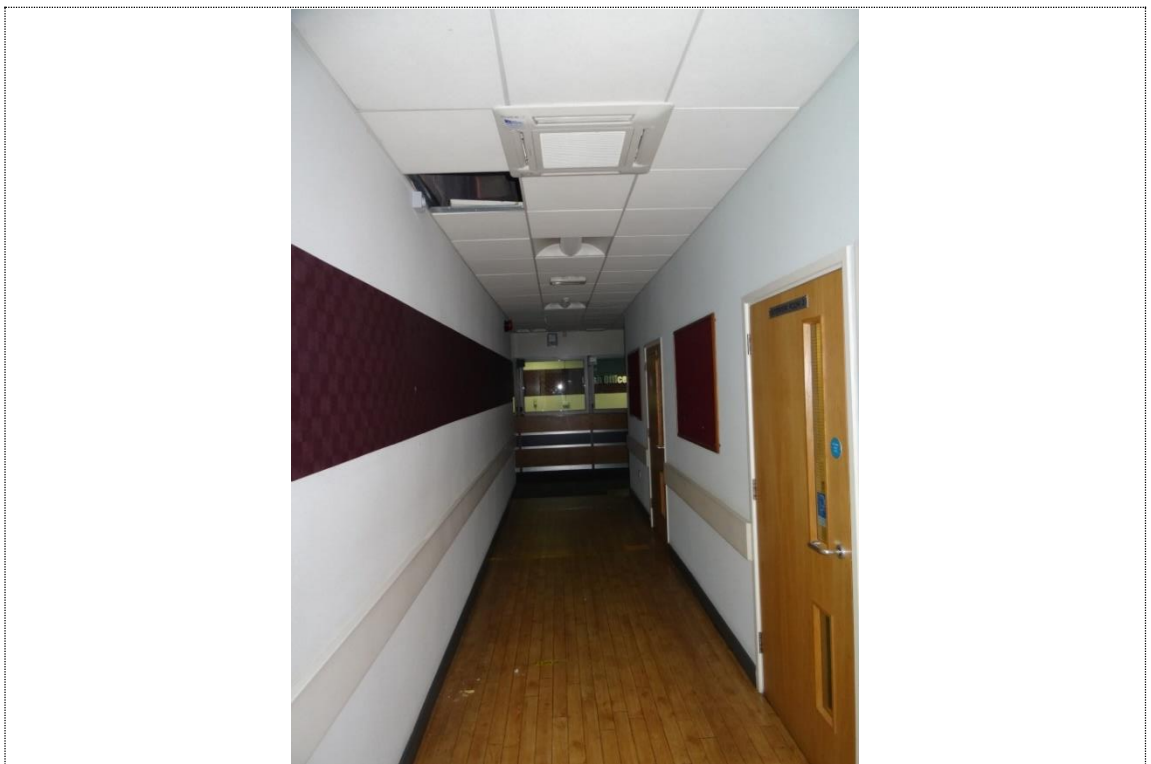
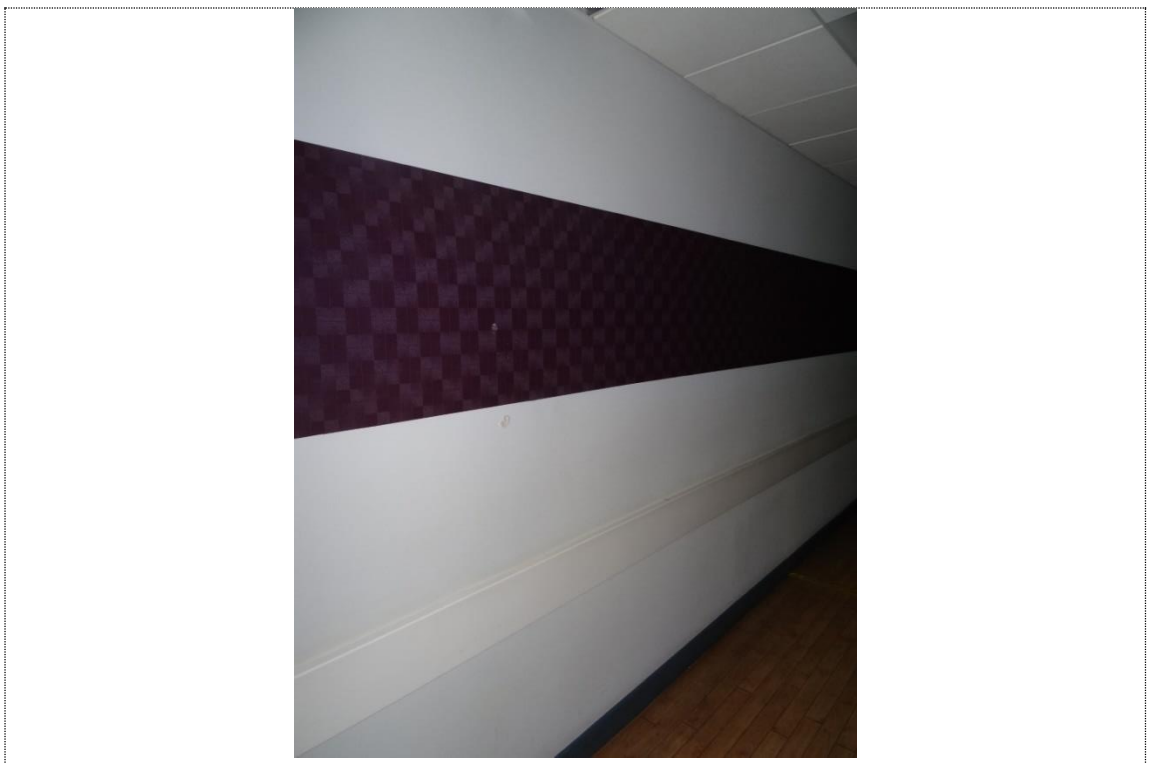
| | <p><b>Ground Floor Area</b></p> | <p><b>Description/Photo:</b> Suspended ceiling grid with mineral tiles. Walls are finished with textured wallpaper. Decorated timber skirtings. Floors are covered with carpet tiles and vinyl tiles.</p> <p style="text-align: right;">Photos 68-70, 80-88, 96-102, 104-105</p> <p><b>Defect:</b> The occasional ceiling tiles are stained. Some impact damaged and staining noted to the walls. Slight scuff marks to skirtings. Carpet floor tiles worn and begrimed.</p> <p><b>Remedial Action:</b> Replace ceiling tiles as required. Repair and upgrade/decorate wall finishes and skirtings as required. Clean or replace floor tiles.</p> |

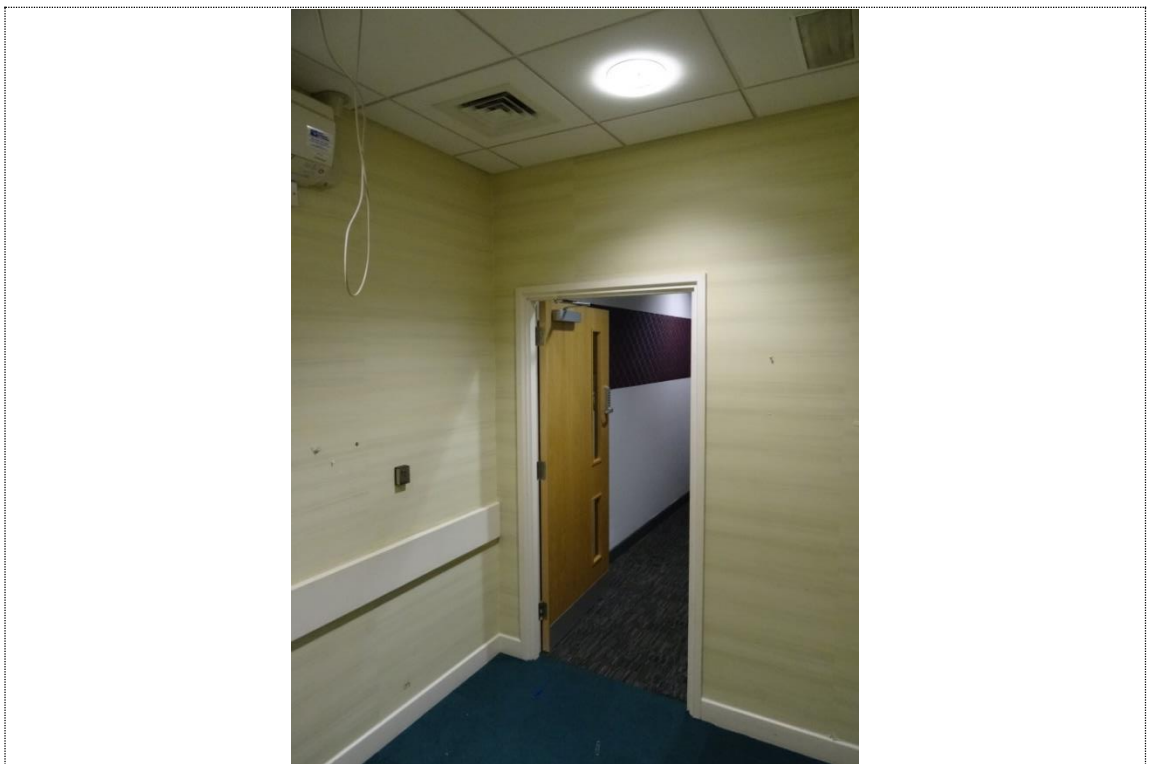
72

| | <p><b>Central Office</b></p> | <p><b>Description/Photo:</b> Suspended ceiling grid with mineral tiles. Walls are finished with textured wallpaper. Decorated timber skirtings and carpet floor tiles.</p> <p style="text-align: right;">Photos 71 - 72</p> <p><b>Defect:</b> The occasional ceiling tiles are stained. Some impact damaged and staining noted to the walls. Slight scuff marks to skirtings. Carpet floor tiles worn and begrimed.</p> <p><b>Remedial Action:</b> Replace ceiling tiles as required. Repair and upgrade/decorate wall finishes and skirtings as required. Clean or replace floor tiles.</p> |

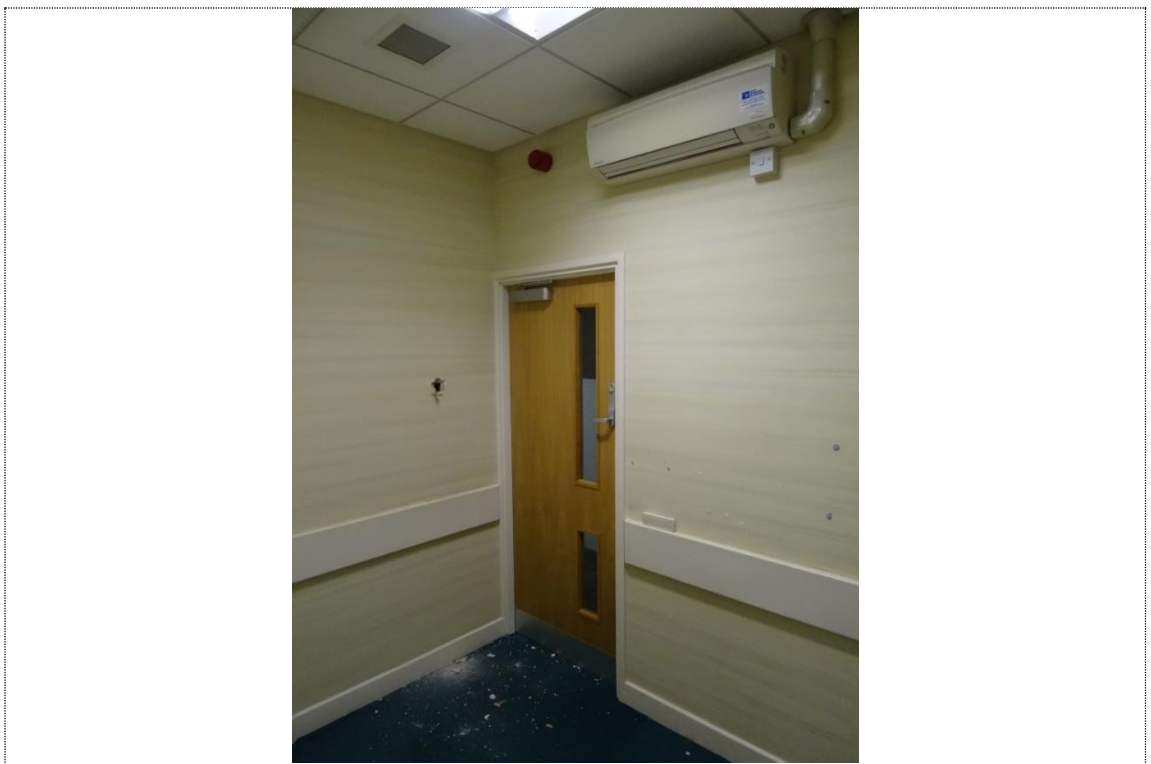
76

| | <p><b>Front Office</b></p> | <p><b>Description/Photo:</b> Suspended ceiling grid with mineral tiles. Walls are finished with textured wallpaper. Decorated timber skirtings and carpet floor tiles.</p> <p style="text-align: right;">Photos 76-79</p> <p><b>Defect:</b> The occasional ceiling tiles are stained. Some impact damaged and staining noted to the walls. Slight scuff marks to skirtings. Carpet floor tiles worn and begrimed.</p> <p><b>Remedial Action:</b> Replace ceiling tiles as required. Repair and upgrade/decorate wall finishes and skirtings as required. Clean or replace floor tiles.</p> |

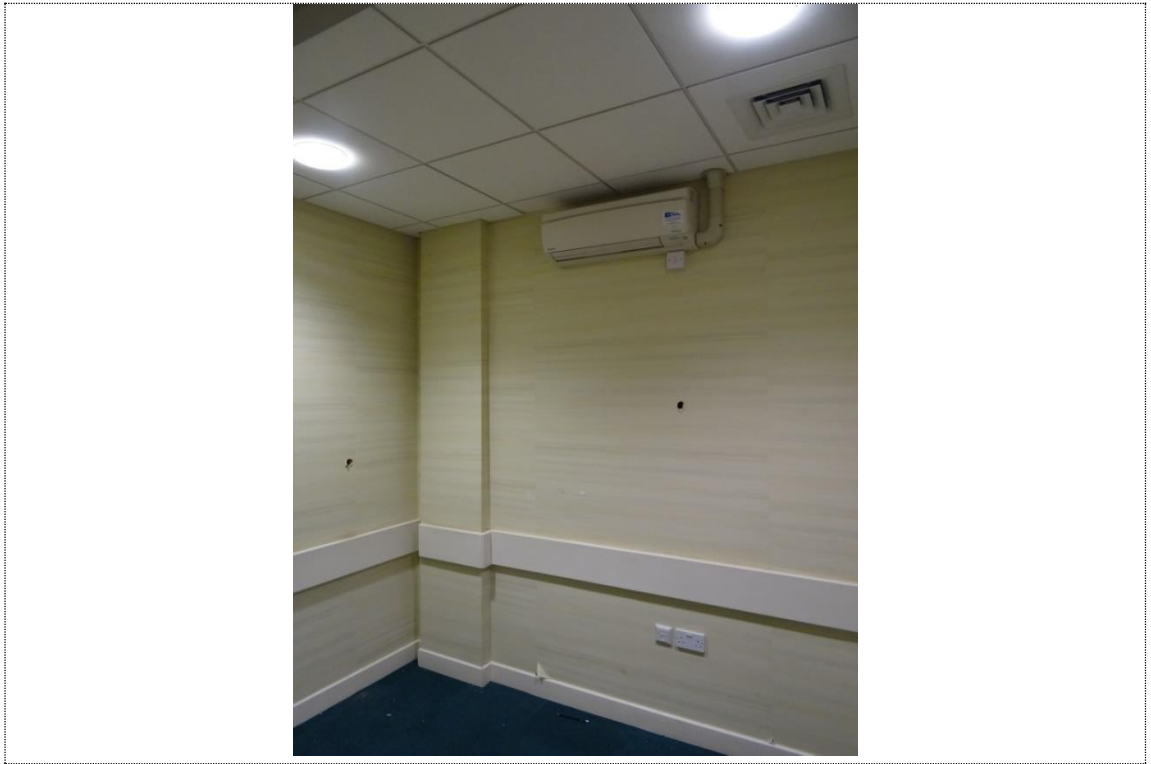
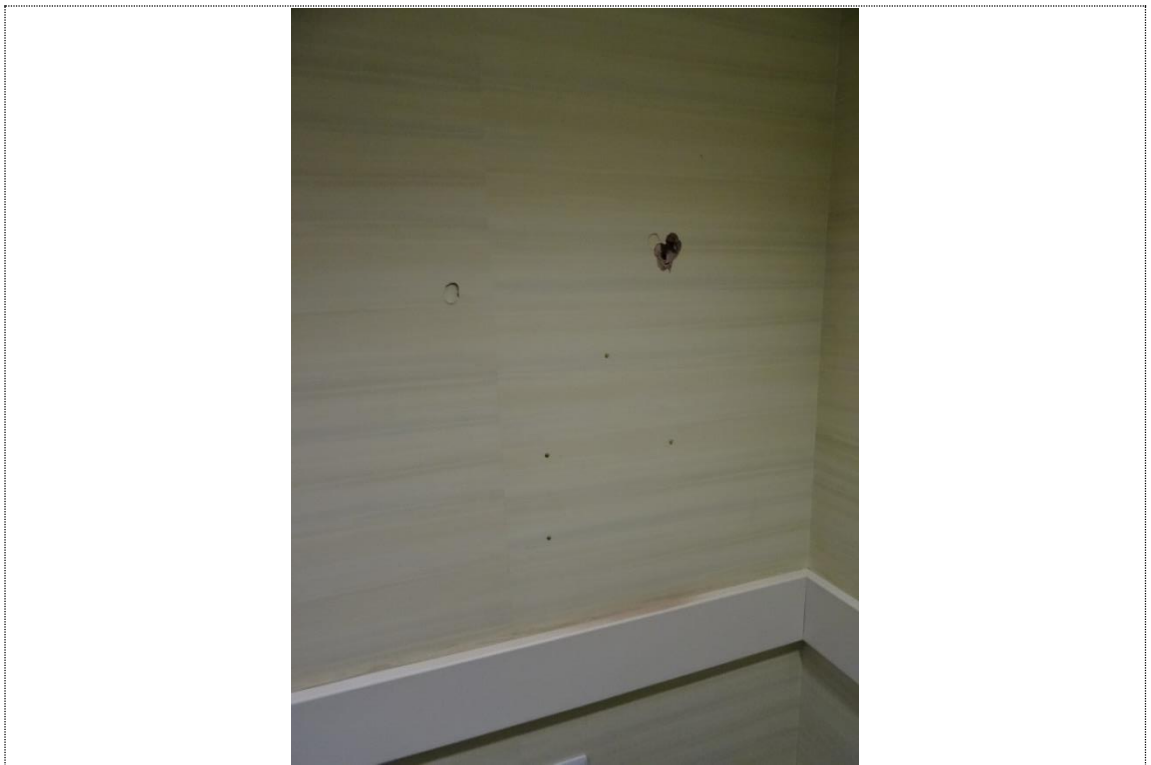
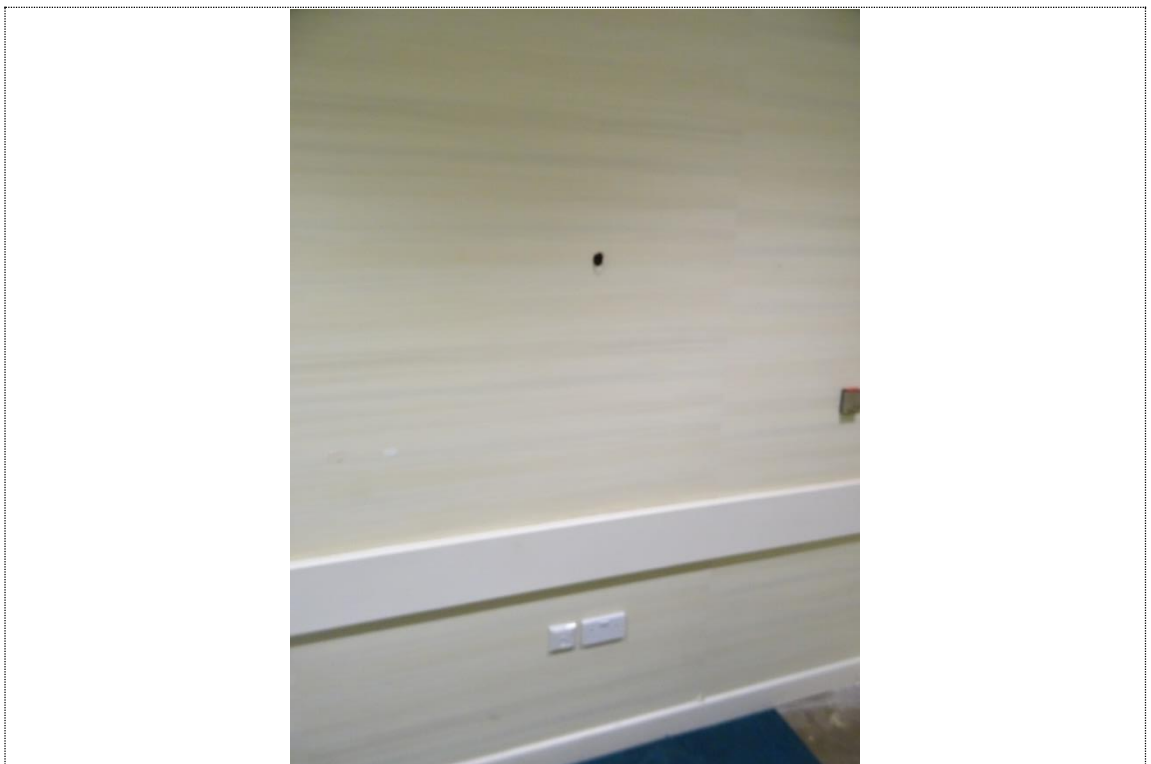
| | <p><b>Rear Office</b></p> | <p><b>Description/Photo:</b> Suspended ceiling grid with mineral tiles. Walls are finished with textured wallpaper. Decorated timber skirtings and carpet floor tiles.</p> <p style="text-align: right;">Photos 89 - 95</p> <p><b>Defect:</b> The occasional ceiling tiles are stained. Some impact damaged and staining noted to the walls. Slight scuff marks to skirtings. Carpet floor tiles worn and begrimed.</p> <p><b>Remedial Action:</b> Replace ceiling tiles as required. Repair and upgrade/decorate wall finishes and skirtings as required. Clean or replace floor tiles.</p> |
