Building Inspection Report

Project preface

We have been requested by the prospective purchaser to carry out a Building Survey of the above property.

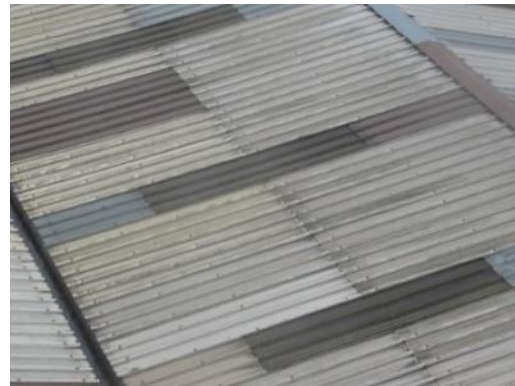
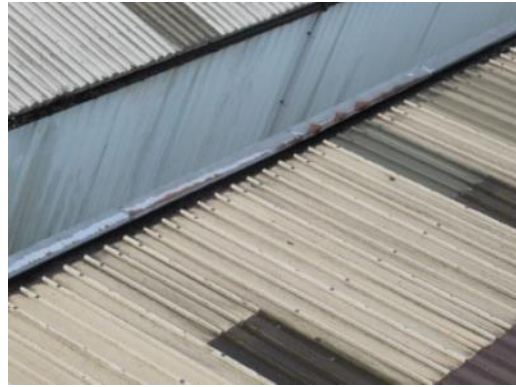
The factory finished profile metal sheet roof covering generally appears to be in satisfactory condition however areas of cut edge corrosion are evident to the roof sheets particularly towards the rear of the roof.

We recommend that works are undertaken in the immediate term to treat the cut edges of the roof sheets with a suitable proprietary repair system in order to address this and as a precaution against further deterioration and moisture ingress.

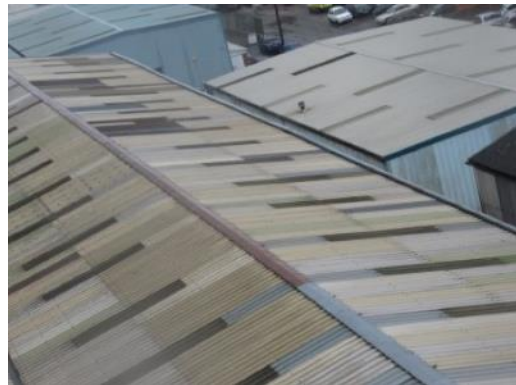
The preformed metal ridge flashing is heavily corroded throughout its length with the fillers present to its underside and the junction with the roof covering displaced in areas. We recommend that the ridge flashing is replaced in the immediate term together with the associated fillers.

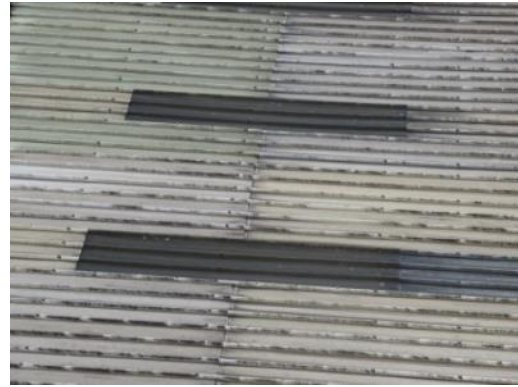
The GRP plastic rooflights present to the roof appear to be in a serviceable condition however are heavily soiled and showing signs of solar degradation. We anticipate that the rooflights will require replacement in the short to medium term.

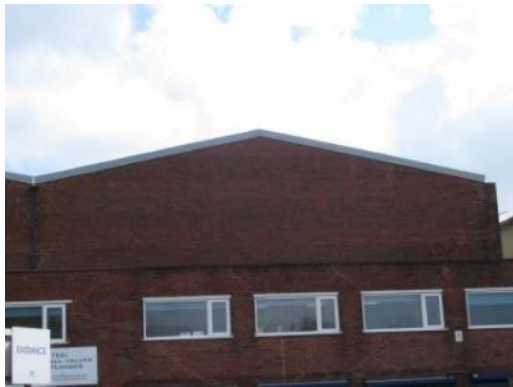
The brickwork present to the front elevation generally appears to be in satisfactory condition however areas of deteriorated mortar pointing are evident particularly to the left hand side of the elevation and adjacent to the downpipes and to the right hand side of the elevation. Where mortar pointing has deteriorated this provides a potential for moisture ingress into the property and as such we recommend these areas are repointed in the immediate term.

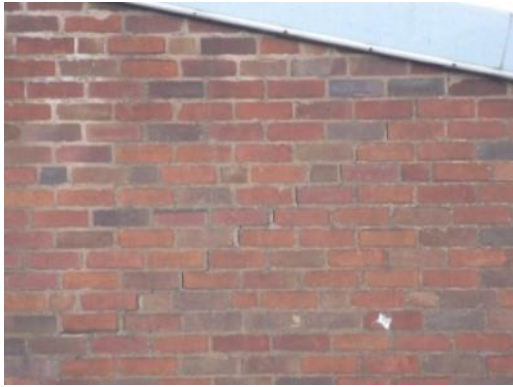
An area of very slight stepped cracking is evident to the mortar joint of brickwork at high level to the right hand side of the elevation. Although the cracking does not appear to be significant at present it suggests that a degree of slight structural movement has occurred at this location. We are unable to confirm from a visual inspection whether the movement is historic or ongoing and as such recommend the area is repaired and repointed in the immediate term and then visually monitored as a precaution.

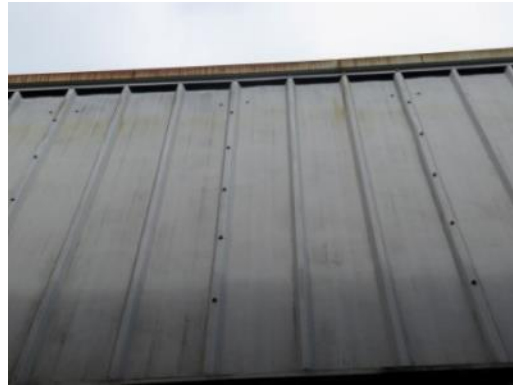
The painted profile metal cladding present to the right hand elevation appears to be in a serviceable condition however the painted coatings are deteriorating throughout with areas of minor impact damage also noted.

We recommend that the cladding is redecorated in the short term. Where minor impact damage is present to the cladding this does not appear to be significant however the damaged sheets would benefit from replacement in the short term.

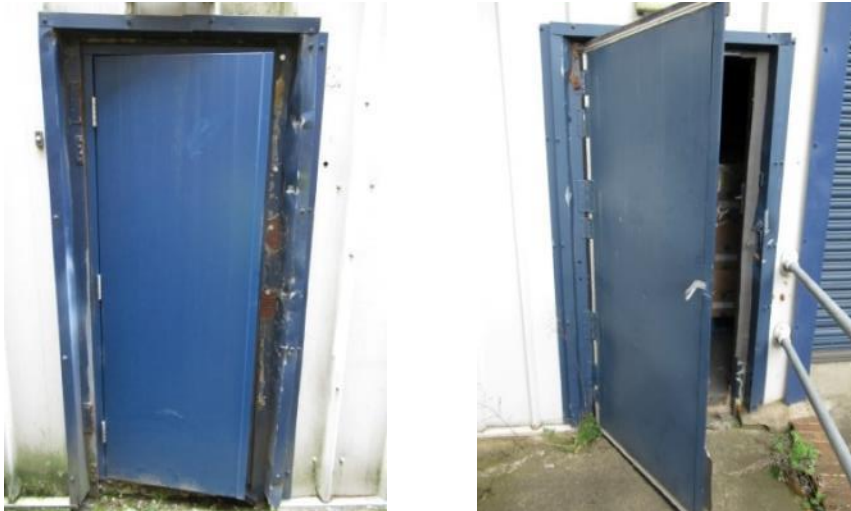
The preformed metal surrounds to the fire exit doors are damaged and require replacement in the immediate term.

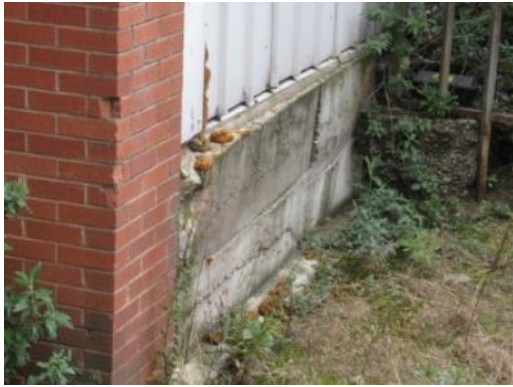
The in situ concrete present at low level towards the rear of the elevation generally appears to be in satisfactory condition with no significant defects noted. We note that only a limited view is possible of the rear of the elevation due to the extensive vegetation growth and waste present adjacent to this area.

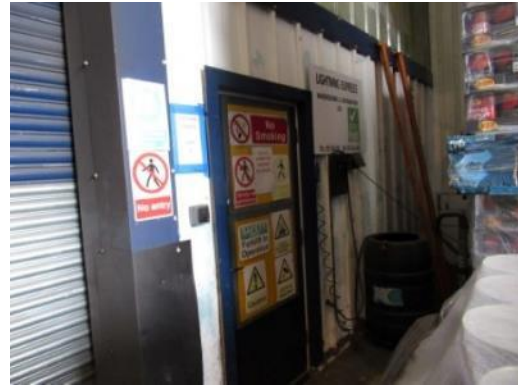
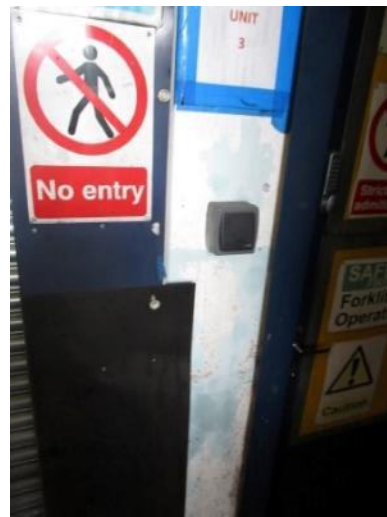
The painted profile metal cladding present to the rear elevation appears to be in a serviceable condition however the painted coatings are deteriorating. Where areas of minor impact damage are present to the profile metal cladding these does not appear to be significant.

We recommend that the cladding is redecorated in the short term.

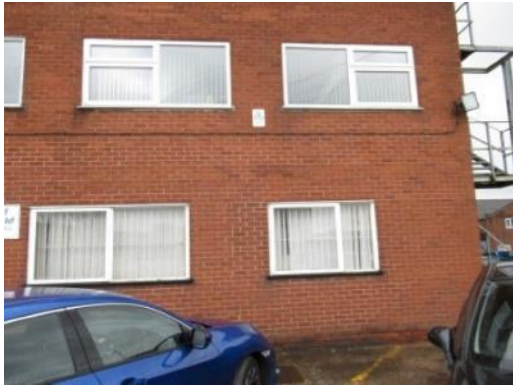
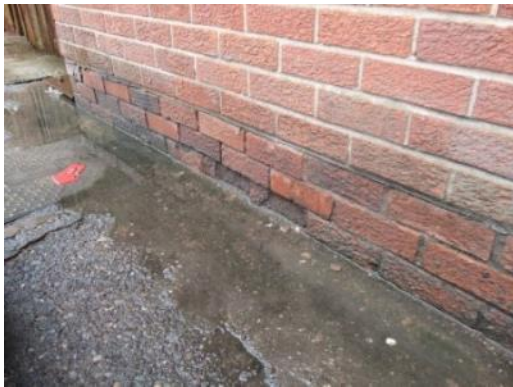
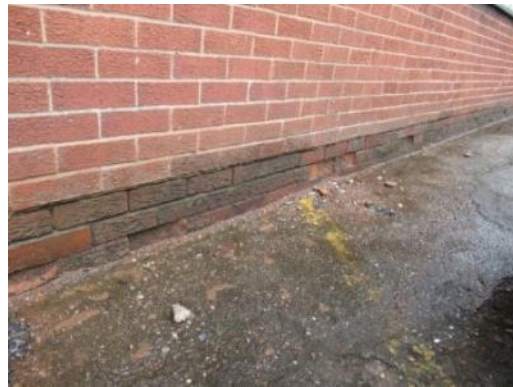
The brickwork present to the front elevation of Unit 4 generally appears to be in satisfactory condition however areas of deteriorated mortar pointing together with a number of spalled and defective bricks are evident particularly at low level.

The aforementioned provides a potential for moisture ingress into the property and as such we recommend that works are undertaken in the immediate term to repoint areas of deteriorated mortar pointing and cut out and replace spalled and defective brickwork.

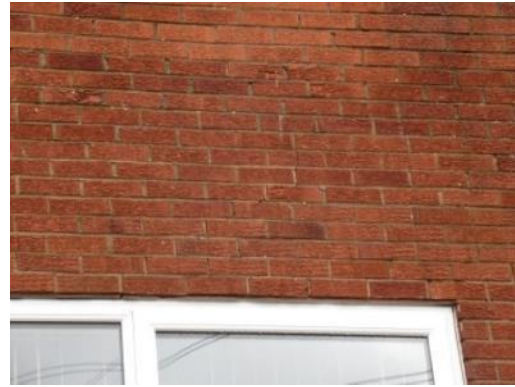
Areas of very slight to slight cracking are evident to the brickwork above the second first floor window from the left hand side of the elevation and above the ground floor right hand window with very slight cracking also evident above the first floor right hand window and main entrance door. The cracking at these locations suggests that a degree of structural movement has been experienced however we are unable to confirm from visual inspection whether this is historic or ongoing. Where cracking is present to the brickwork we recommend the areas are repaired and repointed in the immediate term and then visually monitored as a precaution.

The pattern of cracking suggests that the movement may be as a result of insufficient or deterioration of the lintel support above the openings. We recommend that further investigation works are undertaken in order to confirm that suitable lintels are present above the opening. If necessary new lintels may require installation.

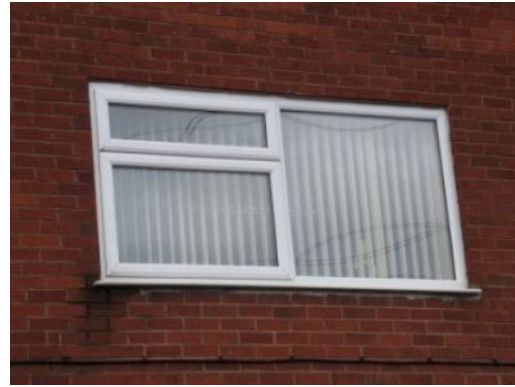
The uPVC framed double glazed windows generally appear to be in satisfactory condition however a number of failed double glazed units are evident with condensation present within the units. We recommend works are undertaken in the immediate term to replace failed double glazed units where present.

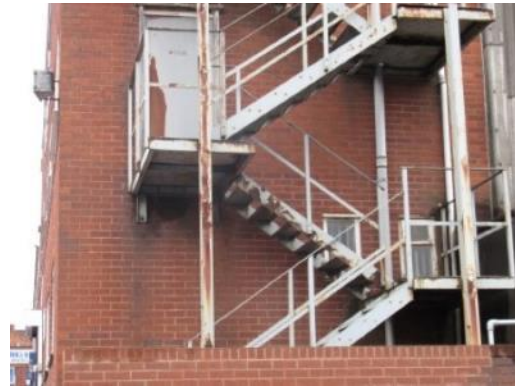
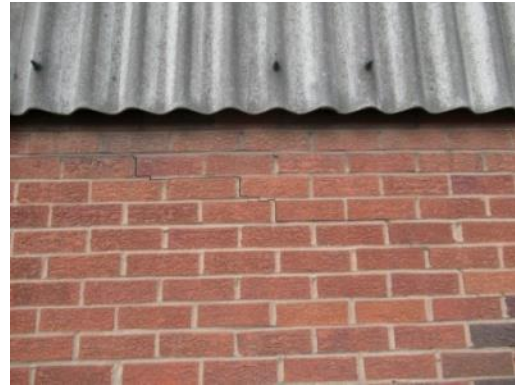
The brickwork present to the right hand elevation generally appears to be in satisfactory condition however areas of very slight to slight cracking are evident throughout its length.

Where cracking is present to the elevation this suggests that a degree of structural movement has been experienced however we are unable to confirm from a visual inspection whether this is historic or ongoing. Where cracking is present we recommend that the areas are repaired and repointed in the immediate term and visually monitored as a precaution.

We note that defects to below ground drainage are a potential cause of structural movement. As such we recommend that a CCTV survey is undertaken to the below ground drainage in the immediate term to confirm its condition. Where repairs are identified these should be carried out.

An extent of the cracking may also be as a result of thermal expansion with the brickwork with no expansion joints present within the elevation. We recommend that suitable expansion joints are installed to the brickwork at 10 to 12 m intervals in order to address this.

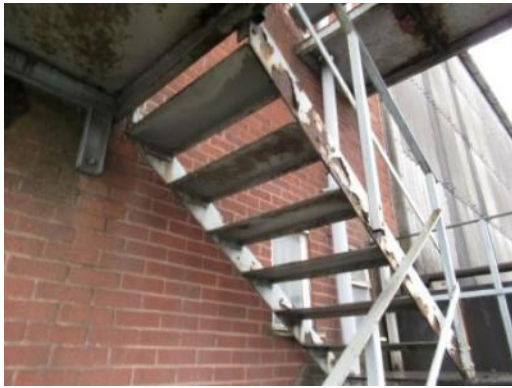
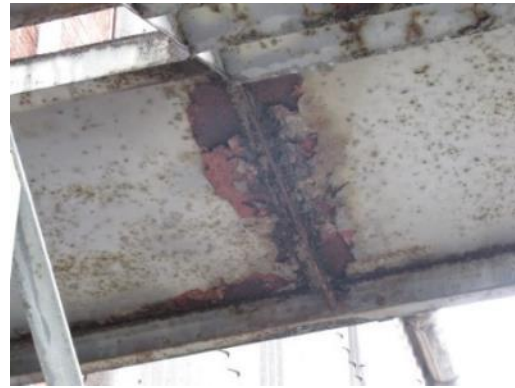
An external metal fire escape staircase is present towards the front of the elevation. The staircase is generally poorly maintained with the painted finish deteriorated and corrosion evident throughout. We recommend that general repairs and redecoration are undertaken to the staircase in the immediate term. Where severely corroded sections are present they will require replacement.

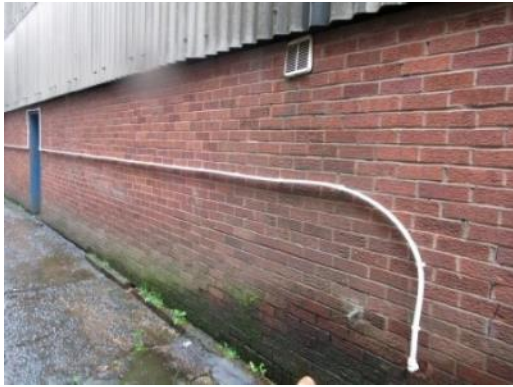
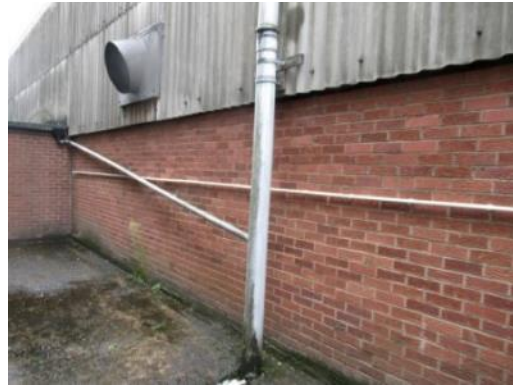
The brickwork present to the left hand elevation generally appears to be in satisfactory condition however areas of deteriorated mortar pointing are evident particularly at low level along with areas of very slight cracking. Where mortar pointing has deteriorated we recommend these areas are repointed in the immediate term

Where cracking is present to the brickwork this suggests that a degree of structural movement has been experienced although we are unable to confirm from visual inspection whether this is historic or ongoing. Defects to below ground drainage are a potential cause for structural movement and we refer you to our previous comments regarding carrying out a CCTV survey.

Following the aforementioned the areas of cracking to the brickwork should be repaired and repointed and then visually monitored as a precaution.

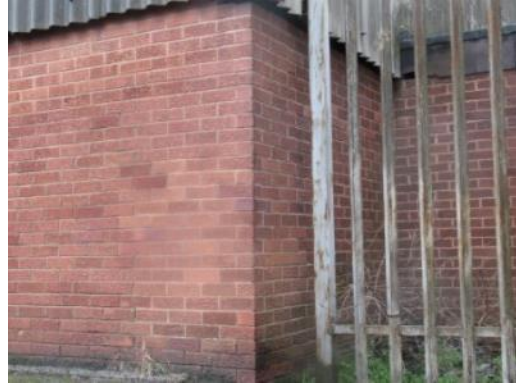
The brickwork present to the rear elevation generally appears to be in satisfactory condition however a number of isolated, spalled and defective bricks are evident. Where spalled and defective brickwork is present this would benefit from cutting out and replacement.

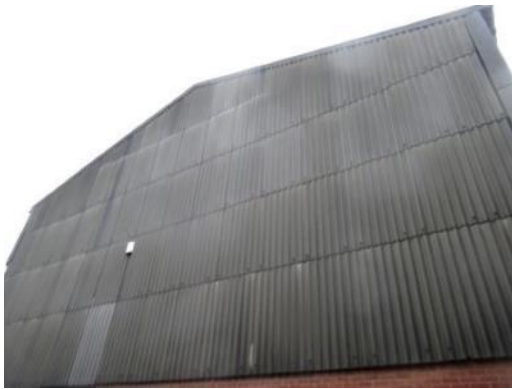
The corrugated sheet cladding present to the rear elevation generally appears to be in satisfactory condition however areas of damage are present particularly to the rear right hand corner and towards the centre of the elevation.

Where damaged cladding is present these areas would benefit from replacement. As noted to the previous elevations the cladding appears to be of an asbestos containing material and we refer you to our previous comments regarding this.

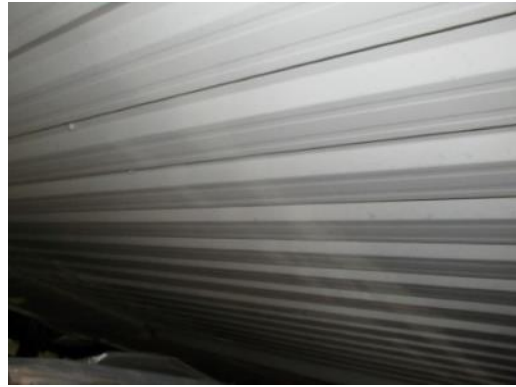
The internal face of the external cladding present to the walls generally appears to be in satisfactory condition with no significant defects noted. Where areas of staining are present to the cladding particularly to the right hand elevation this appears to be as a result of leaks from the above rainwater goods. Please refer to our previous comments within the external condition section of the report regarding the rainwater goods.

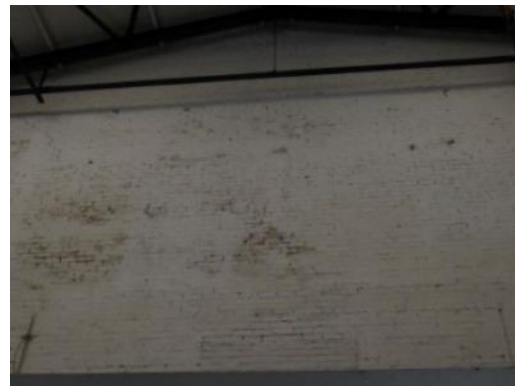
The brickwork present to the internal face of the front elevation appears to be in a serviceable condition however areas of soiling and staining, deteriorated mortar pointing and very slight cracking are evident.

The cracking present to the brickwork suggests that a degree of slight structural movement has occurred to these locations although does not appear to be significant at present. We are unable to confirm from a visual inspection whether the movement is historic or ongoing and as such we recommend the areas are repaired and repointed in the immediate term and then visually monitored as a precaution. The brickwork would also benefit from repointing areas of deteriorated mortar pointing and redecoration.

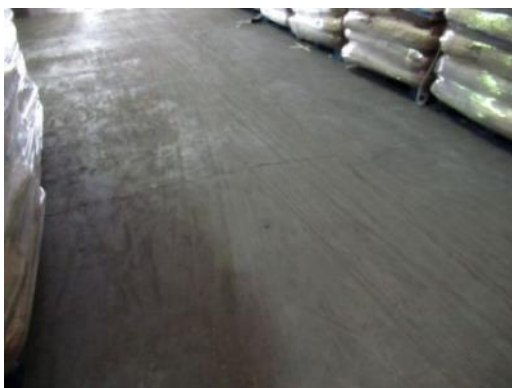
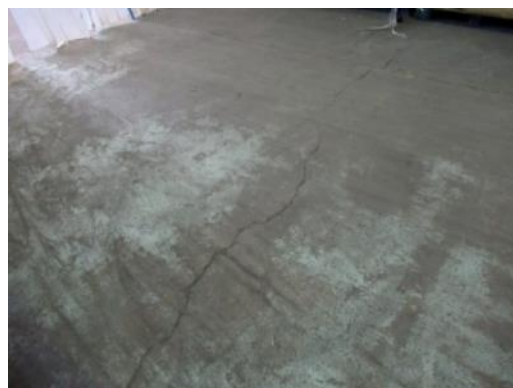
The painted concrete floor to the warehouse generally appears to be in satisfactory condition however the painted finishes are generally deteriorated with areas of cracking also evident to

its surface. The aforementioned does not appear to be significant however the floor would benefit from repair to areas of cracking and redecoration in the short term.

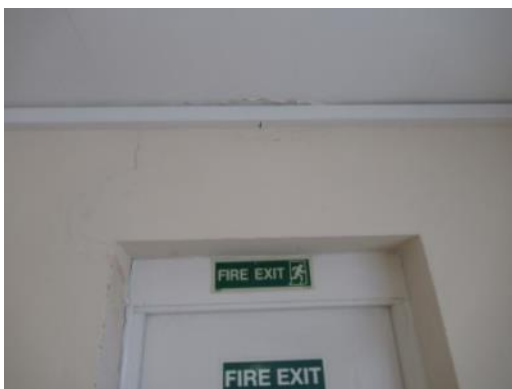
There is evidence of moisture ingress present to the head of the fire escape door to the right hand side of the offices which leads onto the external fire escape staircase. Following repairs

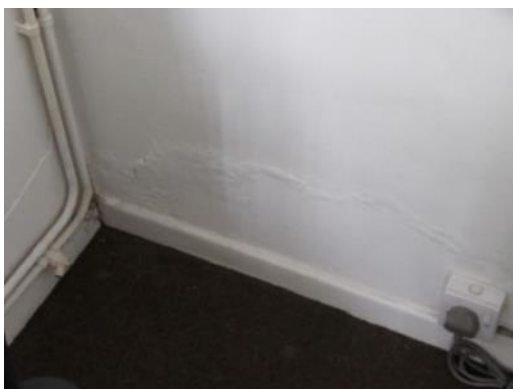
An area of deteriorated plaster finishes and high levels of moisture are evident to the rear left hand corner of the left hand office. A WC is present to the rear of the office and we note high levels of moisture at low level to the walls within this area also and decay present

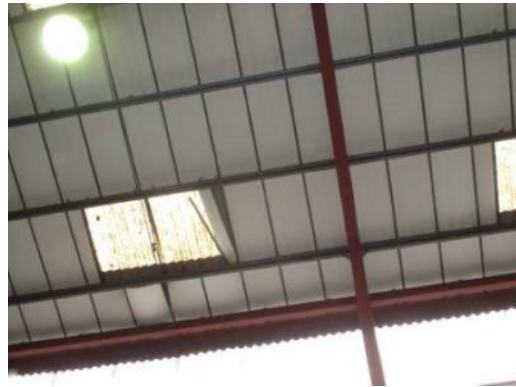
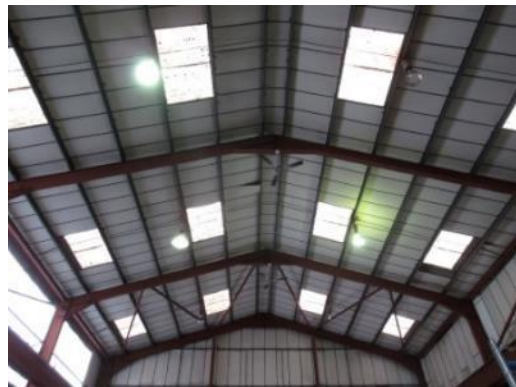
The lining boards to the ceiling generally appear to be in satisfactory condition with no evidence of water ingress however a number of isolated, damaged and displaced lining boards are present and these would benefit from replacement.

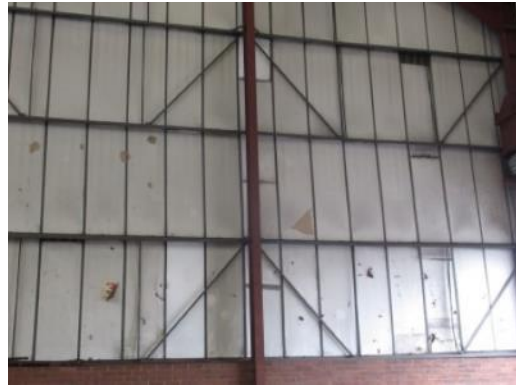
The lining boards present to the perimeter walls generally appear to be in satisfactory condition however numerous damaged lining boards are present particularly to the internal face of the rear elevation. Although this does not appear to be causing any significant problems at present the damaged lining boards would benefit from replacement.

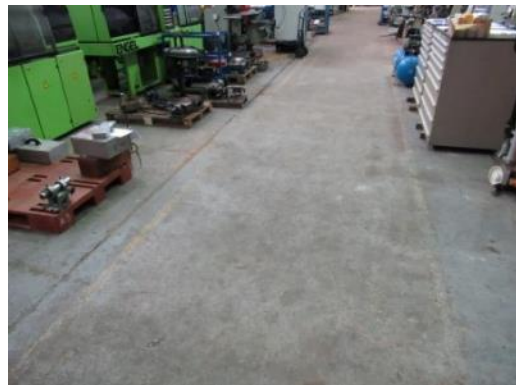
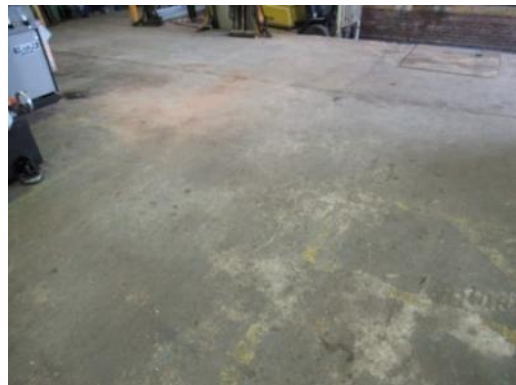
The concrete floor to the warehouse area generally appears to be in satisfactory condition with no significant defects noted however the painted finishes are generally deteriorated throughout and are in need of redecoration.

Where areas of cracking are present to the floor they do not appear to be significant however would benefit from repair as part of the redecoration works.
