# Building Inspection Report

XXXX

Report date XXXX 2022

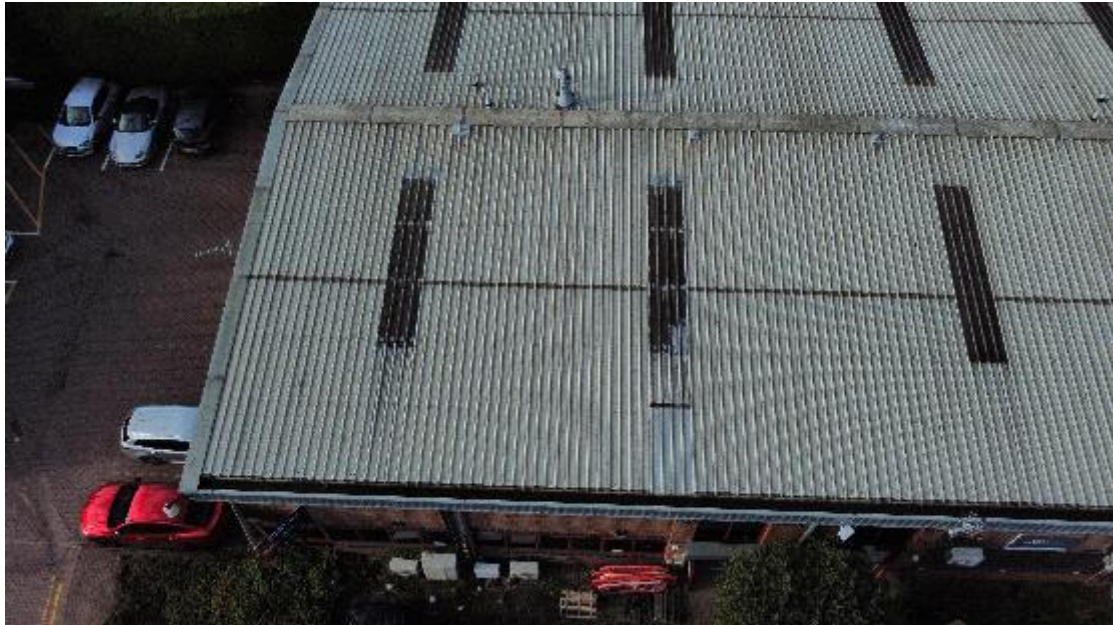
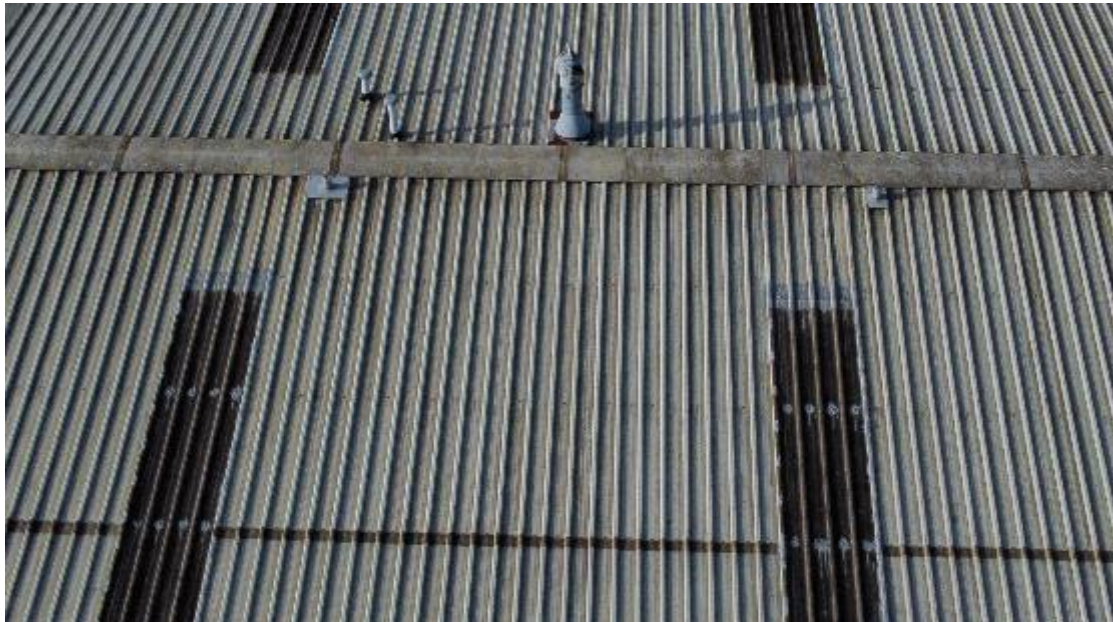
The roof is formed via profiled metal built-up roof structure which incorporates GRP roof lights. The roof sheets generally presented in a fair state of repair and condition. It was noted on closer examination of the plastisol to the sheets, that stages of spot corrosion and breakdown of the plaster sole sheet can be seen in isolated locations. In an attempt to remedy

the cut edge corrosion ends in laps of the profile sheet have been treated, although the liquid applied product has become discoloured and stained. From examination, we believe the rectifications to the ends in laps of the sheet to be to a satisfactory state of repair and condition at the time of the inspection.

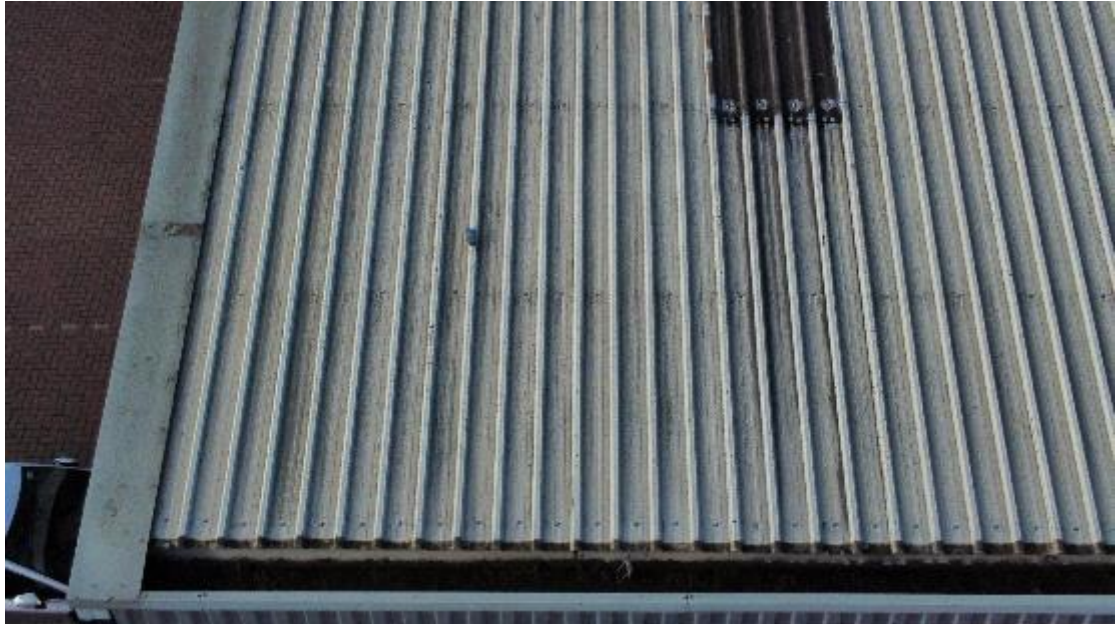
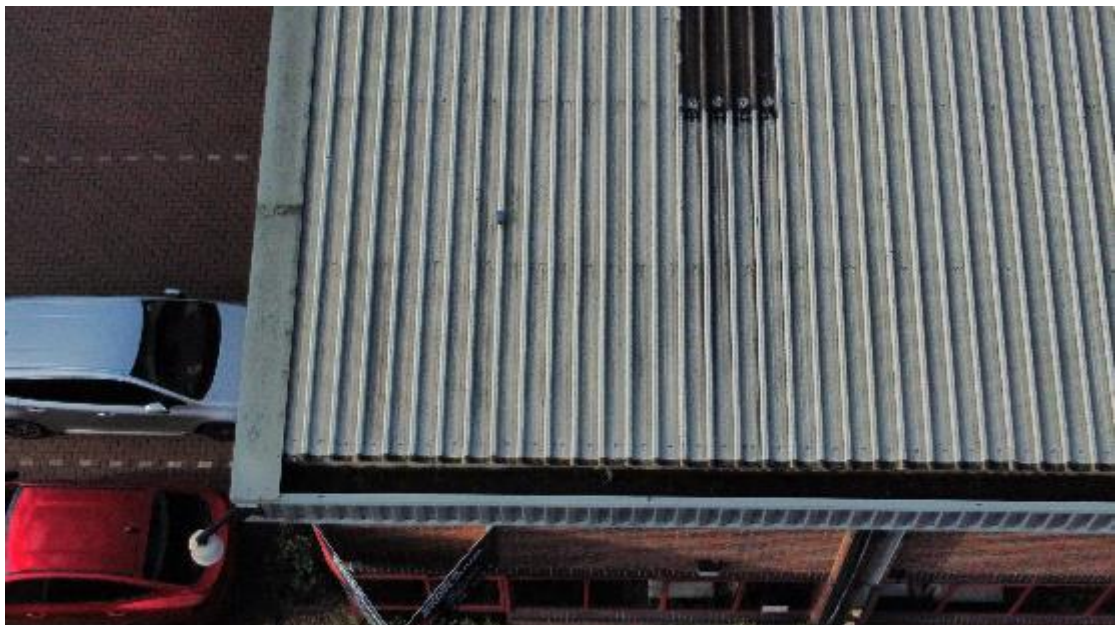
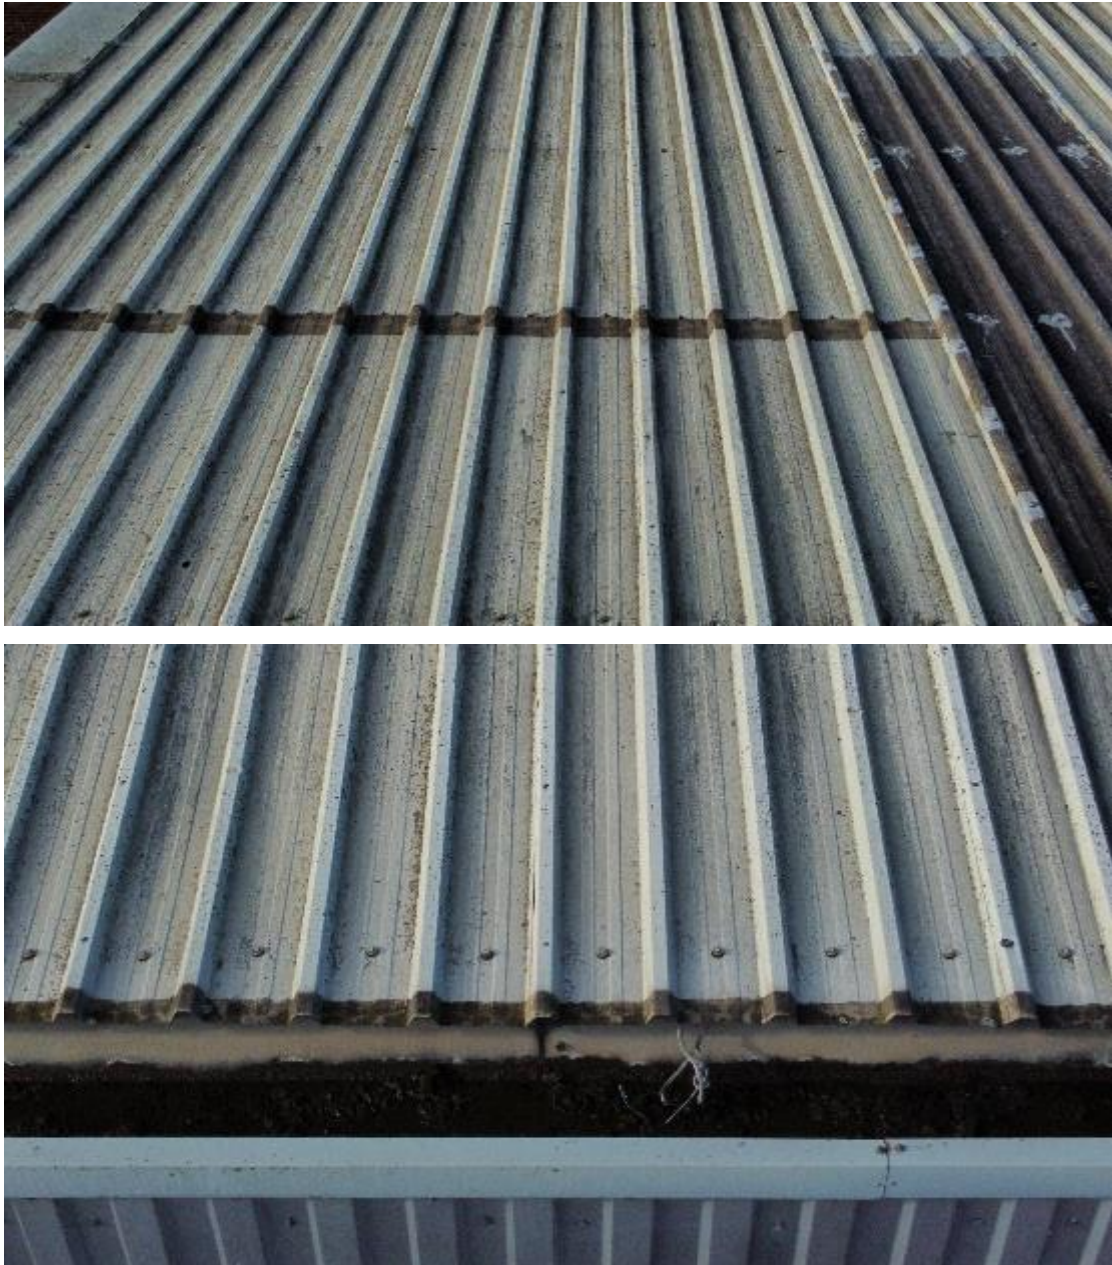
Roof lights presented stained and solar degraded. It was noted that localised remedial works have been undertaken to the perimeters of the sheets which would indicate that some water ingress had been entering the premises. Liquid applied product can be seen to the perimeter of the sheets and to fixing in screws. On the day of the inspection, no water ingress could be seen internally, where the roof sheets have been treated. It was additionally noted that a section of the roof has been treated with a localised repair in the form of replacement cut sheet. The sheet section that has been installed presents to a good state of repair condition, although the liquid applied product to the upper section presented soiled and discoloured.

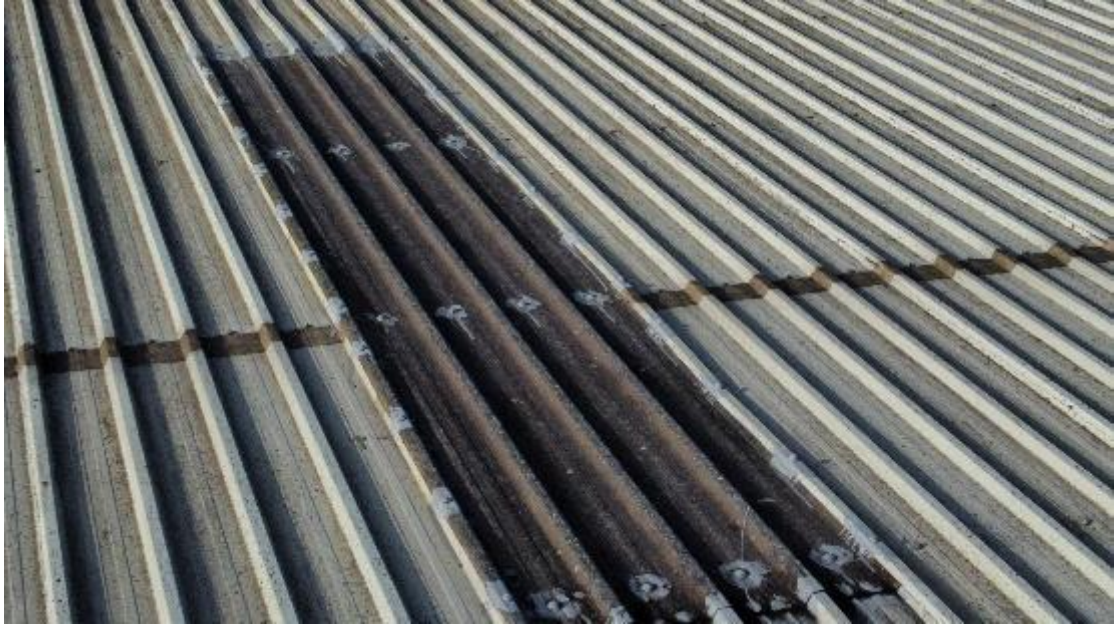
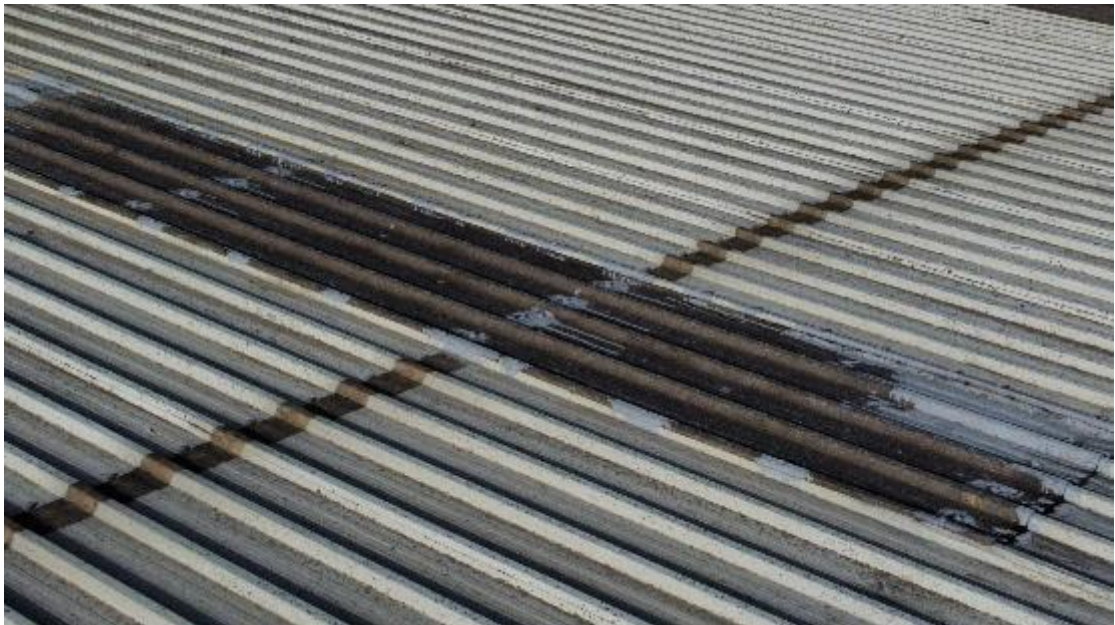
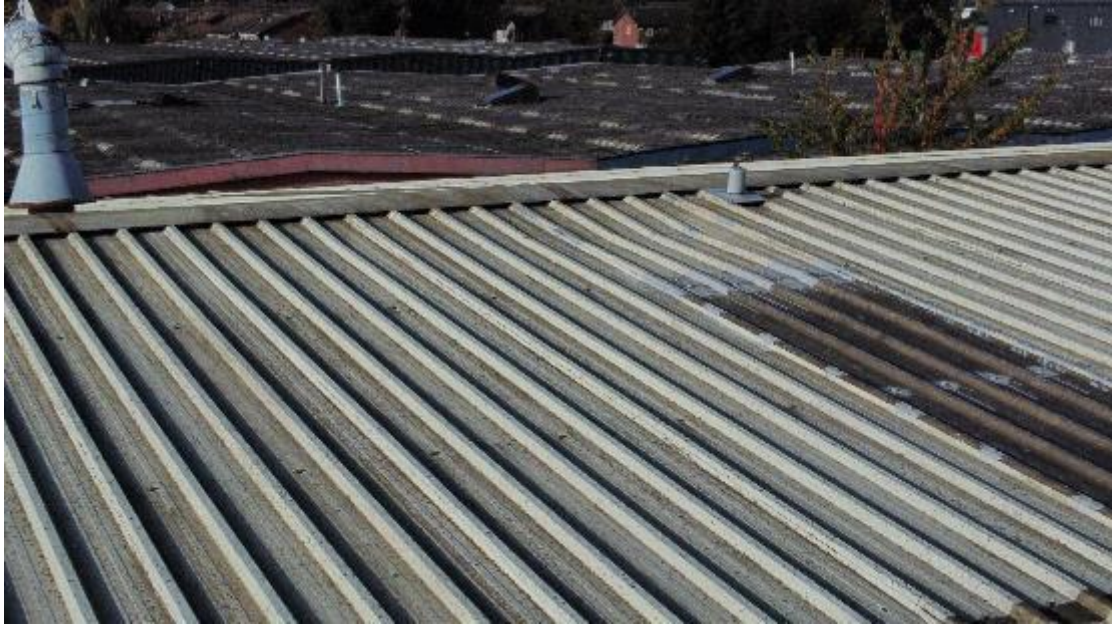
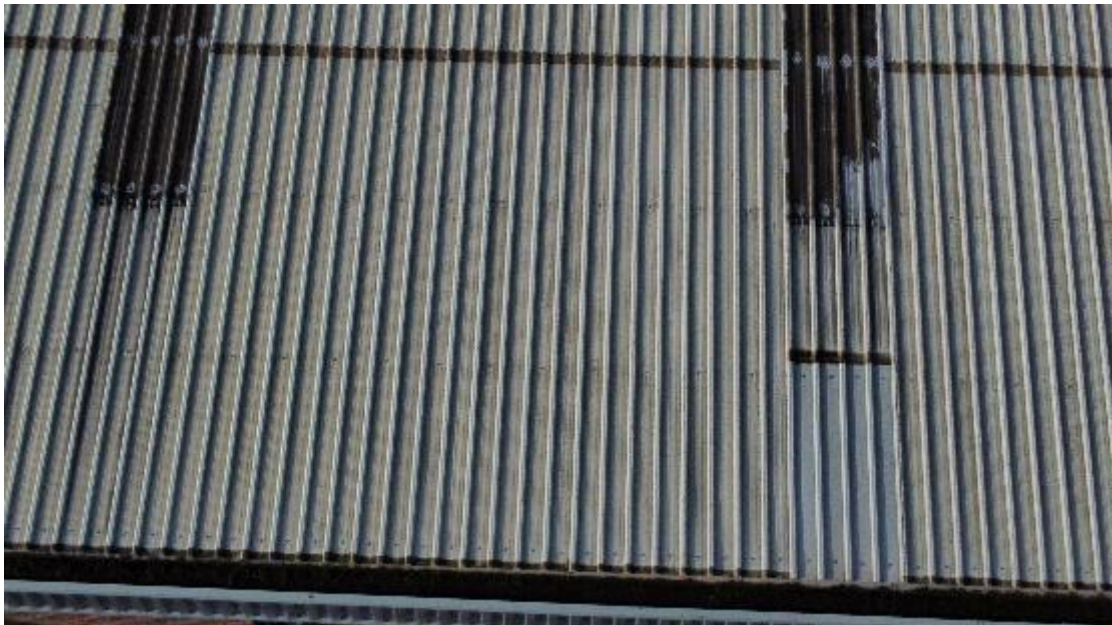
Perimeter trim details presented stained and solar degraded. This is to include the ridge cladding trim details. The roof incorporates a fall arrest (Mansafe) System to the apex of the roof, although we were unable to determine if the minimum annual maintenance and Certification have been undertaken to confirm its compliance with BS EN 365:2004.

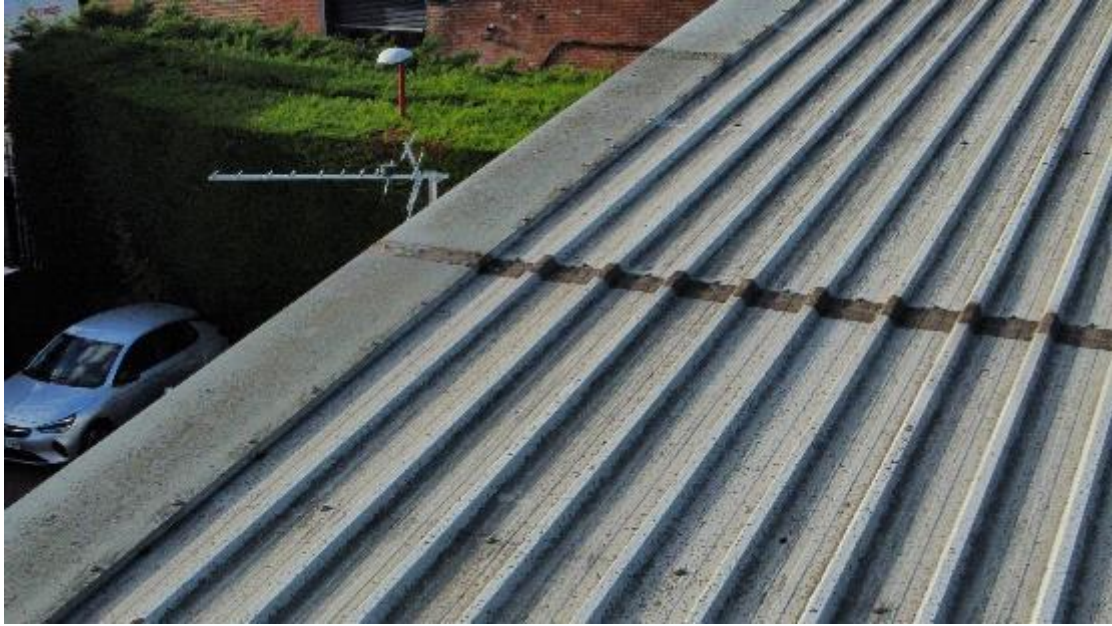
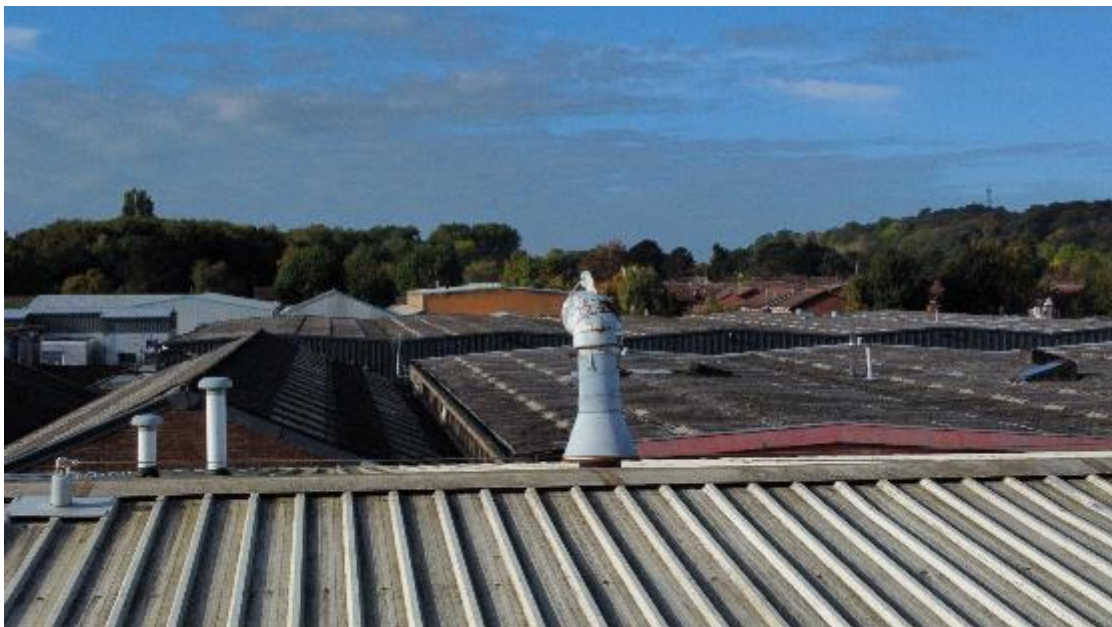
A number of vents and flues can be seen to the apex of the roof additionally visually present in a satisfactory state of repair and condition. It was however noted that redundant flue ventilation was noted. Corrosion could be seen to the fixing plate. Internally on visual inspection, we do not anticipate that this is still in operation. If this is fitting is no long required for ongoing use, we'd advise that this is removed and the penetrations reinstated.

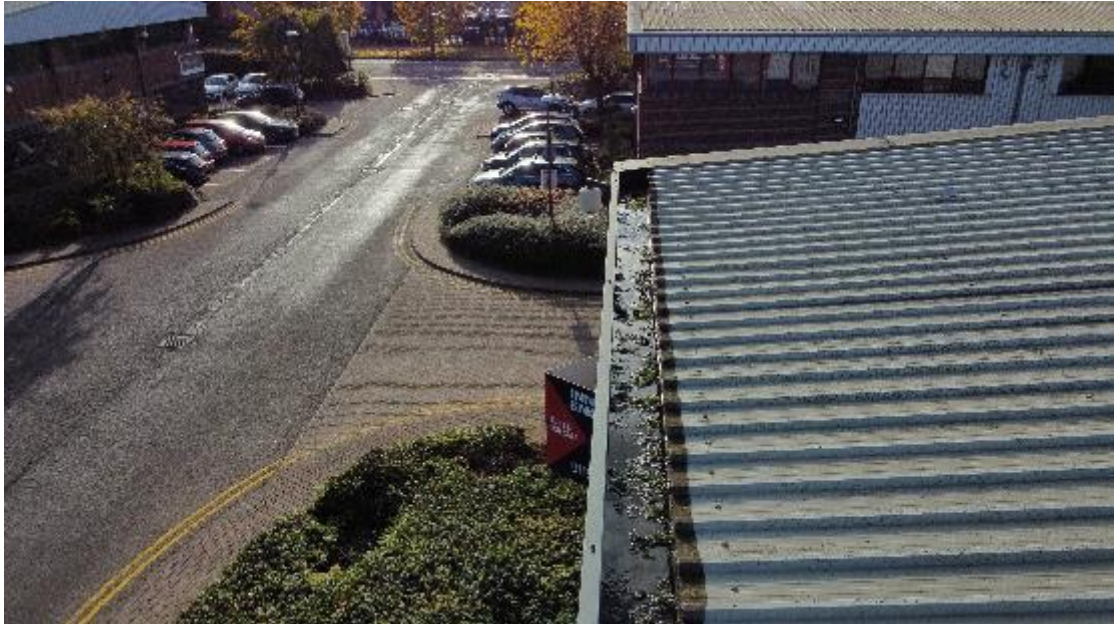
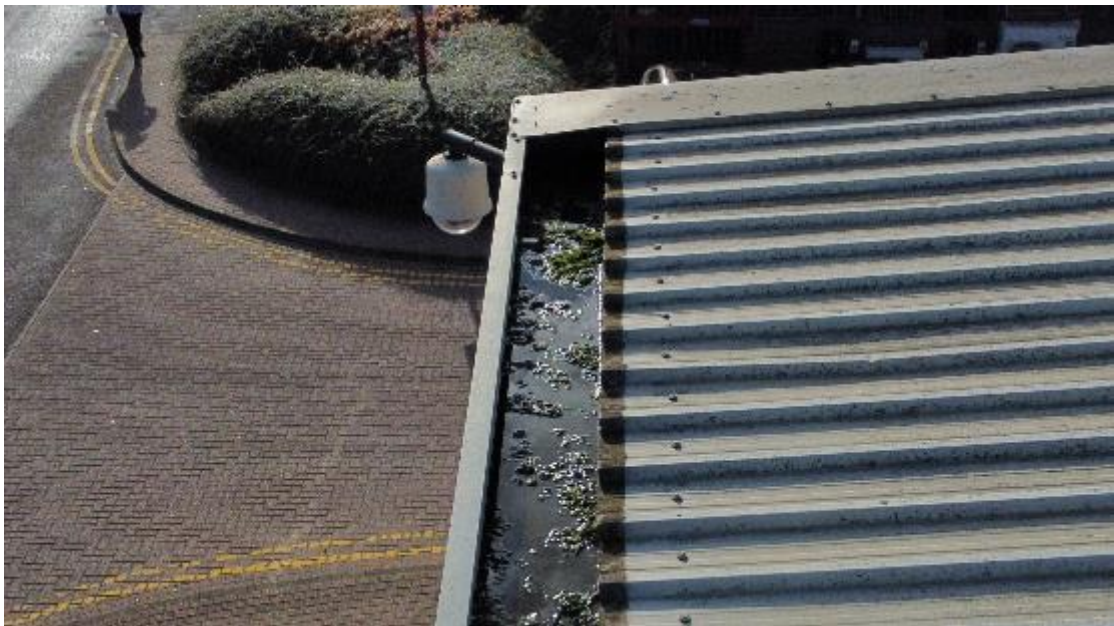
The gutter run to the front elevation was provided by metal box gutter which presented in a satisfactory state of repair, although it was noted debris, soil and some resultant pooling water can be seen. We would recommend that the gutters and downpipes are flushed leaving them

free flowing. No leaks or subsequent deterioration could be noted to the underside soffit detail.

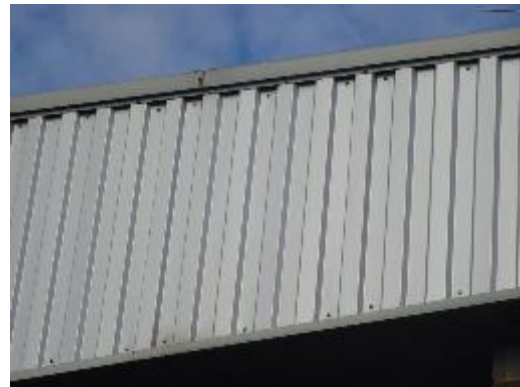
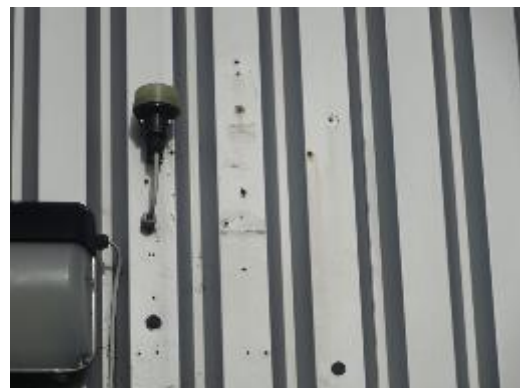
Cladded sections are provided via built-up detailing in section and presented in a visually reasonable state of repair and condition. Minor surface soiling could be seen in isolated locations from assessment where fixing bolts have deteriorated above. Surfaces have isolated scuffs and subsequent marks, but overall present well. Isolated openings from former fixings and fittings can be seen, of which we would recommend are infilled to prevent water ingress and subsequent internal disrepair.

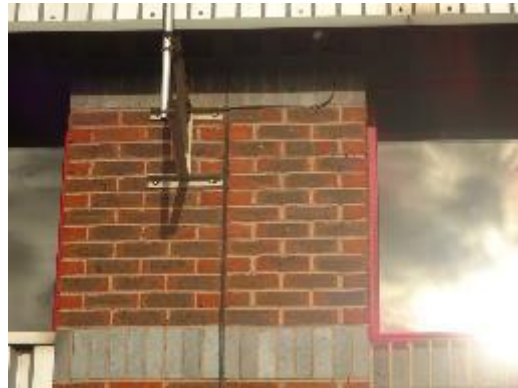
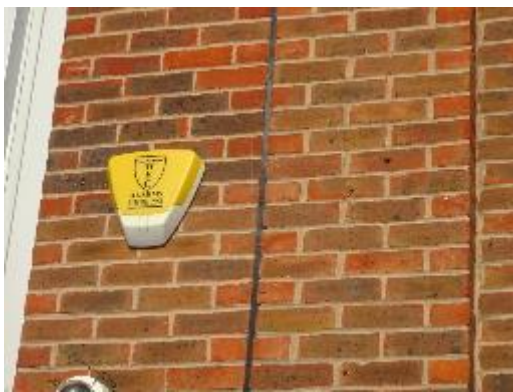
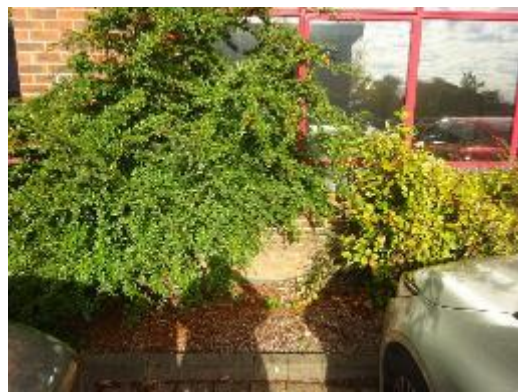
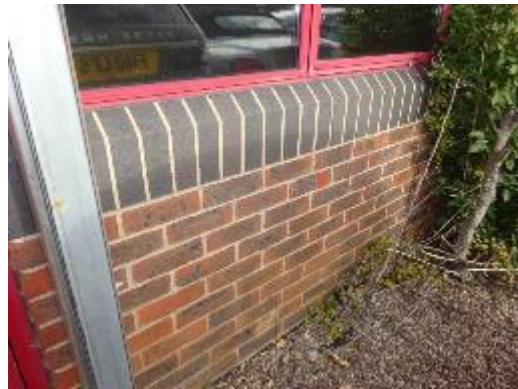
The main walls to the front elevation are provided via cavity wall construction, of which visibility was limited in isolated locations to low level vegetation. Where visible, main walls presented in a good state of repair and condition. No visible areas of deterioration, cracking or impact damage could be seen to the masonry.

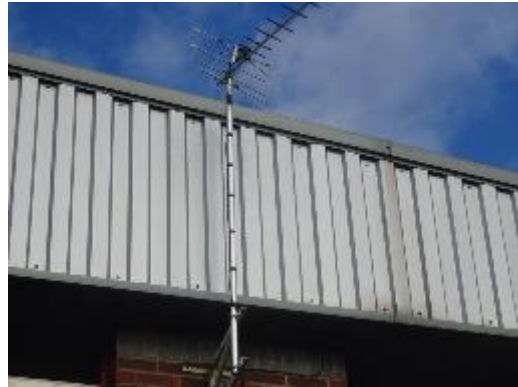
A number of fixtures and fittings can be seen to the front elevation in the form of CCTV, spot lights, alarm systems and control panels. Visually, these fixtures and fittings presented in a satisfactory visual state of repair and condition. We would however recommend that maintenance certification is provided for the fittings to ensure that systems fully functional and in repair.

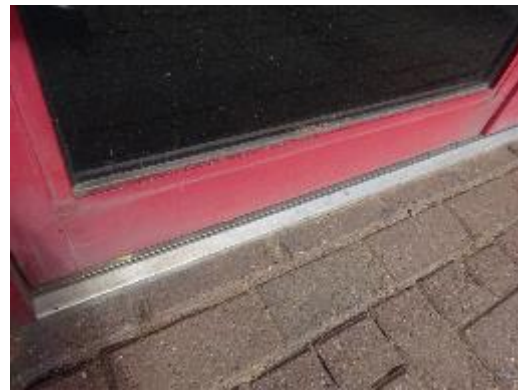
Powder coated finishes presented solar degraded and discoloured. It should be noted that scuffs and minor wear can be seen to push plates and handles. No impact damage or deterioration was noted to the door, although we recommend that decorations are undertaken in the short term to further protect the sub-metals behind.

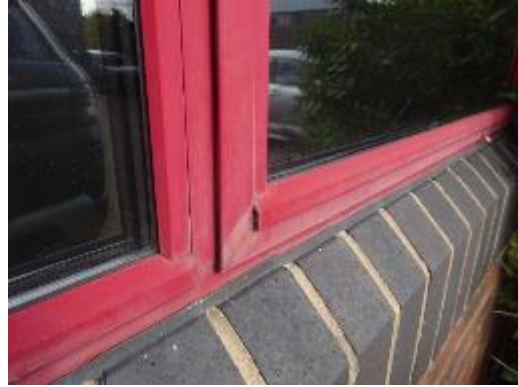
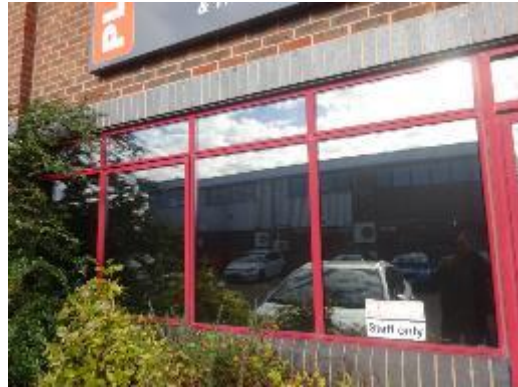
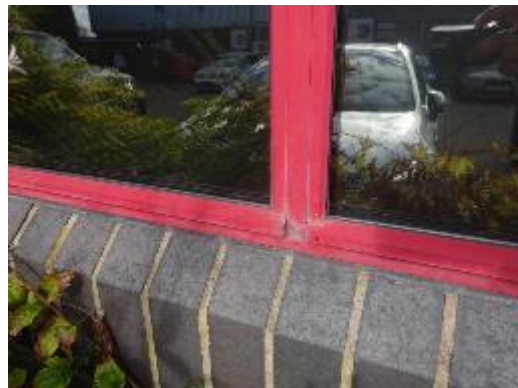
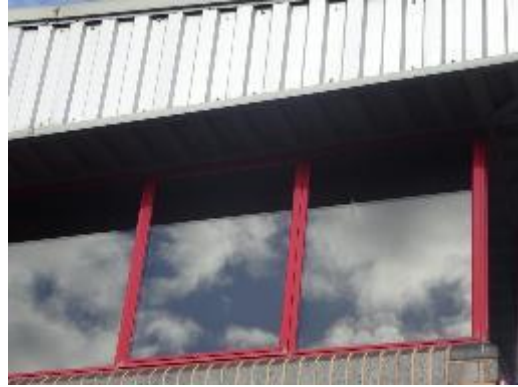
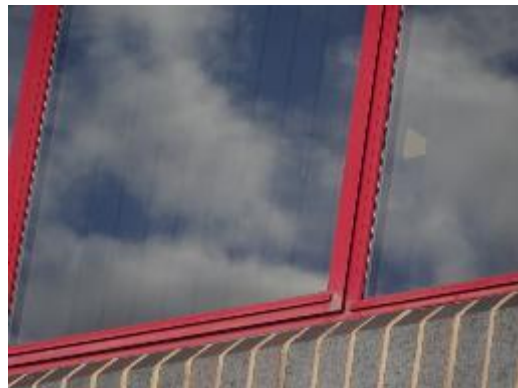
Glazing to the front elevation is provided via powder coated metal frames with double-glazed units which visually presented in a fair state of repair and condition. It was noted that the frames are solar degraded and soiling/discolouration can be seen. Window panes are provided via double-glazing, although were not able to identify any kite marks. Solar reflective and privacy film have been utilised internally to the window units, of which present in a satisfactory state of repair and condition. We would recommend that the glazing is thoroughly prepared and formally decorated with factory finished coatings restored in the short to medium term to ensure that the sub-metals behind remain in good repair and condition.

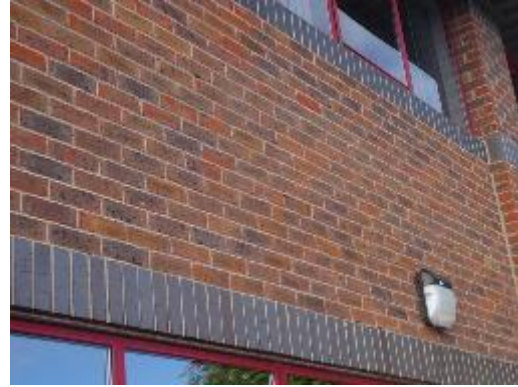
The main walls to the right elevation are provided via cavity wall construction, of which visibility was limited in isolated locations to tenants' fixtures and fittings to include the condenser unit. Where visible, main walls presented in a good state of repair and condition. No visible areas of deterioration, cracking or impact damage could be seen to the masonry.

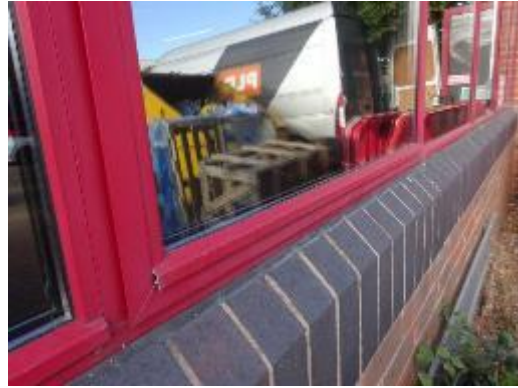
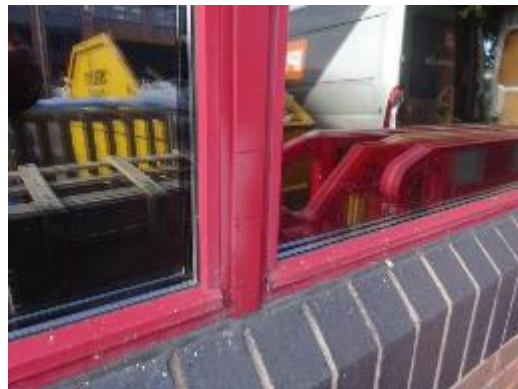
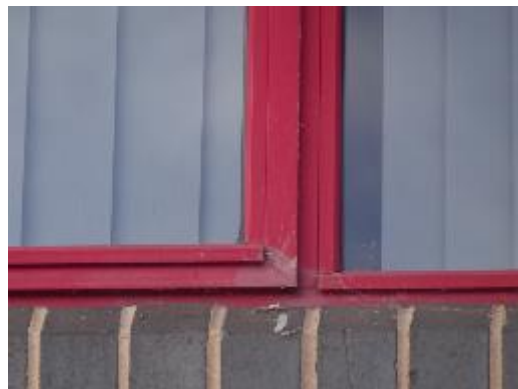
Glazing to the right elevation is provided via powder coated metal frames with double-glazed units which visually presented in a fair state of repair and condition. It was noted that the frames are solar degraded and soiling/discolouration can be seen. Window panes are provided via double-glazing, although were not able to identify any kite marks. Solar reflective and privacy film have been utilised internally to the window units, of which present in a good state of repair and condition. We would recommend that the glazing is thoroughly prepared and

formally decorated with factory finished coatings restored to ensure that the sub-metals behind remain in good repair and condition.

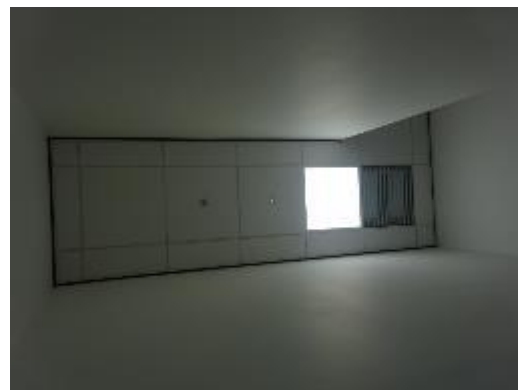
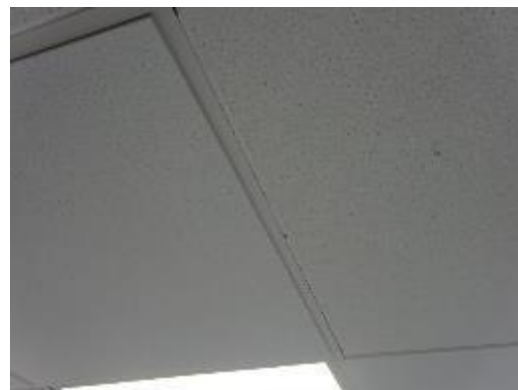
Ceilings throughout the lobby and stairwell area are provided by 600x600 mineral fibre suspended ceiling tile finish incorporate inlaid LED lighting. Visually tiles are presented in a satisfactory condition, although minor scuffs and blemishes could be seen. LED lighting presented well and was operated on PIR sensors. Emergency lighting could also be seen installed inlaid to the suspended grid.

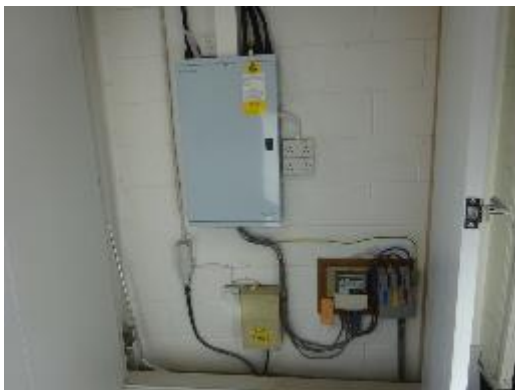
A service cupboard is provided via timber formed enclosure with timber doors of which presented in a good state of repair and condition. Masonry to the rear of the fittings presented in a good state of repair, albeit some minor surface soiling. Incoming three phase power and capped gas supply could be seen. Although installations and fittings can be seen visually in a good state of repair, we recommend that full test and maintenance Certificates are provided.

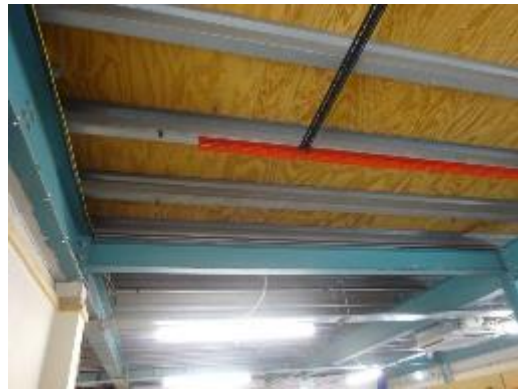
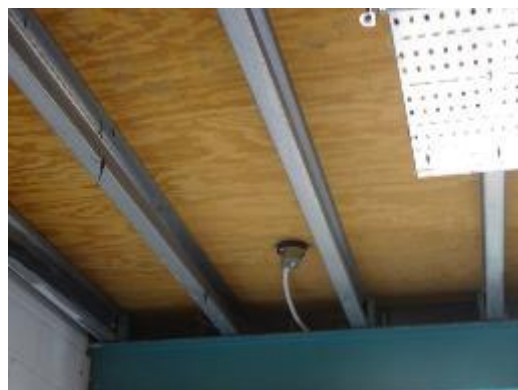
The ceilings are provided via the first-floor floor structure which is provided via timber boarding. Visually timber boards present in a good state of repair and condition. We are however unable to confirm the fire resistance of the boarding used. Though, it is unlikely this provides any resistance, as the above is utilised as a separate space, compartment floors are required to provide a degree of fire resistance of minimum 30min. No fire barrier or separation can be seen throughout and would not meet current day statutory compliance. We would highly recommend a fire risk assessment.

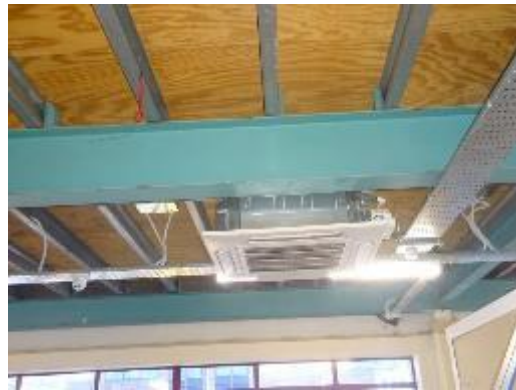
Suspended cable trays incorporates LED light strips, CCTV and air conditioning units. Visually these installations presented in a good state of repair and condition, although again we would advise that maintenance Certification is provided for the AC and CCTV to ensure that these are fully operational and functional. Lighting throughout was fully functional.

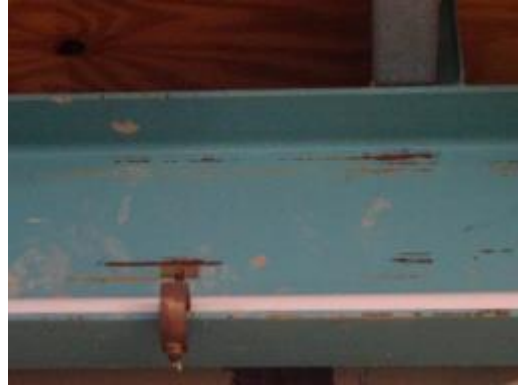
Structural steels presented in a satisfactory state or repair and condition, although isolated surface soiling and surface corrosion could be seen. Though from visual assessment, these do not appear to have any effect on the structural integrity of the building.

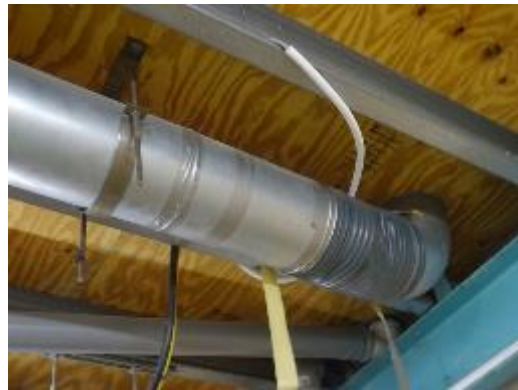
Redundant flue extract system was noted to the ceiling in the store area. Visually this presents in a satisfactory state of repair and condition however if this is not required, we would advise that this is removed and openings reinstated.

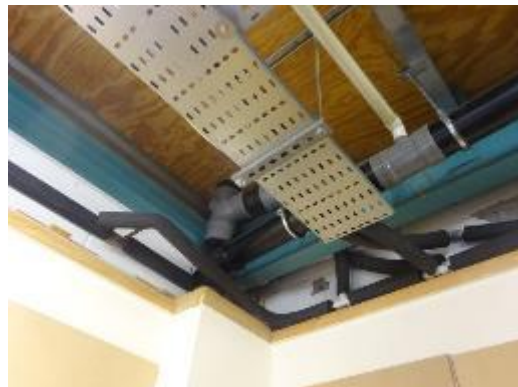
Foul and soil and vent pipes noted from within the store area presented in a visually reasonable state of repair and condition. It was however noted that the supporting cable tie was ad hoc and we would recommend that more secure long term installation is integrated.

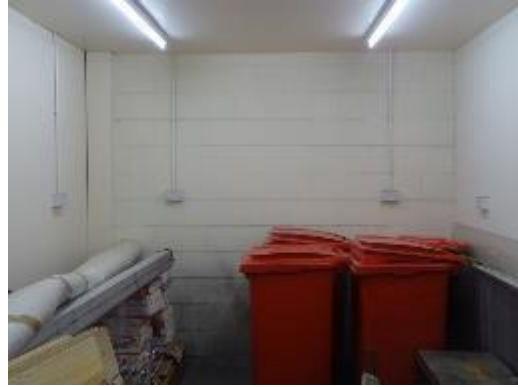
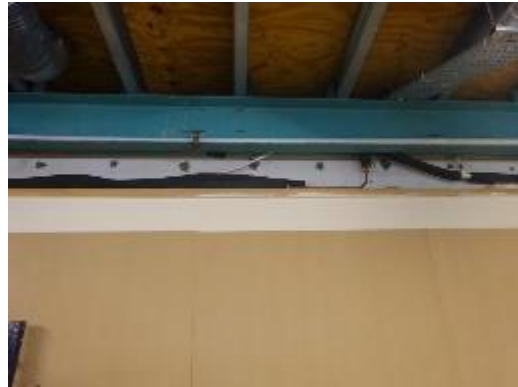
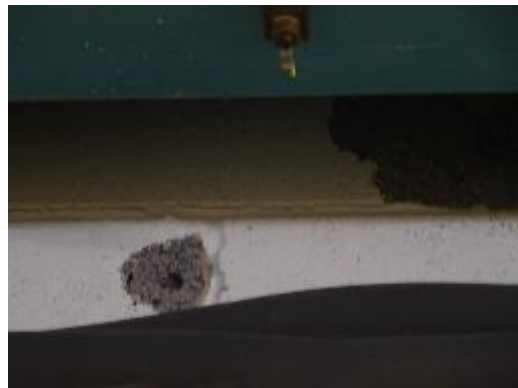
Visibility of the main walls from within the ground floor store area left elevation was limited via tenant boarding finishes. Where painted masonry can be seen, hairline cracking and disturbed Thermolite blocks from former fixtures and fittings were visible.

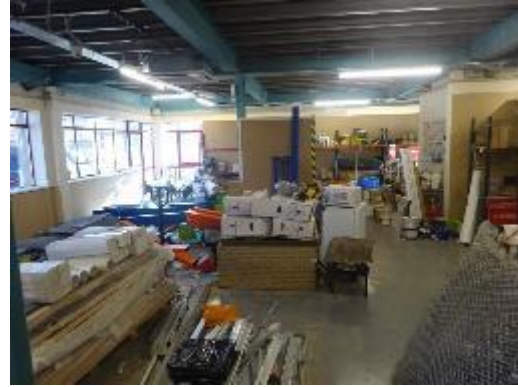
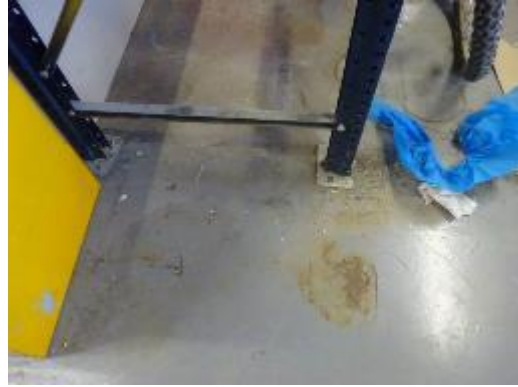
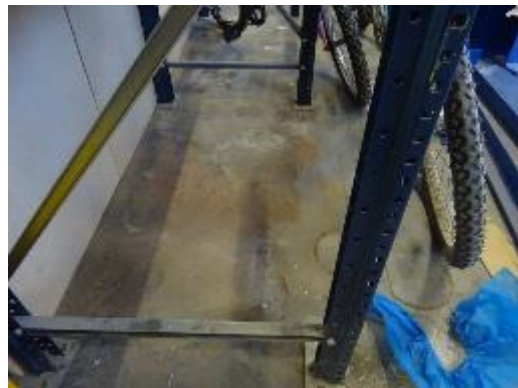
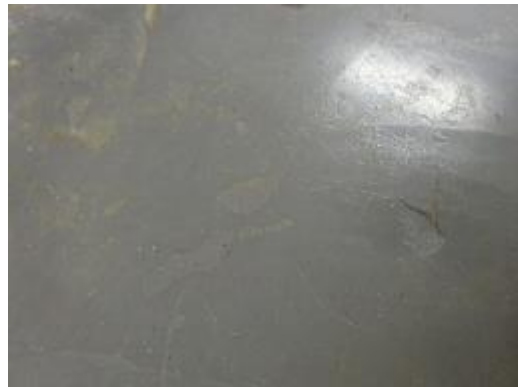
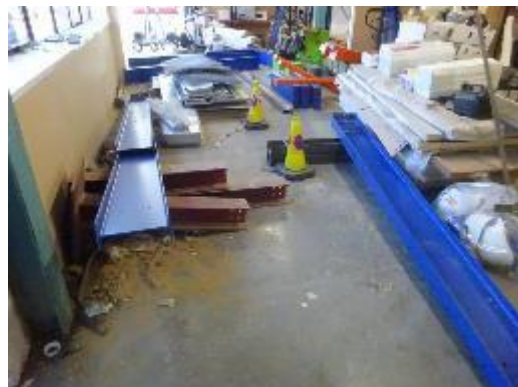
**Floor Structure**

Visibility of the floor structure and finish throughout were limited by tenants fixtures and fittings. Where visible, it was noted that the floor finish was provided via concrete slab with industrial paint application. Evidence of surface soiling, blemishes, scuffs and pitting/impact damage can be seen, although some localised remedial works have been undertaken. No significant areas of deterioration, cracking or failures in its integrity were noted, although we were visually limited to visibility throughout. Additionally note that during the inspection, racking systems were in the process of being removed and thus some fixing bolts were still in situ.

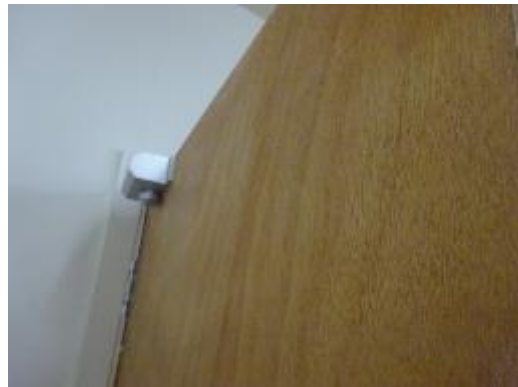
Timber double doors are provided presented in a satisfactory state of repair, although blemishes, minor impact damage and scuffs were seen where visible, although visibility was limited again due to tenants' fixtures and fittings. No smoke strips or seals were noted to the doors.

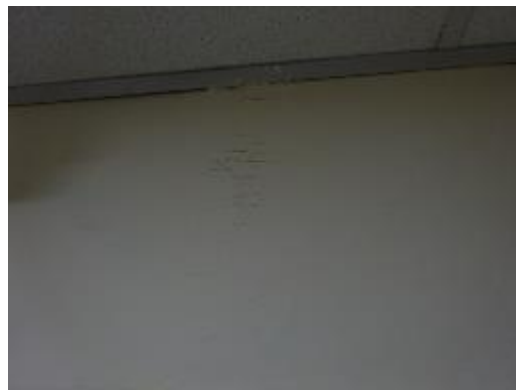
Paint finishes presented surface soiled with some visible blemishes and surface soiling.

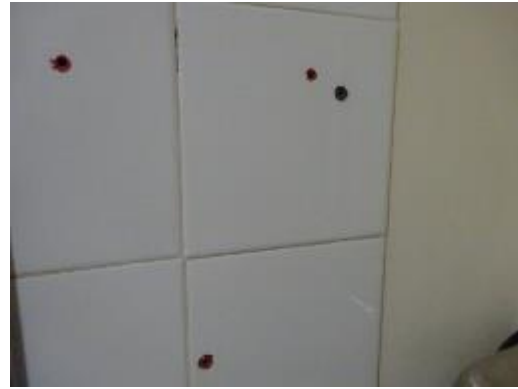
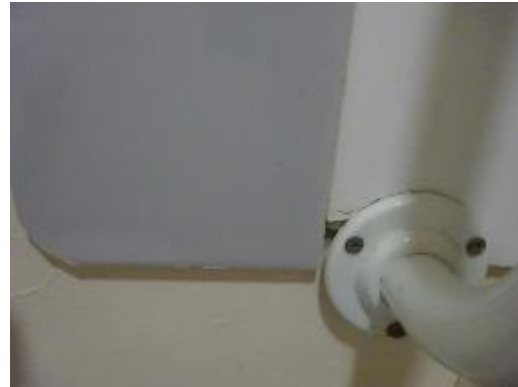
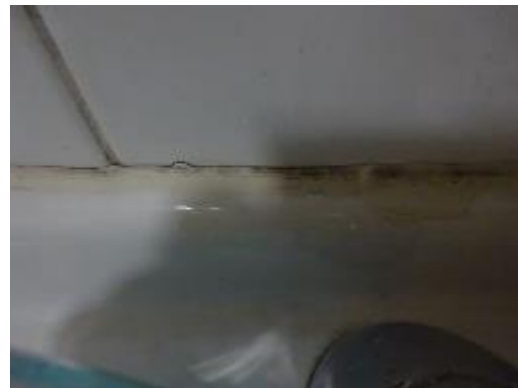
Tiled splashback section to the wash hand basin presented in a fair state of repair and condition. It was noted that former fixing openings rawl plugs can be seen and grout presented soiled and discoloured. Isolated chipped tiles where fixings have been installed were noted and mastic sealant around the wash hand basin was soiled and in part perished. We would

recommend that the tiled splashback in the first instance is suitable for day one operations, although sealant is to be reinstated.

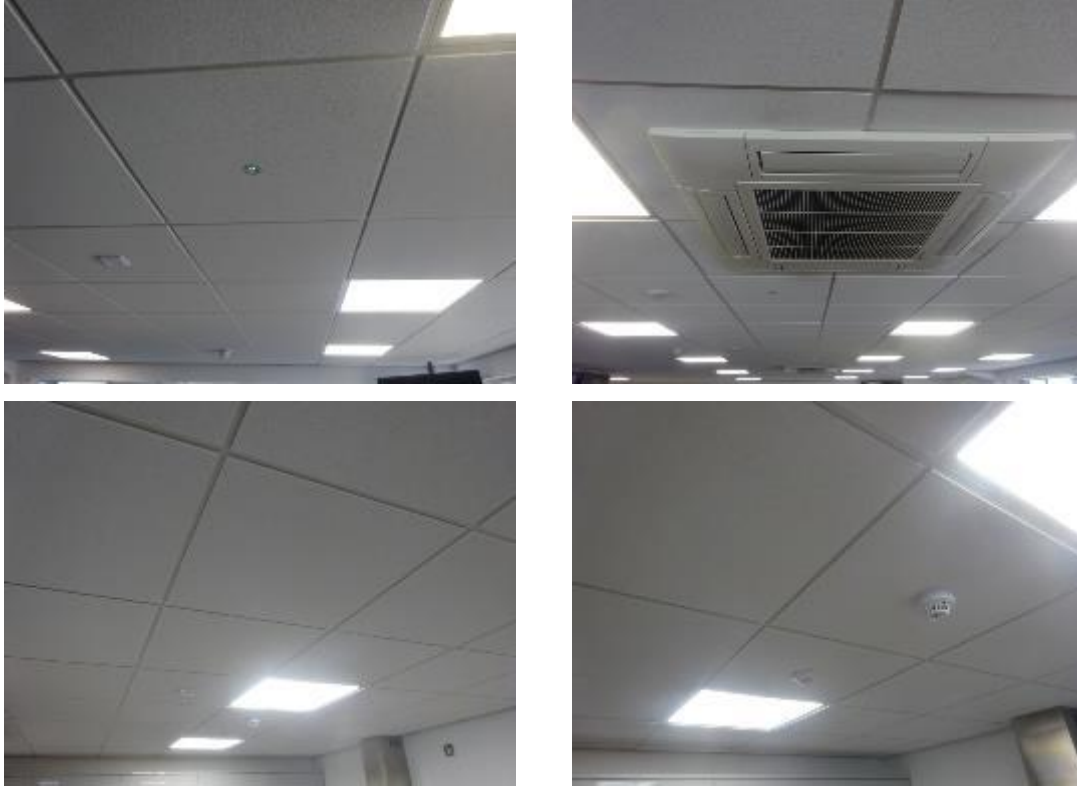
Ceiling finishes around the main open plan office area is provided via 600x600 mineral fibre suspended ceiling tiles with metal grid. The ceiling tiles incorporated LED lights, emergency light fittings, smoke detection and air conditioning units. Lights are operated on PIR sensors. Ceilings presented in a good state of repair with the fixtures and fittings, although some light surface soiling can be seen around the ceiling tiles serving the air condition unit. We would

still advise that full electrical test Certificates, maintenance and service records are provided for the lighting (including emergency) and fire detection system. It was noted above the suspended ceiling that no insulation is utilised.

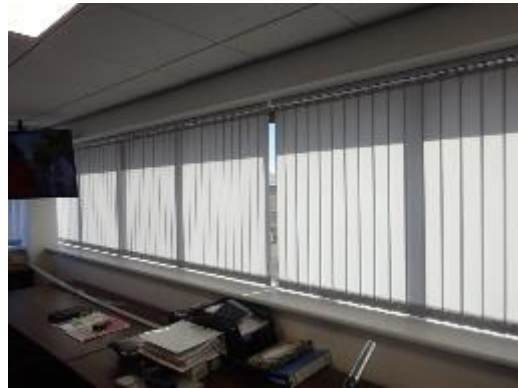
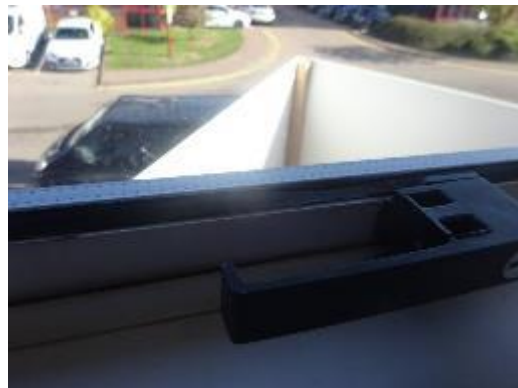
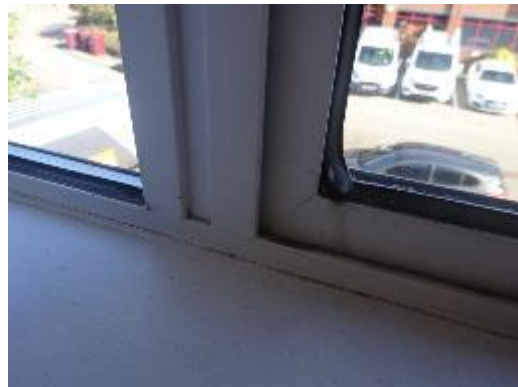
Windows throughout the open plan office area were provided via double-glazed powder coated aluminium framed windows. The windows visually presented in a satisfactory state of repair and condition. It was noted that surfaces were generally soiled and seals between the glazing and the frames were in part distorted, warped or presented minor sections missing. Windows presented in a good state decorative condition and no disrepair could be seen to the window blind fittings. All windows were functional and operational at the time of the inspection, although a request should be made for keys for the purposes of security and clarification with insurers that the locking mechanisms are sufficient.
