# Building Inspection Report

XXXX

Report date XXXX 2022

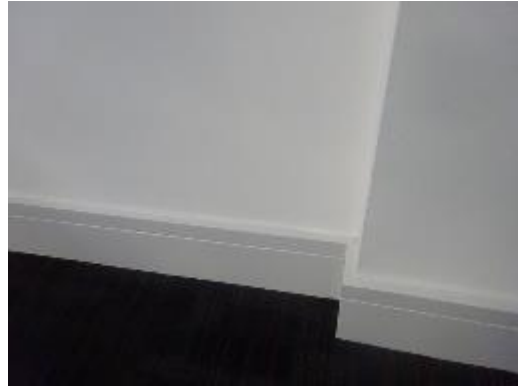
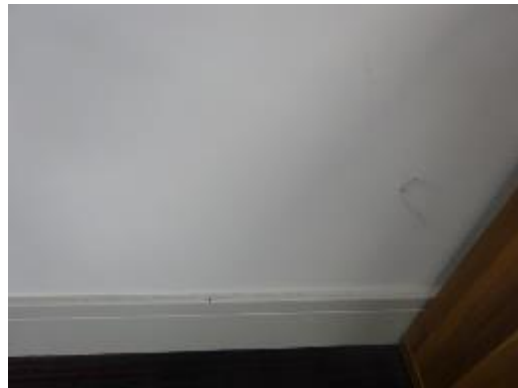
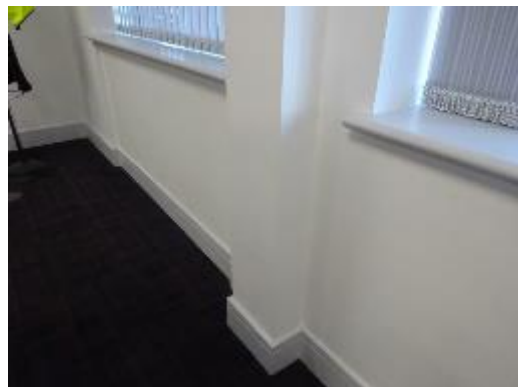
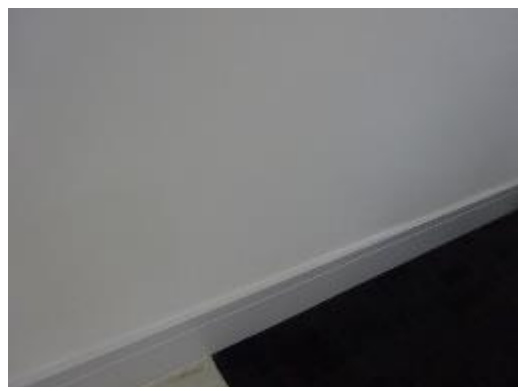
Main walls are provided via painted plaster to a combination of solid masonry and plasterboard, of which visually presented in a satisfactory to good state of repair and condition. Only some minor surface blemishes could be seen. No areas of cracking or water staining to suggest any water ingress was noted throughout.

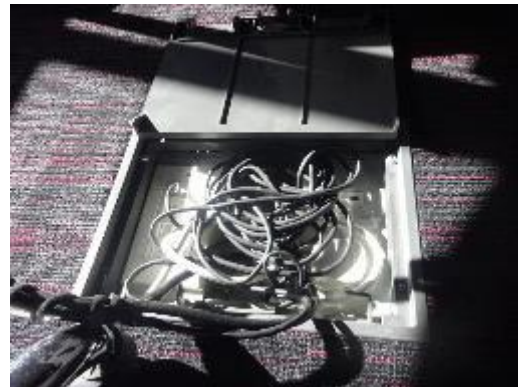
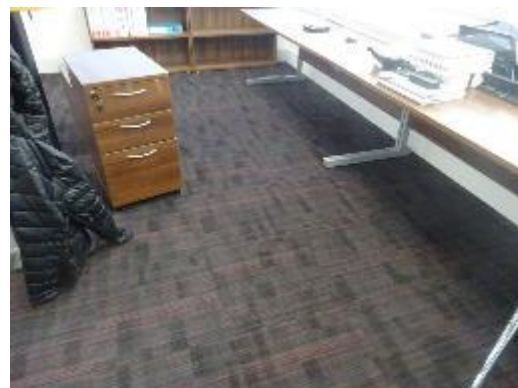
Flooring throughout was provided via timber deck with carpet tile finishes throughout. Floors generally presented in a reasonable state of condition with some minor surface soiling and light wear. We recommend under general wear and tear, regular maintenance. Carpets do not require replacement until the medium term.
