Schedule of Condition

Address XXXX **Prepared for** XXXX
Survey Date XXXX
Prepared by Mark Davies
Email m.davies@allcottassociates.co.uk
Telephone 0333 200 7198
Mobile XXXX
Website www.allcottcommercial.co.uk

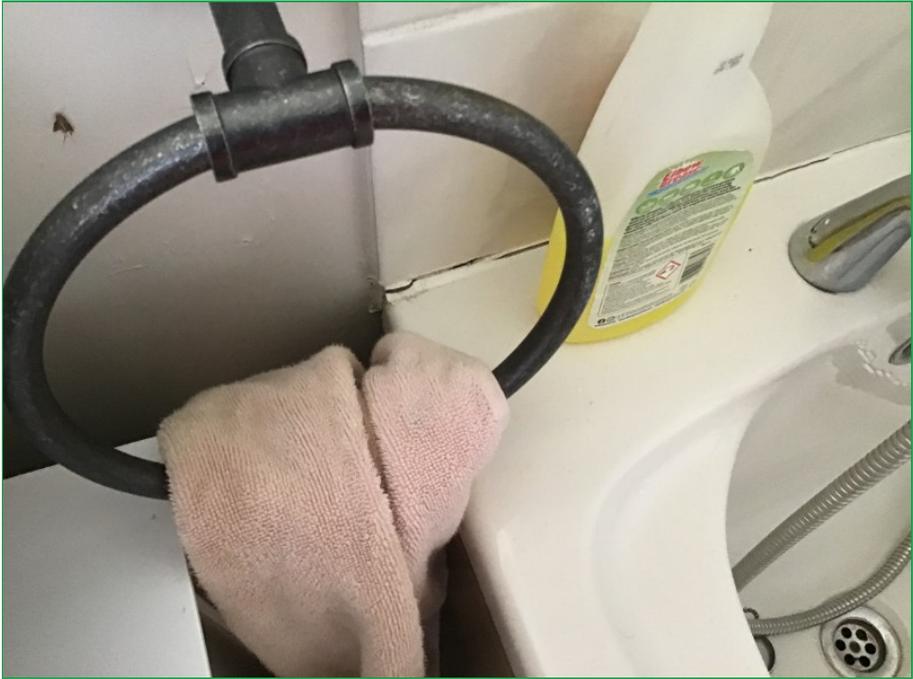
Photo 230

Area	Location	Element	Condition	Description	Photo
Internal	Bathroom	Ceilings - Plasterboard & Skim	Good	No cracks noted	[Photos 193 - 197]
Internal	Bathroom	Internal Walls/ Partitions - Dry Lined	Satisfactory	Generally in satisfactory condition	[Photos 198 - 212]
Internal	Bathroom	Skirting - Softwood	Satisfactory	Blown paint to bottom edge as not sealed to perimeter with the floor finish	[Photos 213 - 214]
Internal	Bathroom	Floor Finishes - Vinyl sheet	Satisfactory	Not sealed to perimeter edge	[Photos 215 - 217]
Internal	Bathroom	Sanitary Fittings - Wall Mounted Wash Basin	Satisfactory	Seal to lh side perishing	[Photos 218 - 220]
Internal	Bathroom	Sanitary Fittings - Low Cistern WC	Good	No damage noted.	[Photos 221 - 222]
Internal	Bathroom	Window - PVCu	Good	No damage noted.	[Photos 223 - 228]
Internal	Bathroom	Sanitary Fittings - Bath	Satisfactory	Soiled grouting Crack to grouting with junction of wall tiling	[Photos 229 - 232]

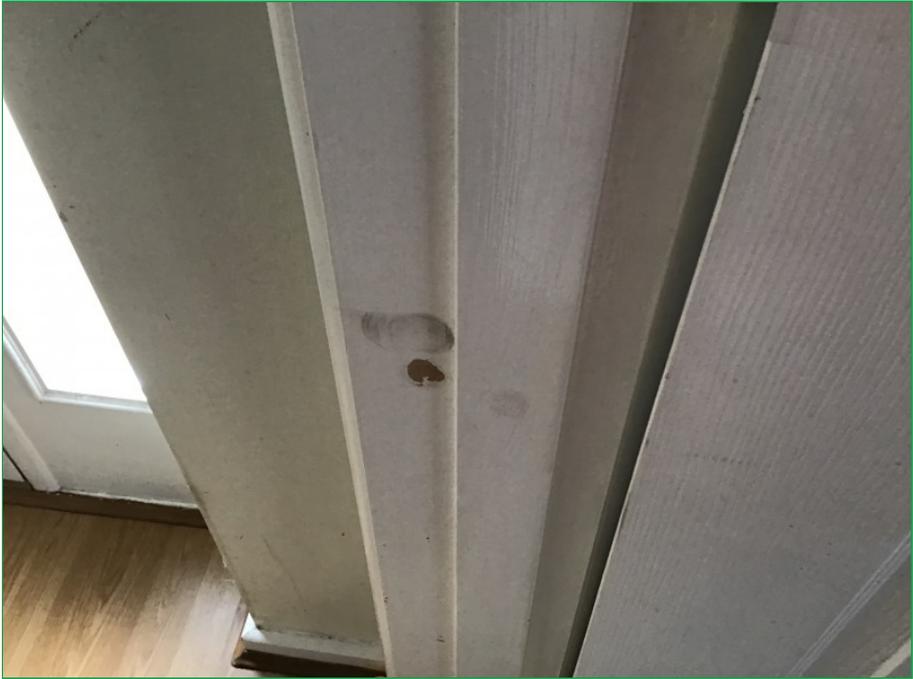
Photo 446

Area	Location	Element	Condition	Description	Photo
Internal	Ground Floor wc	Radiator - Metal	Satisfactory	No damage noted.	[Photo 390]
Internal	Ground Floor wc	Sanitary Fittings - Pedestal Wash Basin	Good	No damage noted.	[Photo 391]
Internal	Ground Floor wc	Sanitary Fittings - Low Cistern WC	Good	No damage noted.	[Photo 392]
Internal	Ground Floor wc	Doors and Frames - Softwood Frame & Panelled	Good	No damage noted.	[Photos 393 - 399]
Internal	Lounge	Ceilings - Plasterboard & Skim	Satisfactory	Minor undulations no cracking evident.	[Photos 400 - 415]
Internal	Lounge	Internal Walls/ Partitions - Dry Lined	Satisfactory	No cracks noted, minor areas of historic filling and minor undulations evident	[Photos 416 - 441]
Internal	Lounge	Floor Finishes - Carpet	Good	No damage noted.	[Photos 442 - 444]
Internal	Lounge	Doors and Frames - Softwood Frame & Panelled	Satisfactory	The paint is flaking on the mdf door frame	[Photos 445 - 448]
