Building Inspection Report

MB/LC/20096

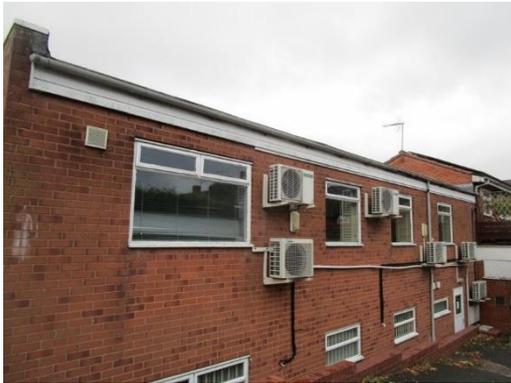
Ranging over brickwork at first floor level this all appeared to largely be in a satisfactory condition. No substantial deterioration of brickwork or mortar pointing was noted.

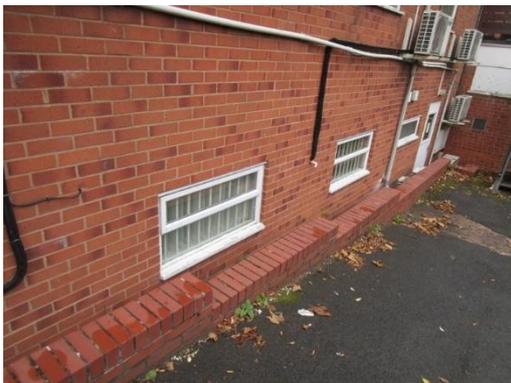
Ranging over brickwork at ground floor level this appeared to be in a satisfactory condition without substantial deterioration of brickwork or pointing noted.

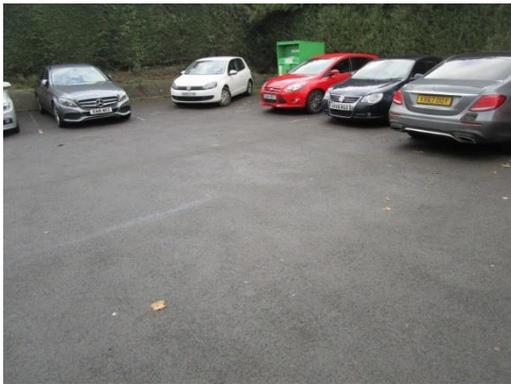
We understand that there is allocated parking to the rear of the property. You should confirm rights of way given that this is a shared access and the extent of your liability for repair. The macadam surface was largely in a fair condition on the day of the survey.

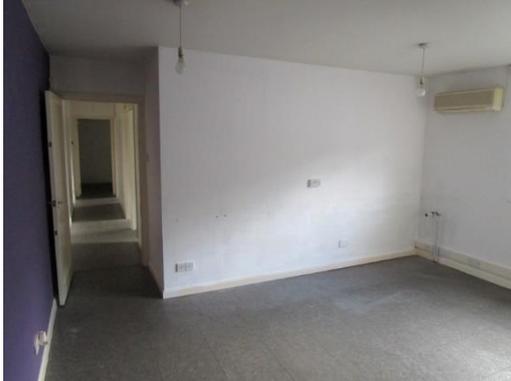
Decorative finishes and floor finishes at first floor level are largely dated and we would suggest they will require renewal.

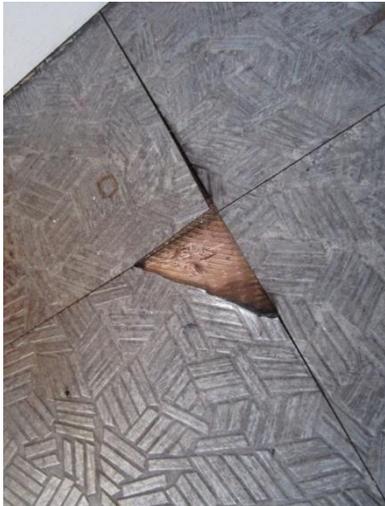
A small section of flooring was removed toward the rear of the first floor. This identified a vinyl tile of a relatively modern age with a timber boarding to the underside.

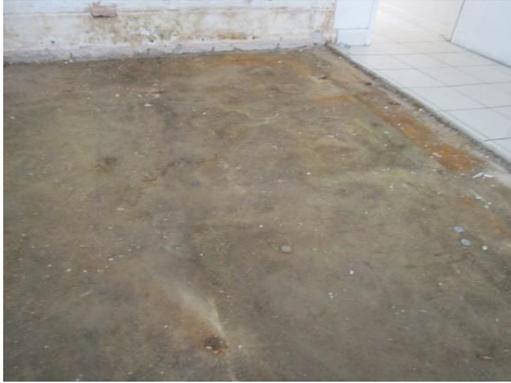
There is a section of floor covering toward the rear of the room exposed. Testing this floor area with a damp meter did not identify any raised levels of damp to suggest deterioration or lack of damp proof membrane.

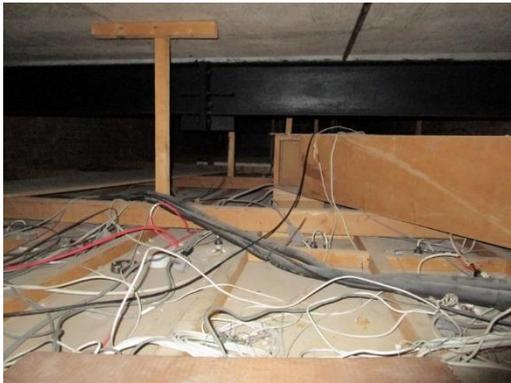
There is a roof access hatch above the room. Inspection above the room identifies the floor slab to be of a cast in situ concrete. The cast in situ concrete floor slab is supported off of substantial steelwork spanning left to right. As a result within the main and original building there are no load bearing walls.

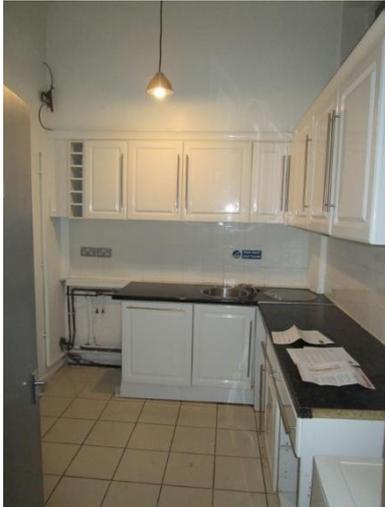
Decorative finish and floor finishes will all benefit from renewal.

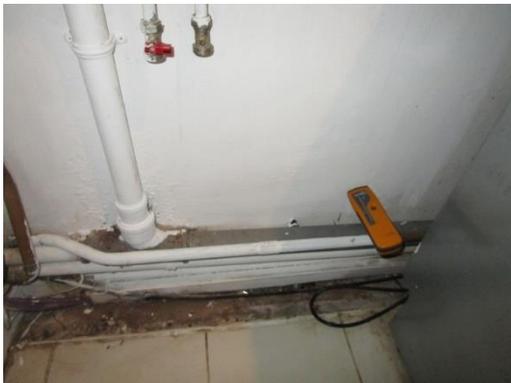
There are areas of blistering to external wall paint finishes. Testing these areas with a damp meter did not identify any raised levels of dampness suggesting this to be historic.

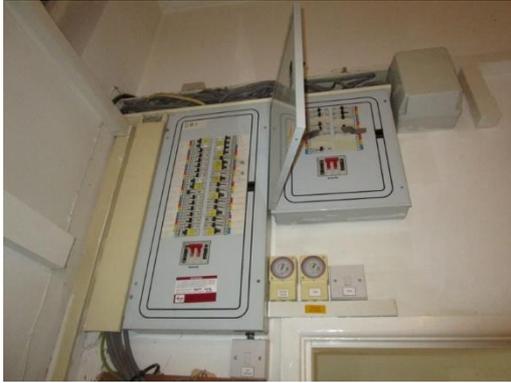
The electrical distribution board is located within the room. This suggests that it was inspected in 2016 and we would recommend that you obtain the test certification in regard to this.

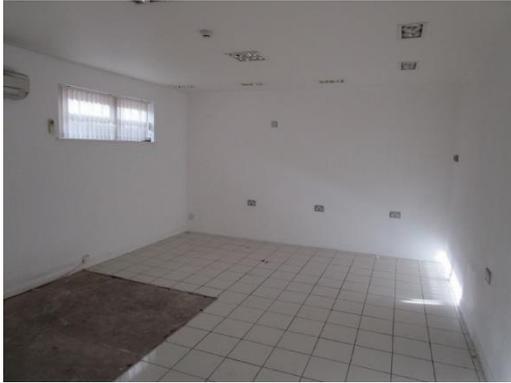
Decorative finish and floor finishes with likely benefit from renewal.

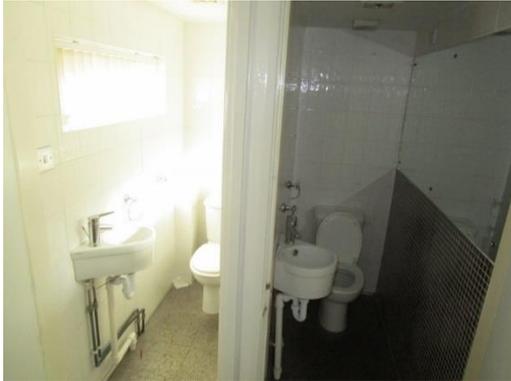
Decorative finish and floor finishes will likely benefit from renewal.
