# Structural Feasibility Report

Relating to: Modifications at  
XXXX  
XXXX  
XXXX

Report date: XXXX 2021

**Job reference:** JB/XXXX

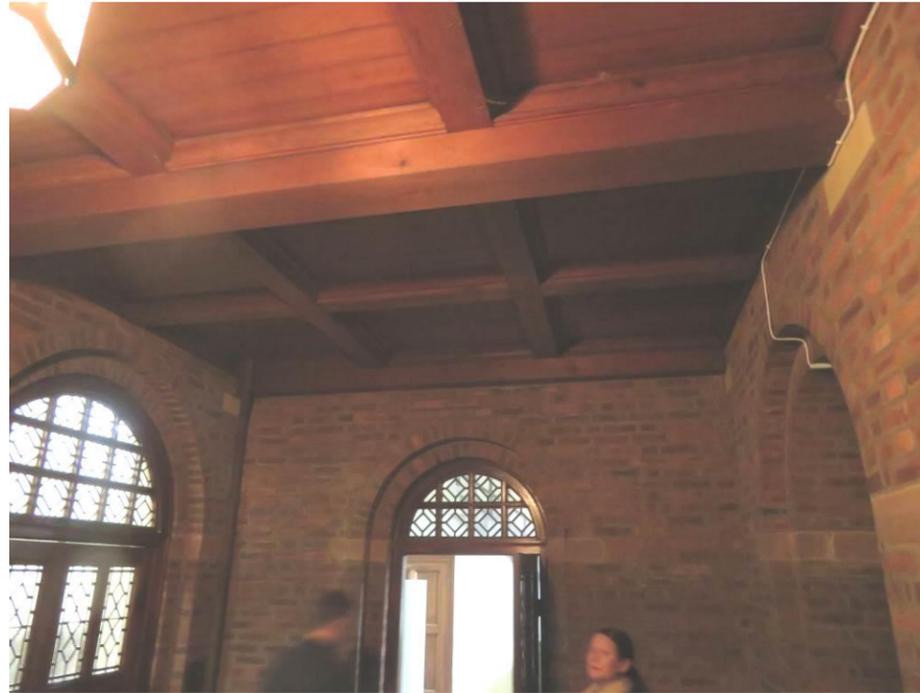
The floor to the existing balcony is understood to be of timber construction. Deep timber beams span between the external west wall and the wall between the Narthex and the Nave. In turn, these support shallower timber beams which support floorboards and joists above.

**Timber Structure to Underside of Balcony**

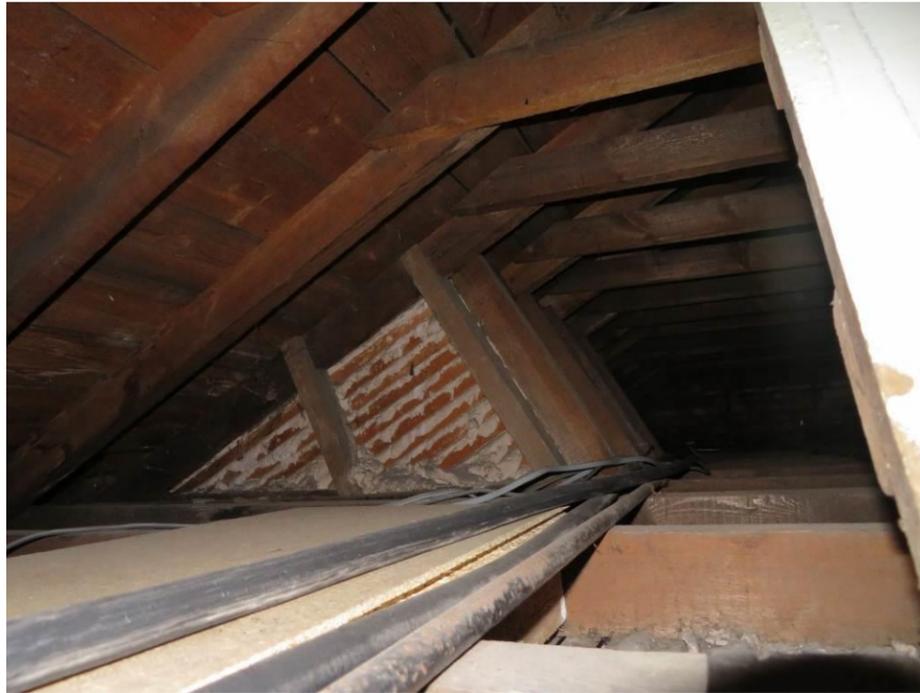
The Cloisters incorporate the entrance into the Church Hall, together with toilets, a boiler room and a storeroom. The building is of simple single storey brick construction, with a pitched roof to the front and a flat roof supported on timber joists to the rear above the female toilets. The pitched roof structure comprises cut timbers, and there is evidence of former roof lights, which have since been roofed over and infilled at ceiling level.

*Roof Void above the Toilets showing Cut Timber Structure and former Roof Lights*

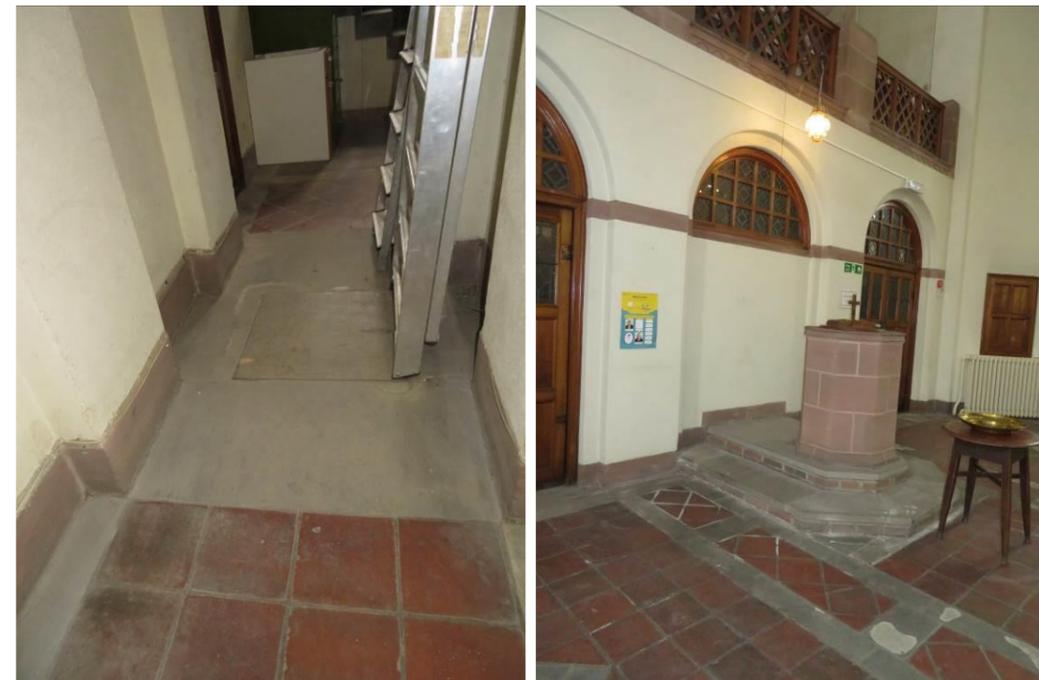
The north and south aisles are finished with a combination of tiles and screed. There are access covers to service ducts beneath these aisles, which contain distribution pipework to the radiators. The ducts are understood to contain asbestos, and the client has advised that due to the impracticality of removing this asbestos, these ducts will be sealed and will become redundant.

*Floor to the South Aisle and to the west end of the Nave*

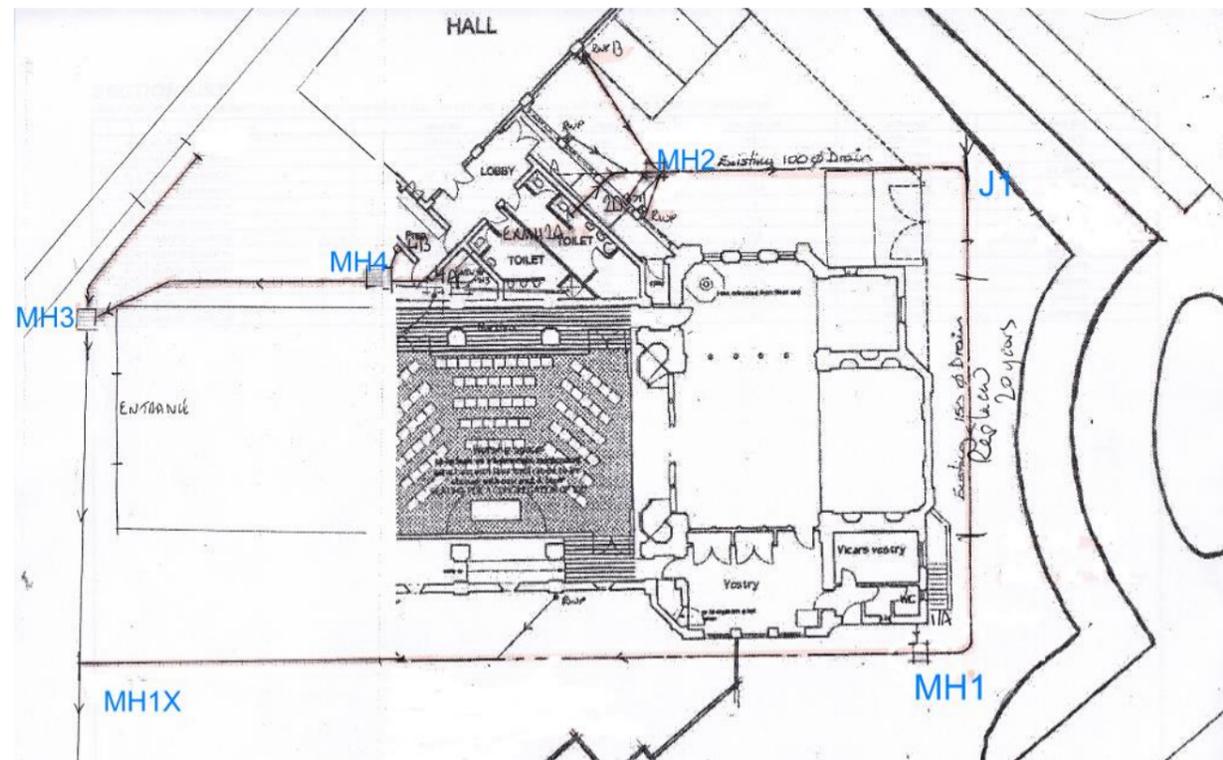
**Sketch of Existing Below Ground Drainage Routes taken from Synopsis of Lanes for Drains CCT Survey**

The Synopsis identifies defects to a majority of the drainage runs, including cracked and displaced pipes, root ingress at joints, and blockages. These were recorded in the following locations:

We recommend that the remedial works set out in the Synopsis shall be planned for and actioned in the next year.

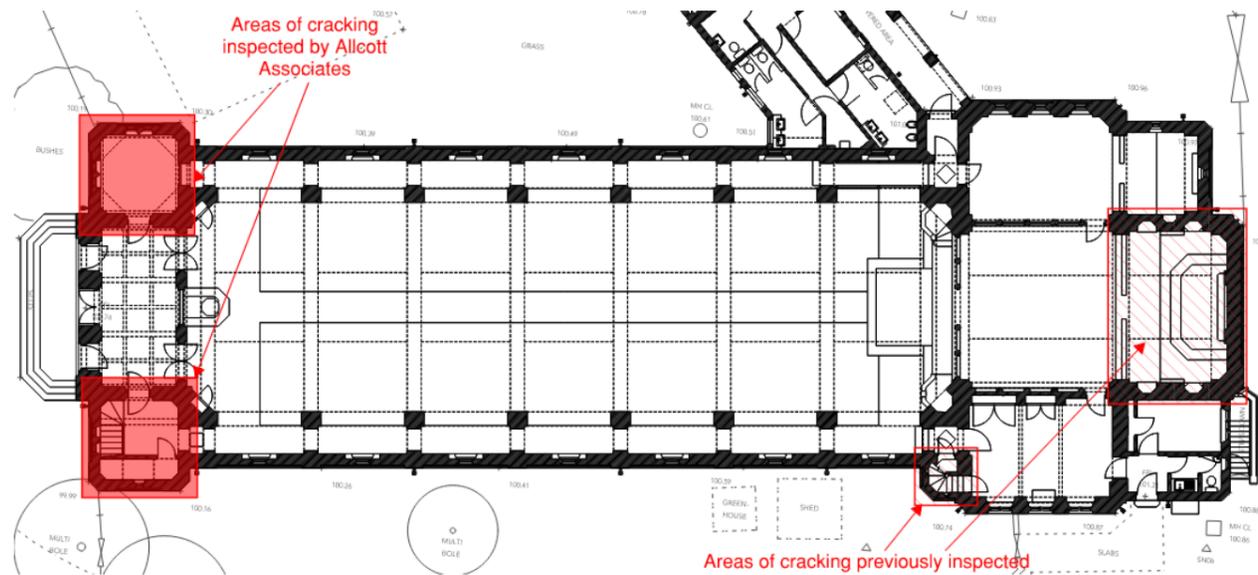
**Locations of Cracking to External Elevations**

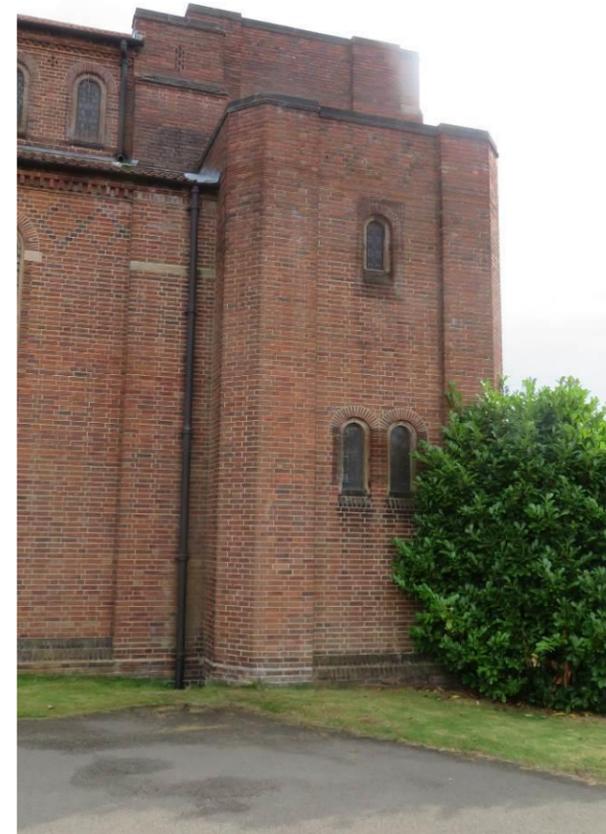
To the north elevation of the northwest tower there were no signs of significant cracking to the facing brickwork. A possible slight bulge was noted close to the top of the wall on the northwest corner, corresponding with the level of the roof deck.

**North Elevation of northwest tower**

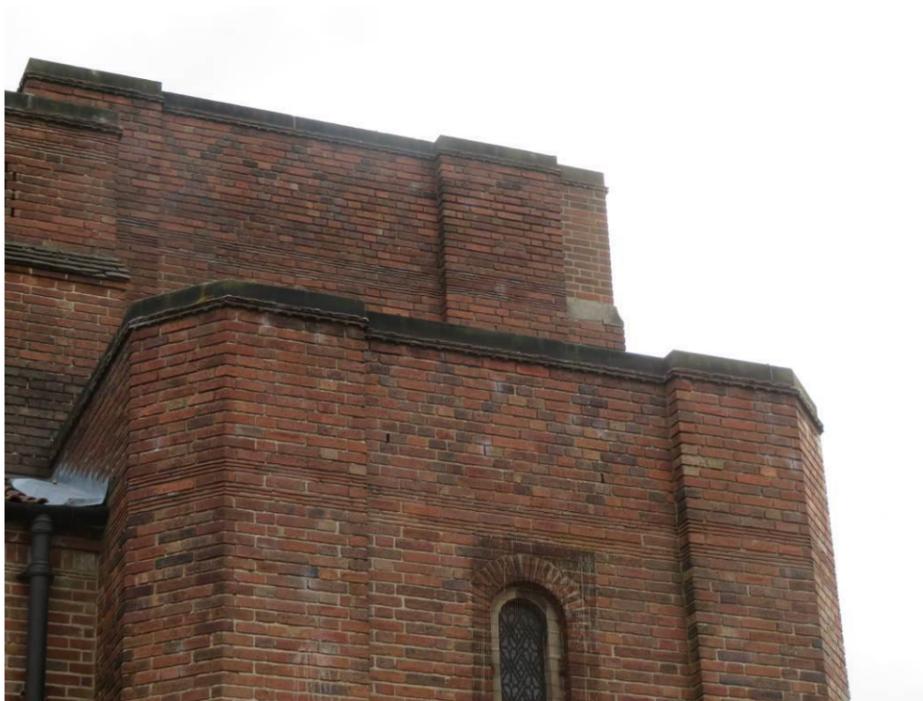
The crack is located at the junction with the main north wall to the Nave. It was noted to be slight, measuring approximately 3-5mm in width. At low level there was evidence of previous decorative repairs to the crack, suggesting it is not recent. Signs of previous water ingress were noted to the walls at high level.

**Parapet to top of north elevation of northwest tower**

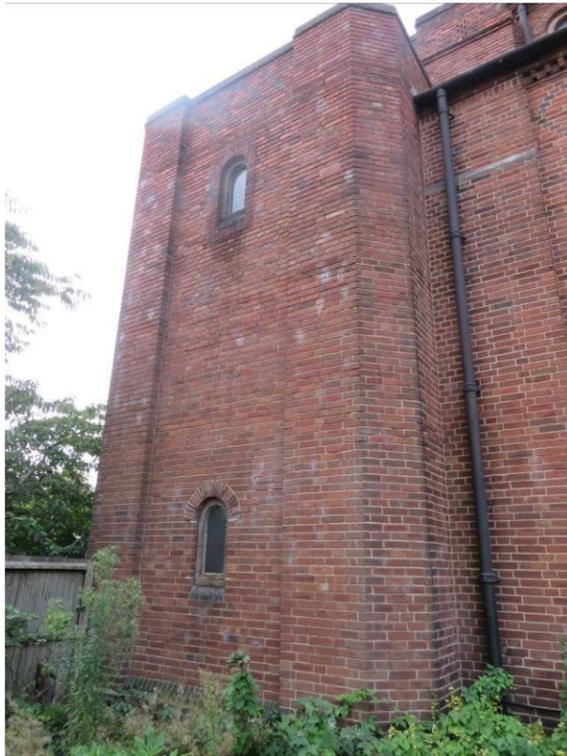
On the southern elevation, very slight cracks were noted to the external face of brickwork both beneath the ground floor window and to the eastern corner. In each case, the cracks were noted to be less than 1mm wide.

The crack beneath the window was noted to run diagonally down towards ground level. It did not appear to continue through the brickwork at ground level, however due to weathering of the mortar joints in the brickwork, this was not confirmed.

*South elevation of the southwest tower*

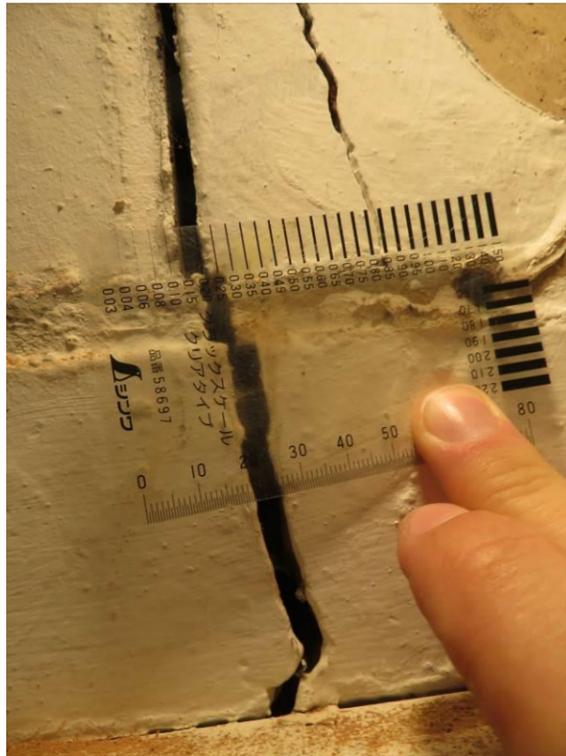
In the same corner of the tower, a gap of approximately 5-10mm has opened up between the quarter landing and the upper flight of concrete stairs. The gap appears to correspond with the crack in the wall, which each part of the stair having moved with the wall it is built into.

Simialrly, following the brickwork repairs to the southwest tower, a lightweight concrete repair mortar or resin shall be injecting into the gap between the concrete stair elements to reinstate the bearing between them.

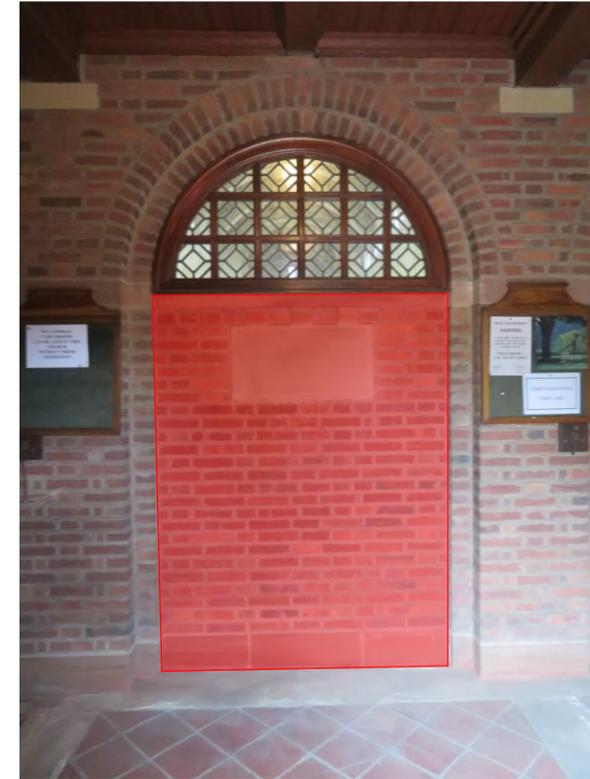
The arch is of the same form of construction as the adjacent arches, where the double doors already exist. In addition, there is an existing timber framed arched window at the head of the existing infill. The infill wall beneath the window comprises a single leaf of brickwork. Based on our observations we are satisfied that the brickwork beneath the arch (shaded red in the following photograph) can be removed without the need to provide additional structural support above.

**Existing central arch between Narthex and Nave**

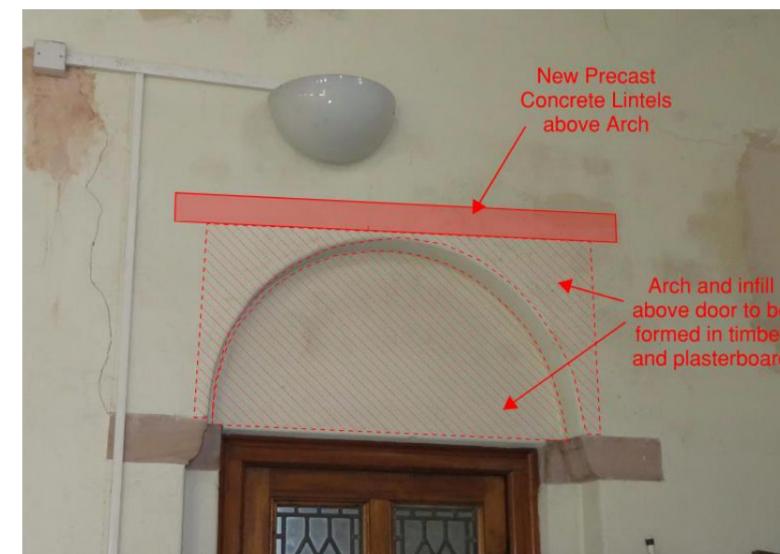
**Existing Door Opening to Balcony showing proposed method for construction of new door opening**

The total width of the existing wall thickness is understood to be approximately 480mm, with the inset section in the order of 225mm thick. To form the new door opening, it is proposed to install multiple precast concrete lintels above the crown of the new arch and form the arch and inset infill above the door in timber stud and plasterboard. Refer to the following marked up photograph. This will avoid the need to construct a new brick arch.

The new lintels shall be designed in accordance with BS 5977-1:1981 *Lintels - Method for assessment of load*. This approach is based on the fact that brickwork will naturally arch above an opening, therefore the load due to the masonry on the lintel is limited to a 45° triangle having 1.1 times the clear span of the lintel at its base. Any additional point loads within an interaction zone outside the 45° triangle are also considered.

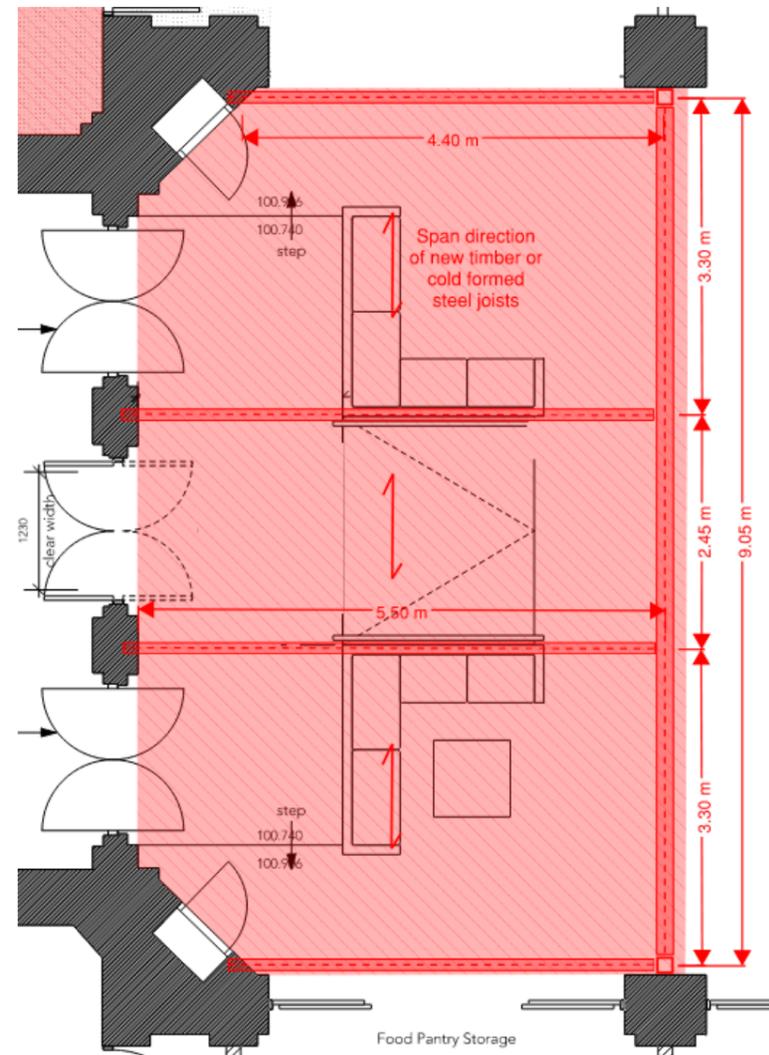
**Indicative arrangement of balcony mezzanine extension**

An extension to the existing balcony is proposed at the west end of the Nave. The additional area of floor will be located in the first structural bay, with overall dimensions of approximately 5.5-6.0m by 9.5m. The mezzanine shall be of lightweight timber and steel construction. This will minimise the need for wet trades, such as casting concrete slabs. The space beneath the balcony extension is to be column free to avoid conflicts with circulation, therefore secondary steel beams will span onto a long span beam at the front edge of the mezzanine. Refer to the floor plan below for an indicative layout.

The mezzanine is to be supported by the existing wall between the Narthex and the Nave, together with new steel columns placed adjacent to the existing main columns in the Nave.

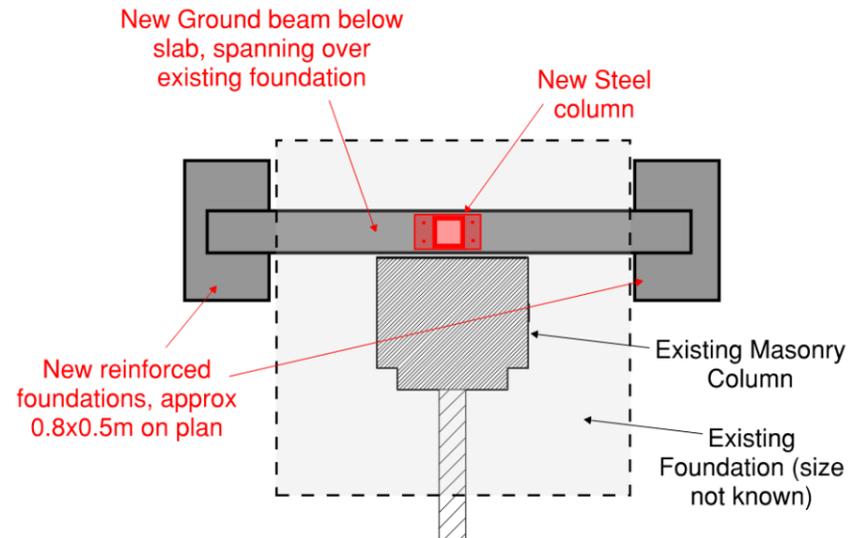
*Indicative arrangement of foundations to balcony extension columns*

The new columns supporting the long span front edge beam impose an unfactored point load of approximately 45kN on the foundations. Details of the existing column foundations are not known; therefore investigation is required to establish whether this additional load can be accommodated by the existing foundations.

If not, it will be necessary to provide a ground beam to the base of the column, spanning above the existing foundation to new reinforced pad footings to either side. Refer to the following diagram for an indicative arrangement. All details are subject to further investigation and detailed design.

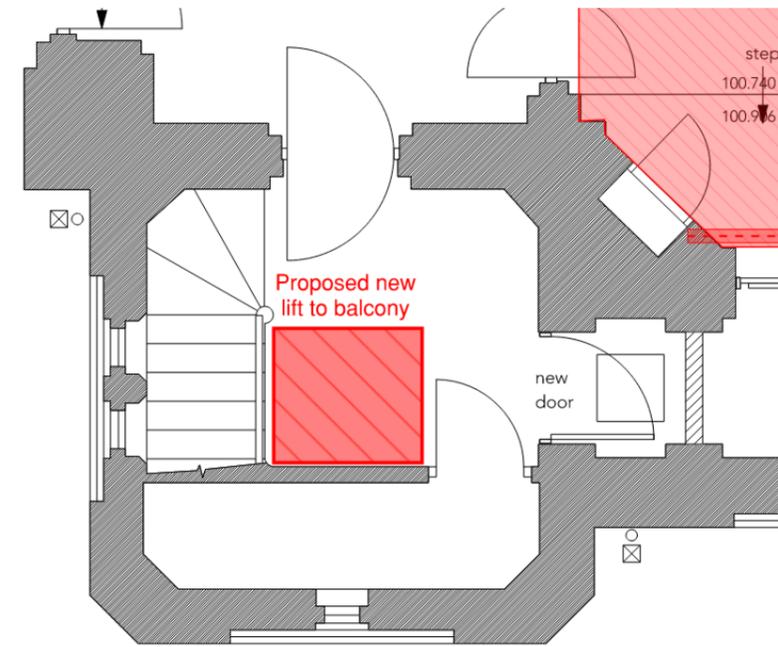
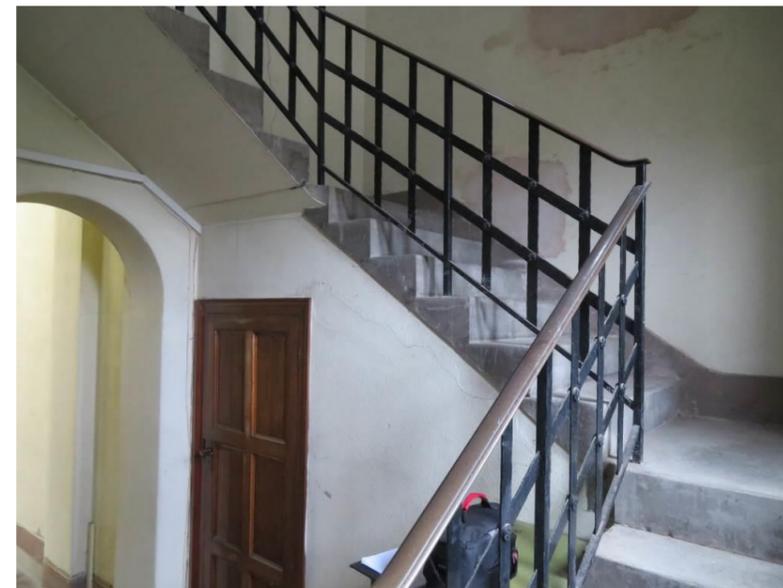
*Location of proposed new lift in southwest tower*

Associated with the balcony extension, it is proposed to provide a new lift in the southwest tower to improve access to the upper level. Refer to the plan extract and photograph below for the proposed location. It is not known whether this will be a standard lift with a full pit, or a platform type lift.

If a standard lift is to be installed, it will require a new reinforced concrete lift pit in the order of 1.1-1.5m deep. It is recommended that a location specific ground investigation and subsurface survey is carried out in the location of the pit prior to construction to inform the ground conditions and foundation design, and also to identify whether any buried obstructions or below ground services are present in this location.

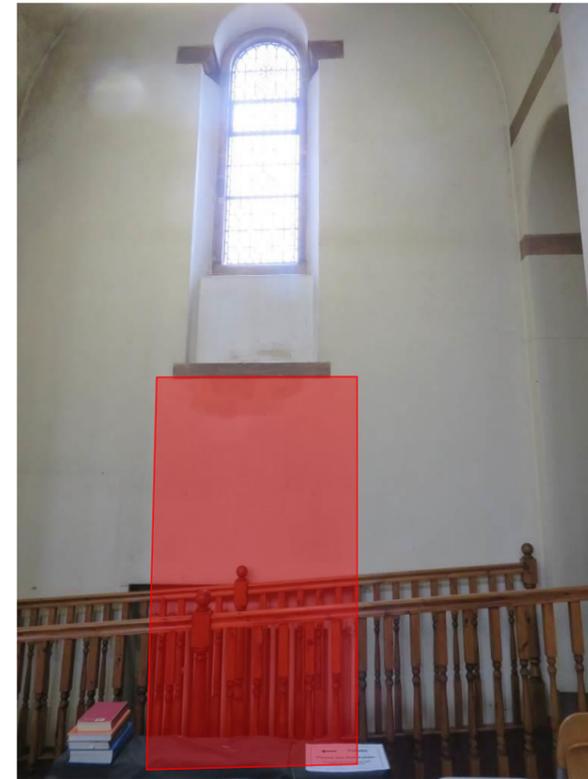
*Location of proposed new door opening*

A new doorway from the Nave into the Toilet block is to be created to improve access. The door is to be located directly beneath the existing high level window, in the location indicated below.

The existing wall thickness is understood to be approximately 480mm, with the inset section to the rear of the radiator in the order of 225mm thick. To form the new door opening, it is proposed to install multiple precast concrete lintels above the new door opening, which will be in the order of 1.0m wide. The new lintels shall be designed in accordance with BS 5977-1:1981 *Lintels - Method for assessment of load*.

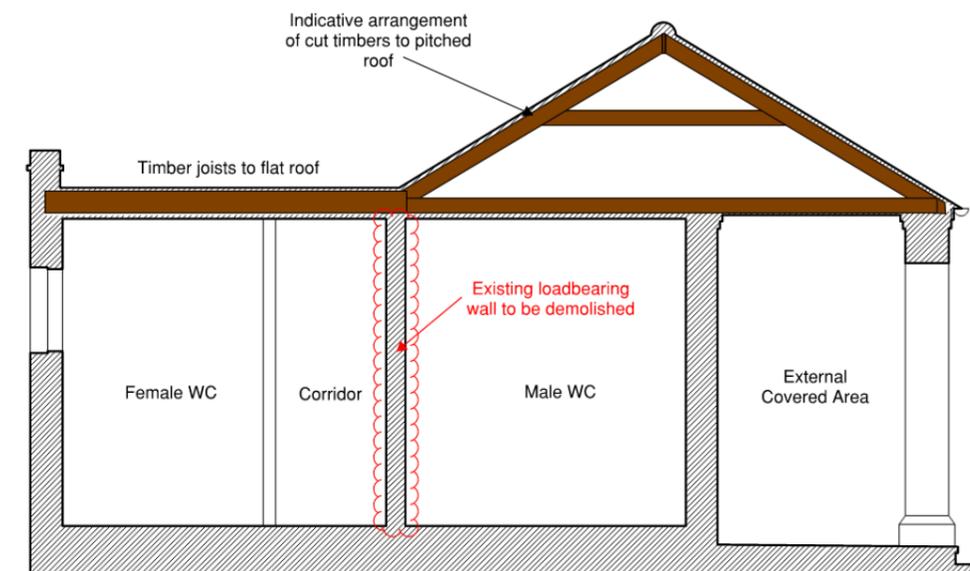
*Cross Section through existing toilet block*

In order to improve circulation and access, it is proposed to remodel the internal arrangement of the Link Building. Based on our site observations, it is apparent that the existing internal blockwork wall between the corridor and the male WC / store is providing support to the roof structure, as shown in the following cross section.

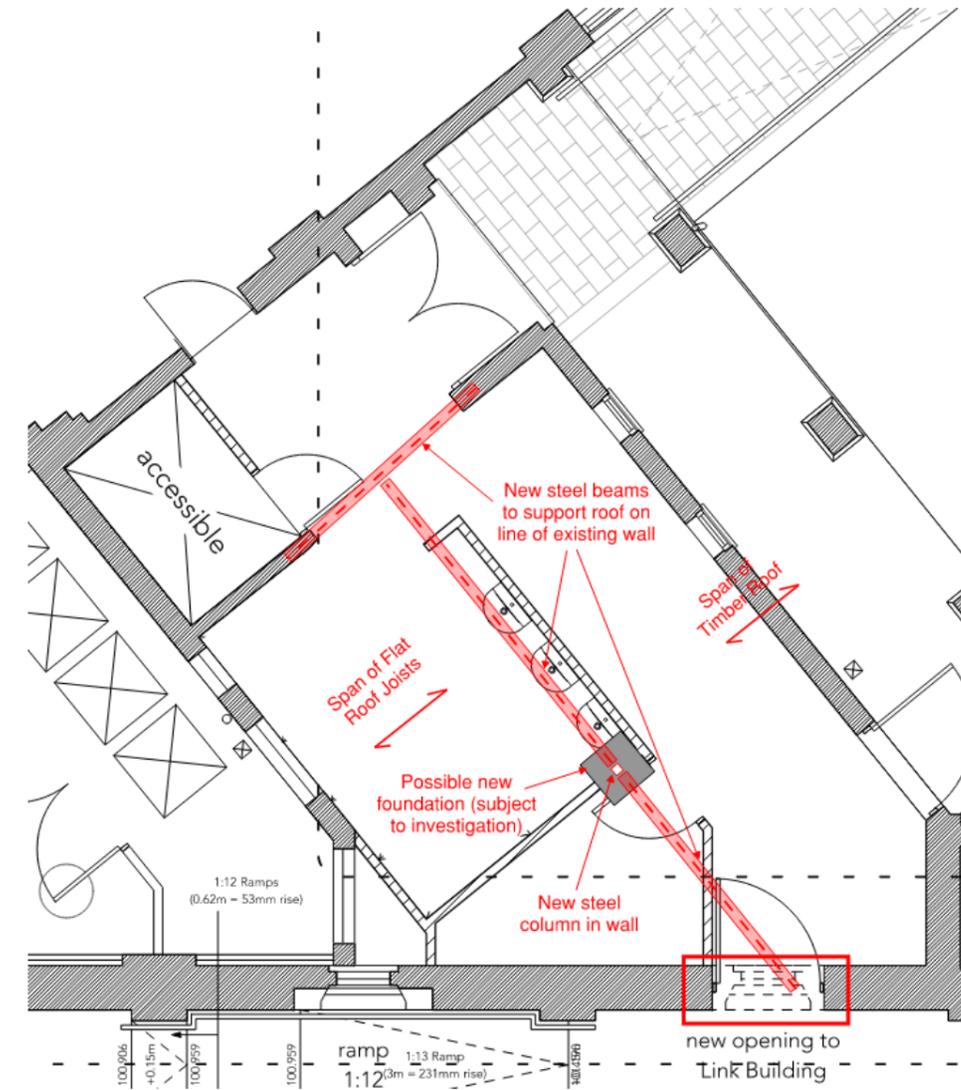
**New Beams and Column in Link Building**

In order to remove the wall, new steel beams will need to be provided on the same line. Initial appraisal suggests that the beam will be approximately 200mm deep, with an 80x80 SHS steel column located within the depth of the new stud partition wall to the toilets to reduce the span (and therefore depth) of the new beam. Subject to investigation of the existing wall foundation, a new pad foundation may be required to support this new column. Refer to the following diagram for the proposed arrangement of new structural elements in this area.

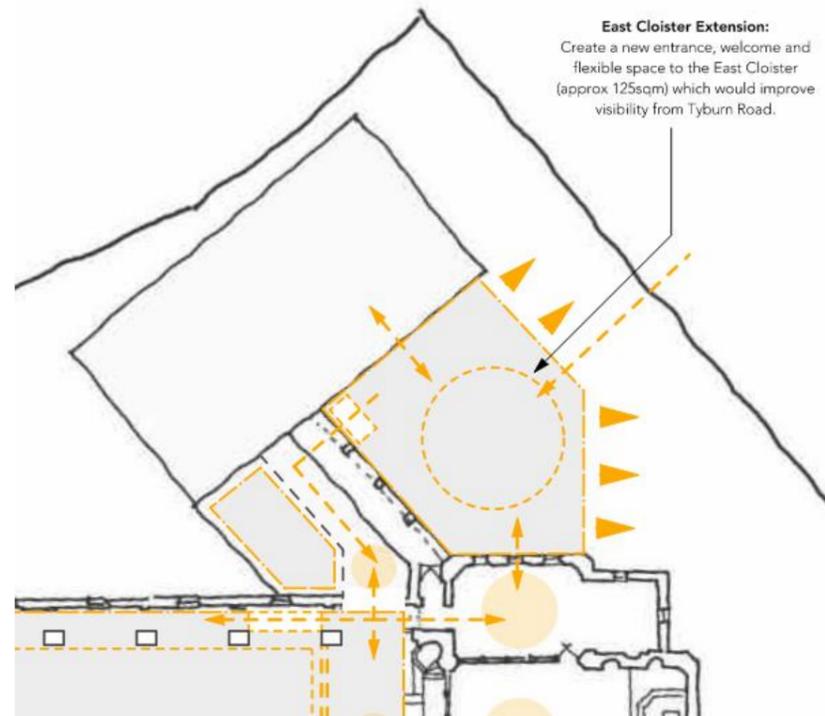
**Extract of Architectural Feasibility Study showing proposed location of East Cloister Extension**

The proposed plans shall be developed with the existing below ground drainage in mind. There are a number of foul drains and surface water pipes at a shallow depth, together with an existing manhole in the centre of the proposed extension. Consideration shall be given to whether the manhole is to be relocated or incorporated into the new construction. It is recommended that this is considered in advance of the extension works to avoid undertaking repair works now to existing drainage that may be replaced in the near future.

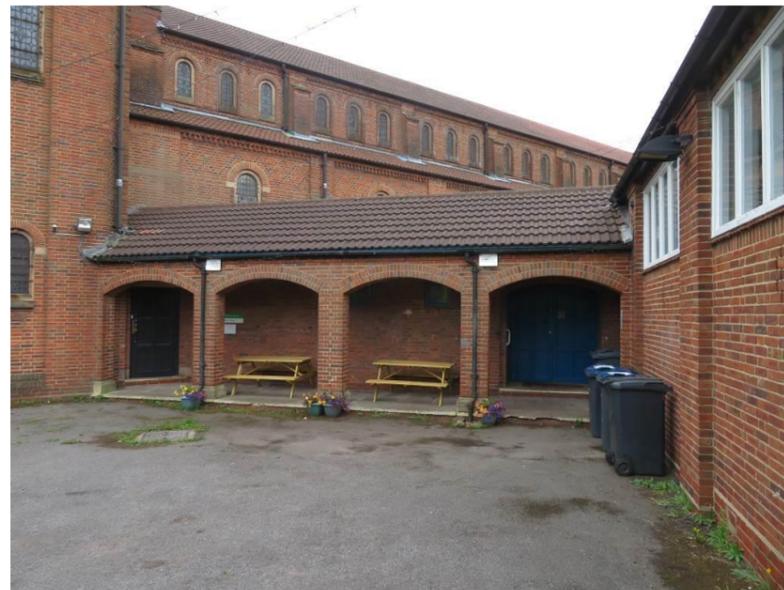
**Proposed location of East Cloister Extension**

The structural form is likely to comprise a lightweight braced steel or timber frame with a flat roof supported on columns. The roof height is anticipated to be higher than the existing Cloisters eaves, to suit the levels of the existing windows to both the church and the church hall. Internal columns will be minimised and where possible located within the depth of internal walls (subject to co-ordination with the proposed layout). Foundations will be lightly
