BRIEF: Carry out a full condition survey of three campus buildings in Oxfordshire.

Case Study

Full Building Condition Survey of Campus Buildings

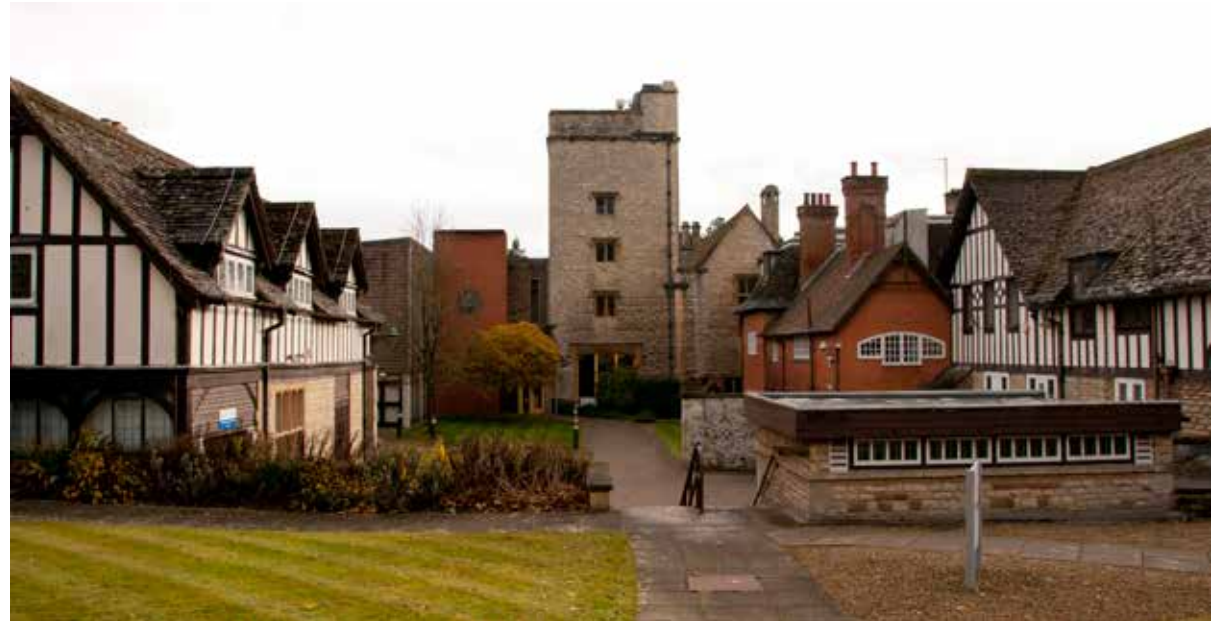
- We also noted some structural movement in several areas of the property, but the evidence we found on site suggested that this was historic and not likely to cause further problems.

STEPS AND BALUSTRADING SHOWED SIGNIFICANT DISTORTION, INDICATING HISTORIC MOVEMENT
