# Elements Survey Report

Report Date: 22<sup>nd</sup> May 2023

| <b>1.10</b> | <b>General Description</b> | Mid terrace retail unit comprising ground and basement accommodation in a retail complex |

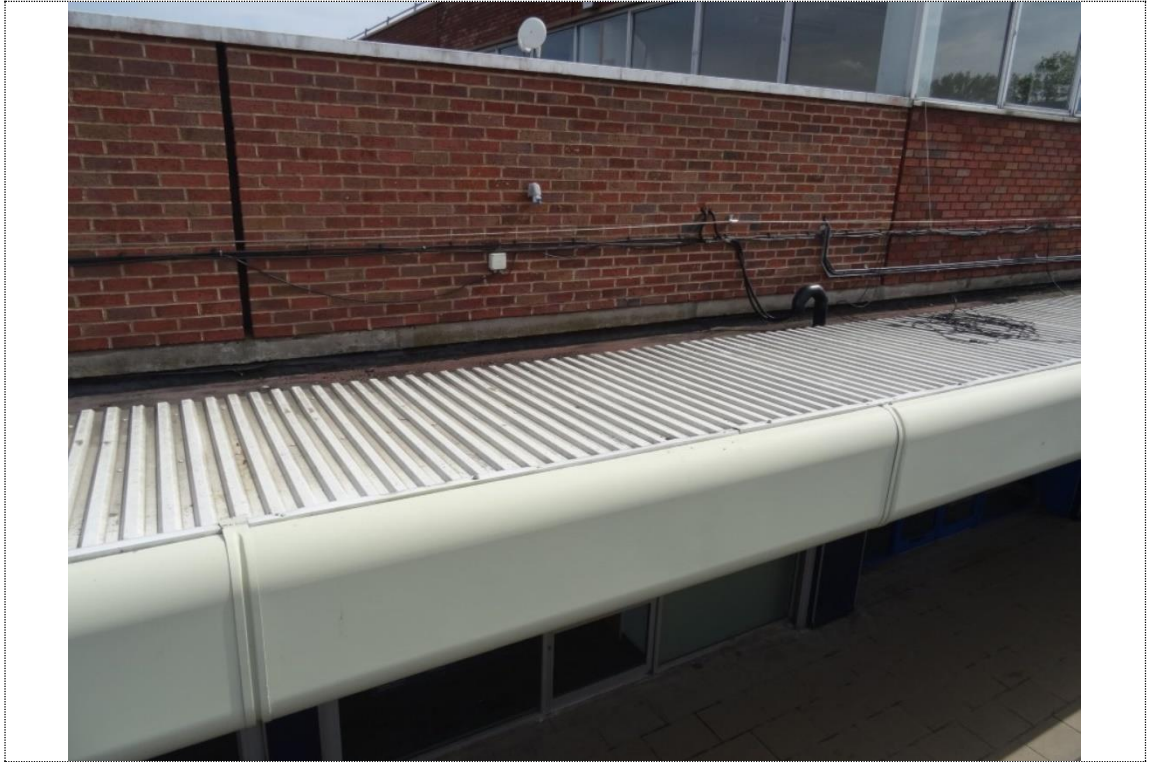
| Photograph: | 3 |

| 2.02 | <b>Main External Walls - Front</b> | <p><b>Description/Photo:</b> Front parapet wall above canopy assumed cavity brickwork. No significant cracking, damage or deterioration noted.</p> <p style="text-align: right;">Photos 2 - 3</p> <p><b>Defect:</b> None</p> <p><b>Remedial Action:</b> None</p> |

| <b>2.03</b> | <b>Canopy – Front</b> | <p><b>Description/Photo:</b> Metal profile sheet canopy. No impact damage or deterioration.</p> <p style="text-align: right;">Photos 3 - 4</p> <p><b>Defect:</b> Begrimed.</p> <p><b>Remedial Action:</b> Deep clean.</p> |

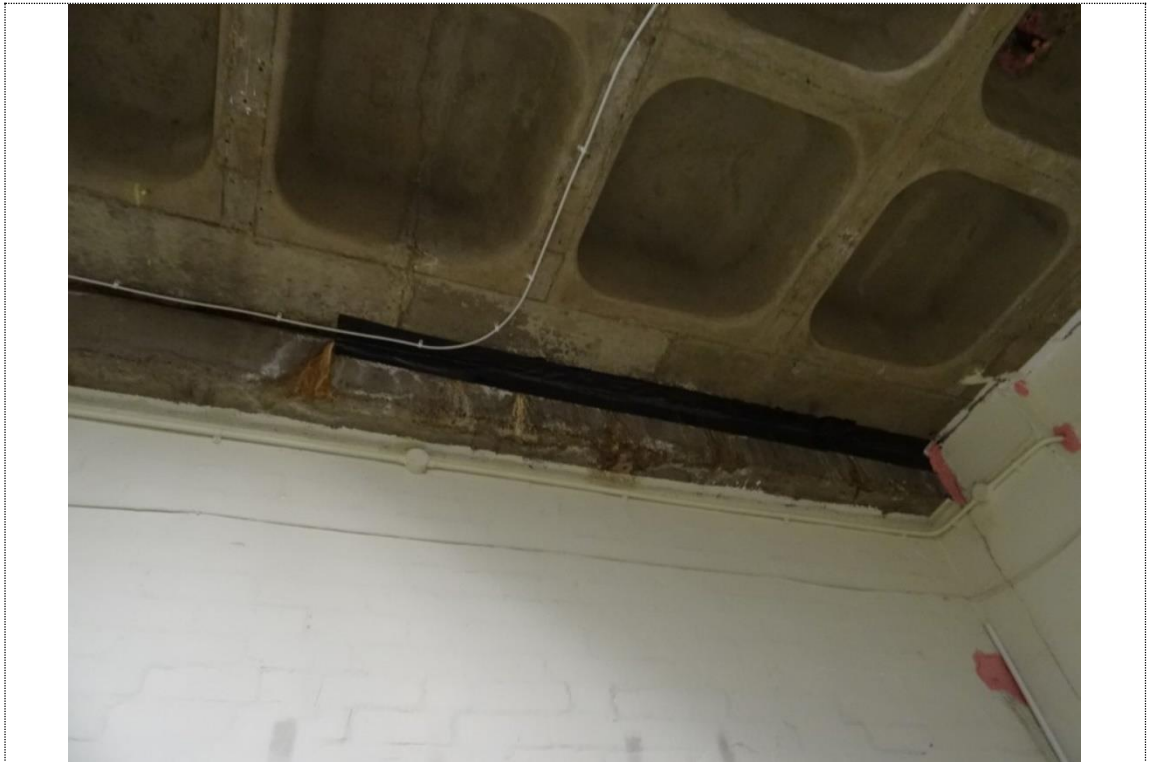
Photograph:

| <b>3.01</b> | <b>Basement Ceiling Structure (Ground floor structure)</b> | <p><b>Description/Photo:</b> Profiled concrete.</p> <p style="text-align: right;">Photos 20, 21, 33 and 34</p> <p><b>Defect:</b> Some minor cracking noted in areas, not considered significant. Repairs carried out to the front of the basement to suggest possible water ingress issues between the wall and ceiling.</p> <p><b>Remedial Action:</b> Monitor and carry out suitable watertight repair should water ingress become evident.</p> |

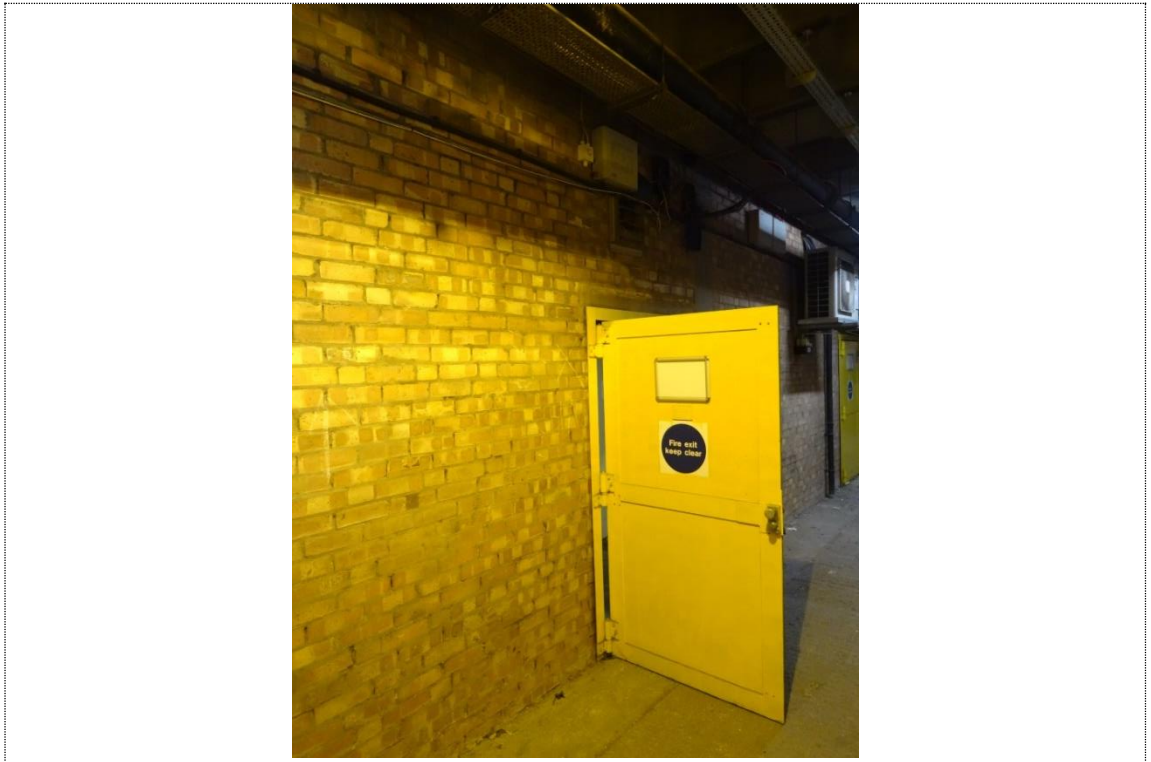
| Photograph: | 29 |

| <b>3.02</b> | <b>Basement Front wall and door</b> | <p><b>Description/Photo:</b> Brickwork showing no significant cracking or deterioration. Fire Exit door scuffed and dated however serviceable and operational.</p> <p style="text-align: right;">Photos 28 and 29</p> |

| | | <p><b>Defect:</b> Begrimed.</p> <p><b>Remedial Action:</b> Deep clean.</p> |

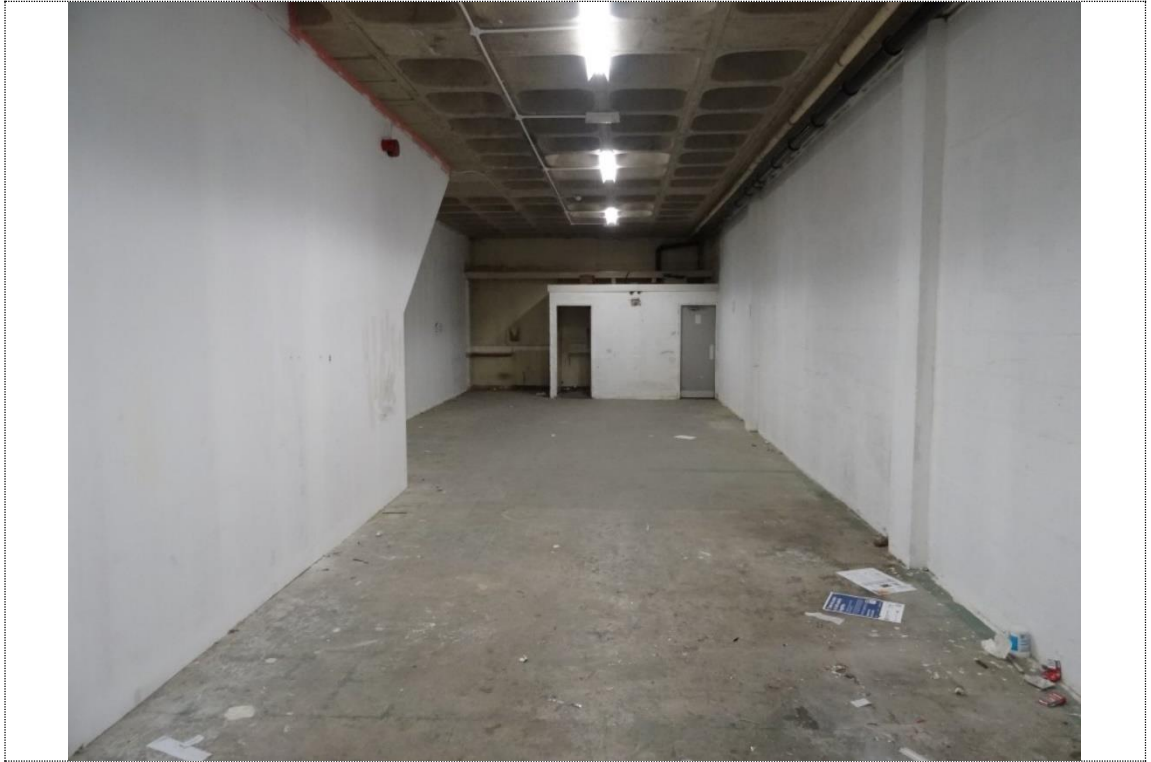
Photograph:

| 3.04 | Basement walls and floors | <p><b>Description/Photo:</b> Largely decorated brickwork and blockwork. Some decorated plasterboard walls adjacent to internal doors.</p> <p>Photos 18, 19, 22-26, 30-32, 35, 36</p> <p><b>Defect:</b> Decorative finish deteriorating in errors. Some impact damage to the right of the stairs.</p> <p><b>Remedial Action:</b> Redecorate and repair damage to provide adequate fire compartmentation.</p> |

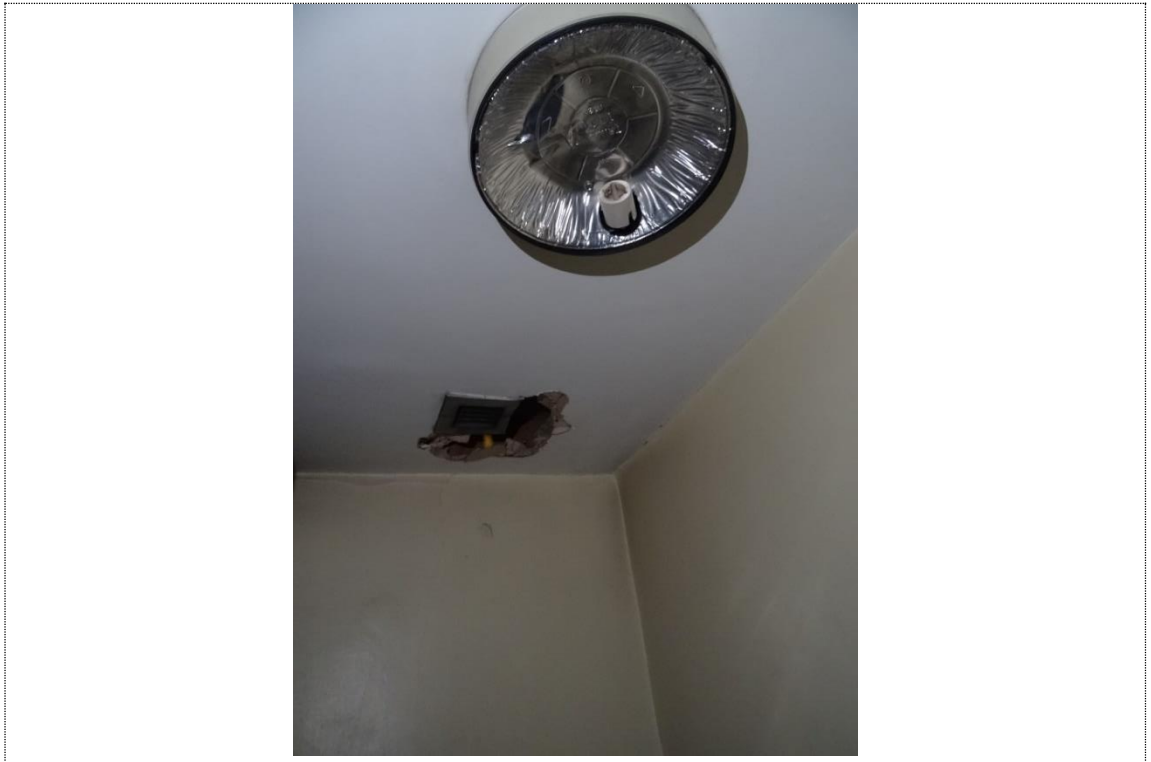
Photograph:

| 3.05 | Basement WC space | <p><b>Description/Photo:</b> Plaster/plasterboard ceiling and wall finishes. Timber internal joinery. Floor tiles removed. No sanitary appliances installed.</p> <p>Photos 37 - 44</p> <p><b>Defect:</b> Damaged wall and ceilings. Decorative finish poor. Staining where possible leakage occurred.</p> |

| | | <p><b>Remedial Action:</b> Consider demolition or entire reconstruction. Re-plaster where staining noted prior to redecoration. Should further leakage occur, investigate as required. Repair walls and ceilings prior to redecoration as required. Reinstate sanitary appliances as required.</p> |

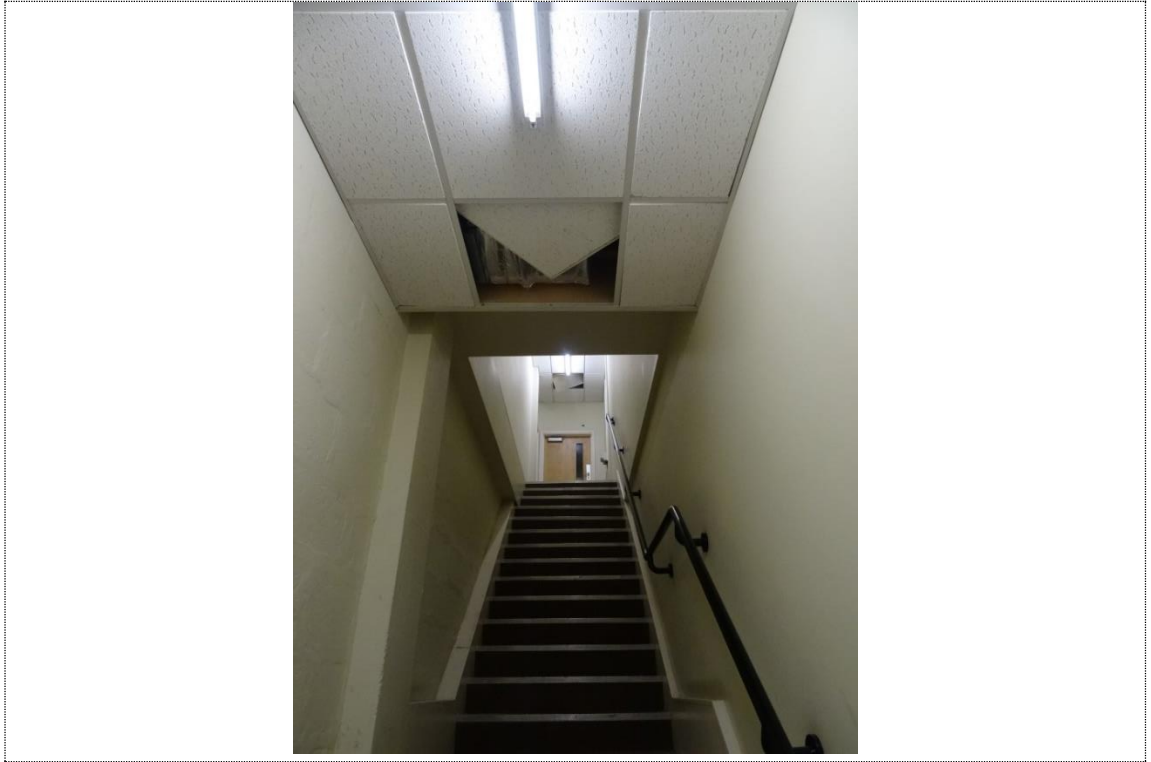
Photograph:

| 3.03 | Ceilings – Stairs and Ground floor | <p><b>Description/Photo:</b> Suspended metal grid with inset mineral fibre ceiling tiles. Emergency lighting and smoke detection provided.</p> <p>Photos 45, 52, 58, 63, 75, 78, 88, 94, 96-97, 103</p> <p><b>Defect:</b> Some tiles are damaged and stained. Staining assumed to be as result of leakage from the air condition system.</p> <p><b>Remedial Action:</b> Replace tiles where required stained or damaged. Should further staining occur, investigate to establish whether ducting is in need of repair.</p> |
