Building Inspection Report

Project preface

We have been requested by the prospective purchaser to carry out a Building Survey of the above property.

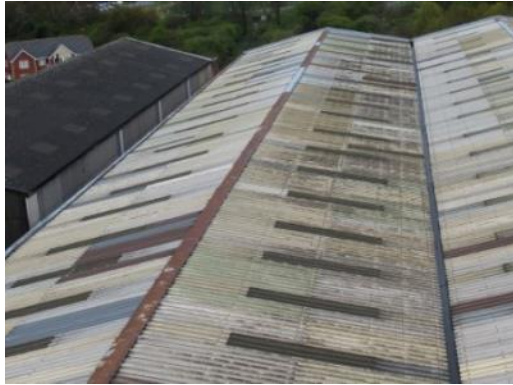
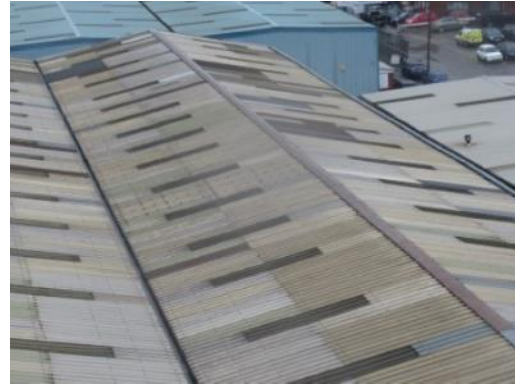
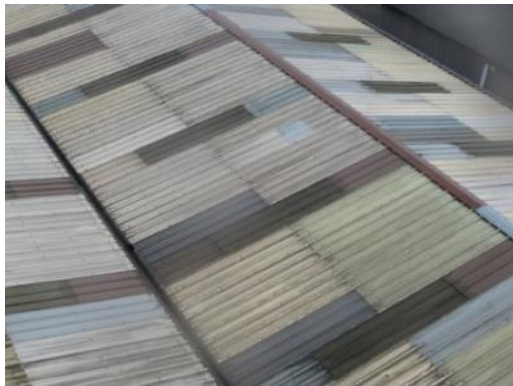
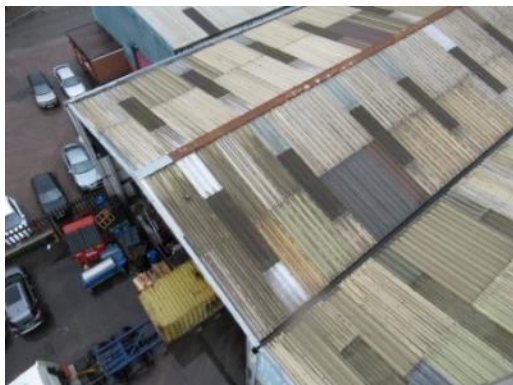
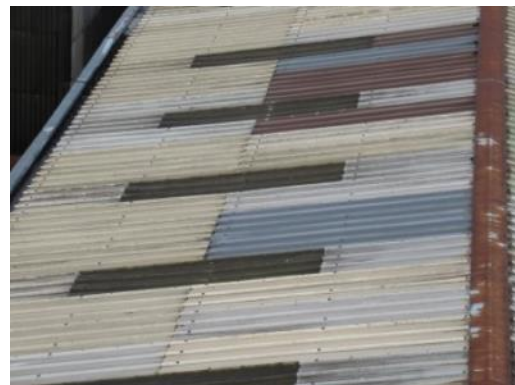
The factory finished profile metal sheet roof covering generally appears to be in satisfactory condition however areas of cut edge corrosion are evident to the roof sheets particularly towards the rear of the roof.

We recommend that works are undertaken in the immediate term to treat the cut edges of the roof sheets with a suitable proprietary repair system in order to address this and as a precaution against further deterioration and moisture ingress.

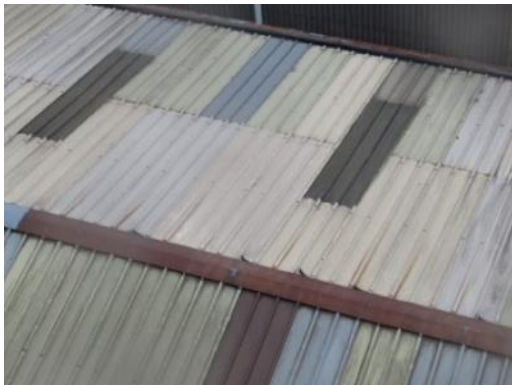
The preformed metal ridge flashing is heavily corroded throughout its length with the fillers present to its underside and the junction with the roof covering displaced in areas. We recommend that the ridge flashing is replaced in the immediate term together with the associated fillers.

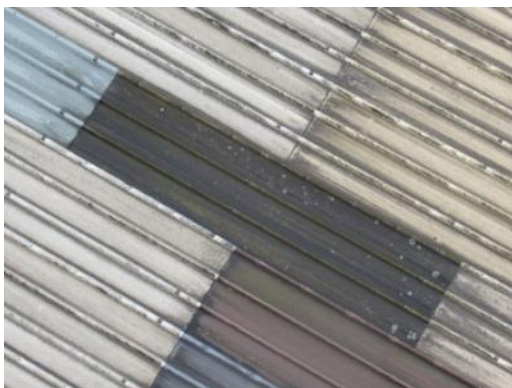
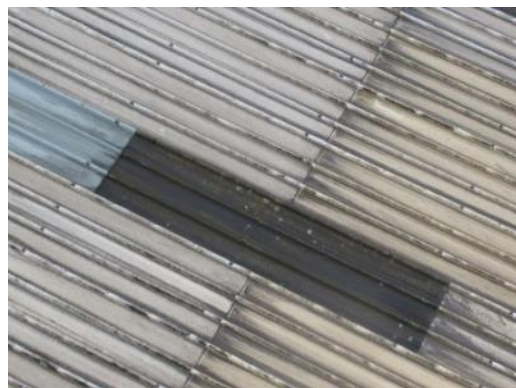
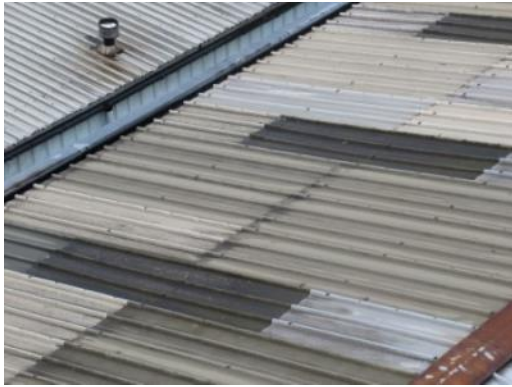
The GRP plastic rooflights present to the roof appear to be in a serviceable condition however are heavily soiled and showing signs of solar degradation. We anticipate that the rooflights will require replacement in the short to medium term.

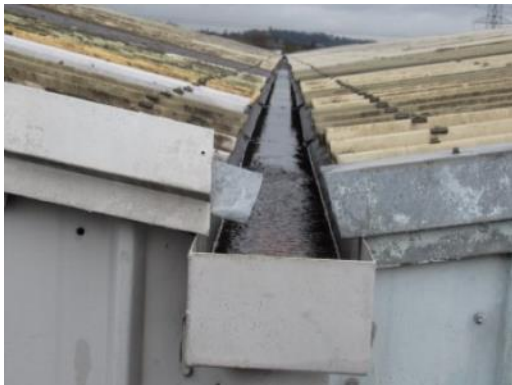
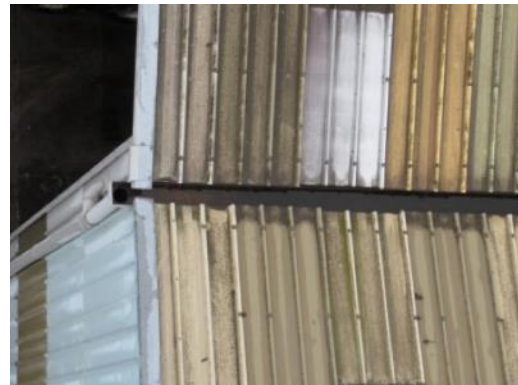
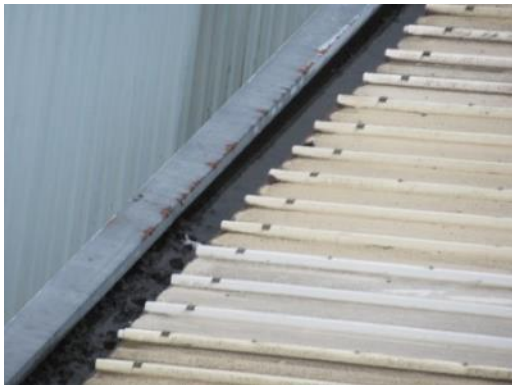
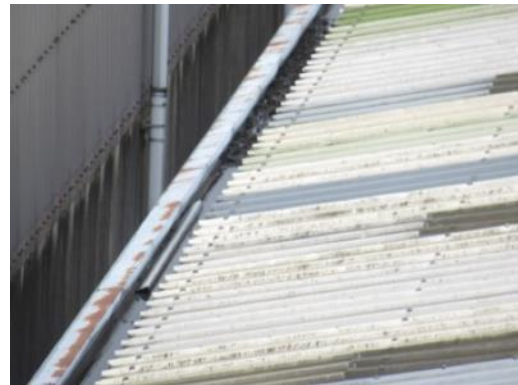
The preformed metal valley gutter at the junction between Unit 3 and Unit 2 and the eaves gutter to the right hand elevation appeared to be in a serviceable condition however are heavily soiled and blocked and require clearing in the immediate term. We anticipate relining of the gutter areas being required in the short term.

Where visible the plastic downpipes serving the gutters appear to be in a serviceable condition however leaking joints are evident. We recommend works are undertaken in the immediate term to reseal joints where necessary to the downpipe.

The bottom section of the downpipe to the rear of the unit is missing with the downpipe dispersion directly onto the adjacent ground. We recommend works are undertaken in the immediate term to replace the missing section of downpipe and connect this directly into the below ground drainage.

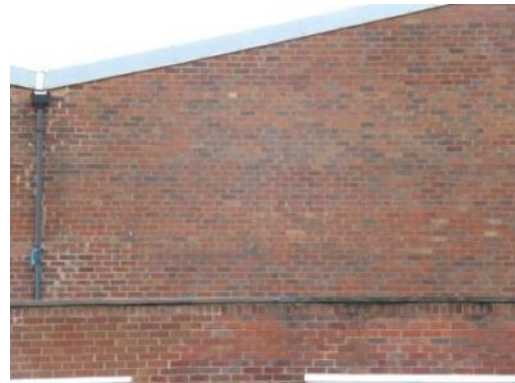
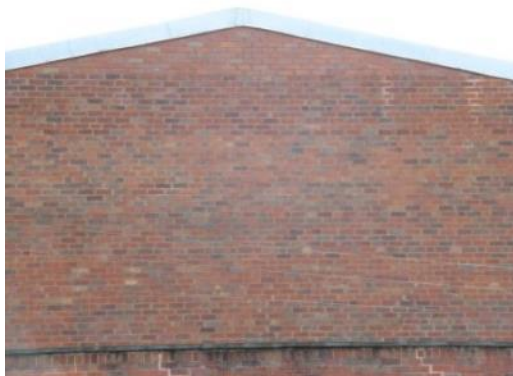
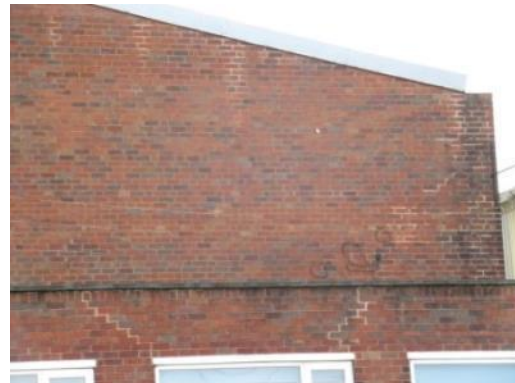
The brickwork present to the front elevation generally appears to be in satisfactory condition however areas of deteriorated mortar pointing are evident particularly to the left hand side of the elevation and adjacent to the downpipes and to the right hand side of the elevation. Where mortar pointing has deteriorated this provides a potential for moisture ingress into the property and as such we recommend these areas are repointed in the immediate term.

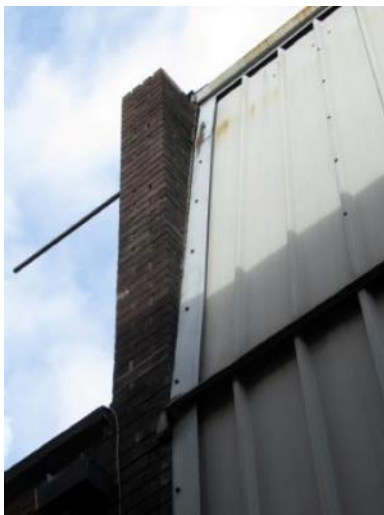
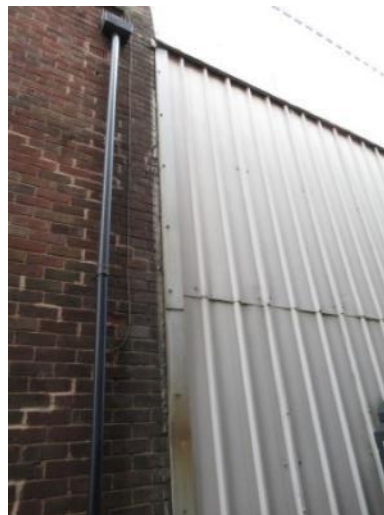
The brickwork present to the front of the left hand elevation generally appears to be in satisfactory condition however areas of deteriorated mortar pointing are evident. Where

mortar pointing has deteriorated we recommend these areas are repointed in the immediate term.

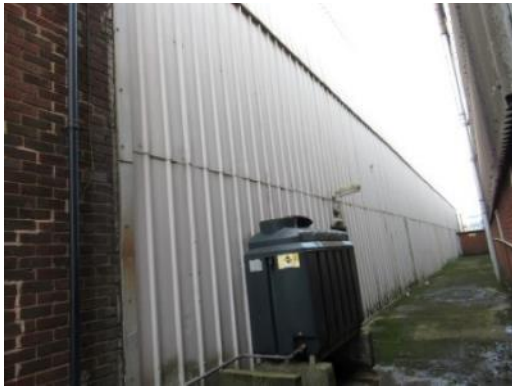
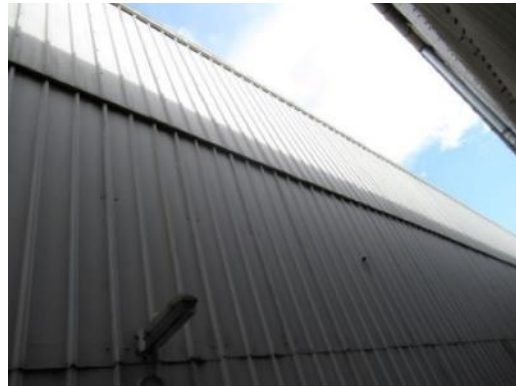
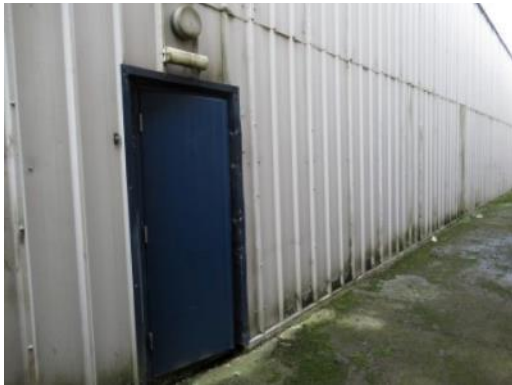
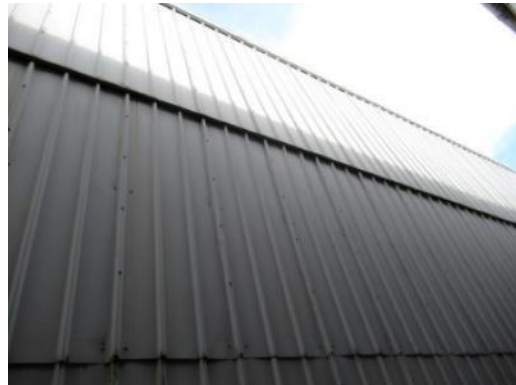
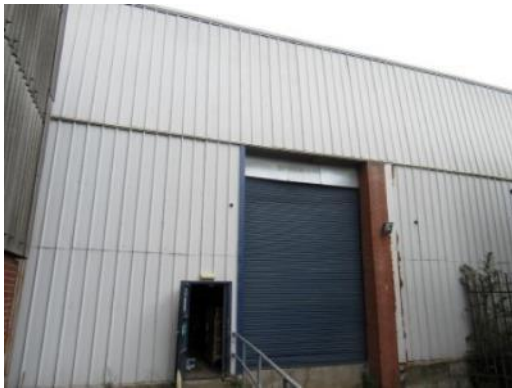
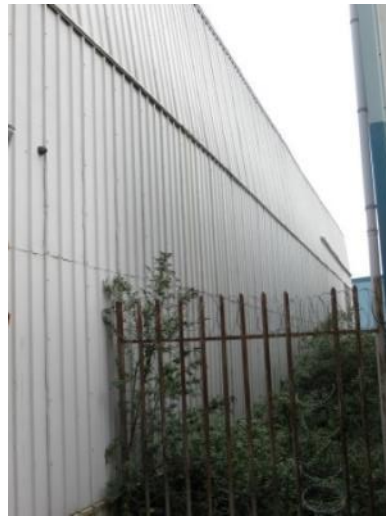
The painted profile metal cladding present to the right hand elevation appears to be in a serviceable condition however the painted coatings are deteriorating throughout with areas of minor impact damage also noted.

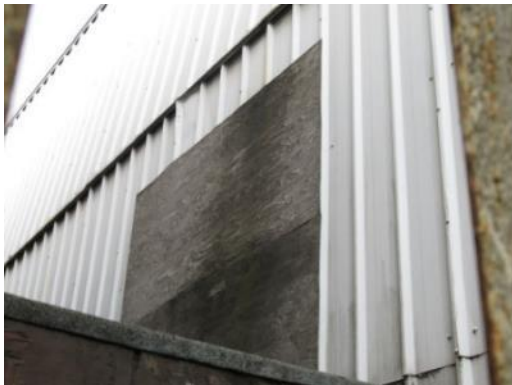
A section of timber boarding is present towards the rear of the elevation and we assume this has been installed where significant damage is present to the underlying profile metal cladding. We recommend that the timber boarding to this location is removed with the underlying cladding sheets replaced as necessary.

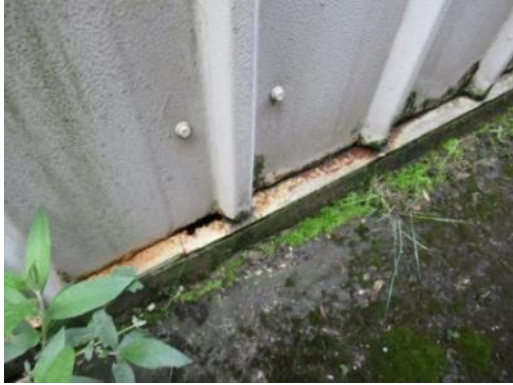
Corrosion is evident to the metal drip flashing present at the base of the cladding. We recommend that works are undertaken in the immediate term to repair the trim including replacement of severely corroded sections where necessary in the immediate to short term.

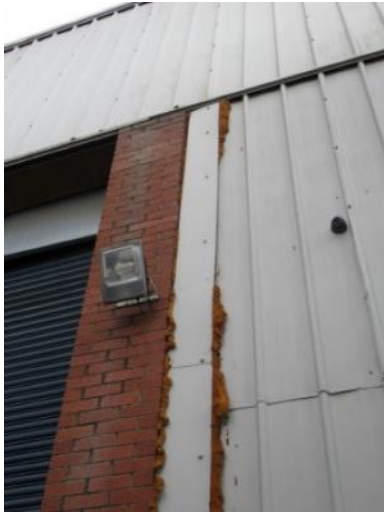
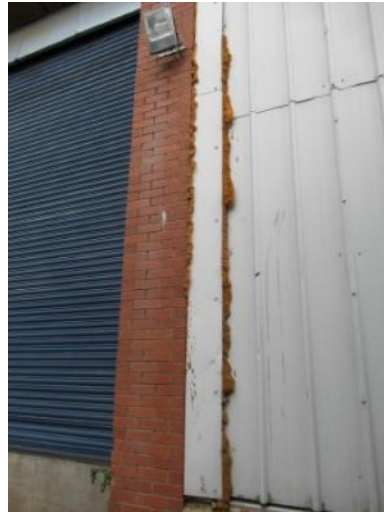
The preformed metal closure flashing present at the junction between the brickwork to the rear of the roller shutter door and the adjacent profile metal cladding is poorly fitted and sealed with expanding foam. Although this does not appear to be causing any significant problems at present the flashing would benefit from replacement.

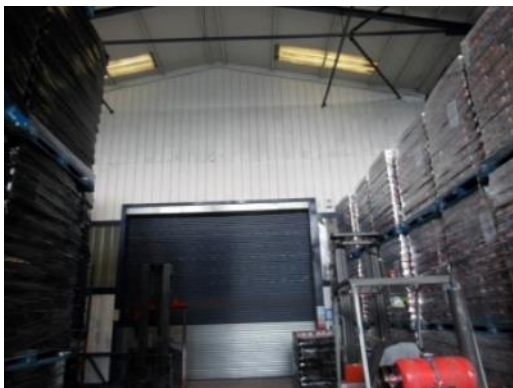
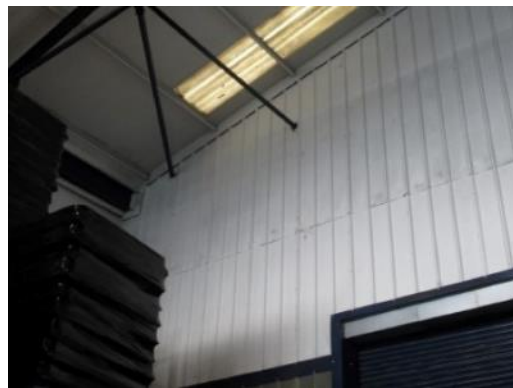
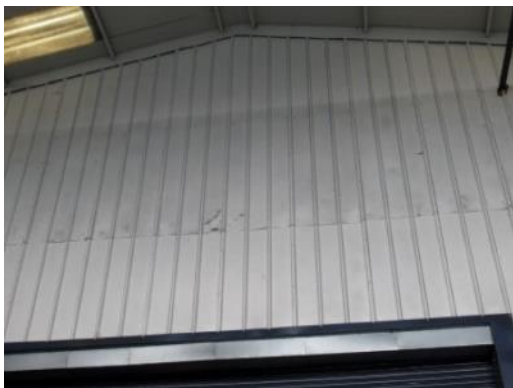
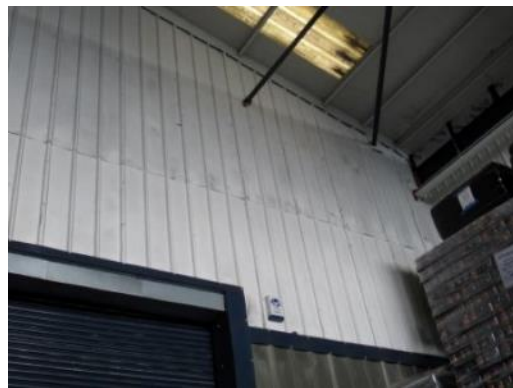
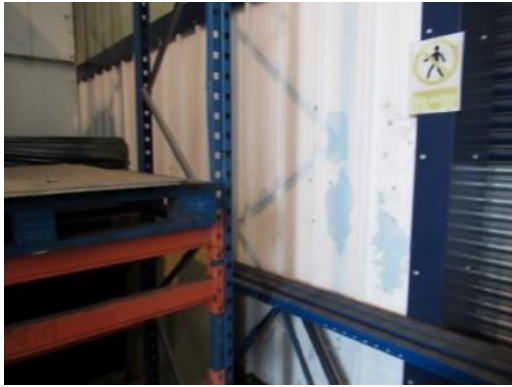
The painted profile metal cladding present to the rear elevation appears to be in a serviceable condition however the painted coatings are deteriorating. Where areas of minor impact damage are present to the profile metal cladding these does not appear to be significant.

We recommend that the cladding is redecorated in the short term.

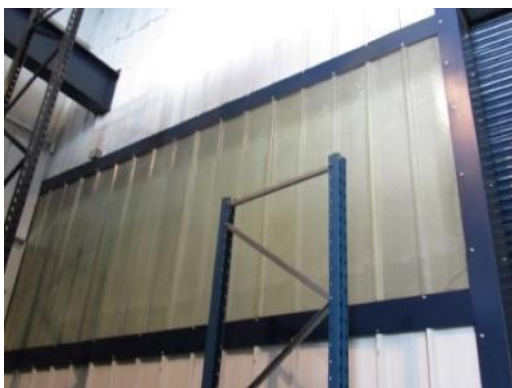
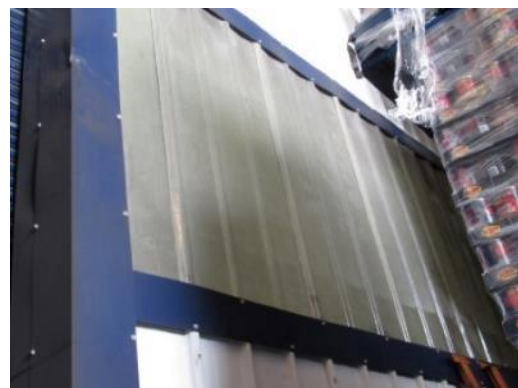
The translucent GRP clad sections to the rear elevation generally appear to be in satisfactory condition.

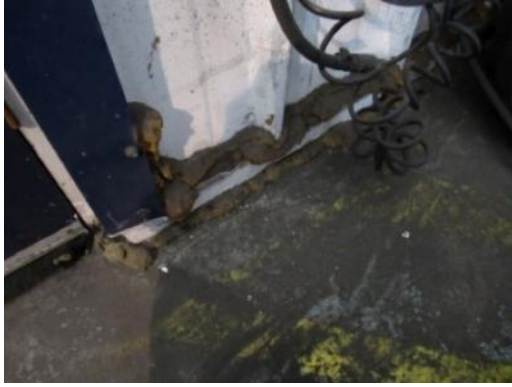
We note that expandable foam has been utilised at the junction between the bottom edge of the cladding and the below timber batten. Although this does not appear to be causing any significant problems at present the junction would benefit from remaking with a suitable termination flashing.

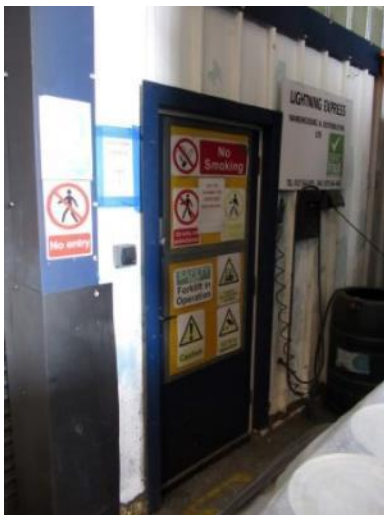
The solid timber external door to the rear elevation generally appears to be in satisfactory condition.

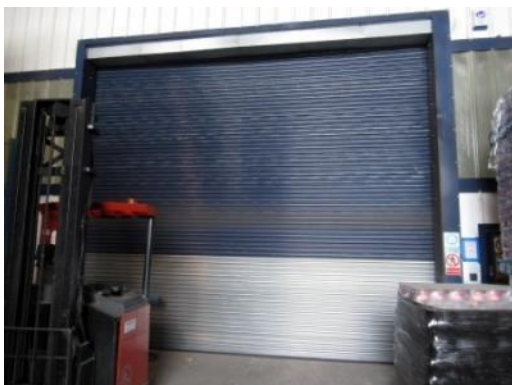
The metal roller shutter door to the elevation generally appears to be in satisfactory condition.

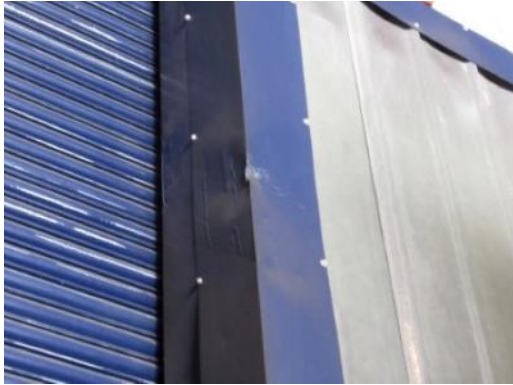
Where areas of minor impact damage are present to the preformed metal flashings to the perimeter of the roller shutter doors they do not appear to be significant.

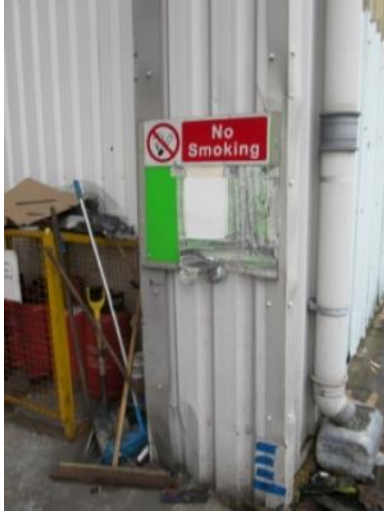
Where areas of impact damage are evident to the cladding to the rear of the extension this does not appear to be significant however the damaged sections would benefit from replacement.

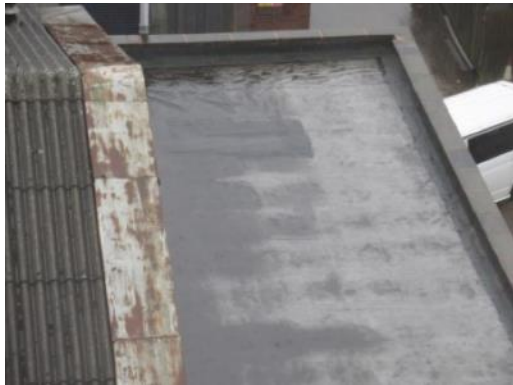
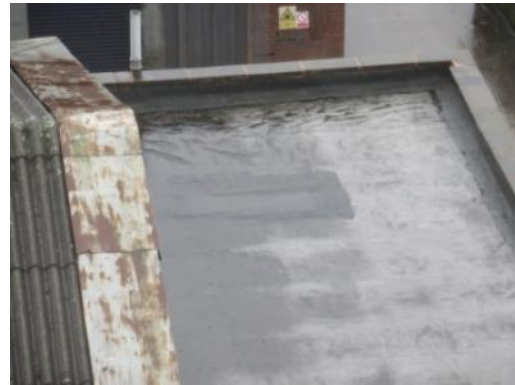
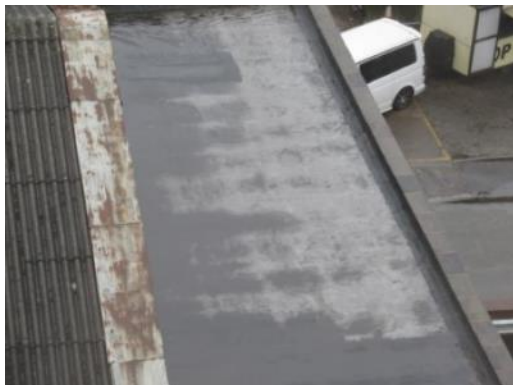
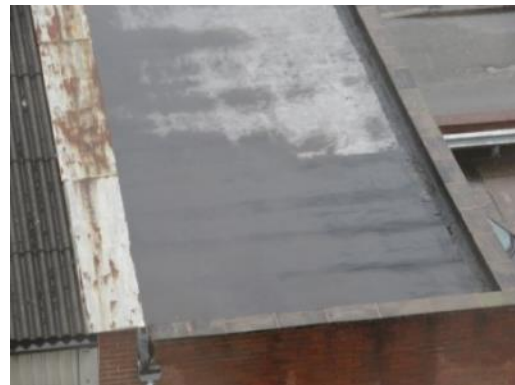
Unit 4**Flat Roof**

The bituminous finish present to the flat roof to the front of Unit 4 appears to be in poor condition with areas of blistering noted to its surface, previous patch repairs and the junction between the mineral felt to the upstands and the main section of the roof are poorly formed and deteriorated. In addition there is evidence of water ingress to the second floor office areas particularly to the right hand office and adjacent store room and adjacent bathroom. We recommend that works are undertaken in the immediate term to re-cover the flat roof.

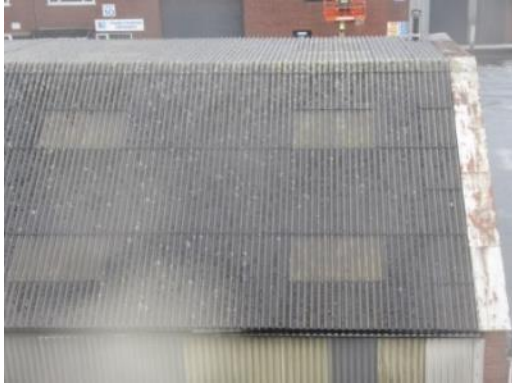
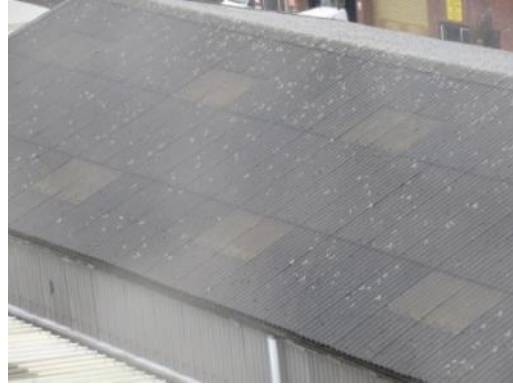
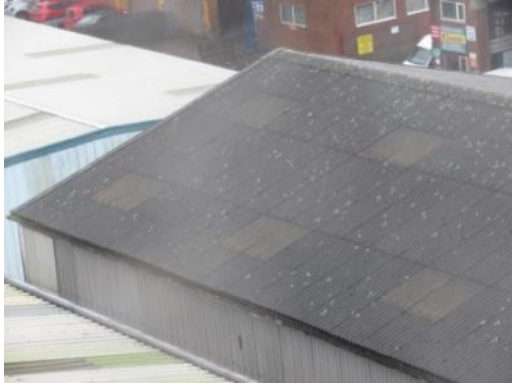
Main Roof

The corrugated asbestos sheet covering present to the main pitched roof generally appears to be in satisfactory condition with no significant defects noted.

Asbestos is hazardous to health and specialist advice should be obtained before any works are undertaken to this material. This type of material will only release asbestos fibres, if present, if it is drilled, sanded or damaged. The presence of asbestos can only be confirmed by specific testing which is outside the scope of this report. We strongly presume that this material contains asbestos and should be treated as such until proved otherwise.

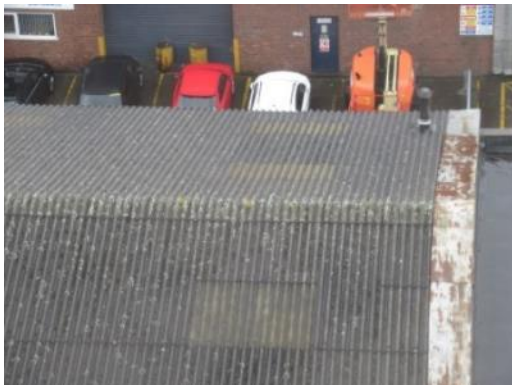
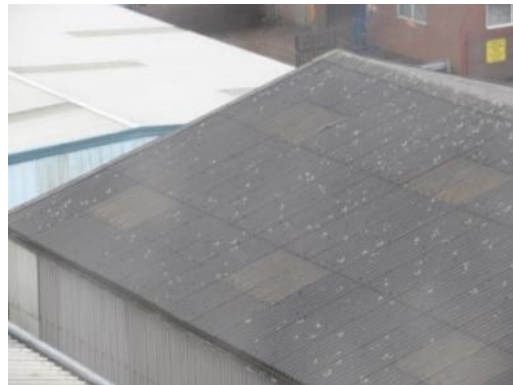
Where GRP rooflights are incorporated into the roof they appear to be in a serviceable condition however are heavily soiled and showing signs of solar degradation. The rooflights would benefit from replacement in the short term.

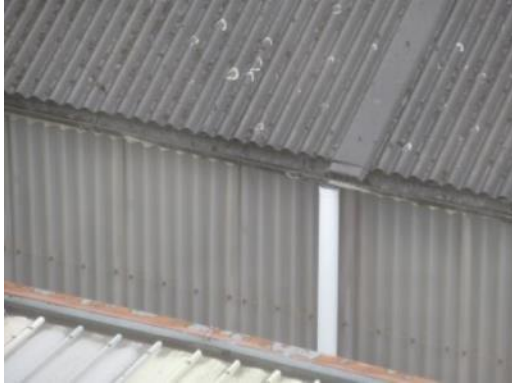
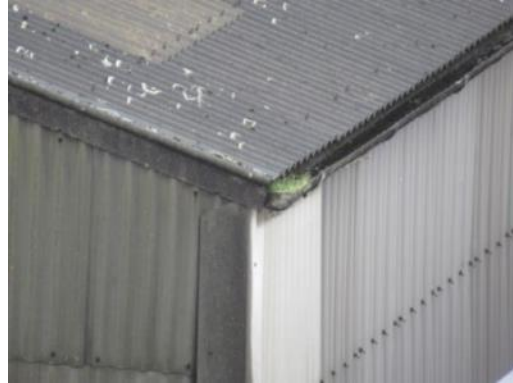
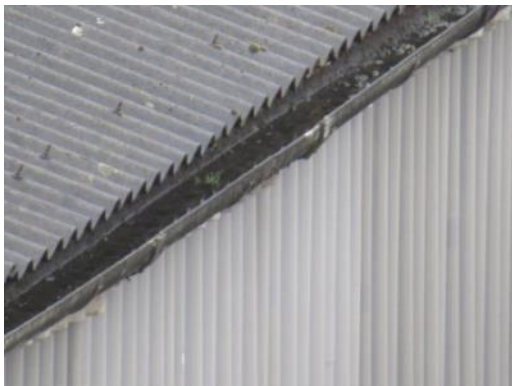
The eaves gutters serving the roof are poorly maintained, heavily soiled and blocked throughout their length with vegetation growth and leaking joints noted. We recommend that general repairs and maintenance are undertaken to the gutters in the immediate term including clearing of gutters removal of vegetation growth and resealing of defective joints. We would also recommend that the gutters are lined with a suitable proprietary lining system.

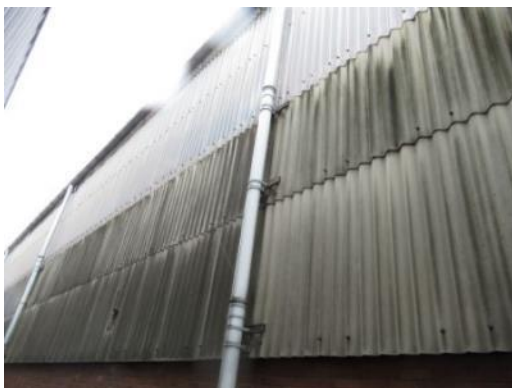
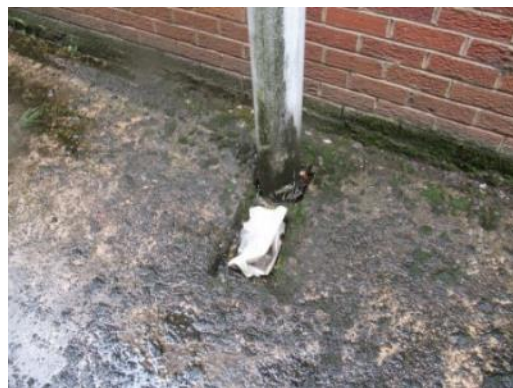
The plastic downpipes serving the eaves gutters appear to be in a serviceable condition however there is evidence of leaking joints present. We recommend that works are undertaken in the immediate term to reseal defective joints to the downpipe.

Where the downpipes are connected at ground level to the below ground drainage the junctions are deteriorated and damaged in areas and require repair.

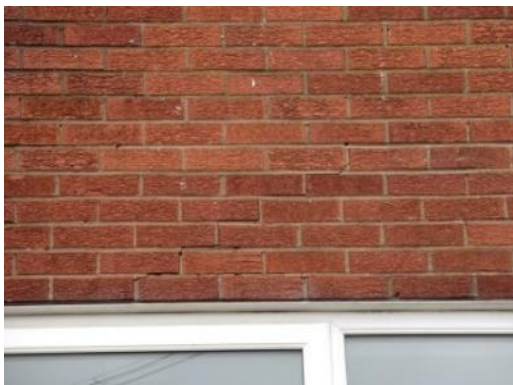
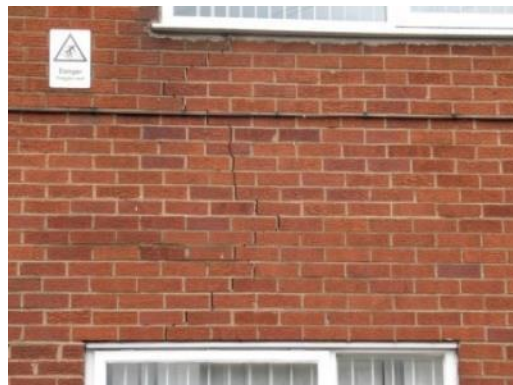
The brickwork present to the front elevation of Unit 4 generally appears to be in satisfactory condition however areas of deteriorated mortar pointing together with a number of spalled and defective bricks are evident particularly at low level.

The aforementioned provides a potential for moisture ingress into the property and as such we recommend that works are undertaken in the immediate term to repoint areas of deteriorated mortar pointing and cut out and replace spalled and defective brickwork.

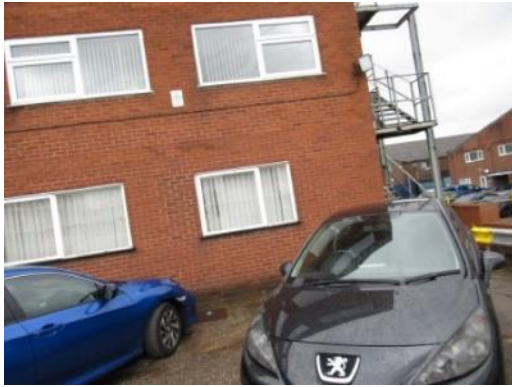
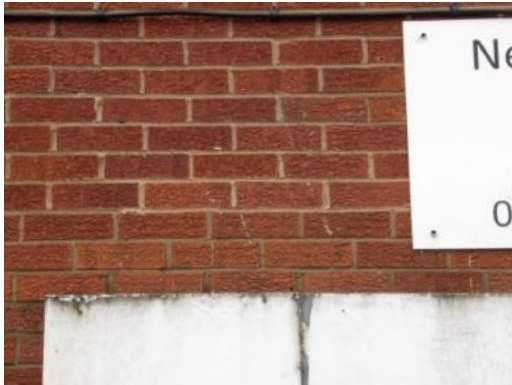
Areas of very slight to slight cracking are evident to the brickwork above the second first floor window from the left hand side of the elevation and above the ground floor right hand window with very slight cracking also evident above the first floor right hand window and main entrance door. The cracking at these locations suggests that a degree of structural movement has been experienced however we are unable to confirm from visual inspection whether this is historic or ongoing. Where cracking is present to the brickwork we recommend the areas are repaired and repointed in the immediate term and then visually monitored as a precaution.

The pattern of cracking suggests that the movement may be as a result of insufficient or deterioration of the lintel support above the openings. We recommend that further investigation works are undertaken in order to confirm that suitable lintels are present above the opening. If necessary new lintels may require installation.

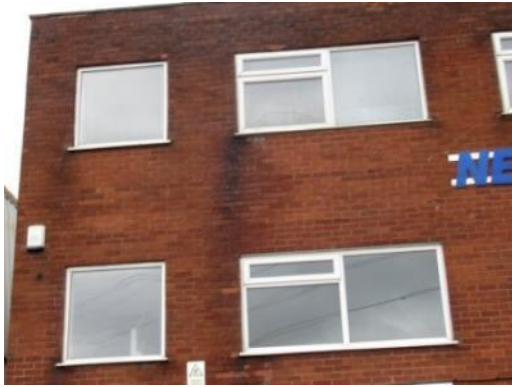
The uPVC framed double glazed windows generally appear to be in satisfactory condition however a number of failed double glazed units are evident with condensation present within the units. We recommend works are undertaken in the immediate term to replace failed double glazed units where present.

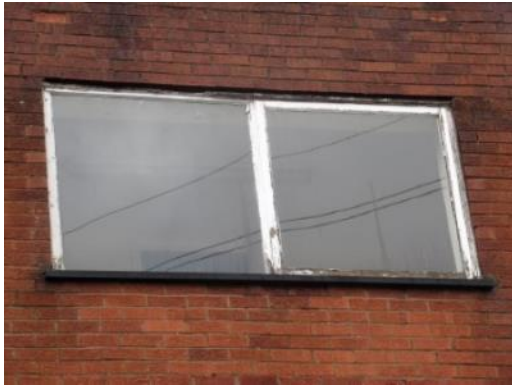
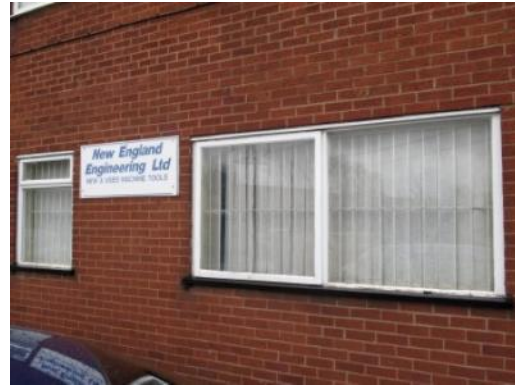
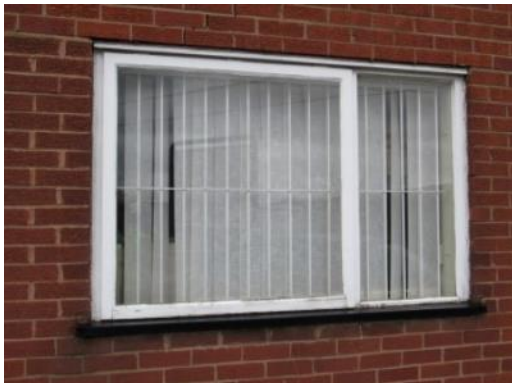
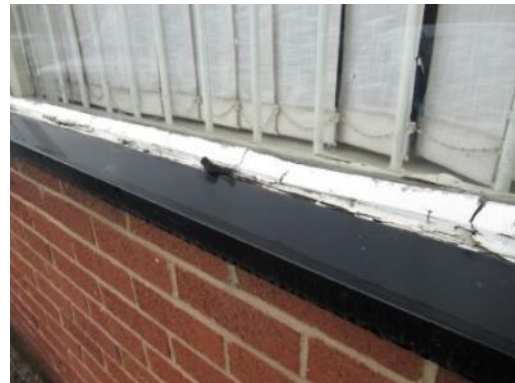
The timber framed single glazed windows are generally in poor condition with decorative paint finishes deteriorated and timber decay evident to the frame. We recommend that the timber framed windows are replaced in the immediate term.

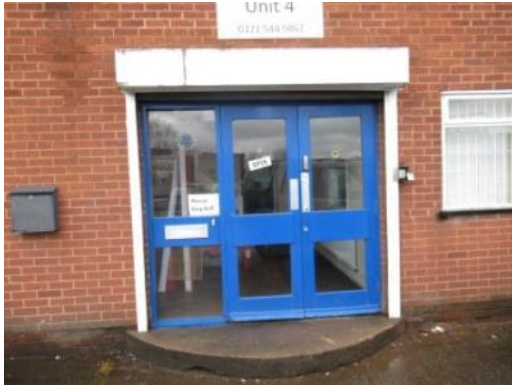
The glazed timber entrance doors and adjacent glazed screen appeared to be in a serviceable condition however decorative paint finishes are deteriorated with areas of minor timber decay also evident. We recommend that general repairs and redecoration are undertaken to the doors and screen in the immediate term.

We are unable to confirm from a visual inspection whether the glazing to the doors and screen is safety glass. Where glazing is provided at critical locations within doors and adjacent the doors safety glass should be present. As such we recommend the glazing is tested to confirm this and replaced as necessary.

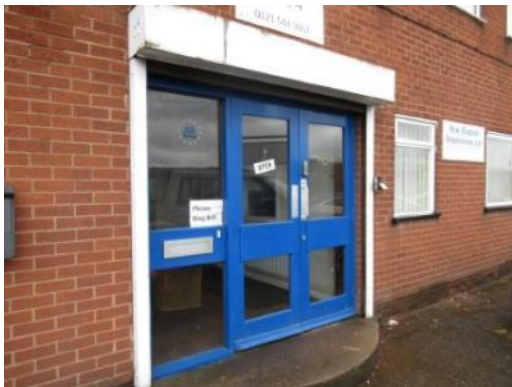
A metal security shutter is present to the main entrance. We recommend that this is checked to confirm it operates correctly.

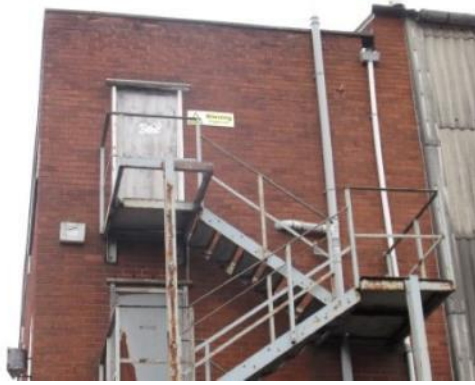
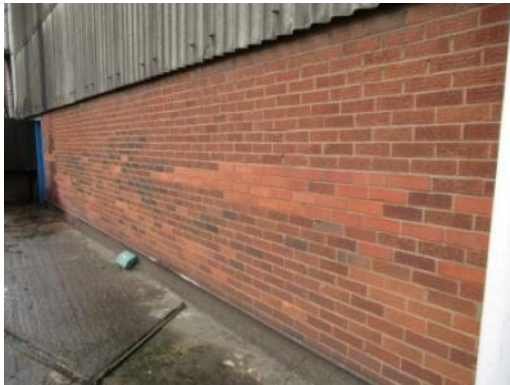
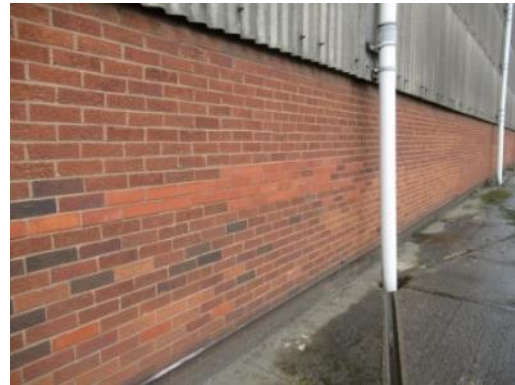
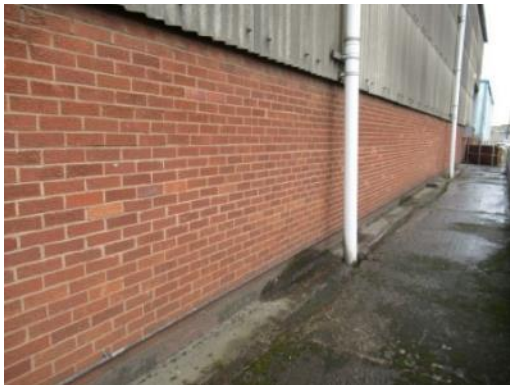
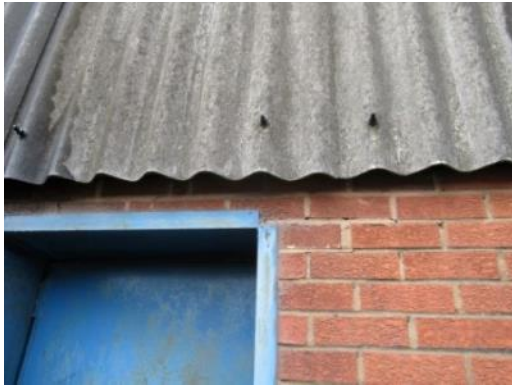
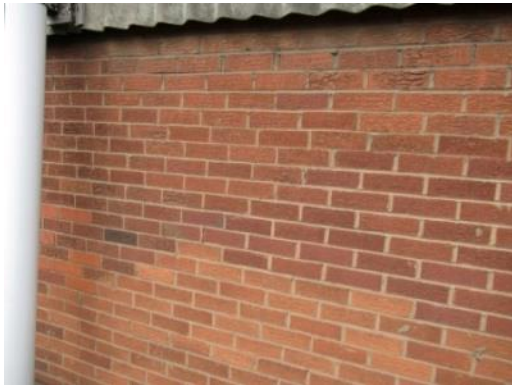
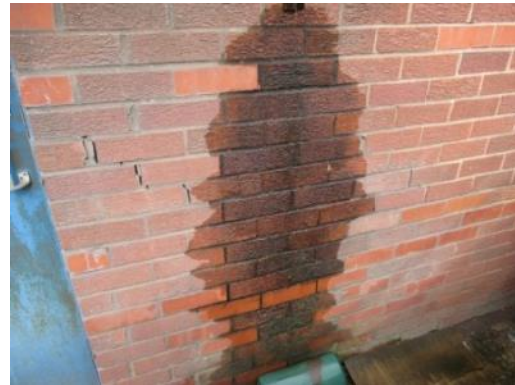
The brickwork present to the right hand elevation generally appears to be in satisfactory condition however areas of very slight to slight cracking are evident throughout its length.

Where cracking is present to the elevation this suggests that a degree of structural movement has been experienced however we are unable to confirm from a visual inspection whether this is historic or ongoing. Where cracking is present we recommend that the areas are repaired and repointed in the immediate term and visually monitored as a precaution.

We note that defects to below ground drainage are a potential cause of structural movement. As such we recommend that a CCTV survey is undertaken to the below ground drainage in the immediate term to confirm its condition. Where repairs are identified these should be carried out.

An extent of the cracking may also be as a result of thermal expansion with the brickwork with no expansion joints present within the elevation. We recommend that suitable expansion joints are installed to the brickwork at 10 to 12 m intervals in order to address this.

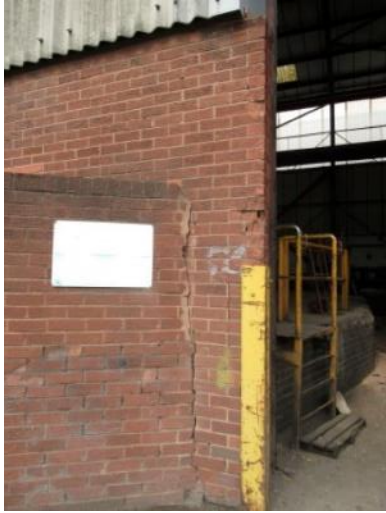
An area of damaged brickwork is present to the front of the roller shutter door to the rear of the elevation. Where the brickwork is damaged this requires repair with defective bricks cut out and replaced.

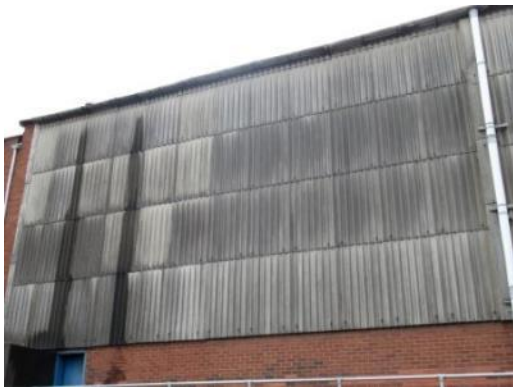
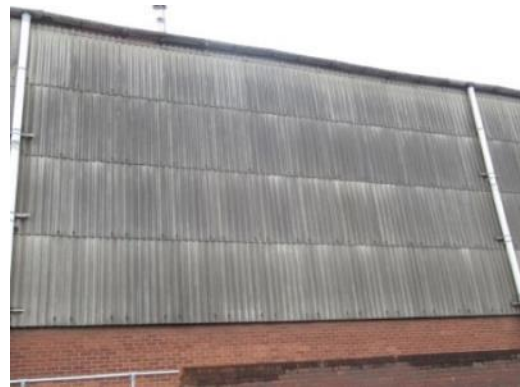
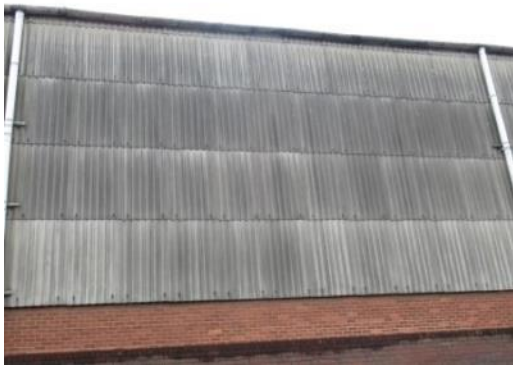
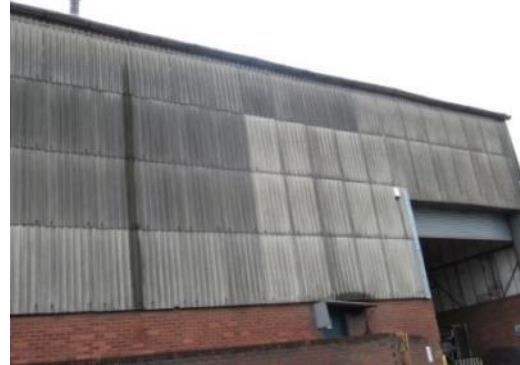
The corrugated sheet cladding present to the right hand elevation generally appears to be in satisfactory condition with no significant defects noted. Where areas of minor damage

are present to the cladding they do not appear to be significant. We consider it likely that the cladding is an asbestos containing material.

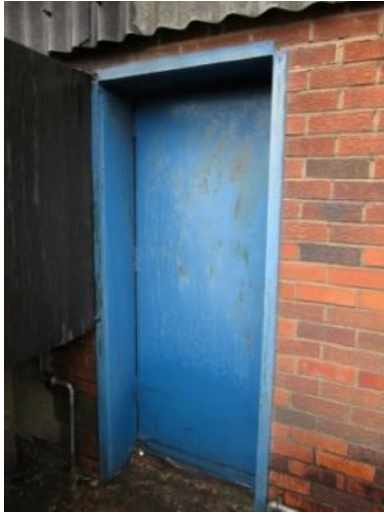
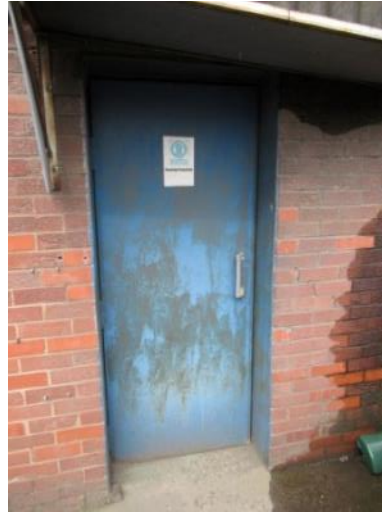
The metal external doors to the right hand elevation appear to be in a serviceable condition however decorative paint finishes are deteriorated with corrosion also present to the surface. We recommend that general repairs and redecoration are undertaken to the doors in the immediate term.

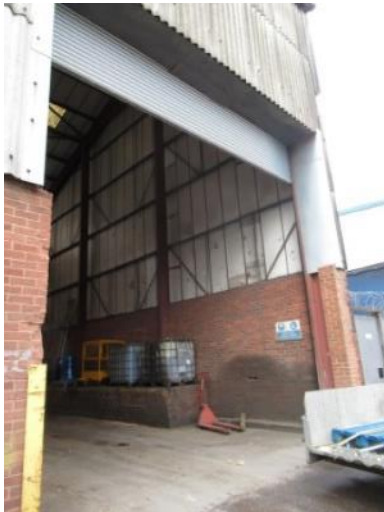
The metal roller shutter door present to the rear elevation generally appears to be in satisfactory condition.

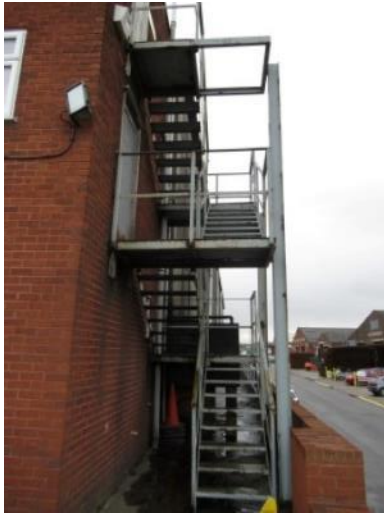
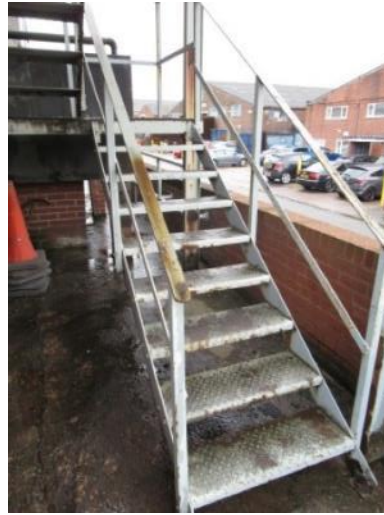
An external metal fire escape staircase is present towards the front of the elevation. The staircase is generally poorly maintained with the painted finish deteriorated and corrosion evident throughout. We recommend that general repairs and redecoration are undertaken to the staircase in the immediate term. Where severely corroded sections are present they will require replacement.

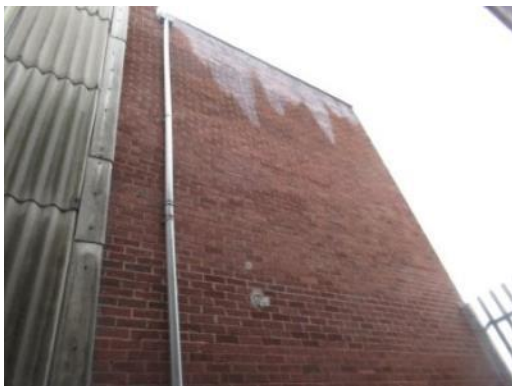
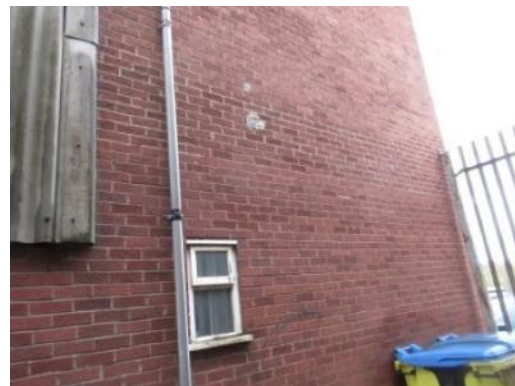
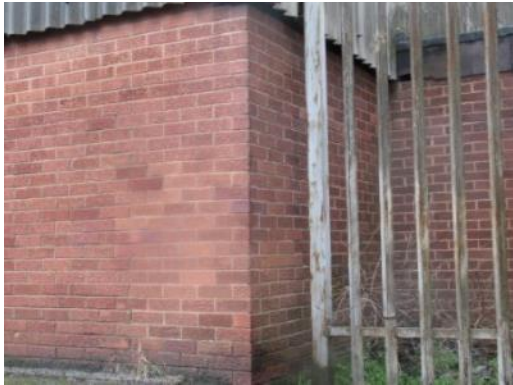
The brickwork present to the left hand elevation generally appears to be in satisfactory condition however areas of deteriorated mortar pointing are evident particularly at low level along with areas of very slight cracking. Where mortar pointing has deteriorated we recommend these areas are repointed in the immediate term

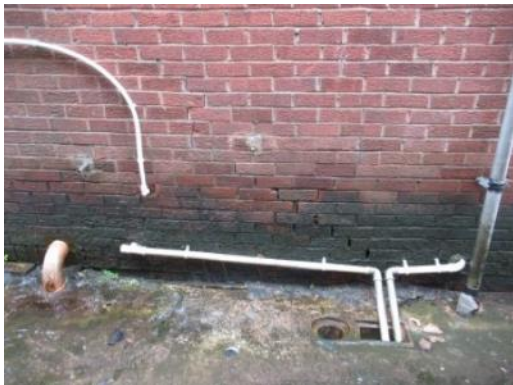
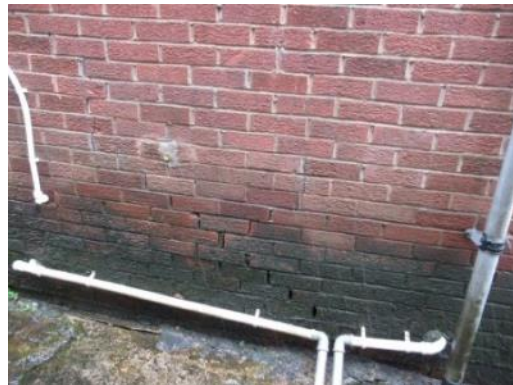
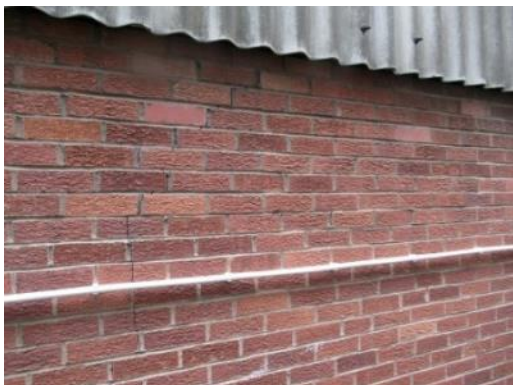
Where cracking is present to the brickwork this suggests that a degree of structural movement has been experienced although we are unable to confirm from visual inspection whether this is historic or ongoing. Defects to below ground drainage are a potential cause for structural movement and we refer you to our previous comments regarding carrying out a CCTV survey.

Following the aforementioned the areas of cracking to the brickwork should be repaired and repointed and then visually monitored as a precaution.

As noted to the right hand elevation an extent of the cracking may also be as a result of thermal expansion with the brickwork with no expansion joints present within the elevation. We recommend that suitable expansion joints are installed to the brickwork at 10 to 12 m intervals in order to address this.

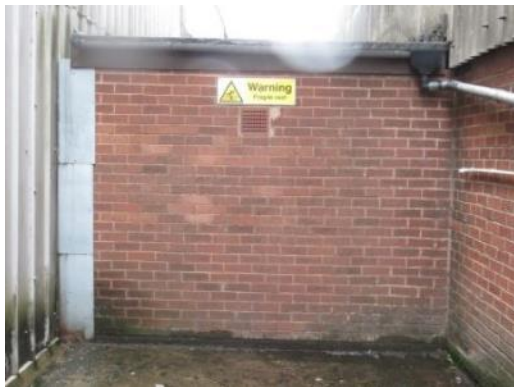
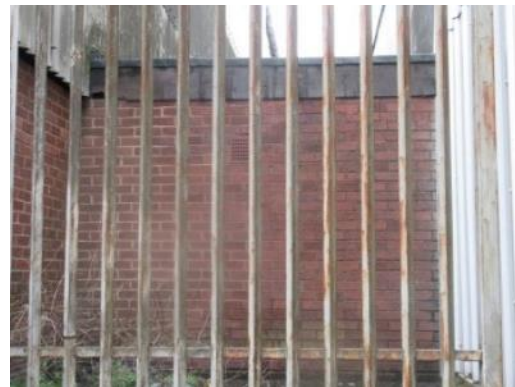
The brickwork present to the external elevation to the single storey extension between Unit 3 and 4 generally appears to be in satisfactory condition.
