Building Inspection Report

Project preface

We have been requested by the prospective purchaser to carry out a Building Survey of the above property.

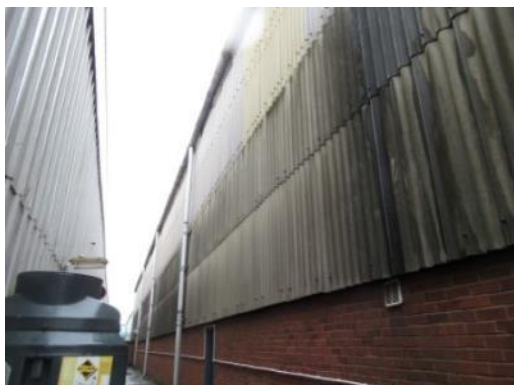
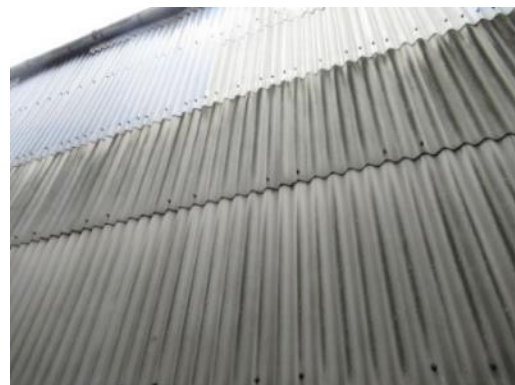
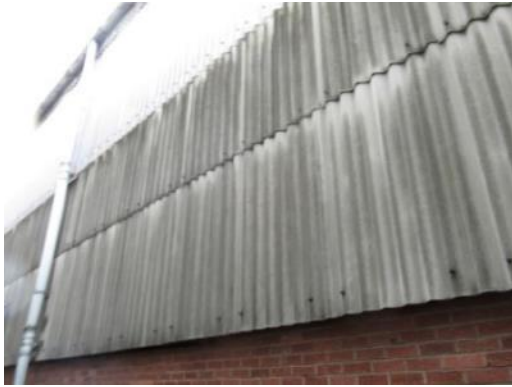
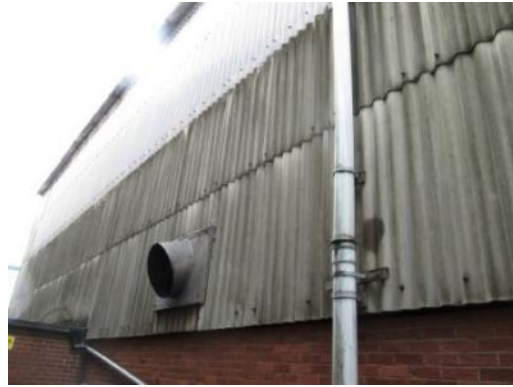
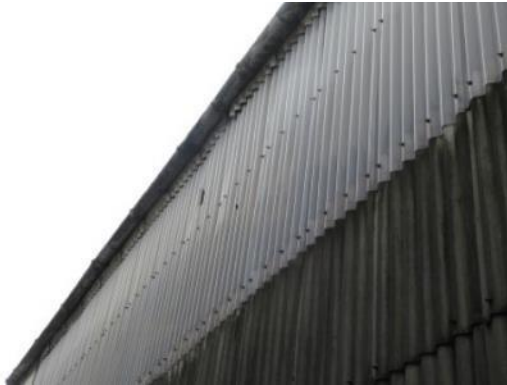
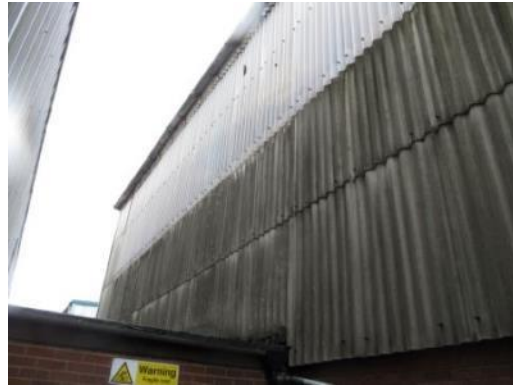
The corrugated sheet cladding present to the left hand elevation generally appears to be in satisfactory condition with no significant defects noted. Where areas of minor damage are present to the cladding they do not appear to be significant however would benefit from repair in the short term. We note the cladding appears to be of an asbestos containing material. Please refer to our previous comments regarding asbestos.

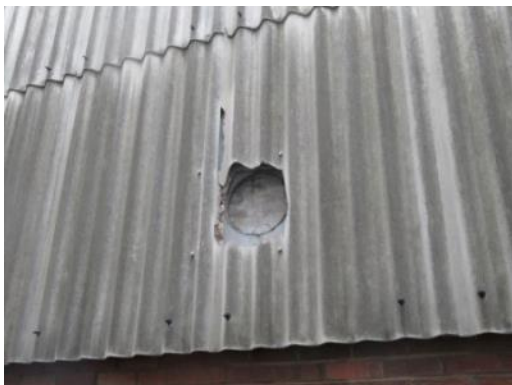
Where a redundant flue penetration has been removed and blocked up to the elevation the damaged sheet is still present and this would benefit from replacement.

The translucent roof sheets present to the upper section of the elevation generally appear to be in satisfactory condition however section of damage is present towards the rear of the elevation. We recommend the damaged section is replaced in the immediate term.

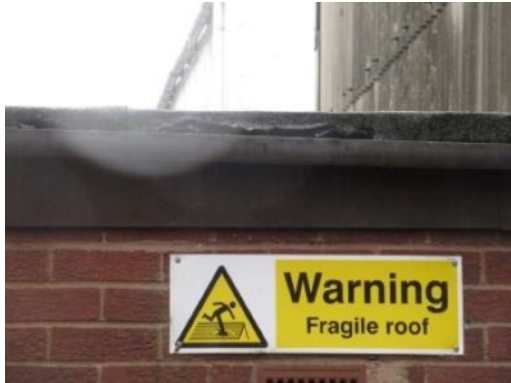
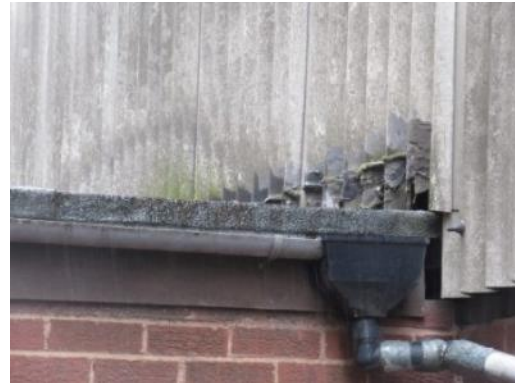
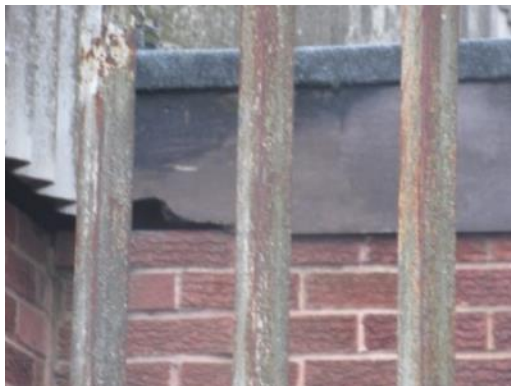
The flat roof over the single storey extension between Unit 3 and 4 where visible appears to be deteriorating although we note no evidence of current water ingress internally. We anticipate the roof requiring re-covering in the short term.

The timber fascias are generally deteriorated and would benefit from replacement.

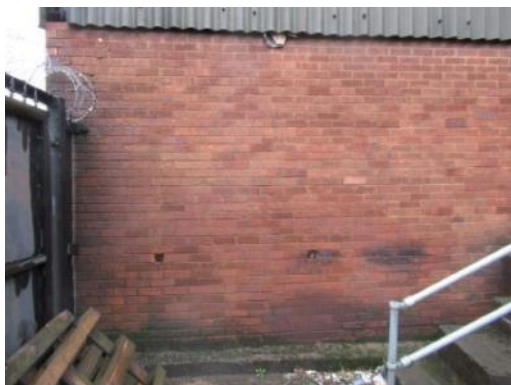
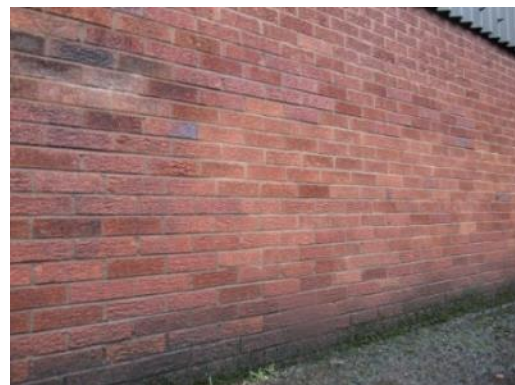
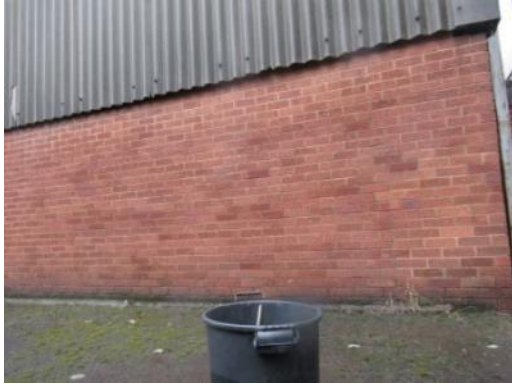
The brickwork present to the rear elevation generally appears to be in satisfactory condition however a number of isolated, spalled and defective bricks are evident. Where spalled and defective brickwork is present this would benefit from cutting out and replacement.

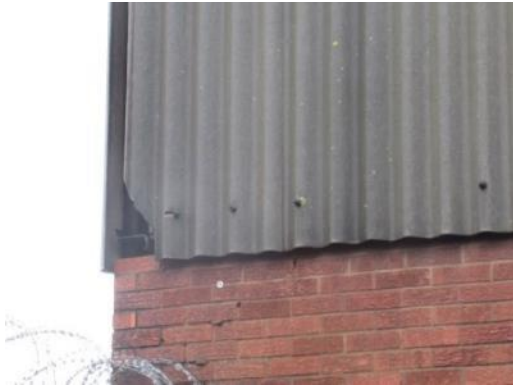
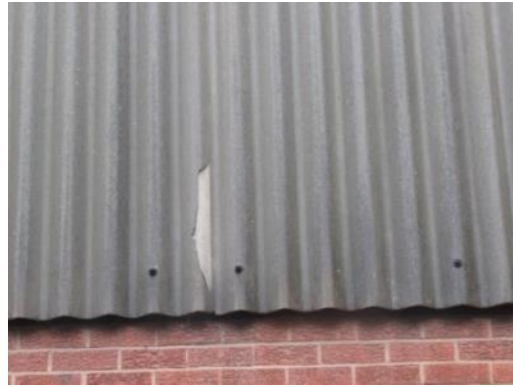
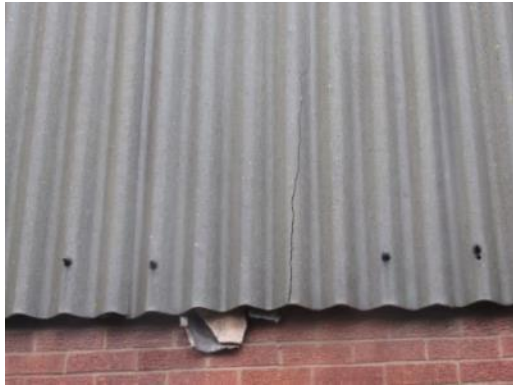
The corrugated sheet cladding present to the rear elevation generally appears to be in satisfactory condition however areas of damage are present particularly to the rear right hand corner and towards the centre of the elevation.

Where damaged cladding is present these areas would benefit from replacement. As noted to the previous elevations the cladding appears to be of an asbestos containing material and we refer you to our previous comments regarding this.

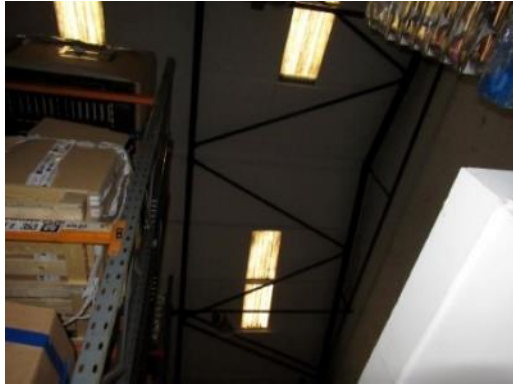
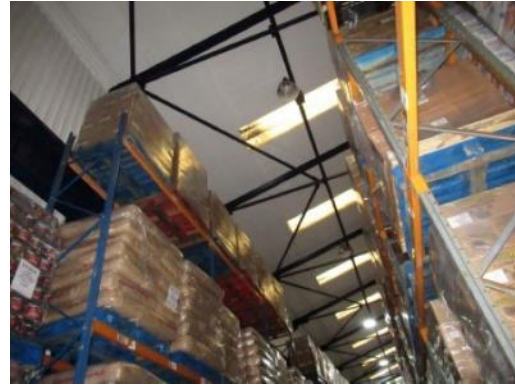
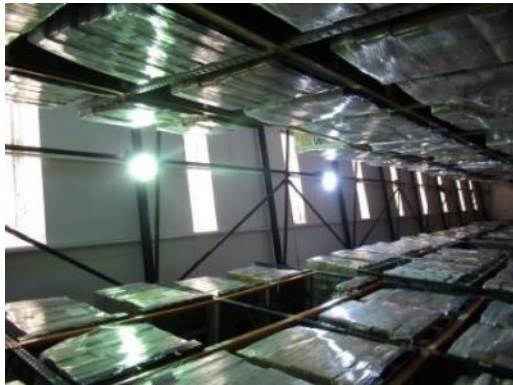
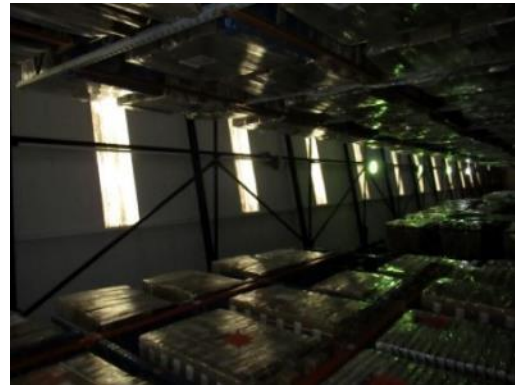
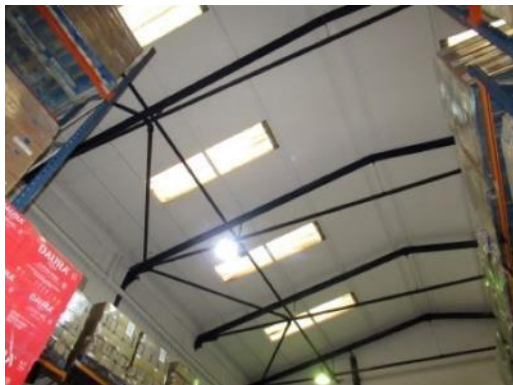
Inspection of the warehouse area is limited due to the racking and stock present.

Where visible the underside of the composite roof covering which forms the ceiling within the warehouse generally appears to be in satisfactory condition.

Where visible the steel portal framed structure generally appears to be in satisfactory condition with no significant defects or distortion noted.

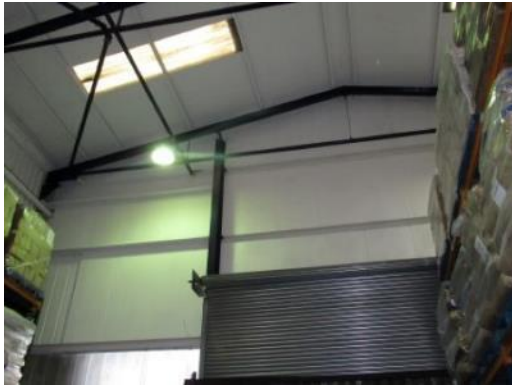
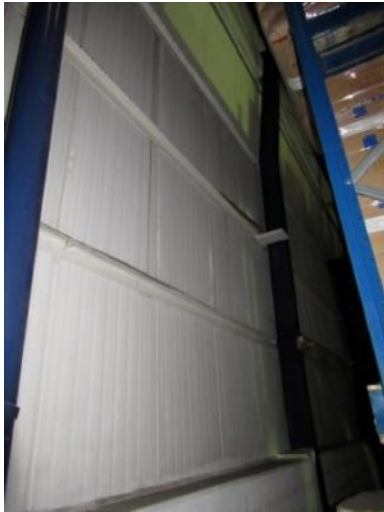
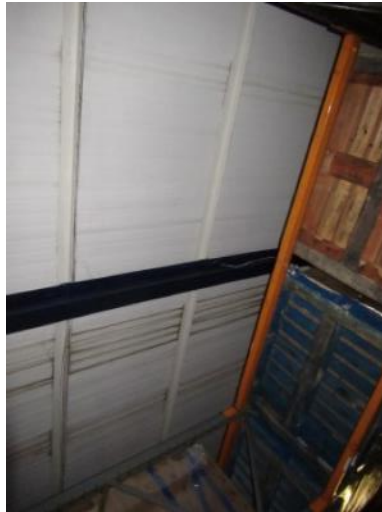
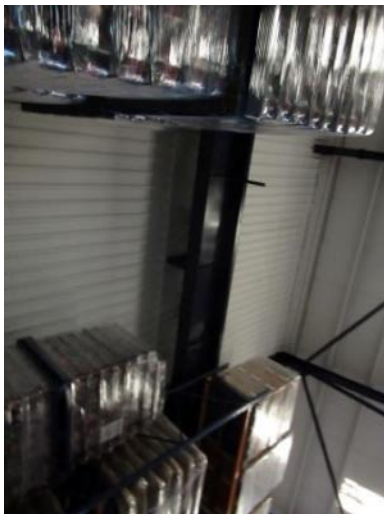
The internal face of the external cladding present to the walls generally appears to be in satisfactory condition with no significant defects noted. Where areas of staining are present to the cladding particularly to the right hand elevation this appears to be as a result of leaks from the above rainwater goods. Please refer to our previous comments within the external condition section of the report regarding the rainwater goods.

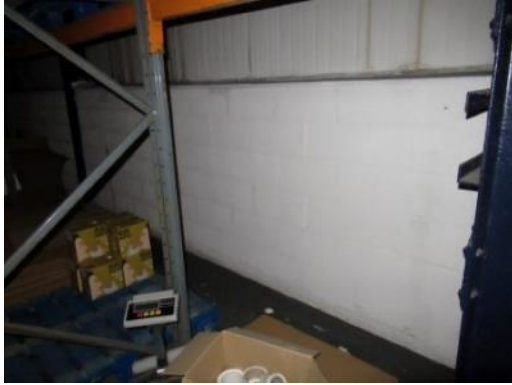
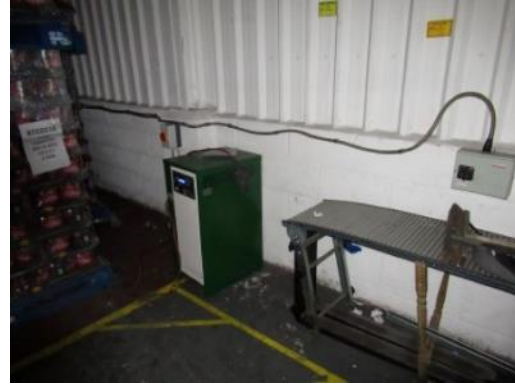
The painted blockwork present to the internal face of the external walls generally appears to be in satisfactory condition with no significant defects noted.

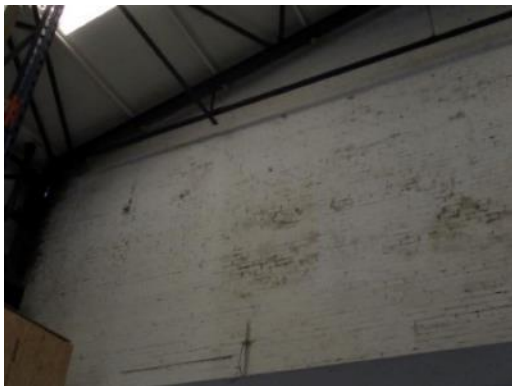
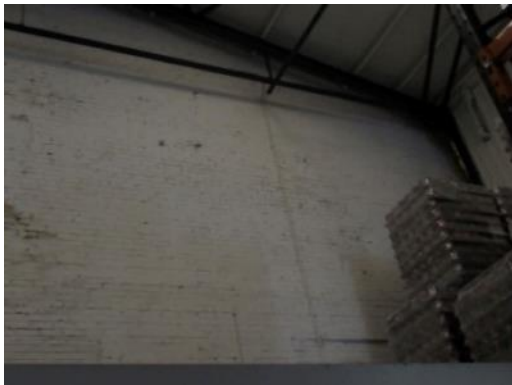
The brickwork present to the internal face of the front elevation appears to be in a serviceable condition however areas of soiling and staining, deteriorated mortar pointing and very slight cracking are evident.

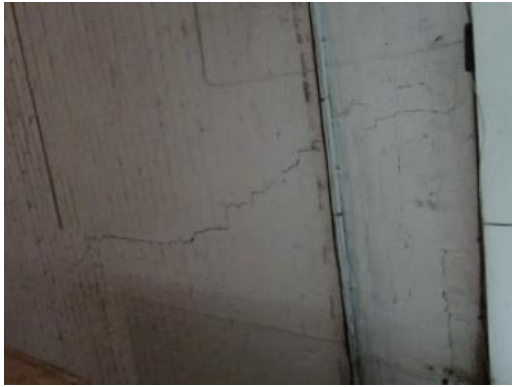
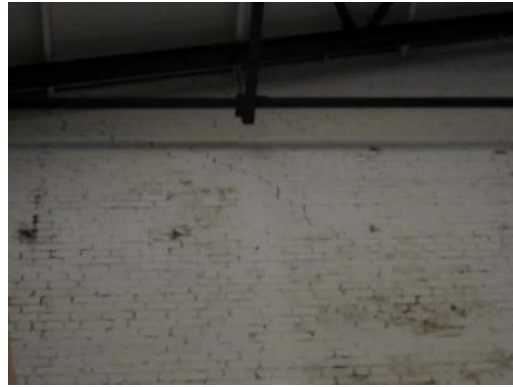
The cracking present to the brickwork suggests that a degree of slight structural movement has occurred to these locations although does not appear to be significant at present. We are unable to confirm from a visual inspection whether the movement is historic or ongoing and as such we recommend the areas are repaired and repointed in the immediate term and then visually monitored as a precaution. The brickwork would also benefit from repointing areas of deteriorated mortar pointing and redecoration.

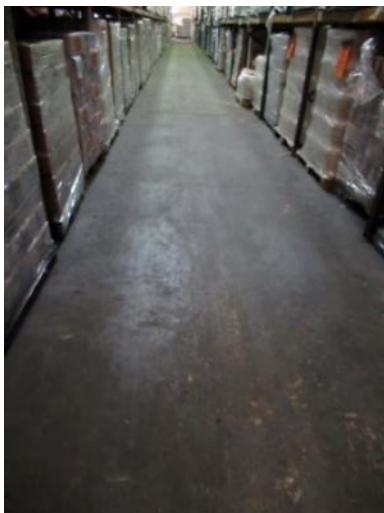
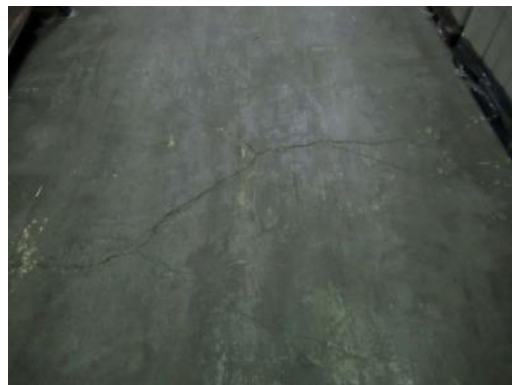
The painted concrete floor to the warehouse generally appears to be in satisfactory condition however the painted finishes are generally deteriorated with areas of cracking also evident to

its surface. The aforementioned does not appear to be significant however the floor would benefit from repair to areas of cracking and redecoration in the short term.

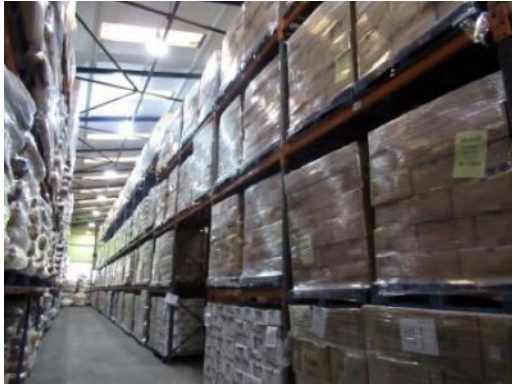
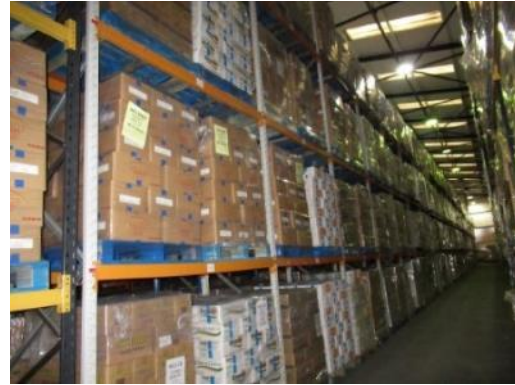
Extensive racking is present throughout the warehouse which we assume is the tenant's fittings. Following removal of the racking repairs and making good will be required to the floor where fixing bolts have been installed.

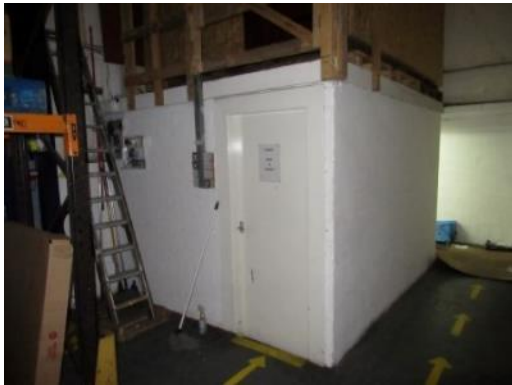
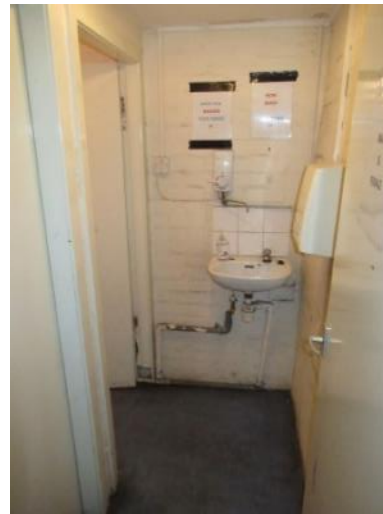
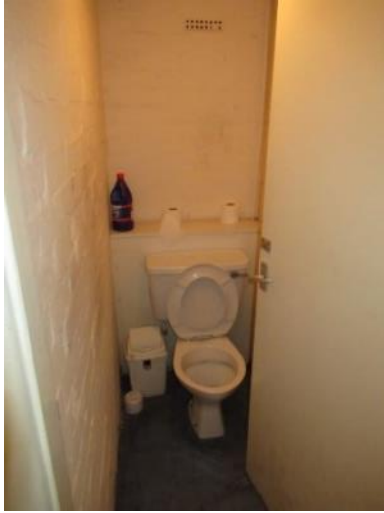
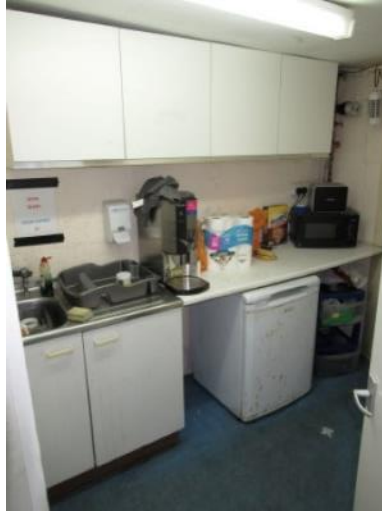
WC/Kitchen Block

The WC/kitchen block appears to be in a serviceable condition however is generally tired and worn throughout and would benefit from refurbishment and redecoration including replacement of the floor covering.

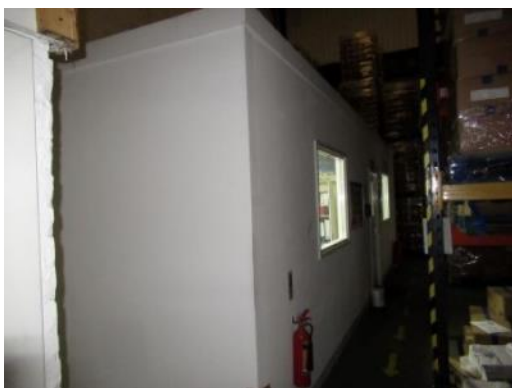
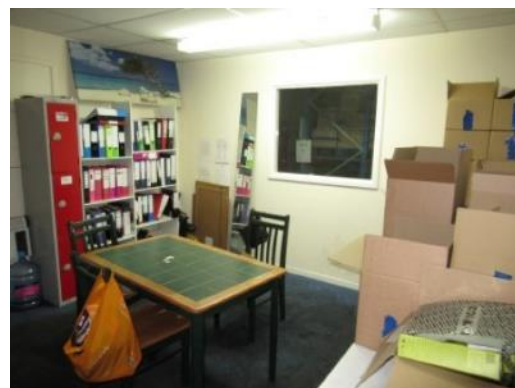
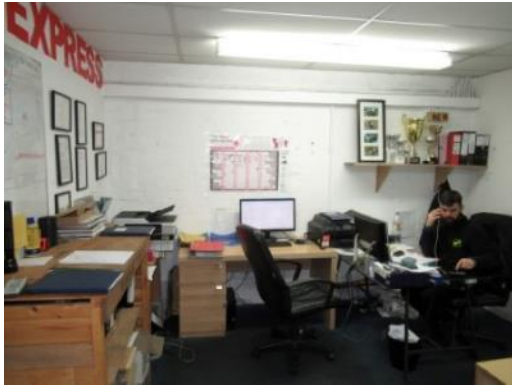
Offices

The office areas appear to be in a serviceable condition however are generally tired and worn and would benefit from general refurbishment, redecoration and replacement of the floor covering.

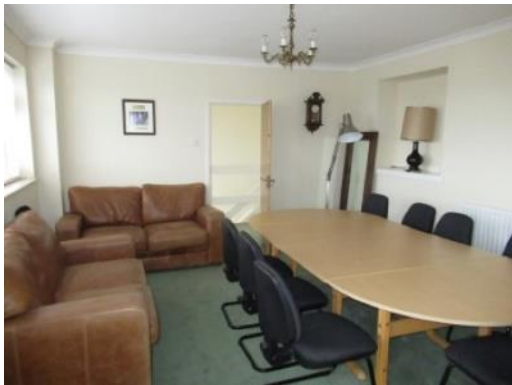
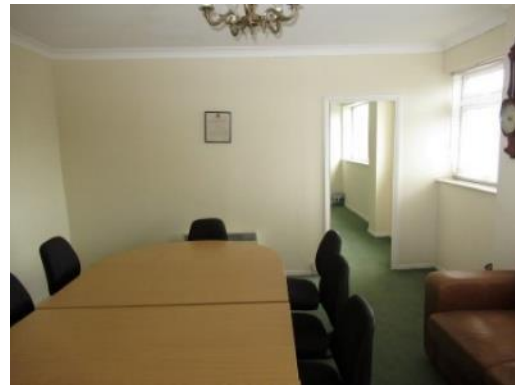
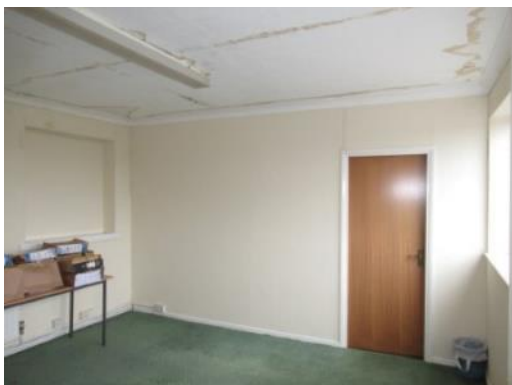
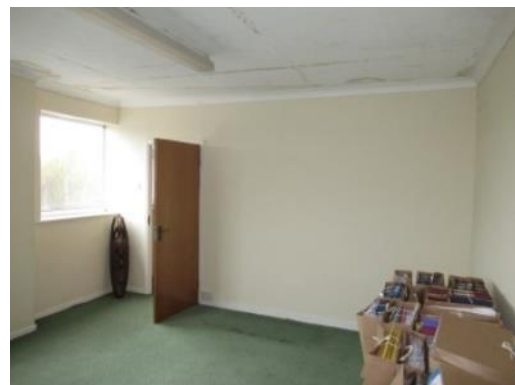
Second Floor Offices

Office areas generally appear to be in satisfactory condition with no significant defects noted however are in need of redecoration and replacement of floor coverings.

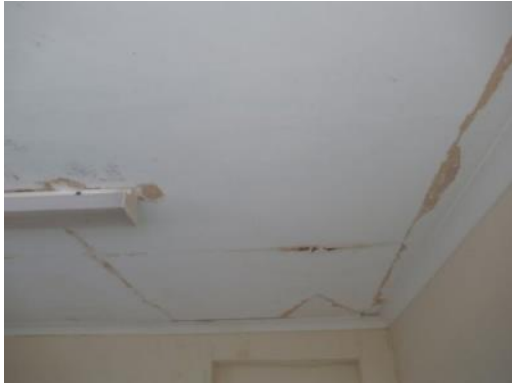
There is evidence of water ingress on the above flat roof within the right hand office with the paper finish removed to the majority of the ceiling and areas of hairline to very slight cracking and water staining present to the underlying plaster finish. Please refer to our comments within the external condition section of the report with regards to the flat roof. Following repairs to the flat roof the ceiling within the right hand office requires repair and redecoration.

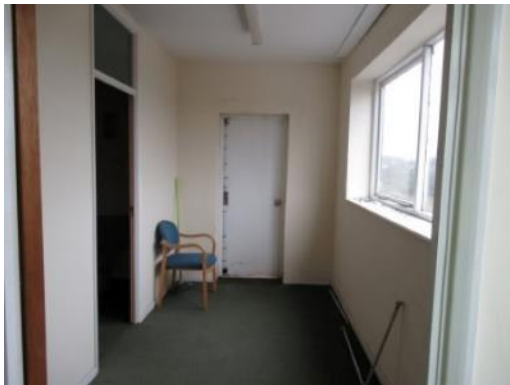
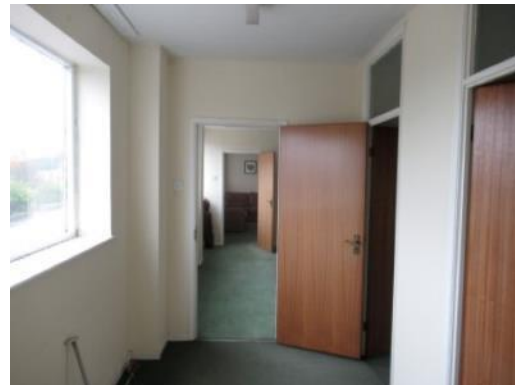
Right Hand Corridor

The areas generally appear to be in satisfactory condition however are in need of redecoration and replacement of the floor covering.

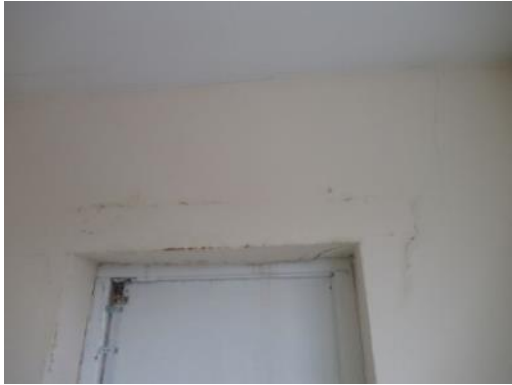
There is evidence of water ingress to the head of the fire escape door with cracking and deterioration of the plaster finishes noted at this location. Following repairs to the roof and external brickwork we recommend that the plaster finishes are repaired and replaced where affected and redecorated.

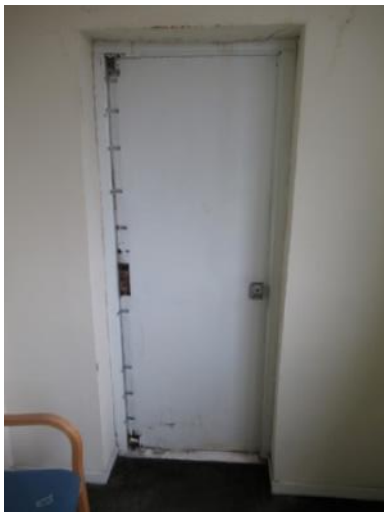
The fire exit door which leads onto the external metal fire escape staircase has been screw fixed closed and as such is not currently in use. We consider that the aforementioned contravenes Fire Regulations and as such recommend that the fire escape is put back into use with the door replaced in the immediate term including the installation of suitable ironmongery.

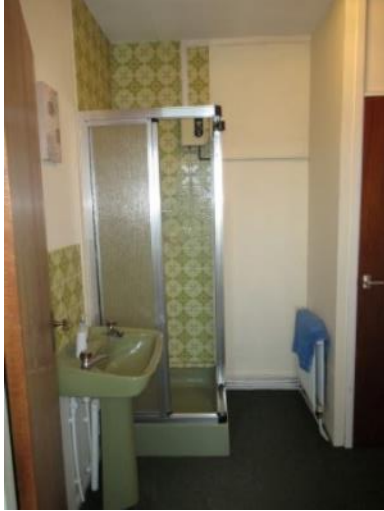
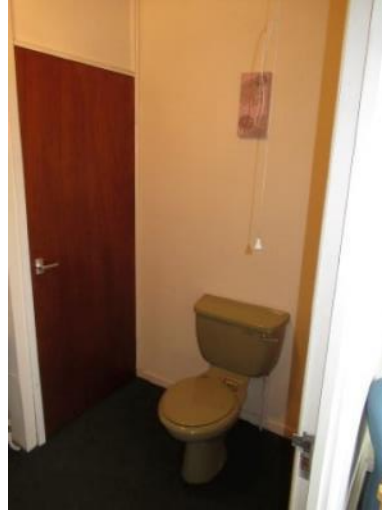
Bathroom

The bathroom generally appears to be in satisfactory condition with no significant defects noted however would benefit from redecoration and replacement of the floor covering. The bathroom fittings are also noted to be dated and you may wish to consider their replacement with modern fittings.

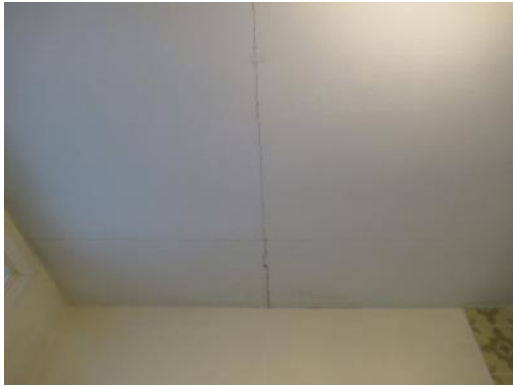
Where very slight cracking is present to the surface of the ceiling this does not appear to be significant however requires repair prior to redecoration.

Water staining is present to the left hand side of the ceiling and also noted to the ceiling within the adjacent store room. Please refer to our previous comments regarding the flat roof within the external condition section of the report. Following repairs to the flat roof the ceiling should be repaired where affected and decorations made good.

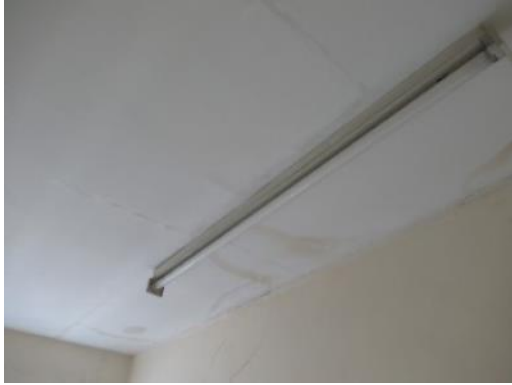
There is evidence of water ingress from the above flat roof to the ceiling with staining and deterioration of the plaster finishes noted. Please refer to our comments regarding repairs to the flat roof within the external condition section of the report. Following repairs to the roof the ceiling should be repaired and decoration made good.

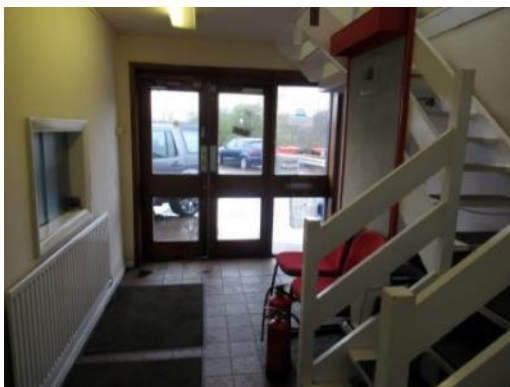
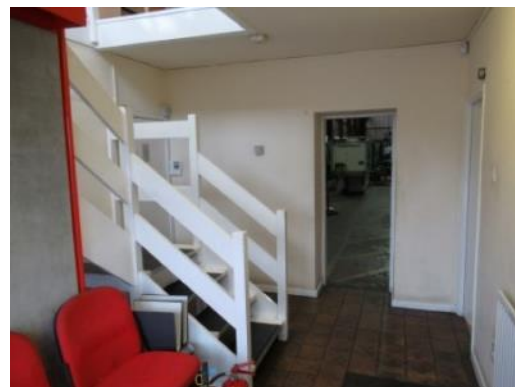
Entrance Lobby

significant defects noted however would benefit from redecoration. Where damaged tiles are present to the floor these would benefit from replacement with deteriorated grouted joints also regouted.

The floor is noted to slope slightly towards the right hand side however this does not appear to be significant and would benefit from levelling.

High levels of moisture and slight deterioration of the decorative and plaster finishes are evident at low level to walls within the entrance hallway suggesting there may be a potential issue with penetrating dampness within the property. As such we recommend that a specialist damp survey is undertaken of the property to further advise on this matter.

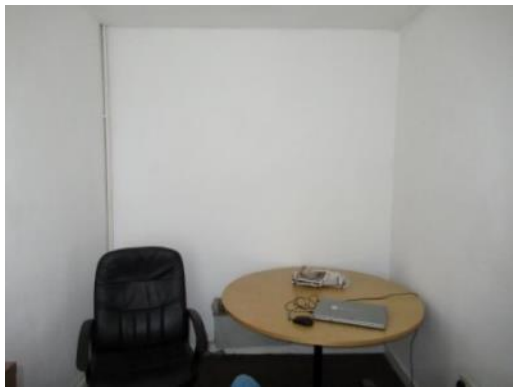
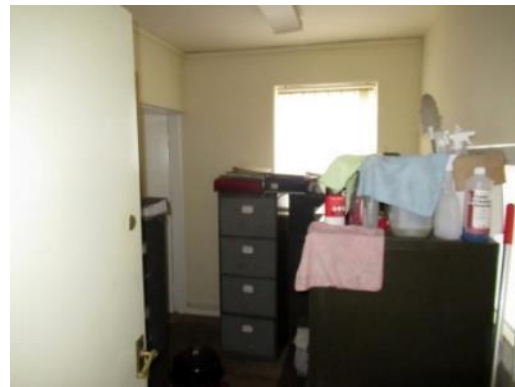
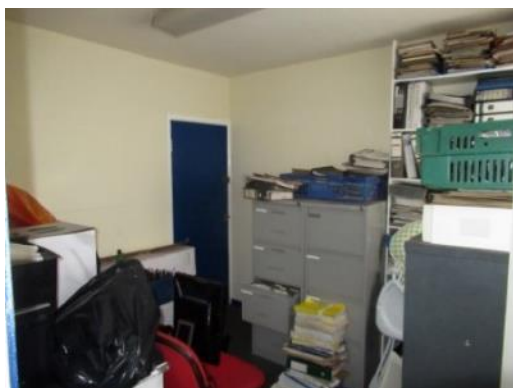
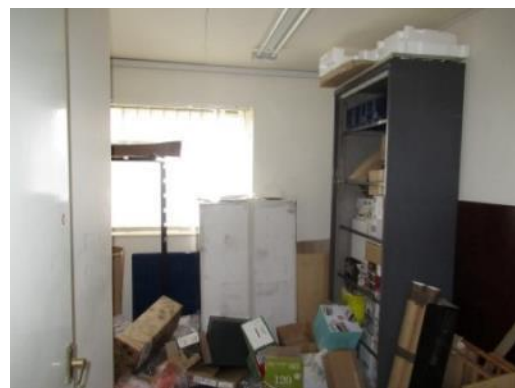
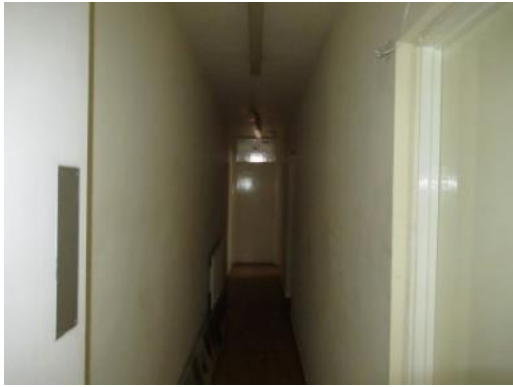
Offices

Where areas of very slight cracking are present to the ceilings they do not appear to be significant however require repair prior to redecoration. Where cracking is present to the front wall of the office area we consider that this is linked to the previously noted structural movement to the front elevation and refer you to our previous comments regarding this. Following completion of repairs externally we recommend that plaster finishes internally are repaired prior to redecoration.

An area of deteriorated plaster finishes and high levels of moisture are evident to the rear left hand corner of the left hand office. A WC is present to the rear of the office and we note high levels of moisture at low level to the walls within this area also and decay present

to the skirting. The aforementioned suggests there is a potential issue with penetrating dampness through the property and we refer you to our previous comments regarding this.

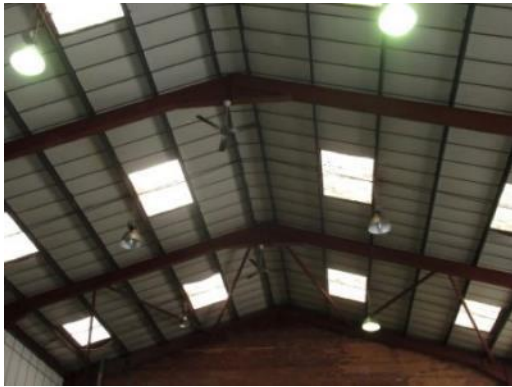
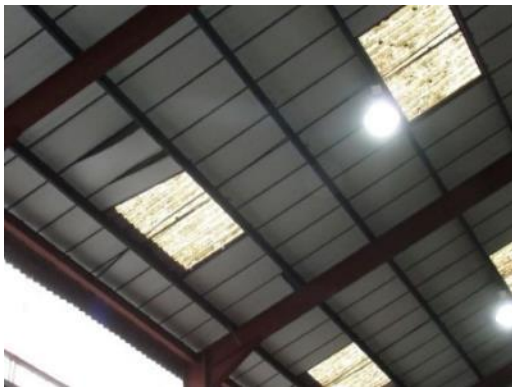
The lining boards to the ceiling generally appear to be in satisfactory condition with no evidence of water ingress however a number of isolated, damaged and displaced lining boards are present and these would benefit from replacement.

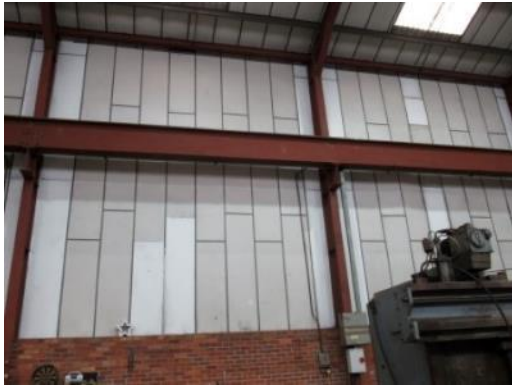
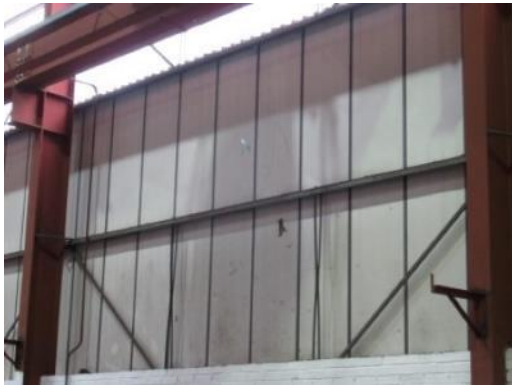
The lining boards present to the perimeter walls generally appear to be in satisfactory condition however numerous damaged lining boards are present particularly to the internal face of the rear elevation. Although this does not appear to be causing any significant problems at present the damaged lining boards would benefit from replacement.

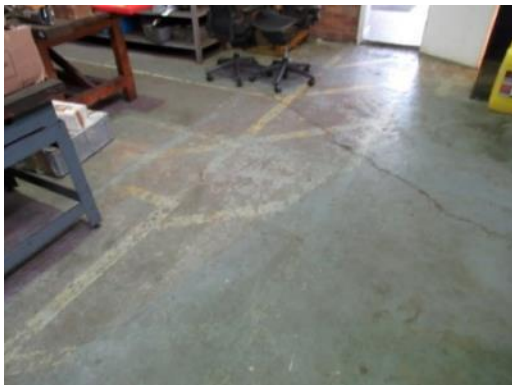
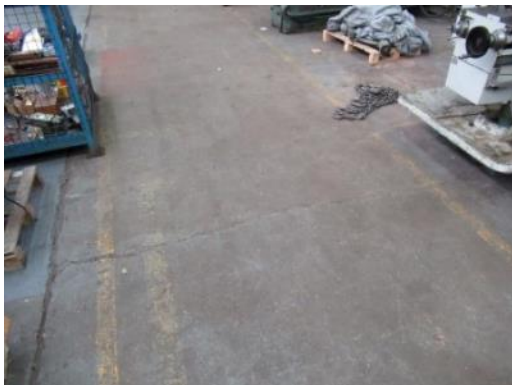
The concrete floor to the warehouse area generally appears to be in satisfactory condition with no significant defects noted however the painted finishes are generally deteriorated throughout and are in need of redecoration.

Where areas of cracking are present to the floor they do not appear to be significant however would benefit from repair as part of the redecoration works.

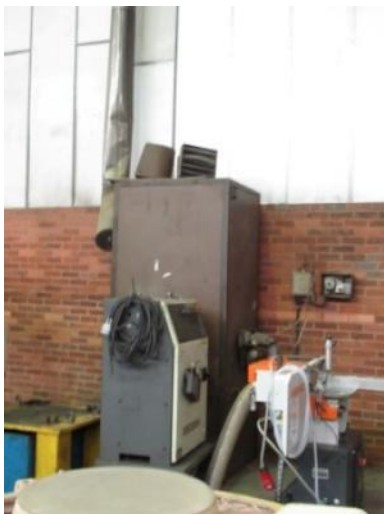
Two gas fired warm air heaters are present to the right hand side of the warehouse area however these appear to be redundant.

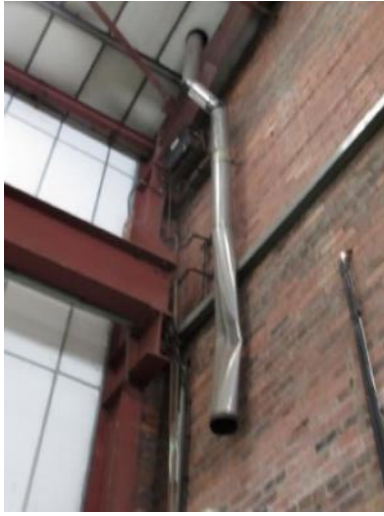
Where a redundant flue is present to the front right hand corner of the warehouse this would benefit from removal with the ceiling and roof where the flue penetrates suitably capped and repaired.

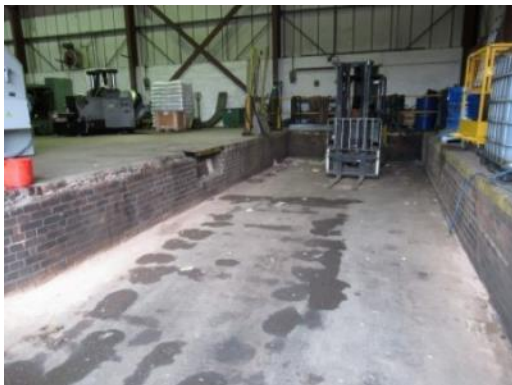
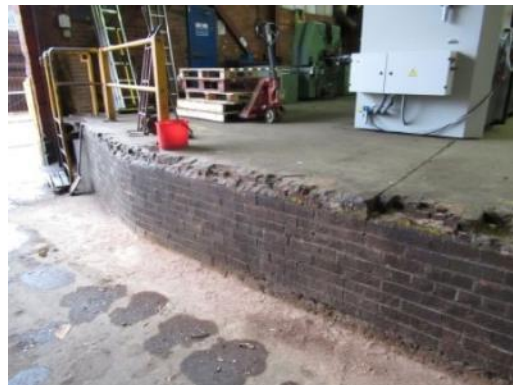
A loading bay area is present to the rear of the warehouse at a lower level than the main warehouse floor. The loading bay generally appears to be in satisfactory condition however where brickwork is damaged to its perimeter it would benefit from repair.

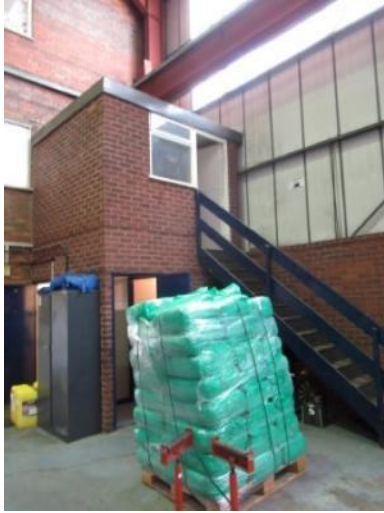
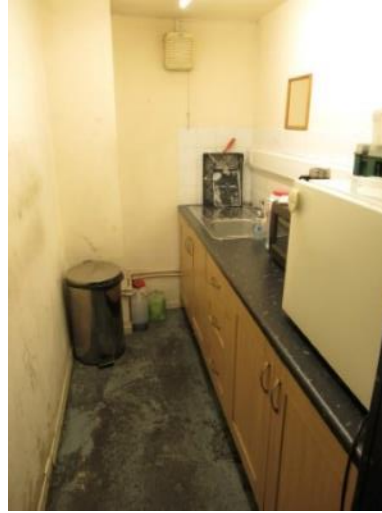
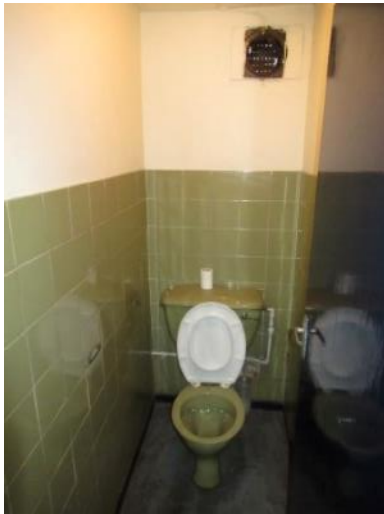
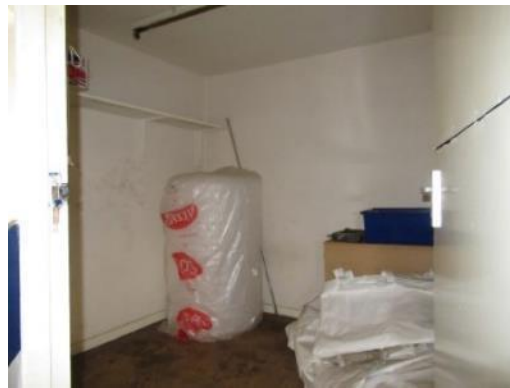
A two storey brickwork block is present to the front left hand corner of the warehouse and houses a small office at first floor level with kitchenette and WC at ground floor level.

Internal areas of the block comprise of painted plastered ceilings with painted plastered walls incorporating ceramic tiling to the kitchen and WC area, gloss painted internal joinery and external doors and a combination of painted concrete and vinyl tile floor covering. The areas generally appear to be in satisfactory condition however would benefit from refurbishment in the short term.

The mechanical extractor fan to the WC area has been removed and requires replacement. The entrance door to the WC area is also damaged and requires replacement.

Where damage is present to the plastic sealant within the kitchen this does not appear to be significant however requires repair.

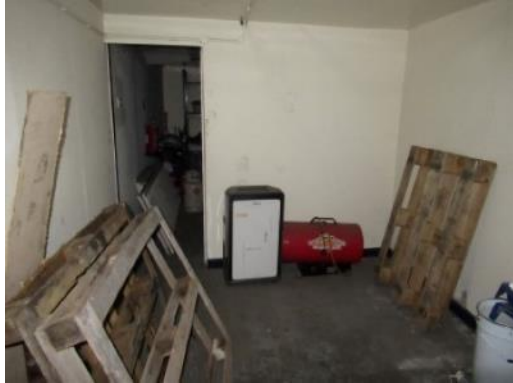
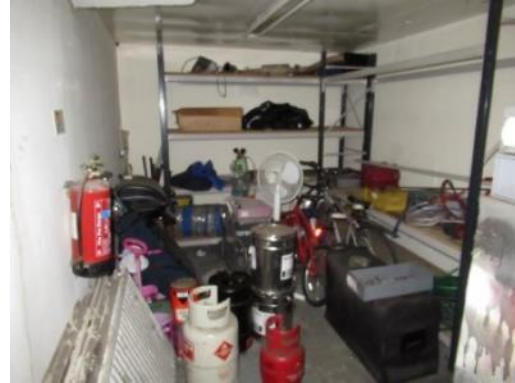
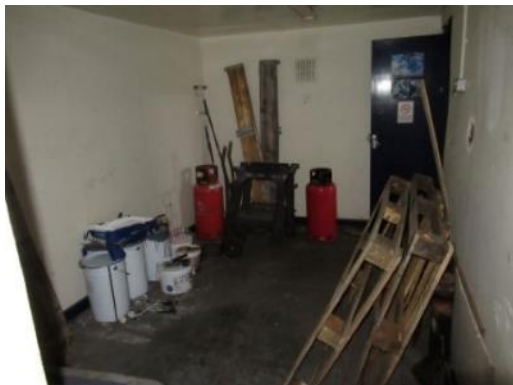
Store Room

A store area is present to the rear left hand side of the warehouse which is located within the single storey brick extension constructed between the left hand elevation of Unit 4 and the right hand elevation of Unit 3. The store room area comprises of painted plastered ceilings with painted plastered walls, gloss painted internal door and internal doors and a painted concrete floor. The store room area generally appears to be in satisfactory condition with no significant defects noted. However the area would benefit from redecoration including decoration of the floor in the short term.
