# Building Inspection Report

XXXX

Report date XXXX 2022

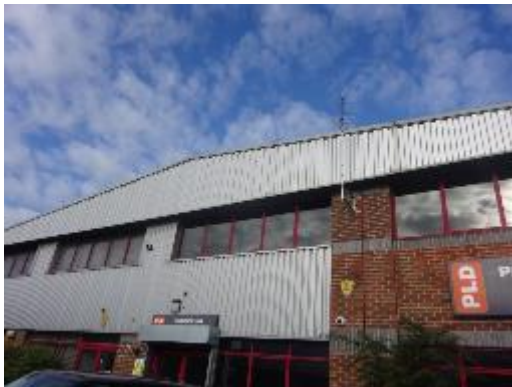
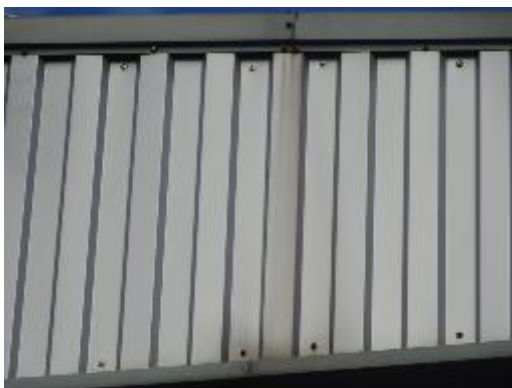
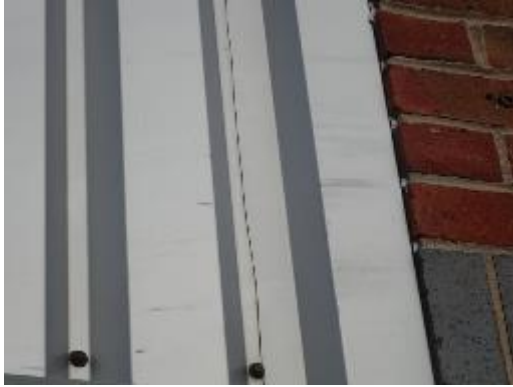
Cladded sections are provided via built-up detailing in section and presented in a visually reasonable state of repair and condition. Minor surface soiling could be seen in isolated locations from assessment where fixing bolts have deteriorated above. Surfaces have isolated scuffs and subsequent marks, but overall present well. Isolated openings from former fixings and fittings can be seen, of which we would recommend are infilled to prevent water ingress and subsequent internal disrepair.

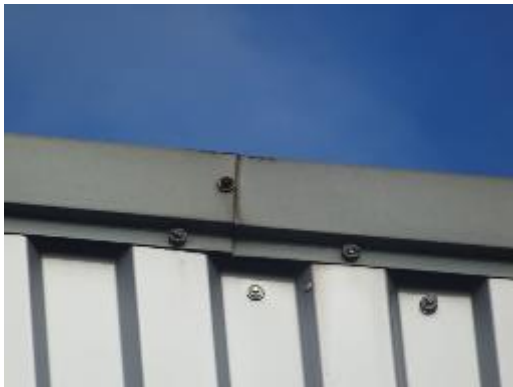
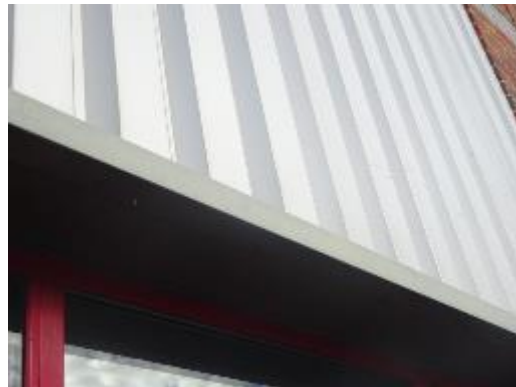
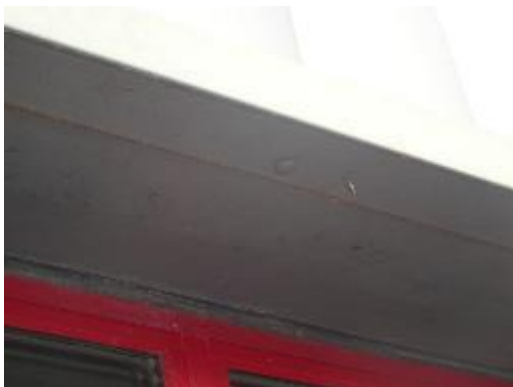
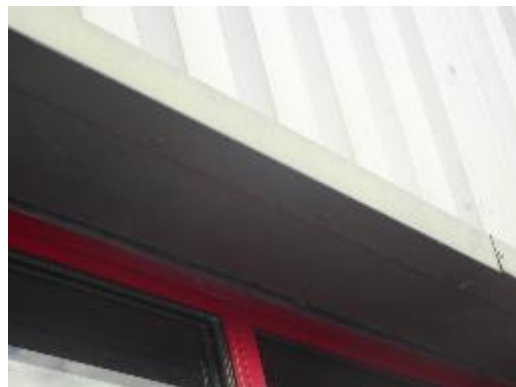
Perimeter trim details to the cladding isolated discoloration and associated soiling as a result of deteriorated fixing screws and bolts. We would recommend that fixing bolts that have deteriorated as replaced in the short term and the trim details are prepared and treated in the short to medium term.

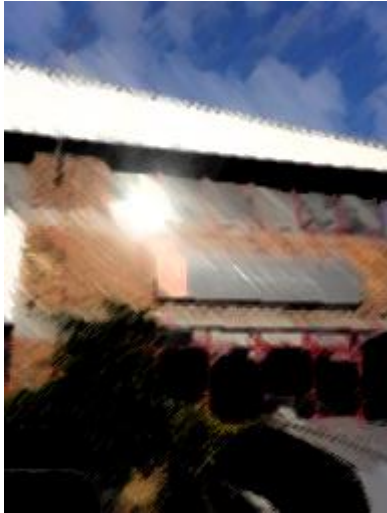
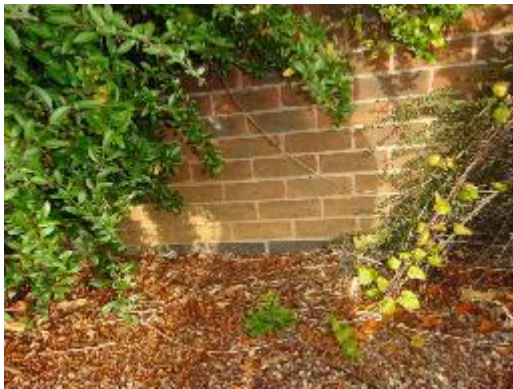
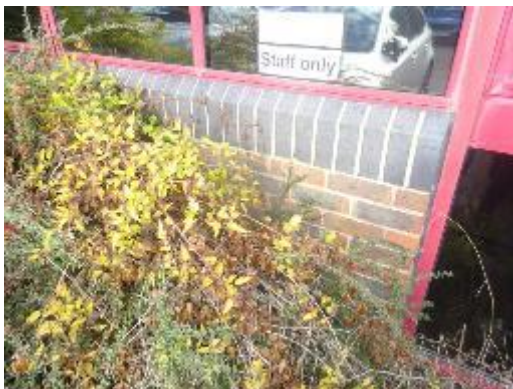
The main walls to the front elevation are provided via cavity wall construction, of which visibility was limited in isolated locations to low level vegetation. Where visible, main walls presented in a good state of repair and condition. No visible areas of deterioration, cracking or impact damage could be seen to the masonry.

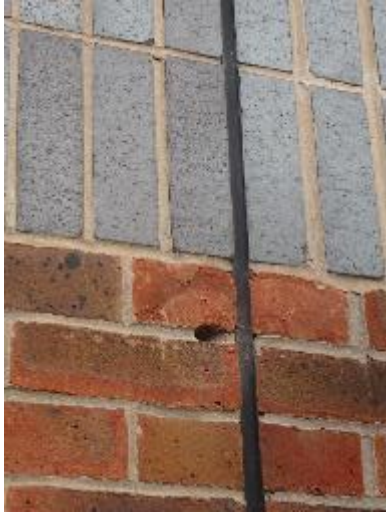
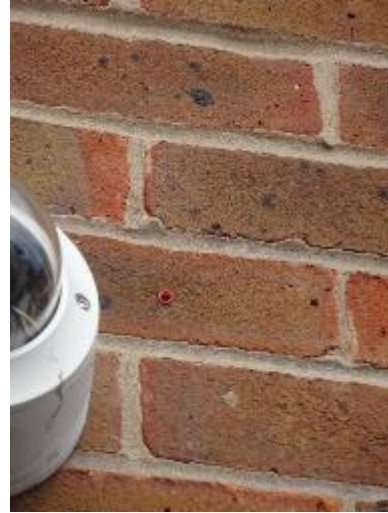
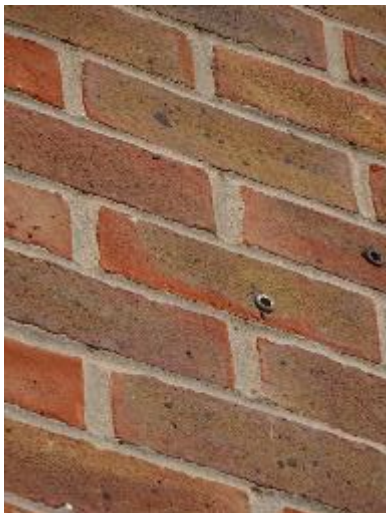
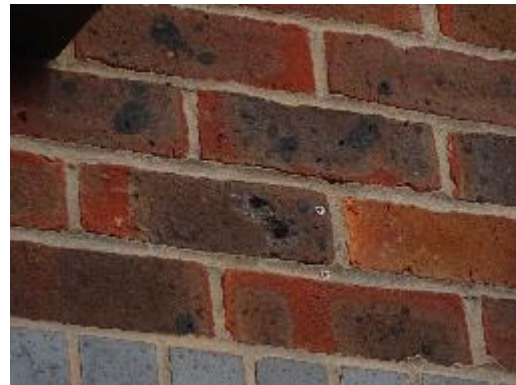
Isolated fixing screws and associated rawl plugs can be seen in isolated locations from former fixtures and fittings. We would recommend that these are removed and infilled to ensure that the accelerated deterioration/expedited deterioration of associated mortar joints and masonry does not occur.

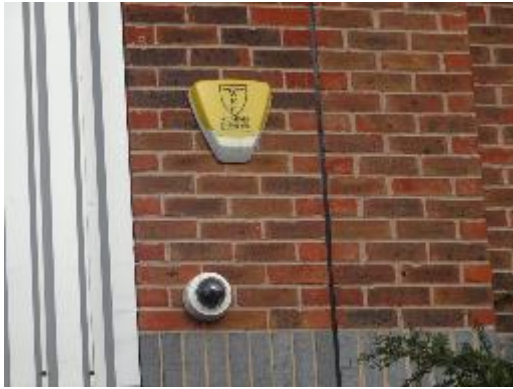
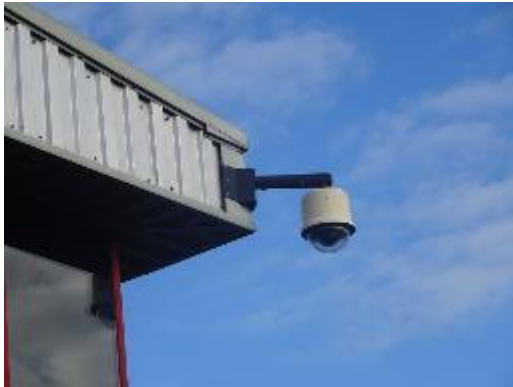
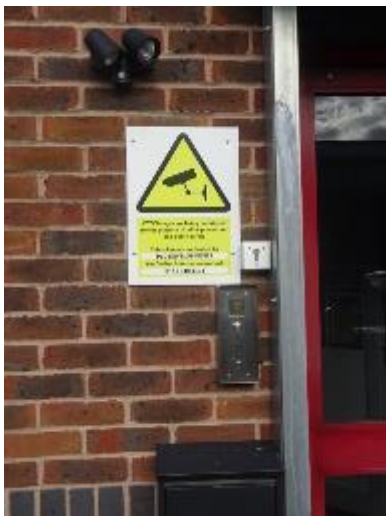
A number of fixtures and fittings can be seen to the front elevation in the form of CCTV, spot lights, alarm systems and control panels. Visually, these fixtures and fittings presented in a satisfactory visual state of repair and condition. We would however recommend that maintenance certification is provided for the fittings to ensure that systems fully functional and in repair.

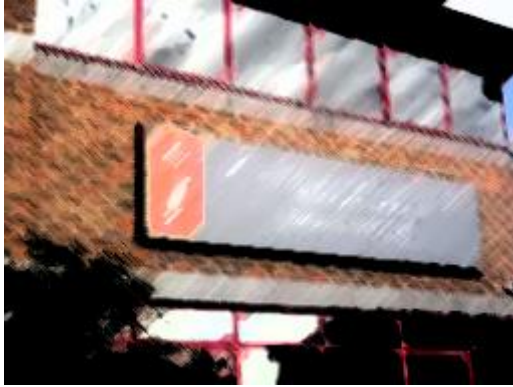
Tenants' signage to the front elevation can be seen above the main pedestrian door and to the right-hand side of the front elevation above the glazing. Visually these present in a good state of repair and condition.

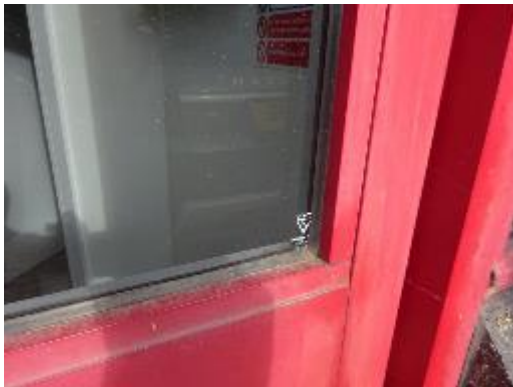
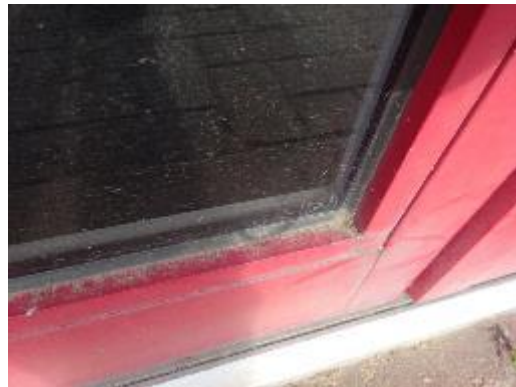
Doors to the front elevation are provided via powder factory coated metal doors with single glazed impact safety sheets. However, BS 6206 was withdrawn in 2006 and superseded by BS EN 12600 which are a more modern gauge on the impact break safe levels.

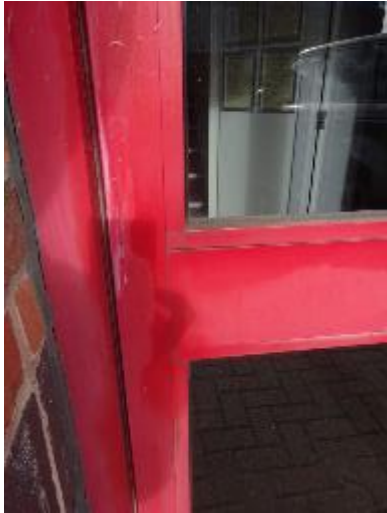
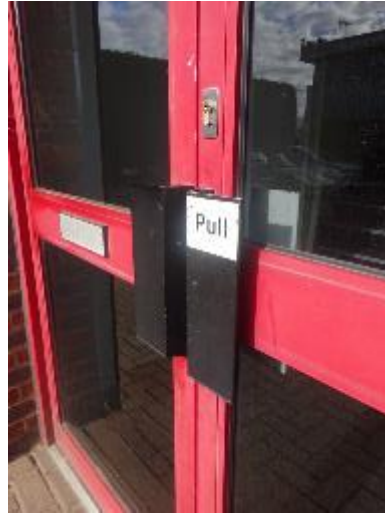
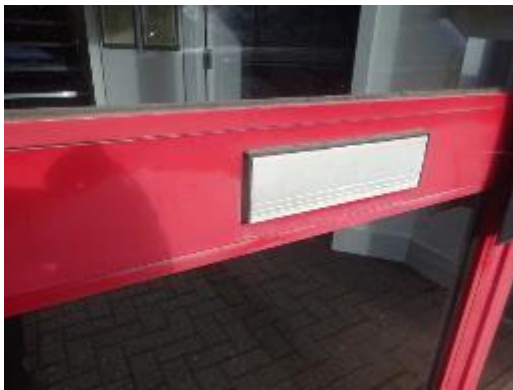
Powder coated finishes presented solar degraded and discoloured. It should be noted that scuffs and minor wear can be seen to push plates and handles. No impact damage or deterioration was noted to the door, although we recommend that decorations are undertaken in the short term to further protect the sub-metals behind.

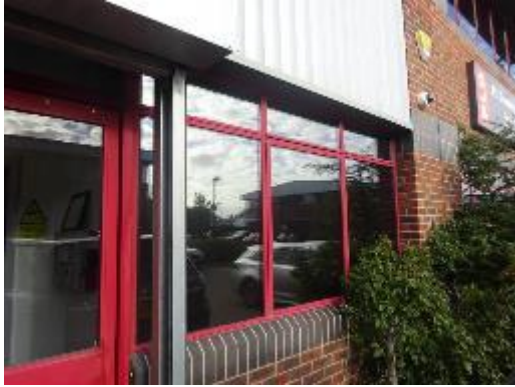
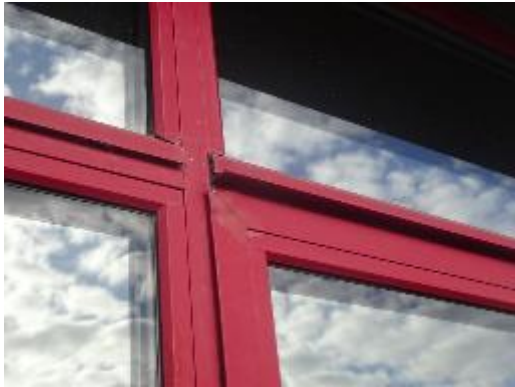
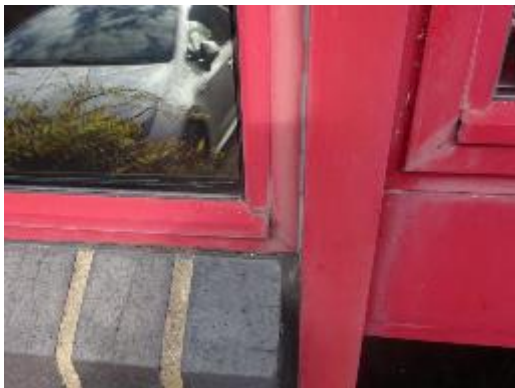
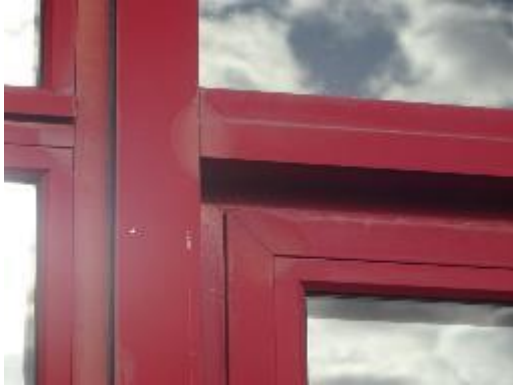
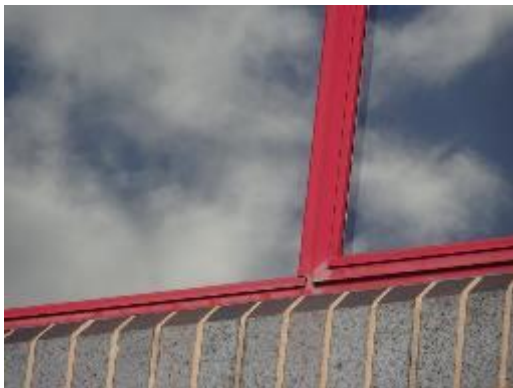
Glazing to the front elevation is provided via powder coated metal frames with double-glazed units which visually presented in a fair state of repair and condition. It was noted that the frames are solar degraded and soiling/discolouration can be seen. Window panes are provided via double-glazing, although were not able to identify any kite marks. Solar reflective and privacy film have been utilised internally to the window units, of which present in a satisfactory state of repair and condition. We would recommend that the glazing is thoroughly prepared and formally decorated with factory finished coatings restored in the short to medium term to ensure that the sub-metals behind remain in good repair and condition.

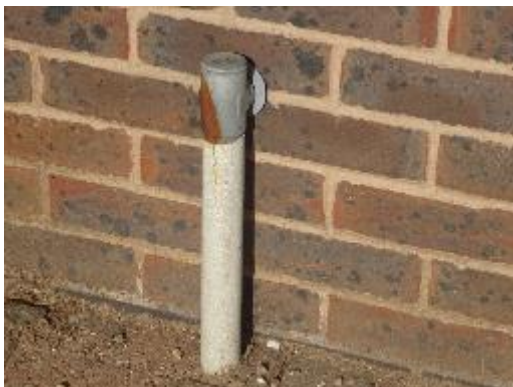
The incoming gas to the front elevation presented in a good state of visual repair and condition. It was however noted internally that the gas installation has been capped. We would recommend that if this is to be utilised, Gas Safe Certificates provided.

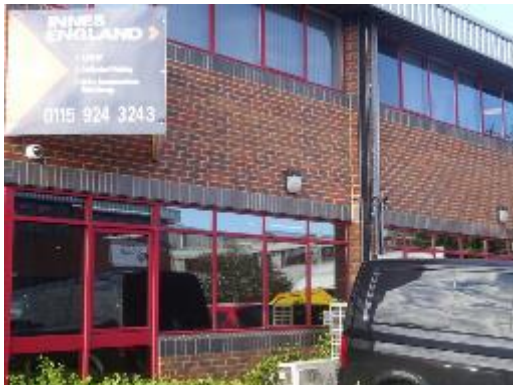
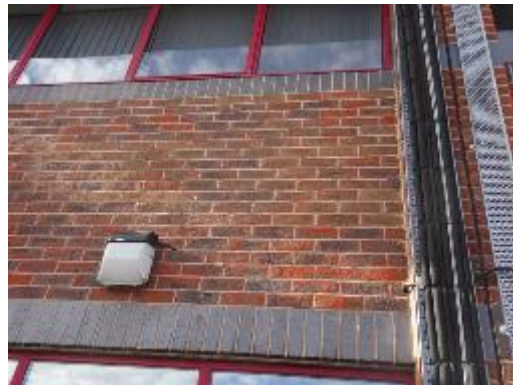
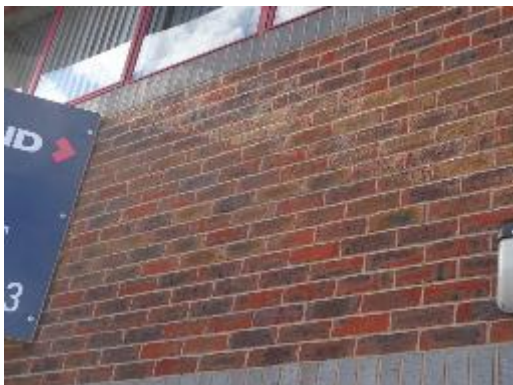
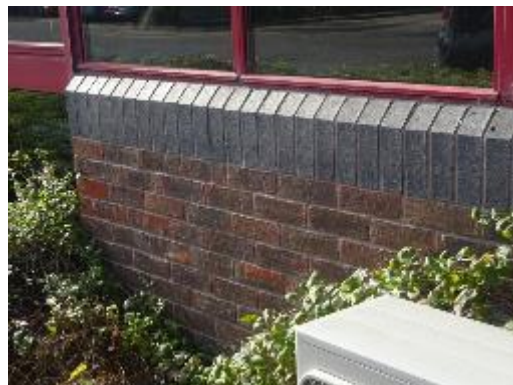
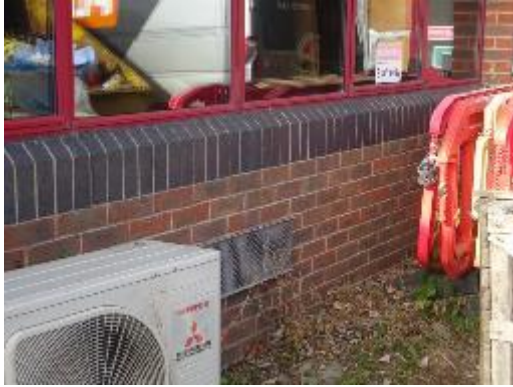
The main walls to the right elevation are provided via cavity wall construction, of which visibility was limited in isolated locations to tenants' fixtures and fittings to include the condenser unit. Where visible, main walls presented in a good state of repair and condition. No visible areas of deterioration, cracking or impact damage could be seen to the masonry.

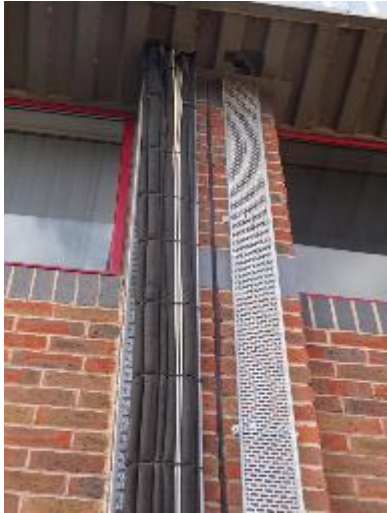
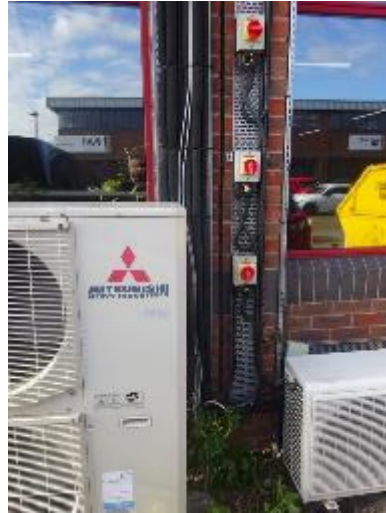
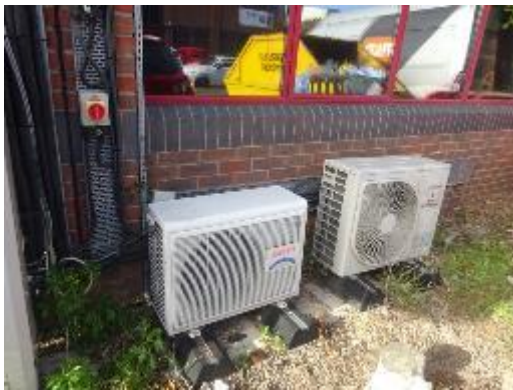
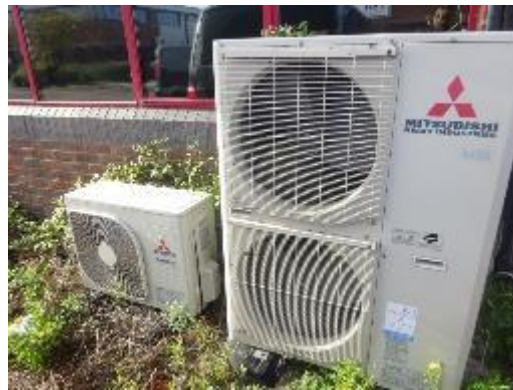
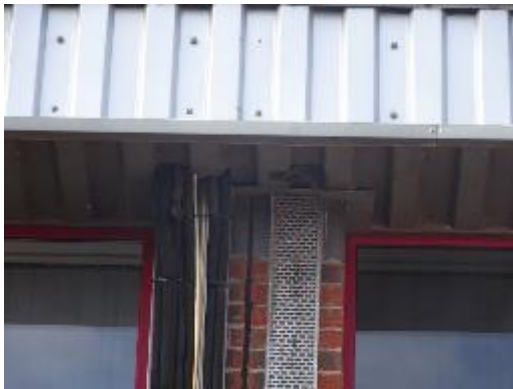
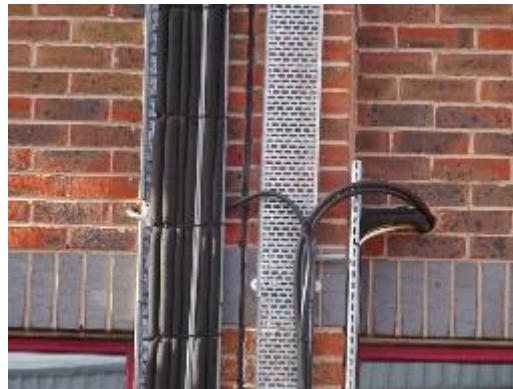
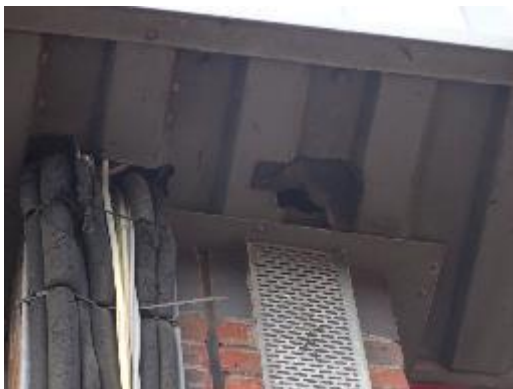
Fixtures and fittings tenant installed condenser units could be seen to the right-side elevation. Piping and associated cables have been routed through both the masonry and the associated soffit detail. Overall, although penetrations in isolated locations can be seen to be rough edged, some localised repairs undertaken from former pipe runs, the associated penetrations present in a satisfactory state, although we would recommend that a permanent localised repair is undertaken for any capped off sources. We would recommend that maintenance Certificates are provided for the air conditioning units and associated condensers to ensure that fixtures and gases contained are compliant, and that the systems are fully functional and operational.

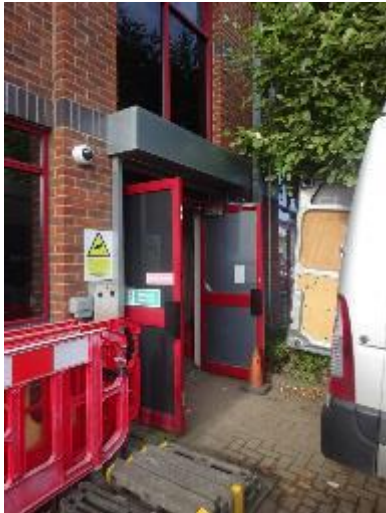
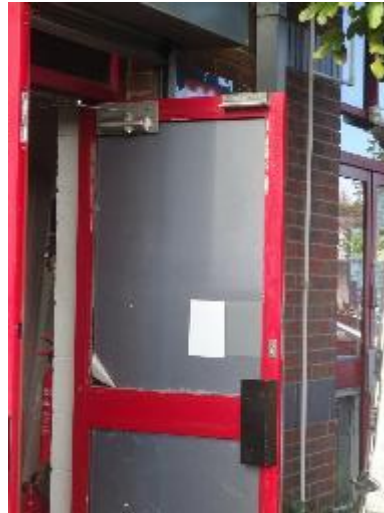
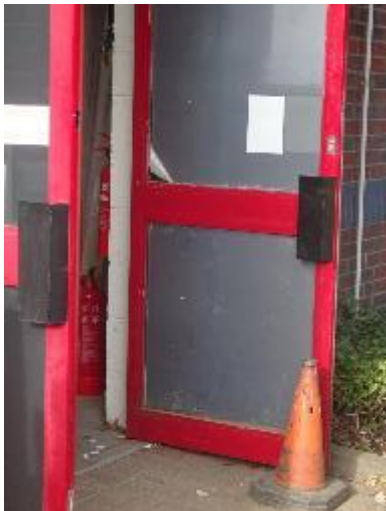
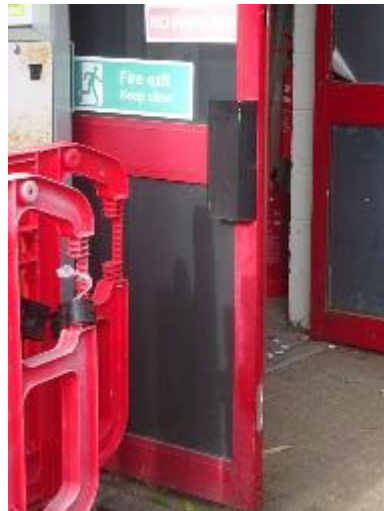
**Main Doors**

The main doors to the right-side elevation were limited in visibility on the day of the inspection due to tenant operations, although where noted, finishes presented scuffed and soiled. It was noted that the door was operated on a magnetic security system which visually presented in a reasonable state of repair and condition. Solar/security film installed to the internal glazing presented delaminated, scuffed and marked. Further noted that surface finishes to the metal frames were solar degraded.

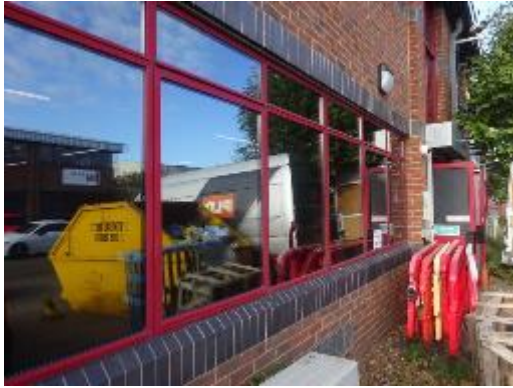
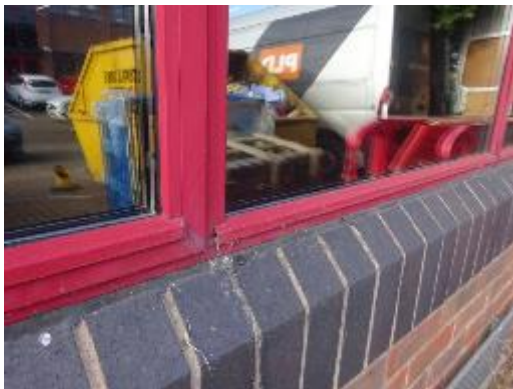
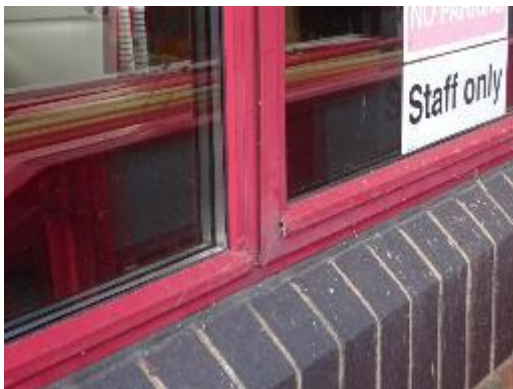
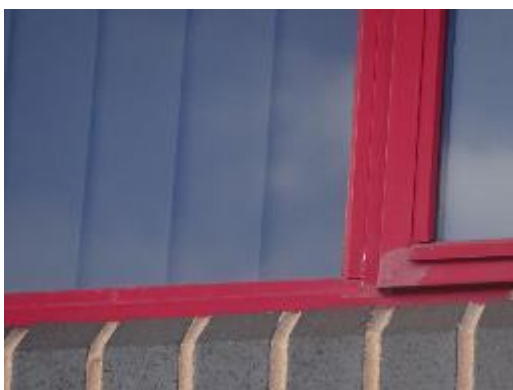
### Glazing

Glazing to the right elevation is provided via powder coated metal frames with double-glazed units which visually presented in a fair state of repair and condition. It was noted that the frames are solar degraded and soiling/discolouration can be seen. Window panes are provided via double-glazing, although were not able to identify any kite marks. Solar reflective and privacy film have been utilised internally to the window units, of which present in a good state of repair and condition. We would recommend that the glazing is thoroughly prepared and

formally decorated with factory finished coatings restored to ensure that the sub-metals behind remain in good repair and condition.

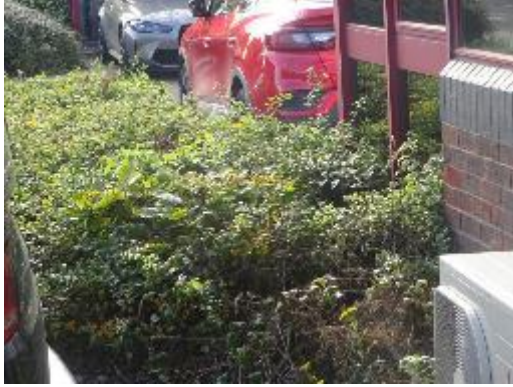
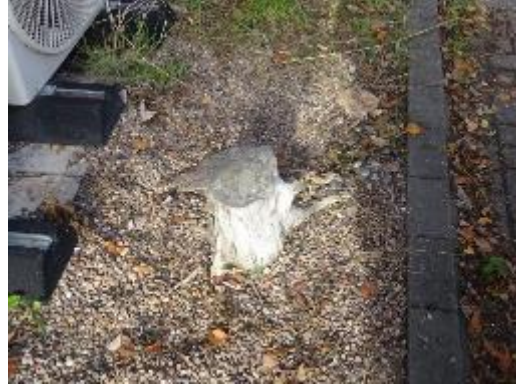
Low-level shrubbery and vegetation could be seen to the right-side elevation. We do not believe this to contain any invasive plant species which will materially affect the integrity of the building. We did however note a metre from the building former mature vegetation which has been cut back. Again, no structural cracking resultant of the vegetation or roots can be seen.

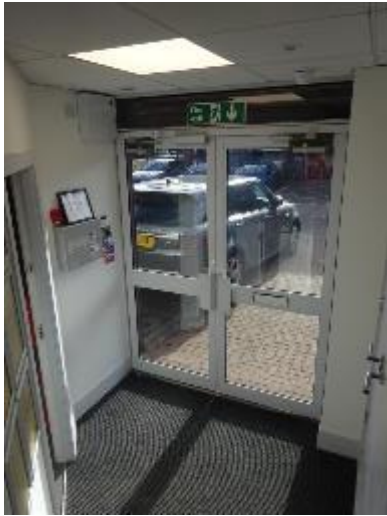
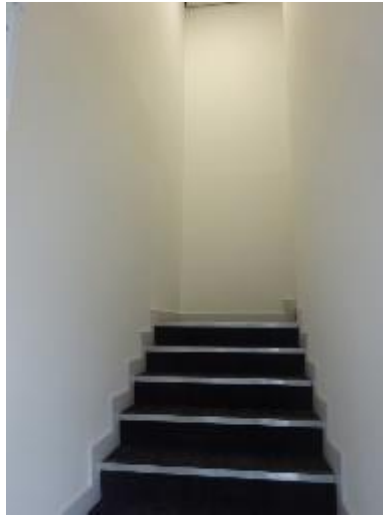
#### Lobby/Stairwell Area

Ceilings throughout the lobby and stairwell area are provided by 600x600 mineral fibre suspended ceiling tile finish incorporate inlaid LED lighting. Visually tiles are presented in a satisfactory condition, although minor scuffs and blemishes could be seen. LED lighting presented well and was operated on PIR sensors. Emergency lighting could also be seen installed inlaid to the suspended grid.

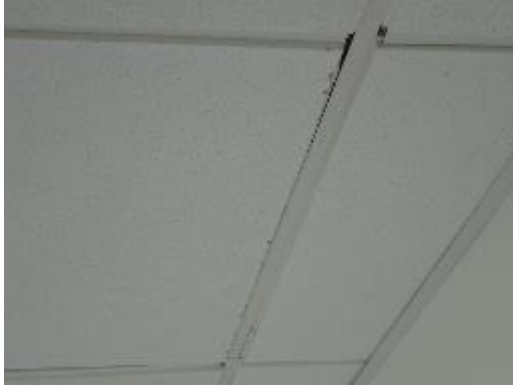
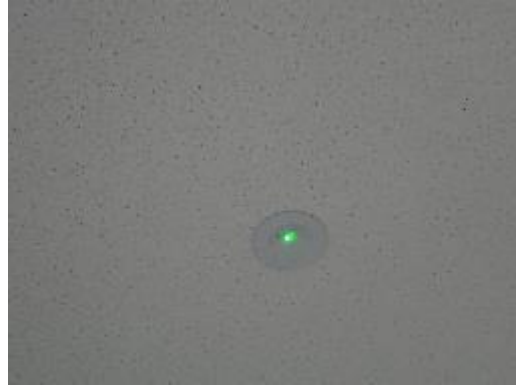
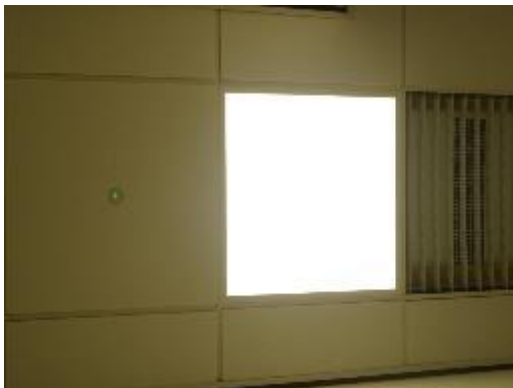
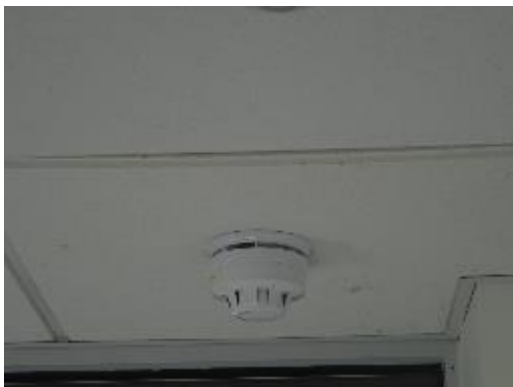
Fire detection systems can be seen incorporated within the suspended ceiling grid and visually presents in a good state of repair and condition; however, we would recommend that fire risk assessments and maintenance Certification is provided to ensure that these are ample and suitable.

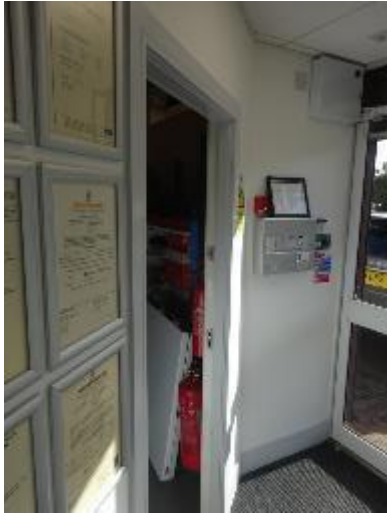
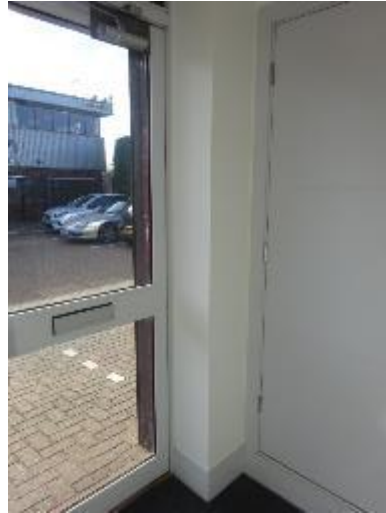
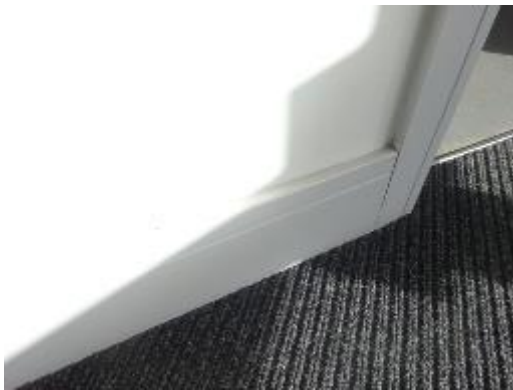
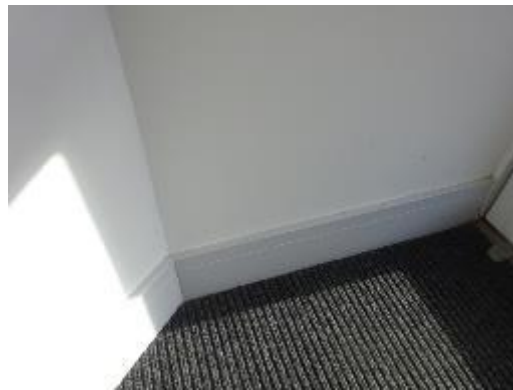
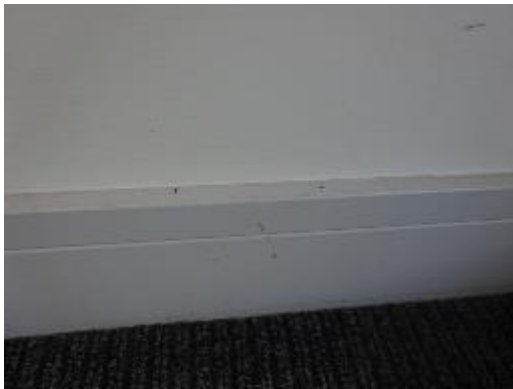
The main walls are provided via a combination of painted plaster to solid masonry and stud partition with low-level painted timber skirting details, of which presented in a satisfactory state of repair and condition. There is some minor surface soiling and scuffs can be seen in isolated locations.

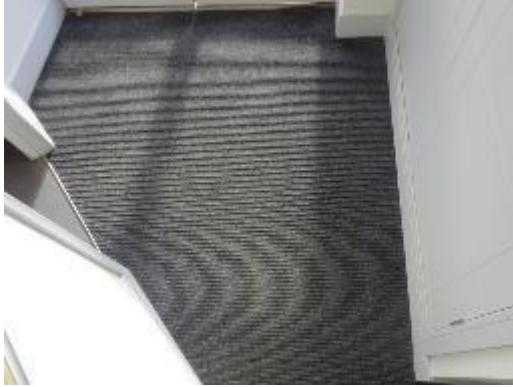
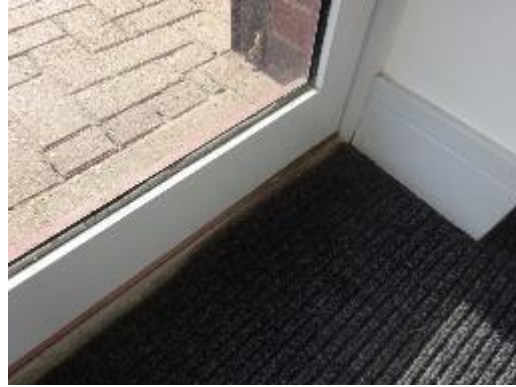
The floor is provided via solid concrete finish with wearing corduroy barrier matting, of which presented in a satisfactory state of repair and condition. There is some minor surface soiling and wear which can be seen. Additionally noted that to the perimeter, edges are slightly frayed and lack adhesion. We would recommend that this is re-adhered to the floor structure to ensure that the expediated deterioration breakdown of the matting does not occur.

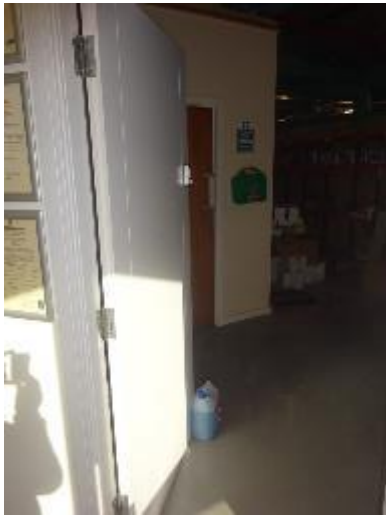
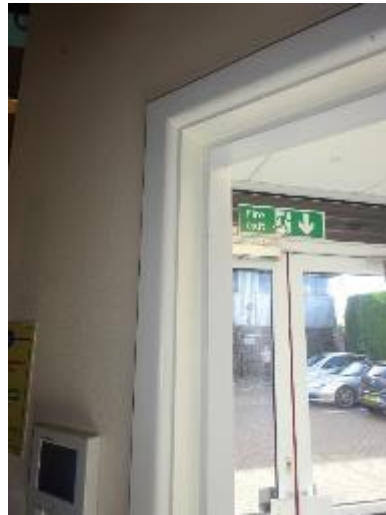
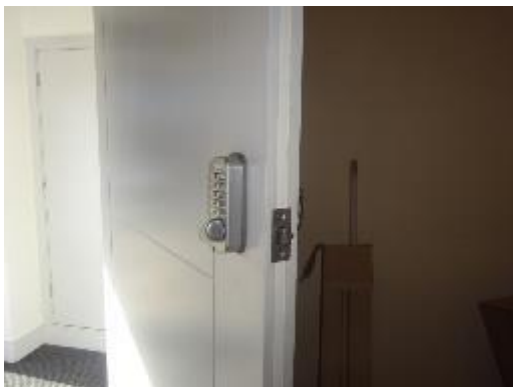
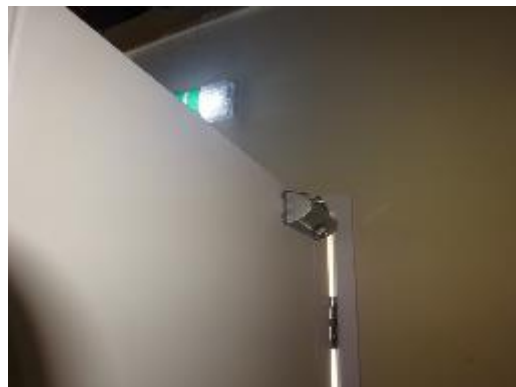
The door from the lobby into the storage facility area is provided via painted timber door which incorporates door closures and recessed intumescent strip seals to the door. The door incorporates digilock which again presented in a satisfactory state of repair and condition.

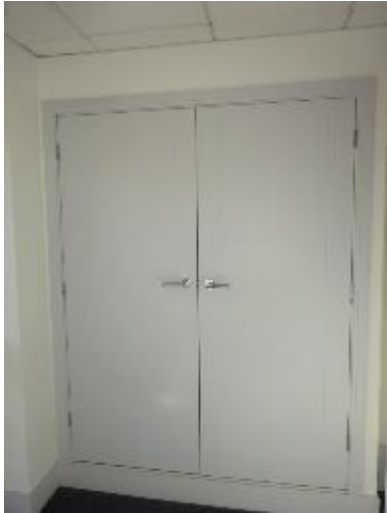
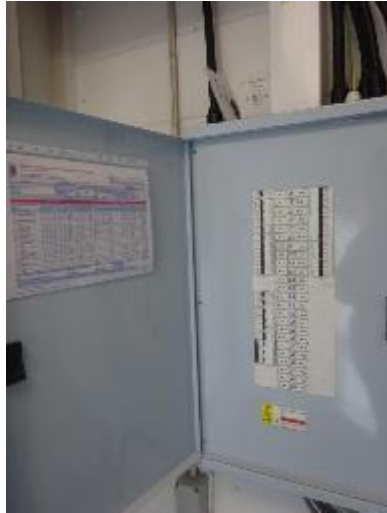
A service cupboard is provided via timber formed enclosure with timber doors of which presented in a good state of repair and condition. Masonry to the rear of the fittings presented in a good state of repair, albeit some minor surface soiling. Incoming three phase power and capped gas supply could be seen. Although installations and fittings can be seen visually in a good state of repair, we recommend that full test and maintenance Certificates are provided.

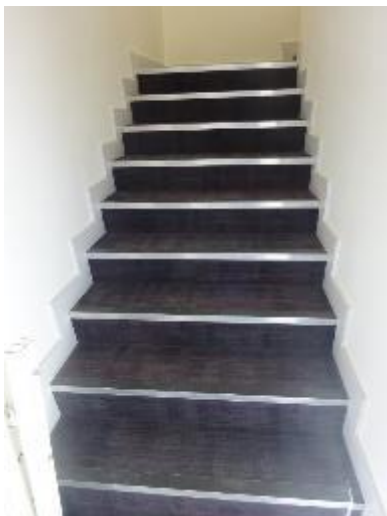
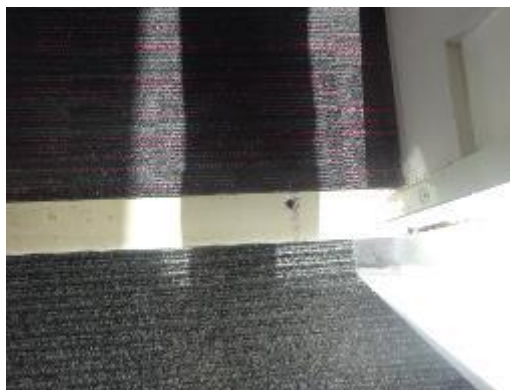
Steps from the lobby to the first-floor office area are provided via solid concrete steps with carpet tile finishes. Visually the carpet tiles presented surface soiled and stained with some isolated scuffs to the nosings and former fixing openings. We would recommend that the carpet is replaced in the medium term, the nosings are thoroughly deep cleaned with isolated infill to the former opening.

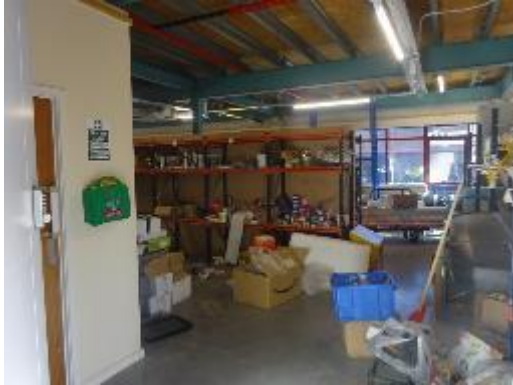
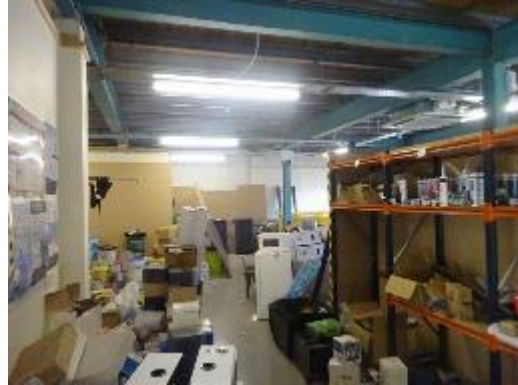
### Ground Floor Storage Area

The ceilings are provided via the first-floor floor structure which is provided via timber boarding. Visually timber boards present in a good state of repair and condition. We are however unable to confirm the fire resistance of the boarding used. Though, it is unlikely this provides any resistance, as the above is utilised as a separate space, compartment floors are required to provide a degree of fire resistance of minimum 30min. No fire barrier or separation can be seen throughout and would not meet current day statutory compliance. We would highly recommend a fire risk assessment.

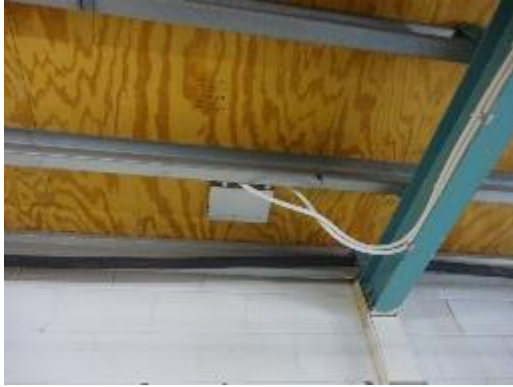
It was noted that the floor boards have a number of electrical installations which serve the first-floor office area to include floor boxes and service cabling. Where seen, service cabling could be seen suspended or fixed on associated cable trays. Visually these presented in a reasonable visual state of repair and condition, although again, we would advise that electrical test certificates are undertaken.

Fire risk assessment should be provided to confirm that the timber boarding is suitable in its current condition without any application/provisions for fire rating and service penetrations are appropriate without duct sleeves or fire collars.

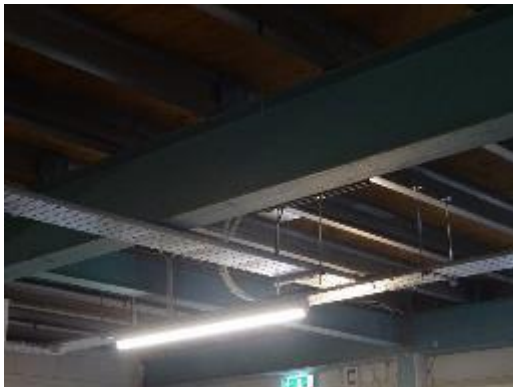
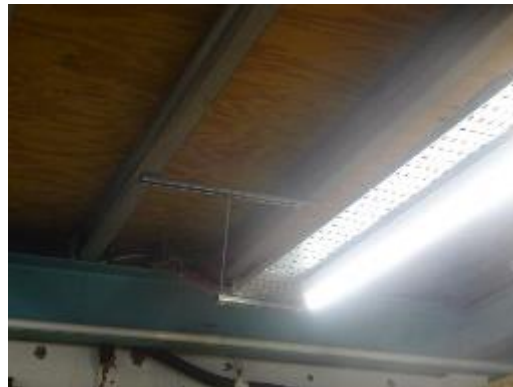
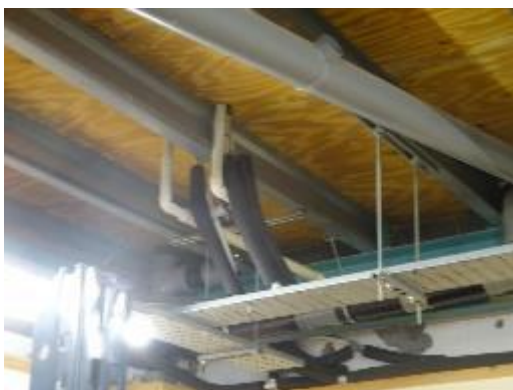
Suspended cable trays incorporates LED light strips, CCTV and air conditioning units. Visually these installations presented in a good state of repair and condition, although again we would advise that maintenance Certification is provided for the AC and CCTV to ensure that these are fully operational and functional. Lighting throughout was fully functional.

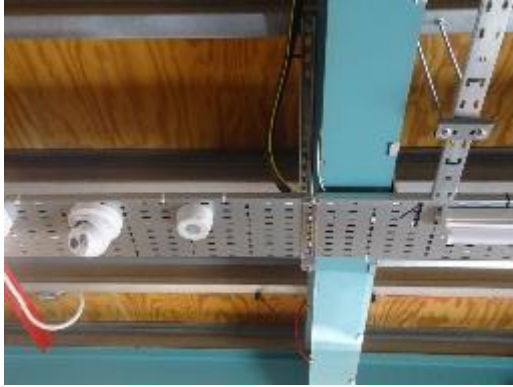
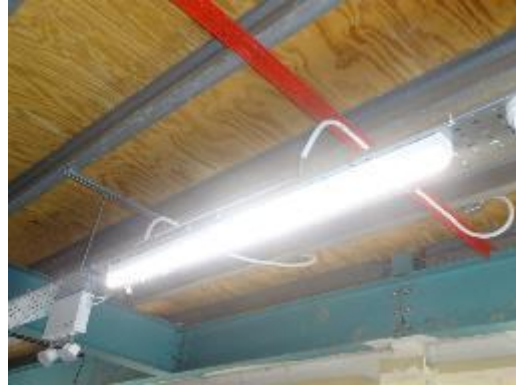
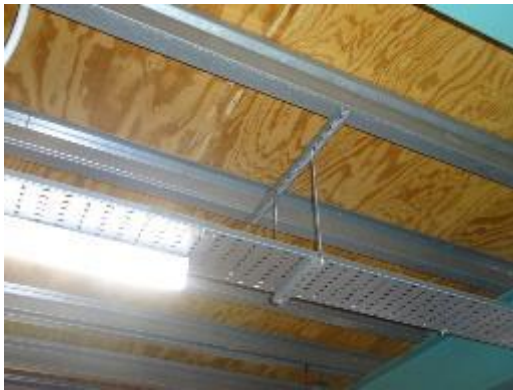
Structural steels presented in a satisfactory state or repair and condition, although isolated surface soiling and surface corrosion could be seen. Though from visual assessment, these do not appear to have any effect on the structural integrity of the building.

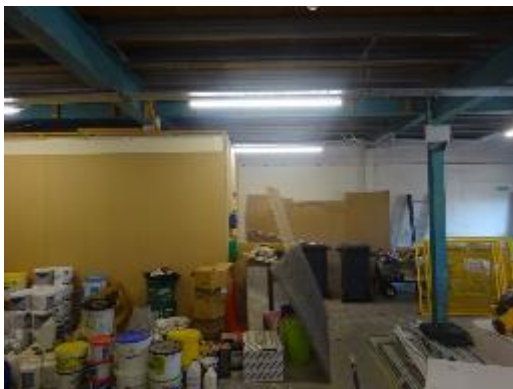
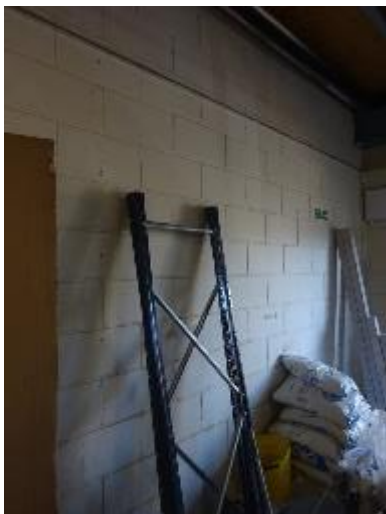
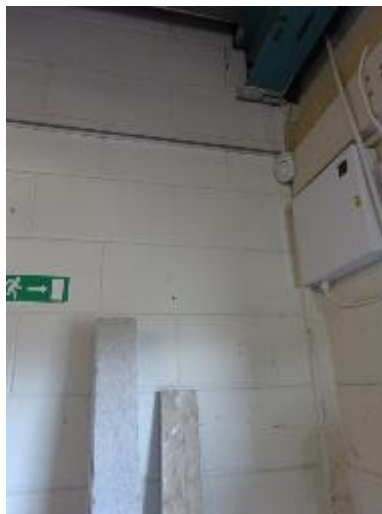
### Internal Rear Elevation

The rear wall within the store is provided via solid blockwork with paint finish. It was noted that some former openings and fixings which have disturbed the finishes were visible to the upper section. Minor hairline step cracking could be seen around the structural steel to the right side. Surfaces presented soiled and stained with some impact damage, scuffs and blemishes, although no water ingress or deterioration can be seen.

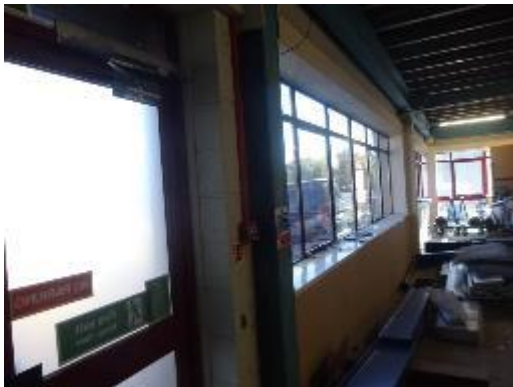
#### Internal Right-Side Elevation

Visibility and access to the right- side internally was limited by tenants' operations on the date of the inspection. It was noted to the main walls at low-level that these were restricted in visibility by timber ply boarding. Where these have been utilised, no areas of water ingress can be seen. Upper section is painted masonry presented in a visually satisfactory state of repair and condition with some minor surface soiling and blemishes.

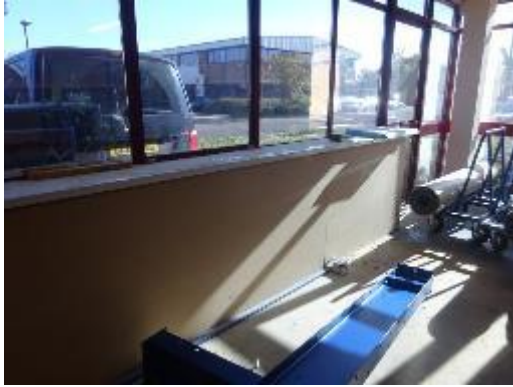
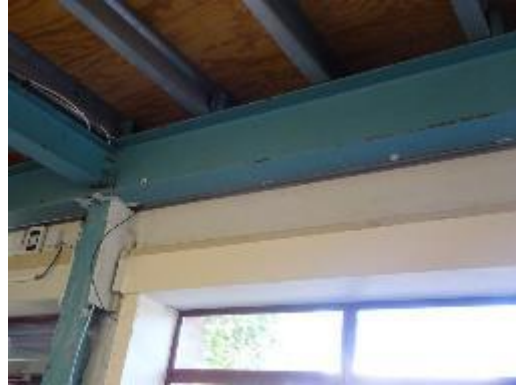
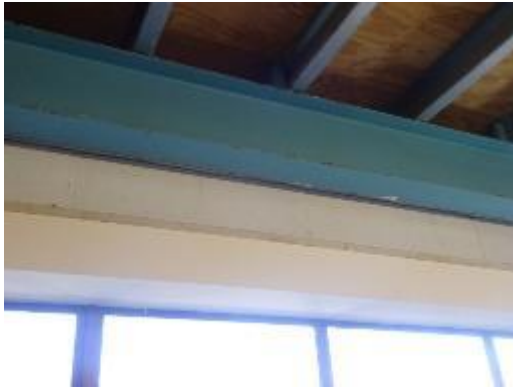
Openings formed for service pipes and cables although rough edged presented in a reasonable state of repair and condition.

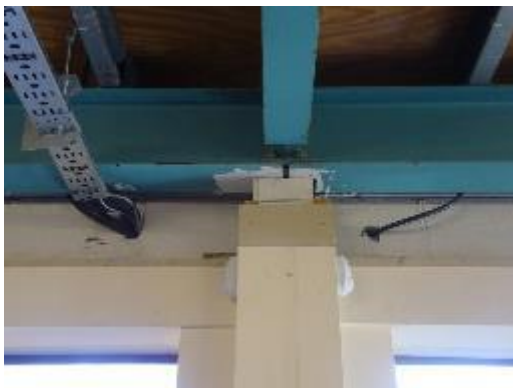
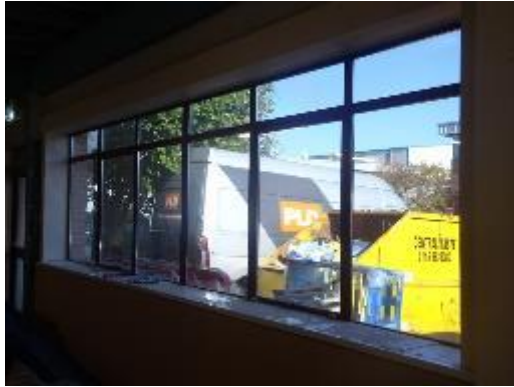
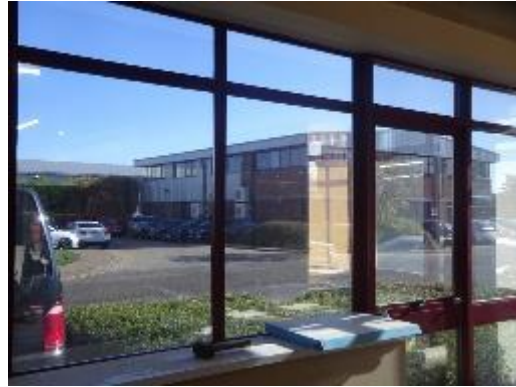
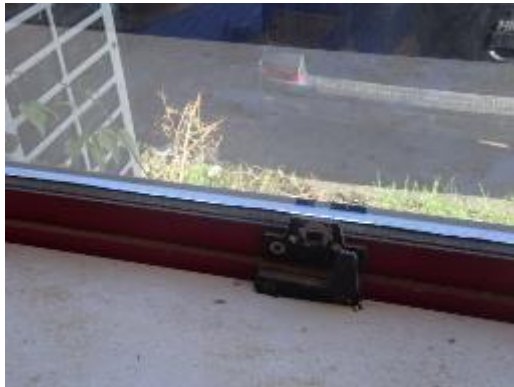
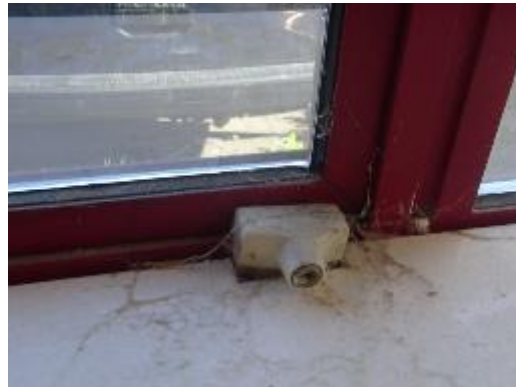
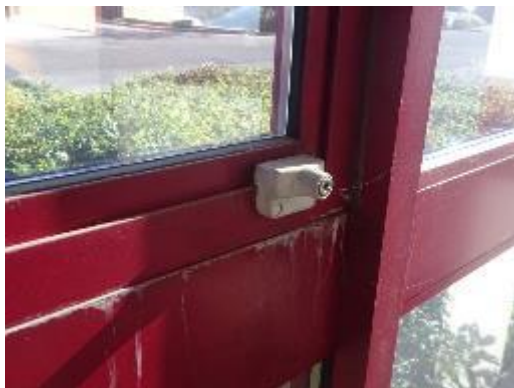
### **Windows**

Windows on the day of the inspection were not operational and could be seen in isolated locations with missing/damaged handles. Additional security mechanisms have been attached though dated, of which we would advise that all windows are overhauled, left fully functional, secure and operational.

Historic water staining can be seen in isolated locations although on the day of the inspection this does not appear to be on-going. Thorough preparation and redecoration should be undertaken to prevent the deterioration of the sub-metal frames.

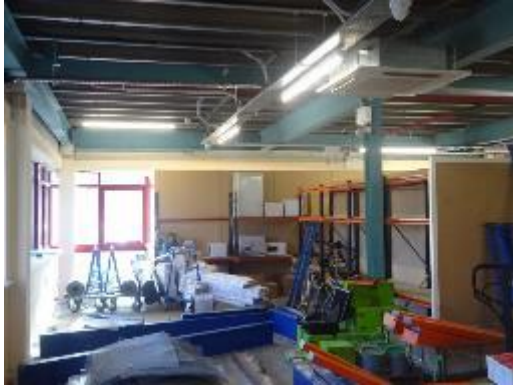
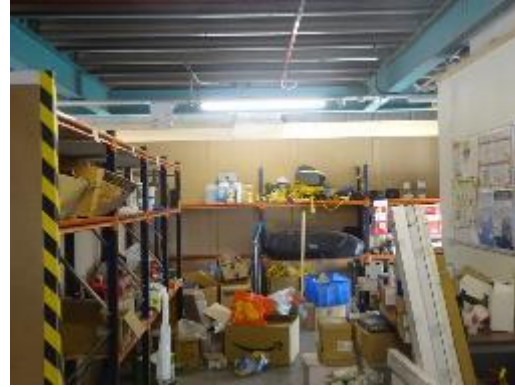
### Internal Front Elevation

Visibility and access to the front elevation internally was limited by fittings and tenants' operations on the date of the inspection. It was noted to the main walls at low-level that these were restricted in visibility by timber ply boarding. Where these have been utilised, no areas of water ingress can be seen. Upper section is painted masonry presented in a visually satisfactory state of repair and condition with some minor surface soiling and blemishes.

Plaster finishes to the window reveal serving the internal front elevation presented disturbed. We would recommend the necessary remedial works are undertaken to rectify.
