# Building Inspection Report

XXXX

Report date XXXX 2022

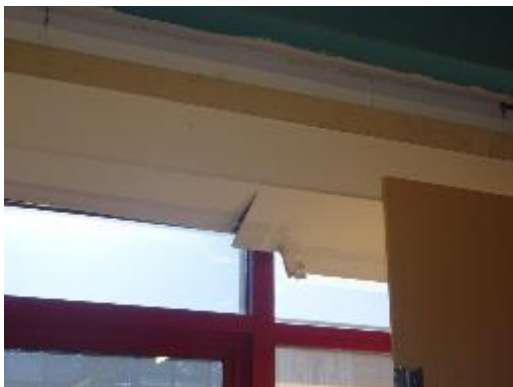
The front elevation internally was restricted by tenants racking fixtures and fittings. We would recommend that further inspection is undertaken if necessary, following the removal.

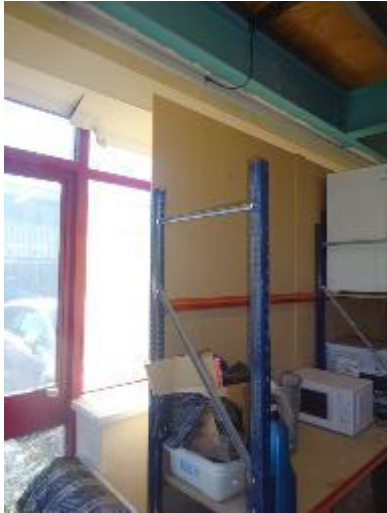
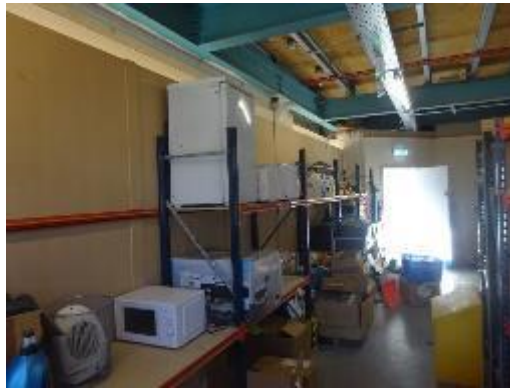
### Windows

Windows on the day of the inspection were not operational. Additional security mechanisms have been attached to the frames, of which we would advise that all windows are overhauled, left fully functional, secure and operational.

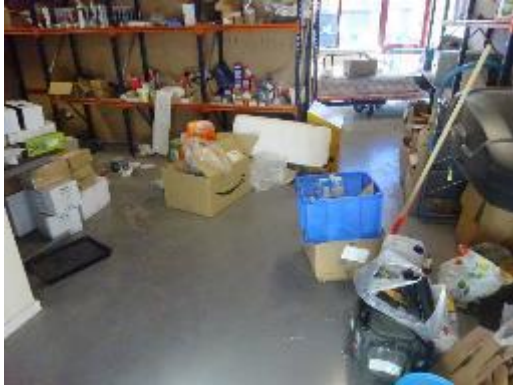
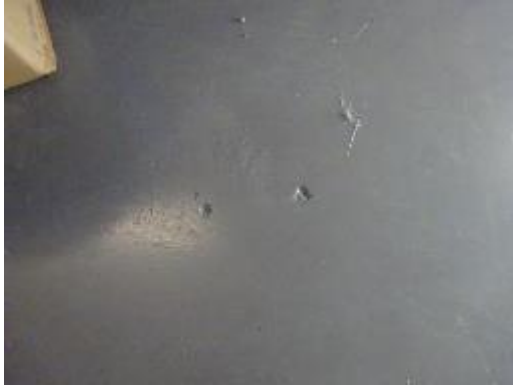
**Floor Structure**

Visibility of the floor structure and finish throughout were limited by tenants fixtures and fittings. Where visible, it was noted that the floor finish was provided via concrete slab with industrial paint application. Evidence of surface soiling, blemishes, scuffs and pitting/impact damage can be seen, although some localised remedial works have been undertaken. No significant areas of deterioration, cracking or failures in its integrity were noted, although we were visually limited to visibility throughout. Additionally note that during the inspection, racking systems were in the process of being removed and thus some fixing bolts were still in situ.

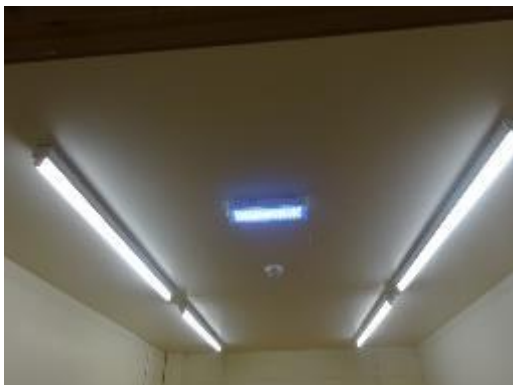
Ceilings are provided via painted timber, they visually presented in a reasonable state of repair and condition which integrated fire detection system, emergency lighting and four LED ceiling mounted strip lights. Visually finishes presented in a good state of repair and condition, although it was noted that no extract or natural air ventilation can be seen throughout.

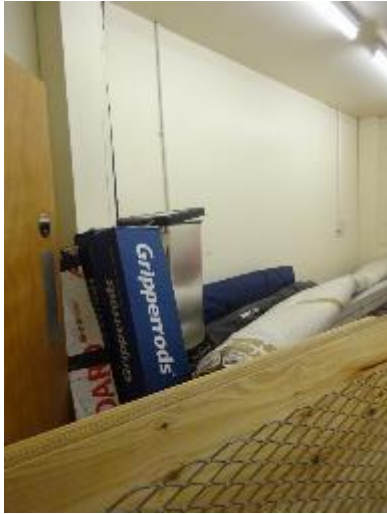
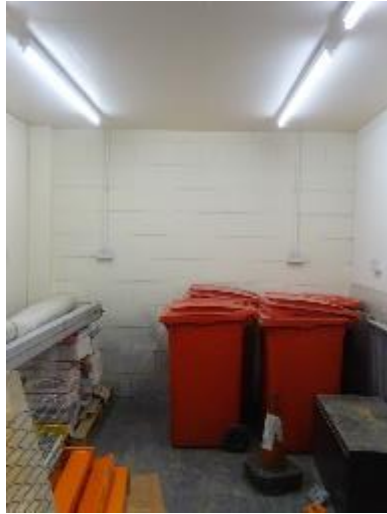
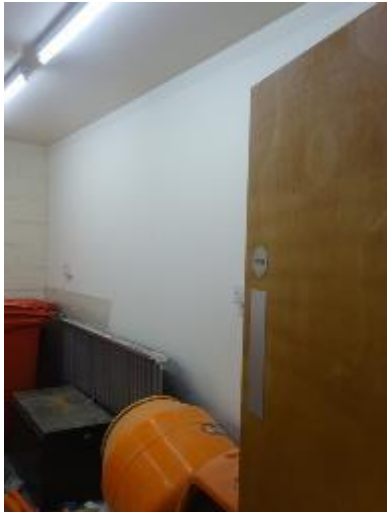
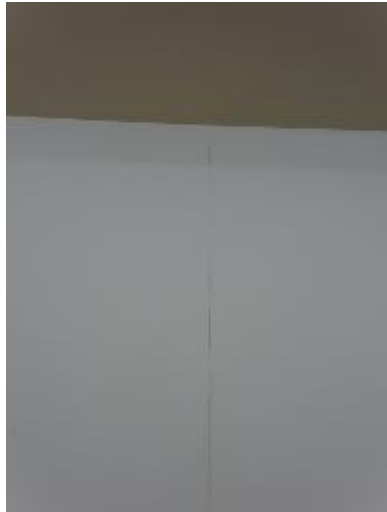
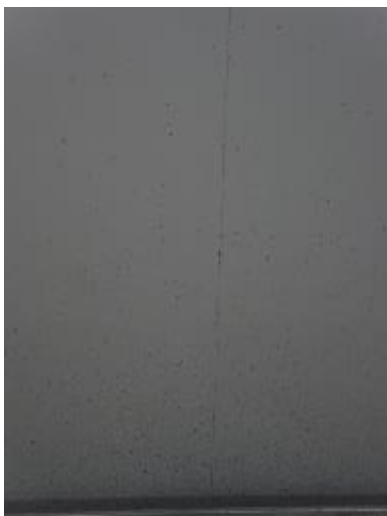
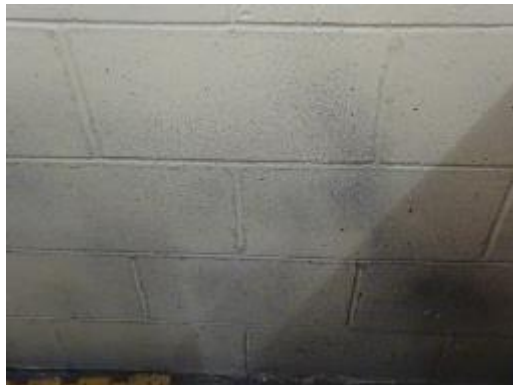
Visibility on the main walls was limited due to tenants' fixtures and fittings, although minor surface soiling, scuffs and blemishes were noted. No visible areas of water damage or failures

to the integrity of the structure were noted, although lateral hairline cracking can be seen which we anticipate is resultant of thermal expansion along joint lines.

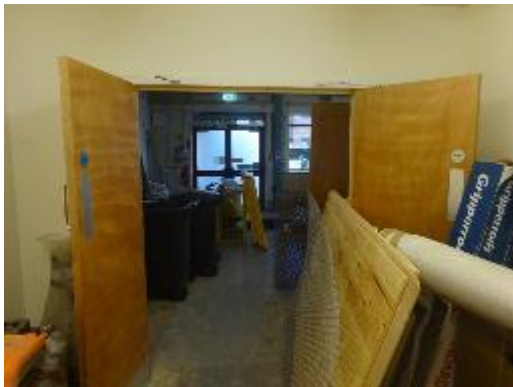
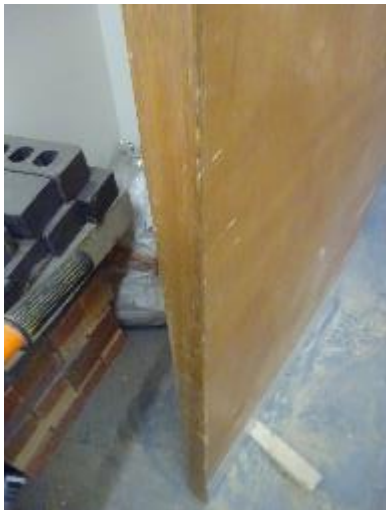
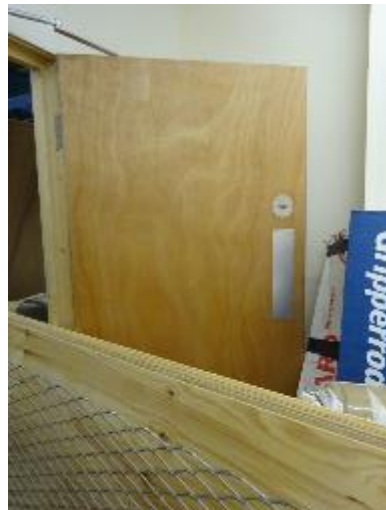
### Doors

Timber double doors are provided presented in a satisfactory state of repair, although blemishes, minor impact damage and scuffs were seen where visible, although visibility was limited again due to tenants' fixtures and fittings. No smoke strips or seals were noted to the doors.

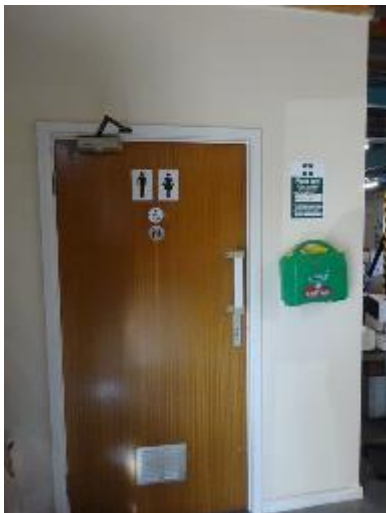
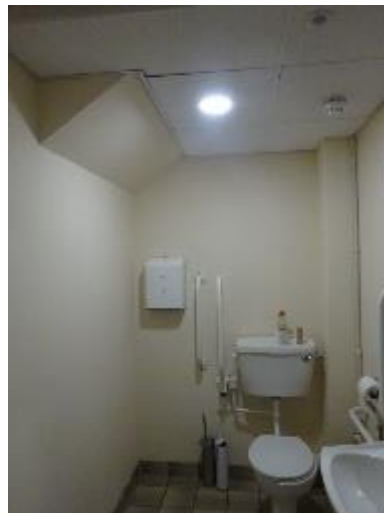
Ceiling provided to the disabled WC is provided via 600x600 mineral fibre suspended ceiling tiles with metal grid which incorporates smoke detection system in the inlay with LED lighting. Lights operated on a PIR sensor. Visually surfaces and installations presented in a reasonable state of repair and condition. It was noted above the suspended ceiling that no insulation is utilised.

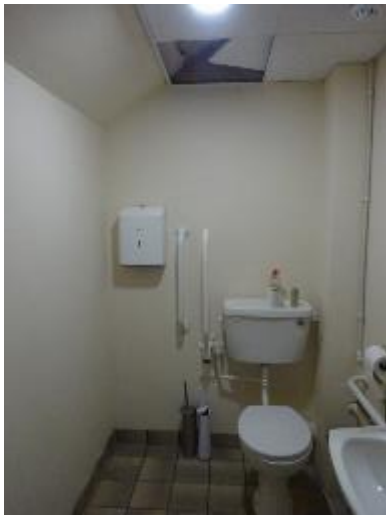
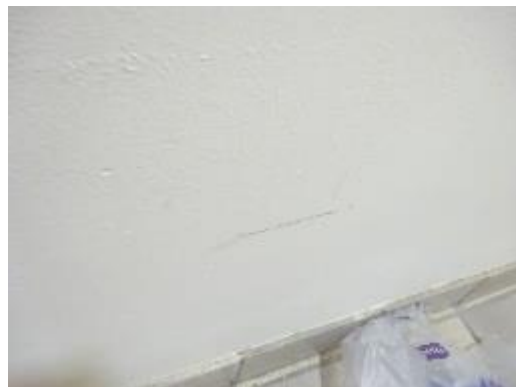
Tiled splashback section to the wash hand basin presented in a fair state of repair and condition. It was noted that former fixing openings rawl plugs can be seen and grout presented soiled and discoloured. Isolated chipped tiles where fixings have been installed were noted and mastic sealant around the wash hand basin was soiled and in part perished. We would

recommend that the tiled splashback in the first instance is suitable for day one operations, although sealant is to be reinstated.

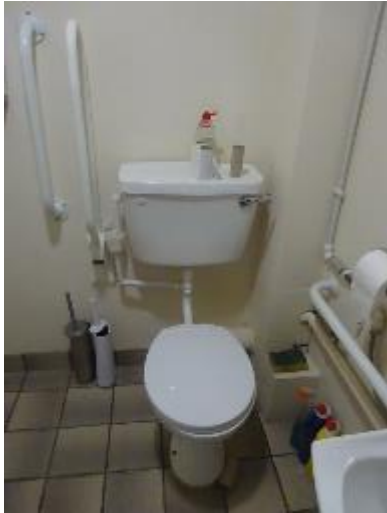
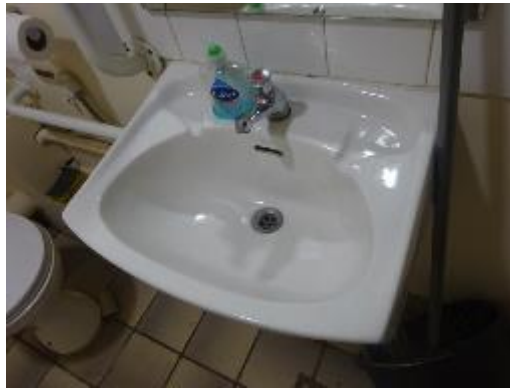
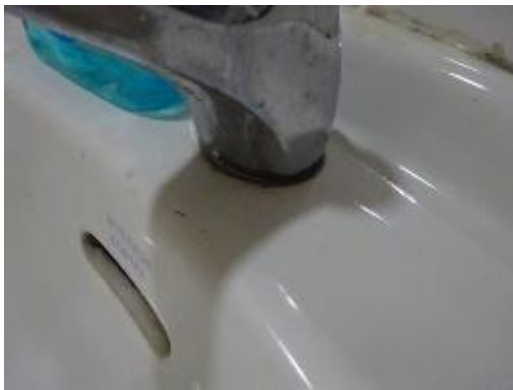
### Sanitaryware

WC, wash hand basin were dated although functional. It was noted that the WC seat was loose and sealant around the tap had perished. Surface soiling stains can be seen to both the WC and wash hand basin, although functional for day one operations. It was noted that although the tap was functional, did not provide running water.

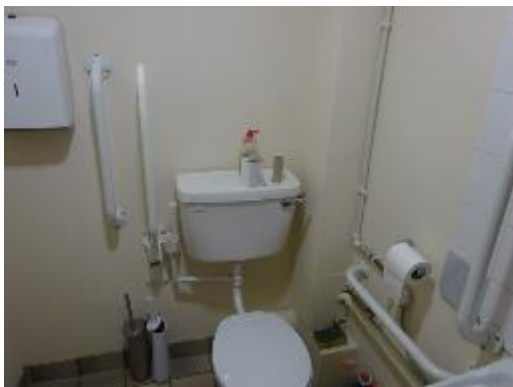
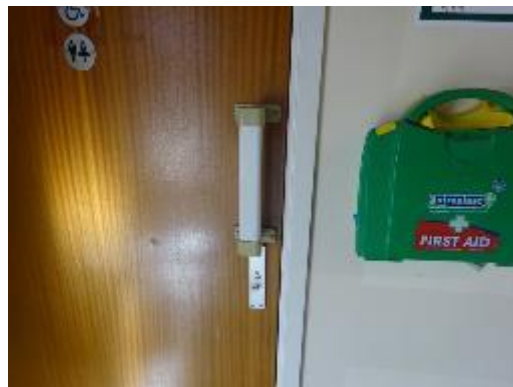
Disabled WC provisions included hand guards, railing and handles which were not compliant with the Quality Act. We would recommend if the WC is to remain disabled WC facilities, that better contrasting handrails and appropriate handles are installed.

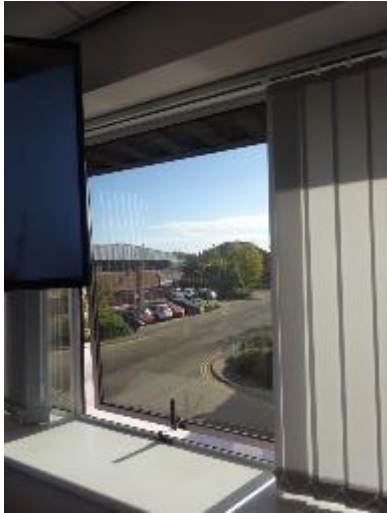
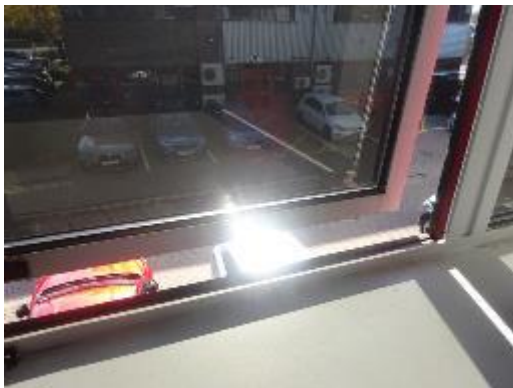
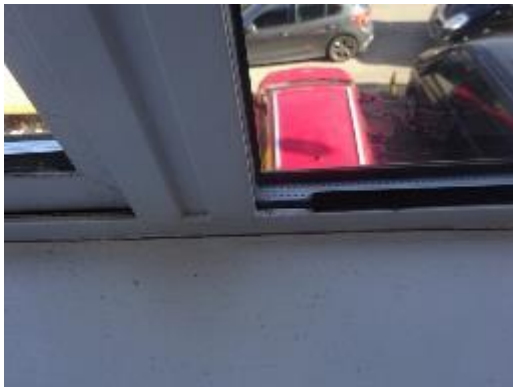
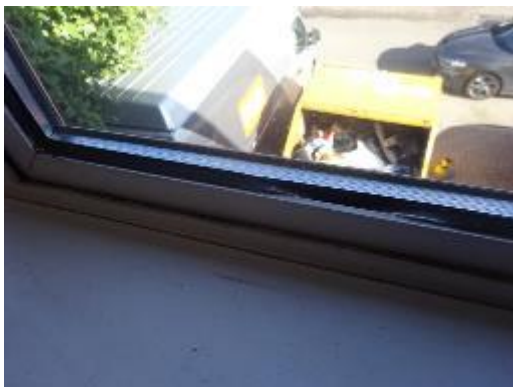
Windows throughout the open plan office area were provided via double-glazed powder coated aluminium framed windows. The windows visually presented in a satisfactory state of repair and condition. It was noted that surfaces were generally soiled and seals between the glazing and the frames were in part distorted, warped or presented minor sections missing. Windows presented in a good state decorative condition and no disrepair could be seen to the window blind fittings. All windows were functional and operational at the time of the inspection, although a request should be made for keys for the purposes of security and clarification with insurers that the locking mechanisms are sufficient.

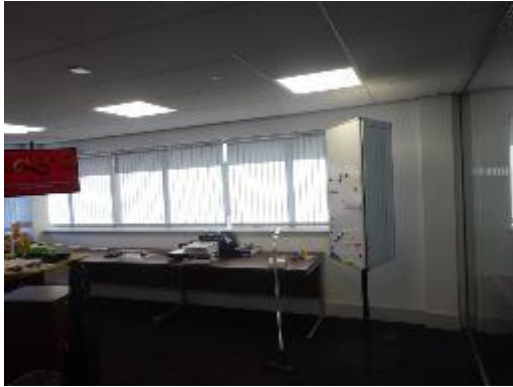
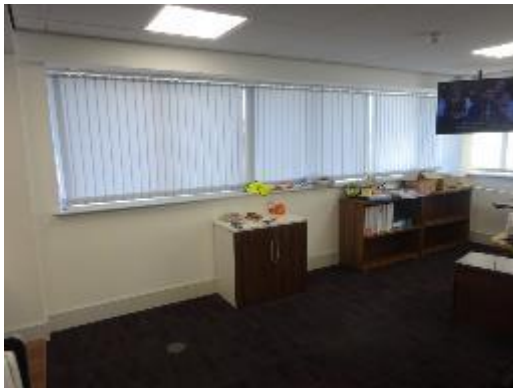
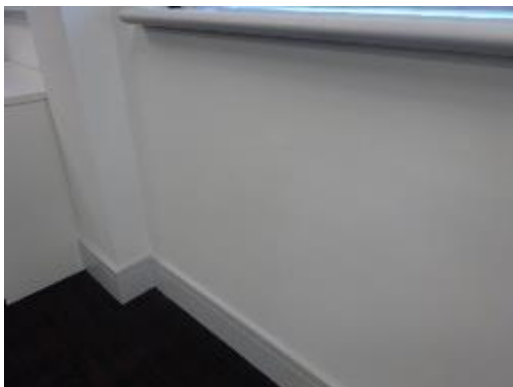
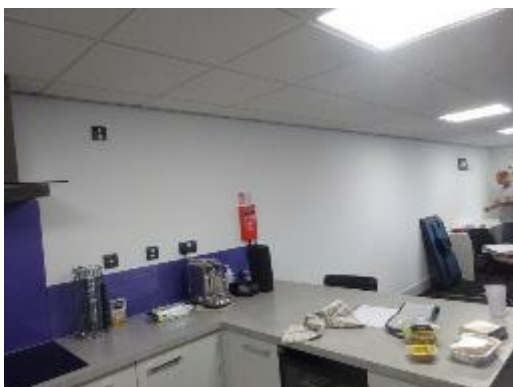
Main walls are provided via painted plaster to a combination of solid masonry and plasterboard, of which visually presented in a satisfactory to good state of repair and condition. Only some minor surface blemishes could be seen. No areas of cracking or water staining to suggest any water ingress was noted throughout.

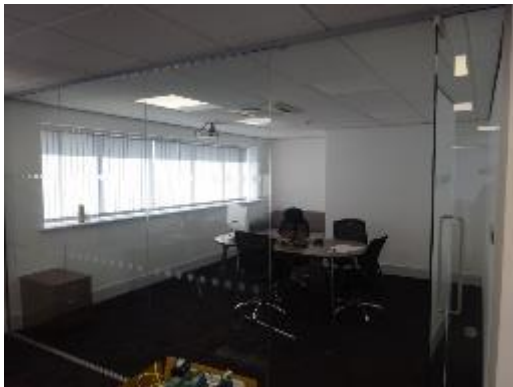
The meeting room was compartmented via glazed curtain walling which presented in a glazed partitioning which presented in a good state of repair and condition. Glazing was fixed from suspended ceiling to the finished floor level and was secure on the day of the inspection. Glazing incorporated manifestations in compliance with approved document K.

It was further noted that the small openings to the grid and the partitioning frame had been infilled.

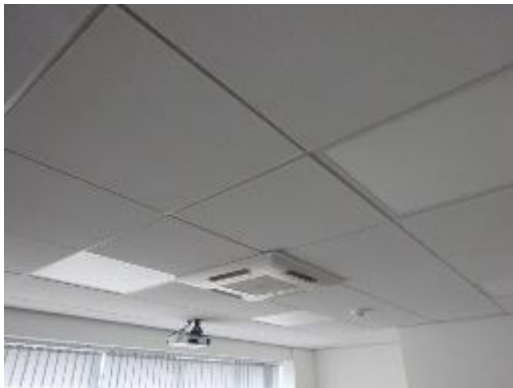
Ceiling finishes around the meeting room area is provided via 600x600 mineral fibre suspended ceiling tiles with metal grid. The ceiling tiles incorporated LED lights, emergency light fittings, smoke detection and air conditioning units. Lights are operated on PIR sensors. Ceilings presented in a good state of repair with the fixtures and fittings, although some light surface soiling can be seen around the ceiling tiles serving the air condition unit. We would still advise that full electrical test Certificates, maintenance and service records are provided for the lighting and fire detection system.

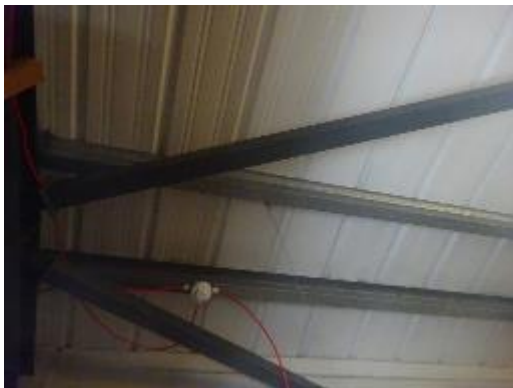
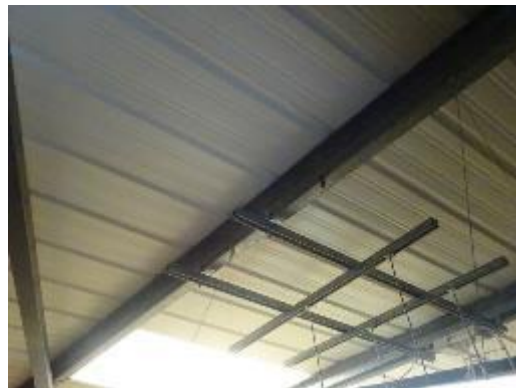
It was noted above the suspended ceiling that voids were not seen to be compartmented and clarification from Fire Risk Assessment should advise the validity.

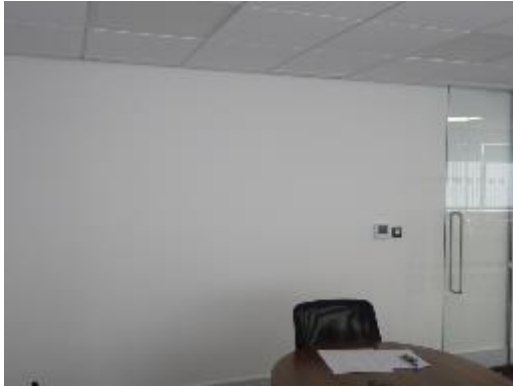
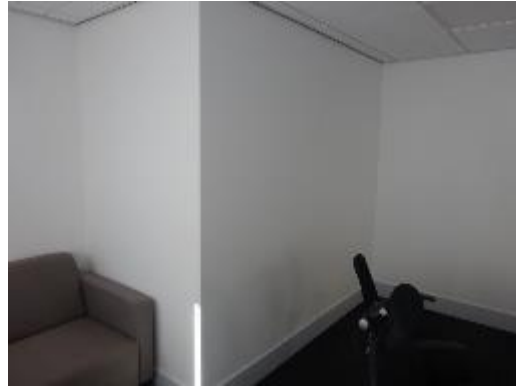
Main walls are provided via painted plaster to a combination of solid masonry and plasterboard, of which visually presented in a satisfactory to good state of repair and condition. Only some minor surface blemishes could be seen. No areas of cracking or water staining to suggest any water ingress was noted throughout.

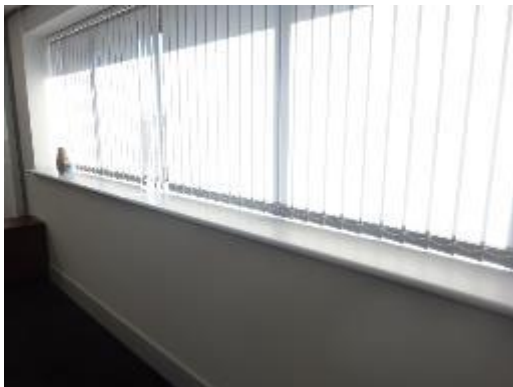
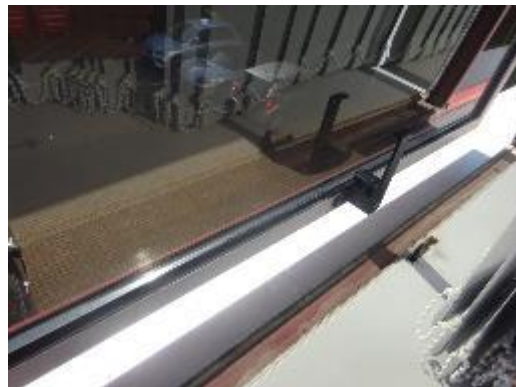
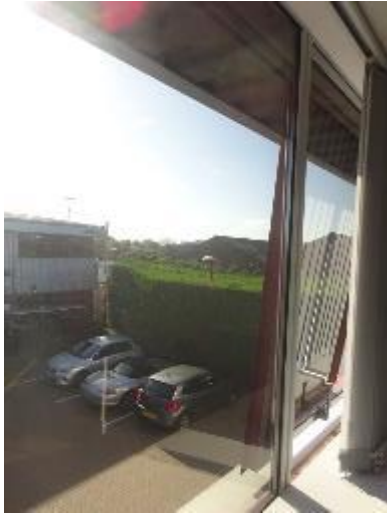
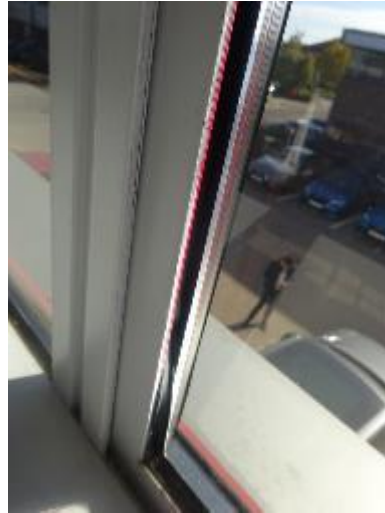
Windows throughout the meeting room area were provided via double-glazed powder coated aluminium framed windows. The windows visually presented in a satisfactory state of repair and condition. It was noted that surfaces were generally soiled and seals between the glazing and the frames were in part distorted, warped or presented minor sections missing. Windows presented in a good state of repair and decorative condition and no disrepair could be seen to the window blind fittings. All windows were functional and operational at the time of the inspection, although a request should be made for keys for the purposes of security and clarification with insurers that the locking mechanisms are sufficient.

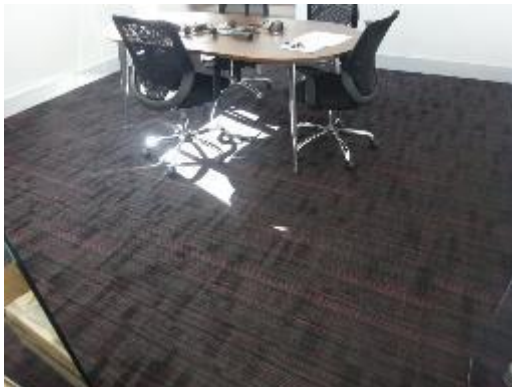
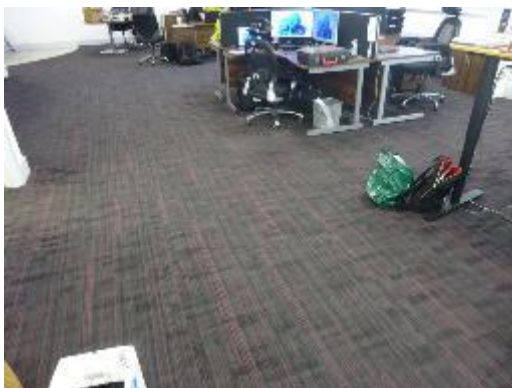
Flooring throughout was provided via timber deck with carpet tile finishes throughout. Floors generally presented in a reasonable state of condition with some minor surface soiling and light wear. We recommend under general wear and tear, regular maintenance. Carpets do not require replacement until the medium term.

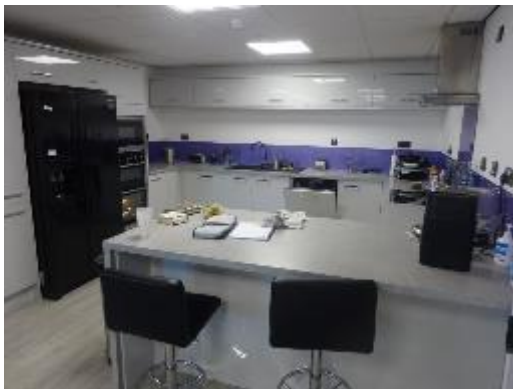
The kitchen forms part of the open plan area and was provided with modern kitchen fit out. Sink and associated plumbing presented functional and in a good state of repair and condition. No leaks or signs of water ingress could be seen to the plumbing below the sink. It was noted that the air extraction unit was not vented and only recycles the intake air within the area. White goods presented in a good state of repair and condition and were functional on the day of the inspection.

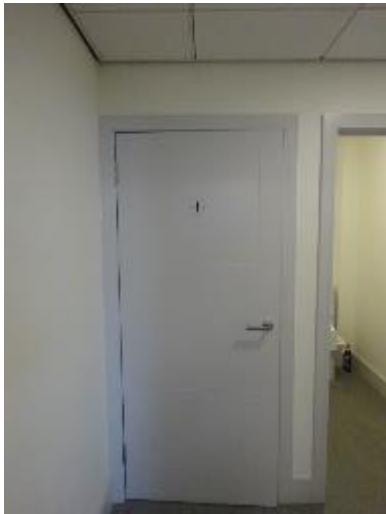
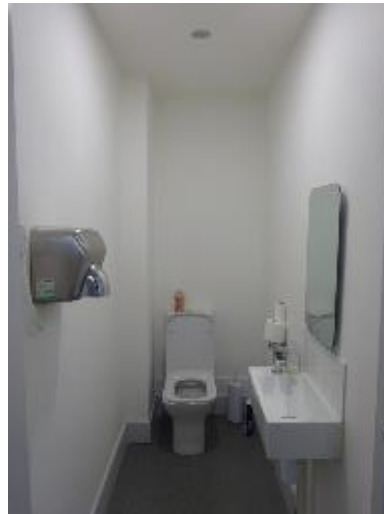
### First Floor Female WC

Ceilings within the WC were provided via painted plasterboard with LED lighting which was controlled on a PIR sensor. On the day of the inspection, lighting was fully functional. Extract ventilation was noted to the WC ceiling, although we were not able to confirm if this was operational on the day. Test and maintenance Certificates should be provided for the fire detection system located to the ceiling, although visually appeared in a good state of repair and condition. Decorative ceiling finishes presented well. No evidence of cracking or water ingress were noted.

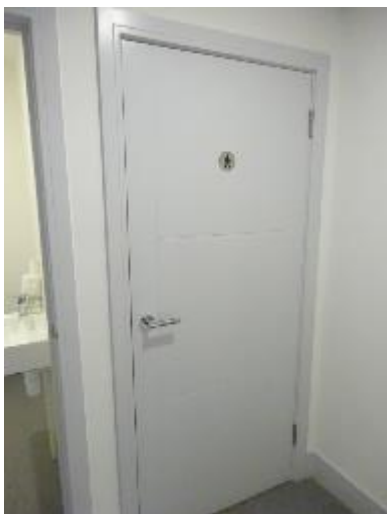
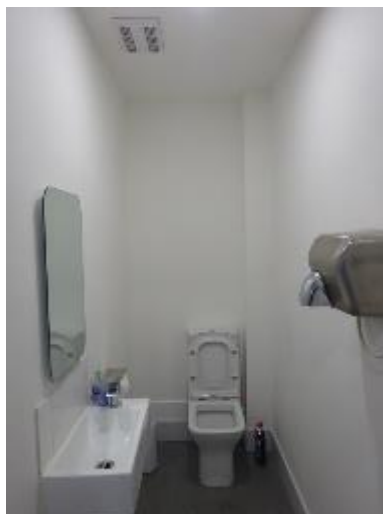
**Male WC**

Ceilings within the WC were provided via painted plasterboard with LED lighting which was controlled on a PIR sensor. On the day of the inspection, lighting was fully functional. Extract ventilation was noted to the WC ceiling, although we were not able to confirm if this was operational on the day. Test and maintenance Certificates should be provided for the fire detection system located to the ceiling, although visually appeared in a good state of repair and condition. Decorative ceiling finishes presented well. No evidence of cracking or water ingress were noted.

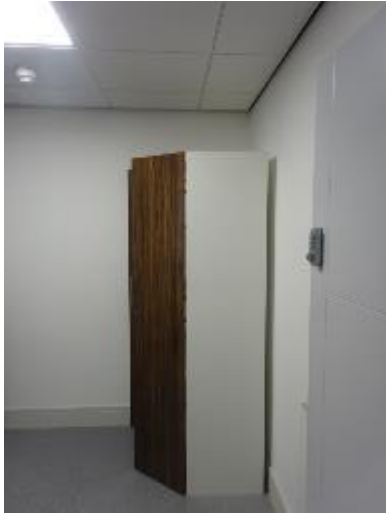
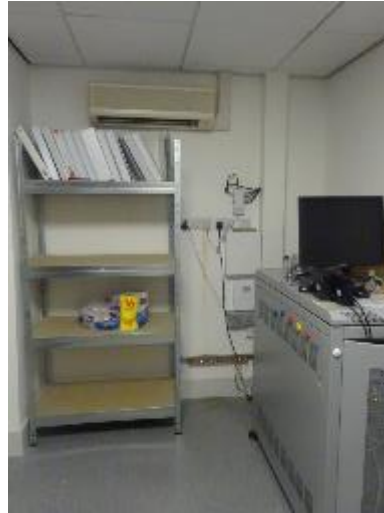
### Comms Room

The ceiling within the comms room was provided via 600x600 suspended ceiling with mineral fibre tiles and inlaid LED lighting. Surface finishes presented in a good state of repair and condition. It was noted that lighting was controlled on a PIR which was functional on the day of the inspection. Fire detection systems presented well however we would recommend that full fire maintenance certificates and records are provided.

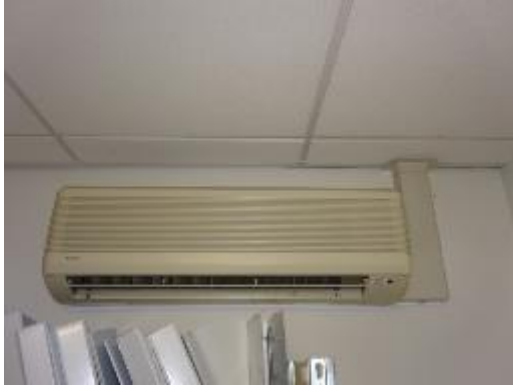
Walls throughout provided by painted plaster with low-level painted timber skirting details, of which presented in a reasonable state of repair and condition. Some minor surface soiling was noted as forementioned from the historic leak from the air conditioning unit, and hairline cracking which we anticipate to be thermal cracking and not to affect the integrity of the building. The cracks were located on joints and suggest thorough preparation and redecoration is undertaken.

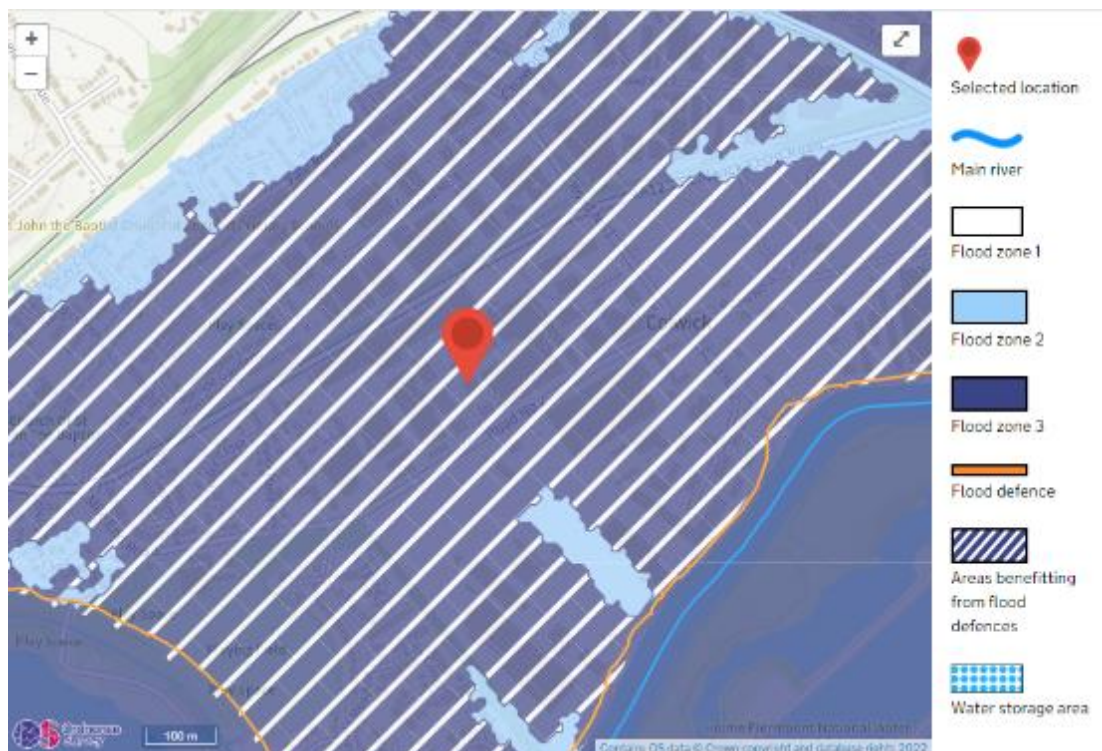
### Flooding risk

We have not undertaken detailed investigations into the potential for flooding of the land on which the property lies. However, we have consulted the website at [www.environment.agency.gov.uk](http://www.environment.agency.gov.uk) of the Environment Agency and their information regarding the potential for flooding suggests that the area is at risk from flooding.

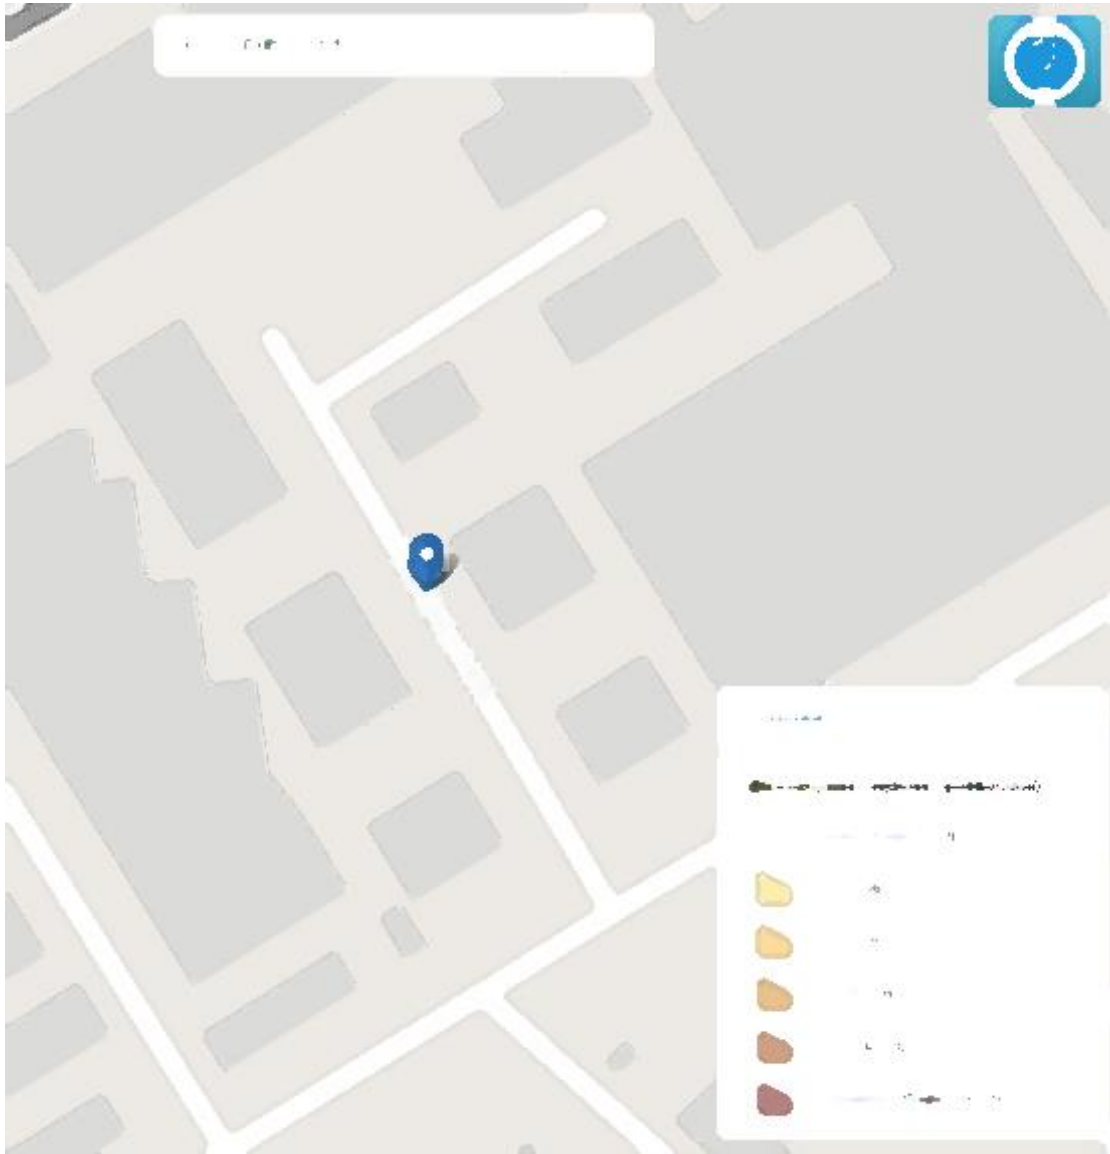
### Radon Risk

Low Radon Risk - Our desktop survey revealed the property to be located in an area where the likelihood of radon is at its lowest. It is not possible in the course of a building survey to determine whether radon gas is present in any given building, as the gas is invisible and odourless. Tests can be carried out to assess the level of radon in the building at a small charge. It is understood there is a testing period, possibly lasting several months, which does not appear to be required in this instance.
