Schedule of Condition

Address XXXX **Prepared for** XXXX
Survey Date XXXX
Prepared by Mark Davies
Email m.davies@allcottassociates.co.uk
Telephone 0333 200 7198
Mobile XXXX
Website www.allcottcommercial.co.uk

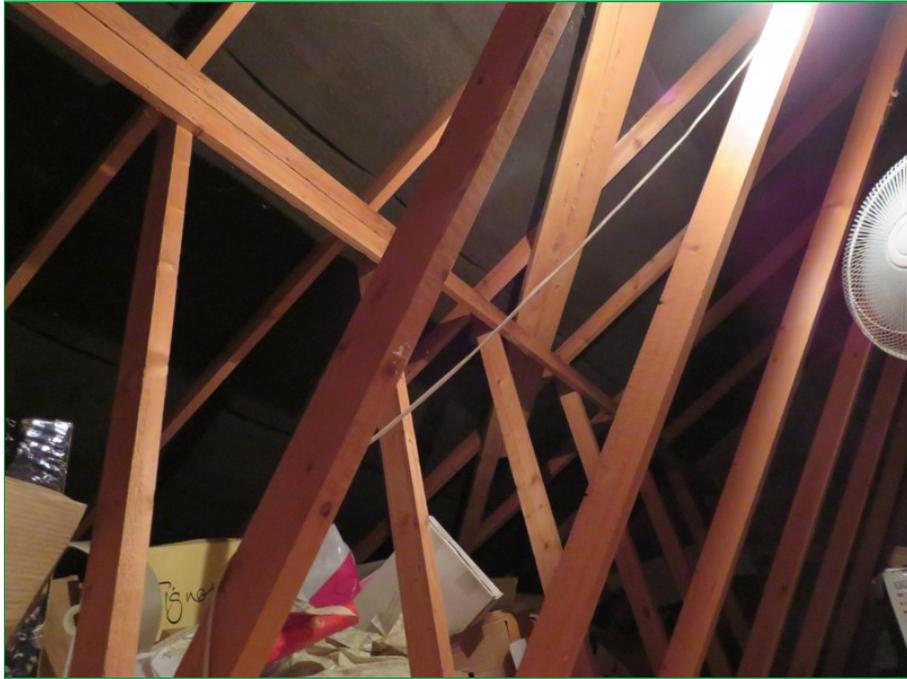
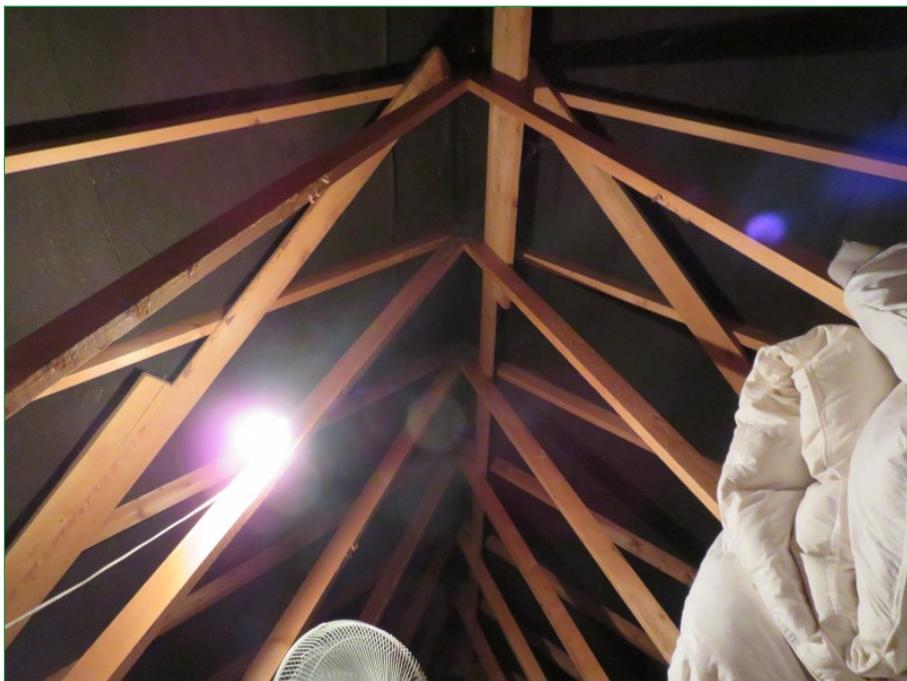
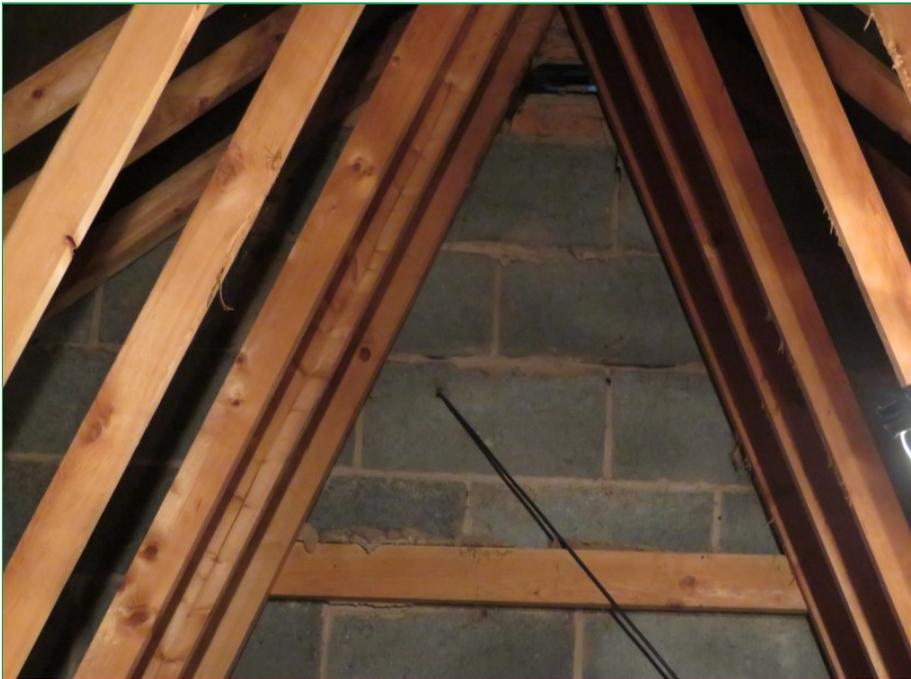
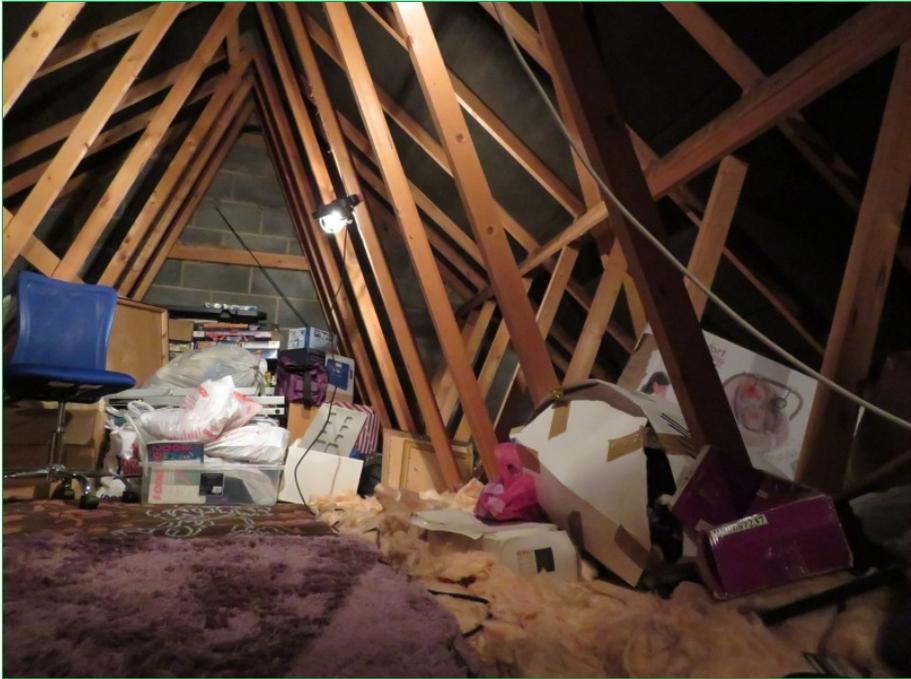
Area	Location	Element	Condition	Description	Photo
Internal	Loft	Roof trusses - Sarking felt	Good	No twisting or cracking noted to the timbers, no damage to the sarking felt Block work in satisfactory condition, no cracking noted	[Photos 1 - 5]
Internal	Office	Ceilings - Plasterboard & Skim	Satisfactory	Satisfactory condition very slight crack across the centre of the room from partition wall to external wall and to the edge of the plasterboards where butt jointed.	[Photos 6 - 13]
Internal	Office	Walls - Plasterboard & Skim	Satisfactory	The wall finish consists of paint , the current condition of the walls are in a reasonable state of repair with minor undulations and scuff marks noted.	[Photos 14 - 21]
Internal	Office	Floor Finishes - Carpet	Satisfactory	General wear and tear. Satisfactory condition.	[Photos 22 - 23]
Internal	Office	Floor Structure - Timber Joist & Board	Good	Level and firm underfoot

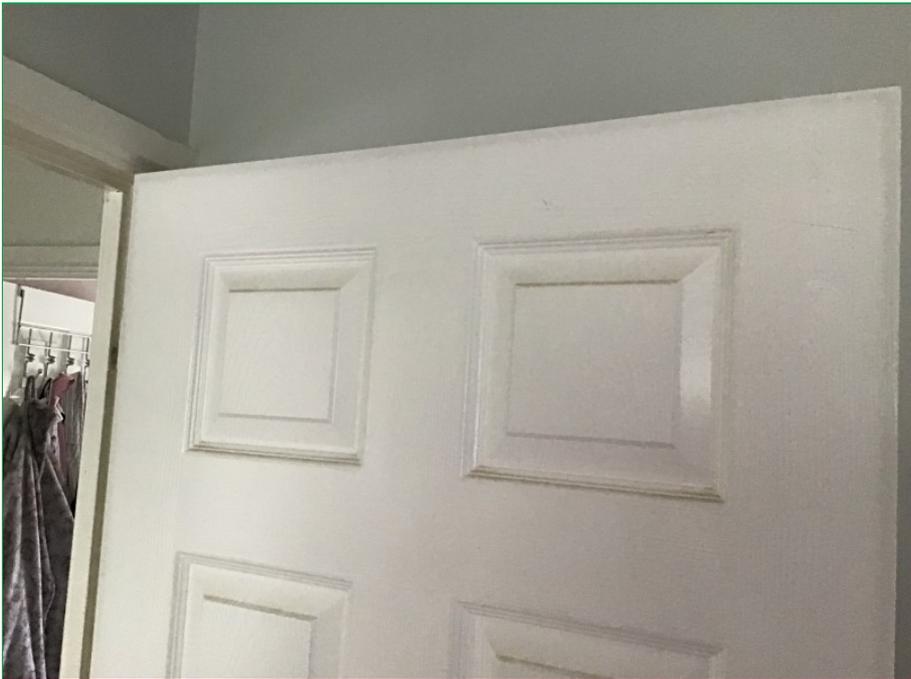
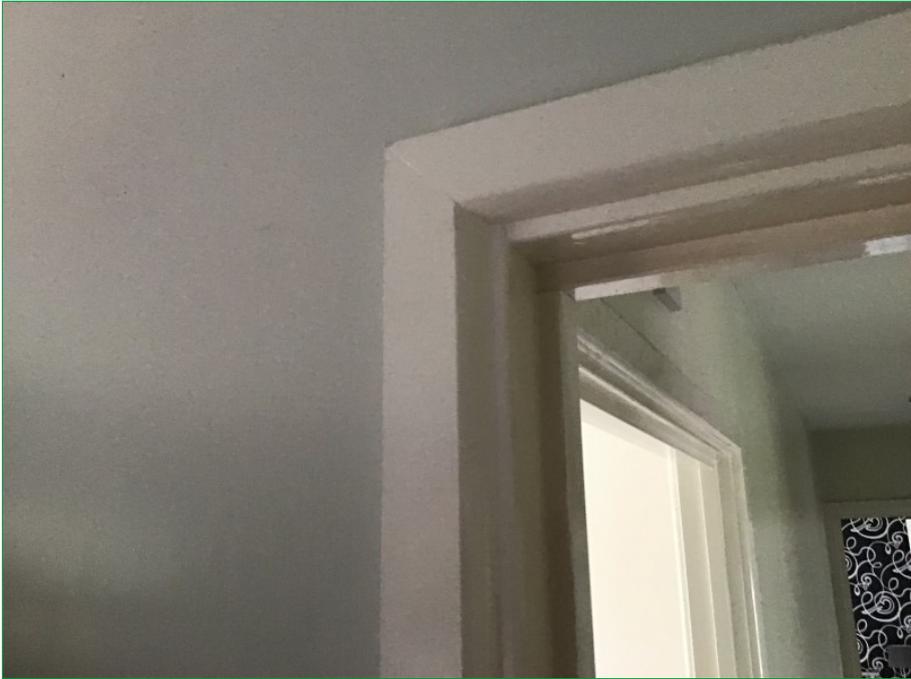
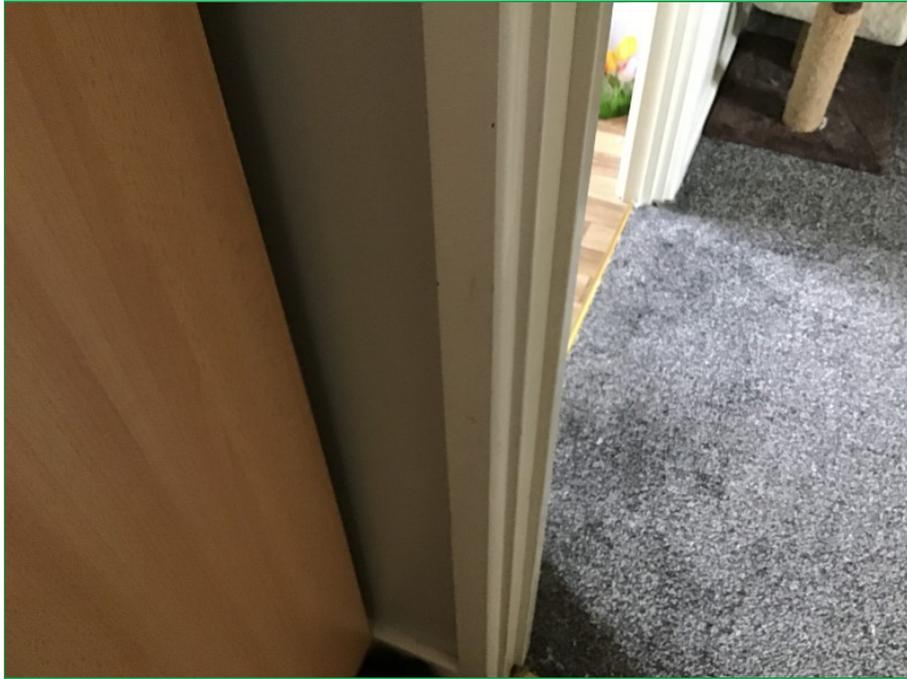
Area	Location	Element	Condition	Description	Photo
Internal	Office	Doors and Frames - Softwood Frame	Satisfactory	Slight scuffs and marks noted, generally Satisfactory condition	[Photos 24 - 27]
Internal	Office	Skirting - Softwood	Satisfactory	The gloss painted softwood timber is scuffed in areas but generally satisfactory	[Photo 28]
Internal	Office	Window - PVCu	Good	Slightly begrimed, generally satisfactory, timber cill in good decorative order	[Photos 29 - 33]
Internal	Bedroom 3	Ceilings - Plasterboard & Skim	Satisfactory	Slight undulations noted throughout. No cracking noted	[Photos 34 - 40]
Internal	Bedroom 3	Internal Walls/ Partitions - Dry Lined	Satisfactory	Generally in satisfactory condition with 1no crack noted above head of door to wardrobe. (Hairline) Slight scuffing evident. Cracked vertically to junction of window frame	[Photos 41 - 55]
Internal	Bedroom 3	Floor Finishes - Carpet	Satisfactory	General wear and tear. Satisfactory condition	[Photos 56 - 60]

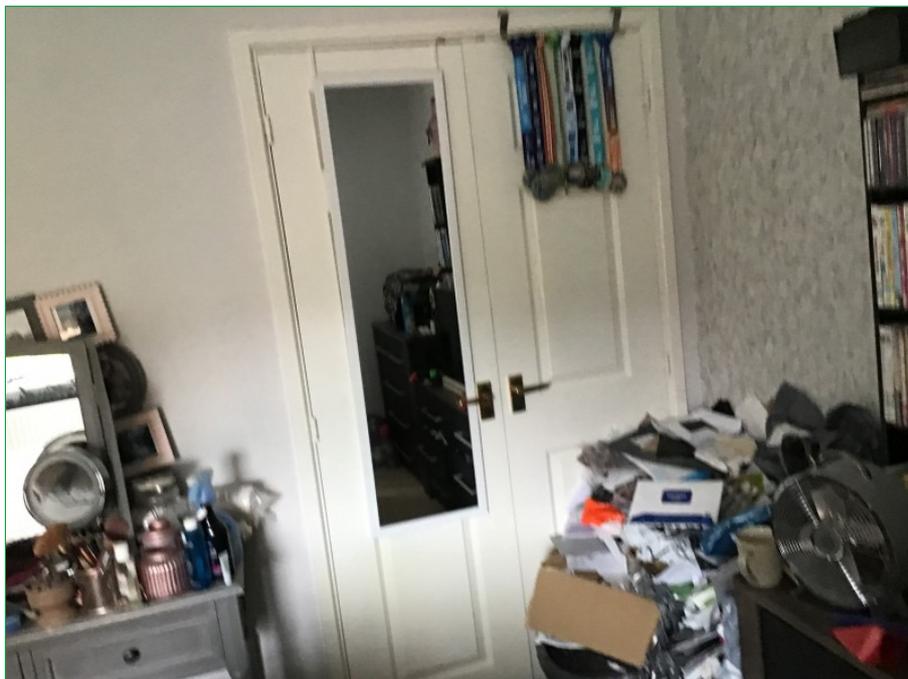
Photo 61

Area	Location	Element	Condition	Description	Photo
Internal	Bedroom 3	Doors and Frames - Softwood Frame & Panelled	Satisfactory	Satisfactory condition, scuffed and marks noted	[Photos 61 - 68]
Internal	Bedroom 3	Skirting - Softwood	Satisfactory	The gloss painted softwood timber is scuffed in areas.	[Photos 69 - 70]
Internal	Bedroom 3	Radiator - Metal	Satisfactory	Very slight scuffing to vented panel	[Photo 71]
Internal	Bedroom 3	Window - PVCu	Good	PVCu casement double glazed good condition.	[Photos 72 - 74]
Internal	Bedroom 2	Ceilings - Plasterboard & Skim	Good	Slight markings, slightly undulating, hairline crack noted along width of room adjacent to en suite to external wall	[Photos 75 - 82]
Internal	Bedroom 2	Internal Walls/ Partitions - Dry Lined	Satisfactory	Slight scuffing and marks noted. Generally satisfactory	[Photos 83 - 93]
Internal	Bedroom 2	Floor Finishes - Carpet	Satisfactory	General wear and tear.	[Photos 94 - 96]

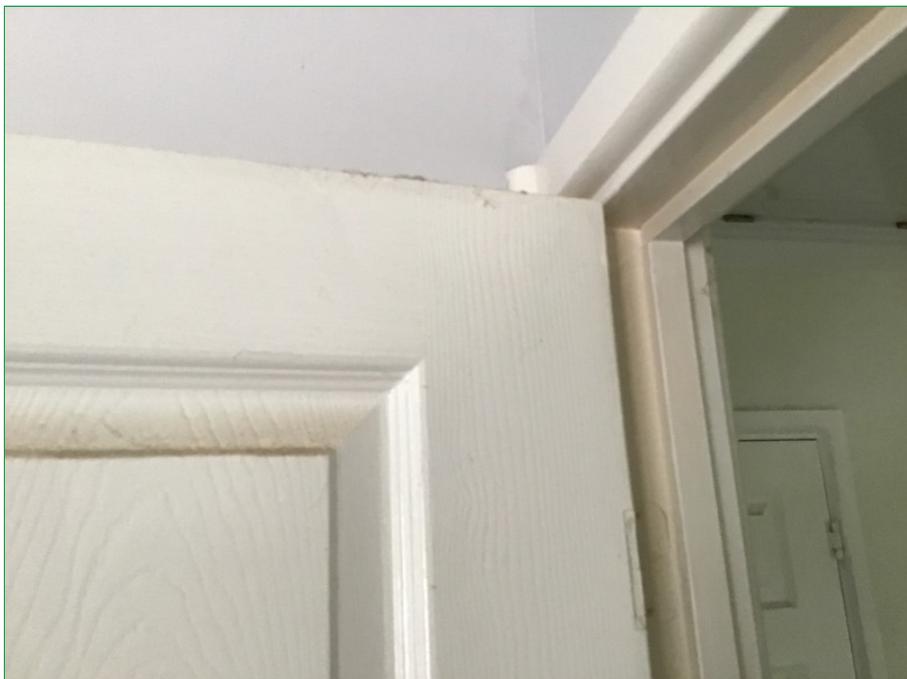
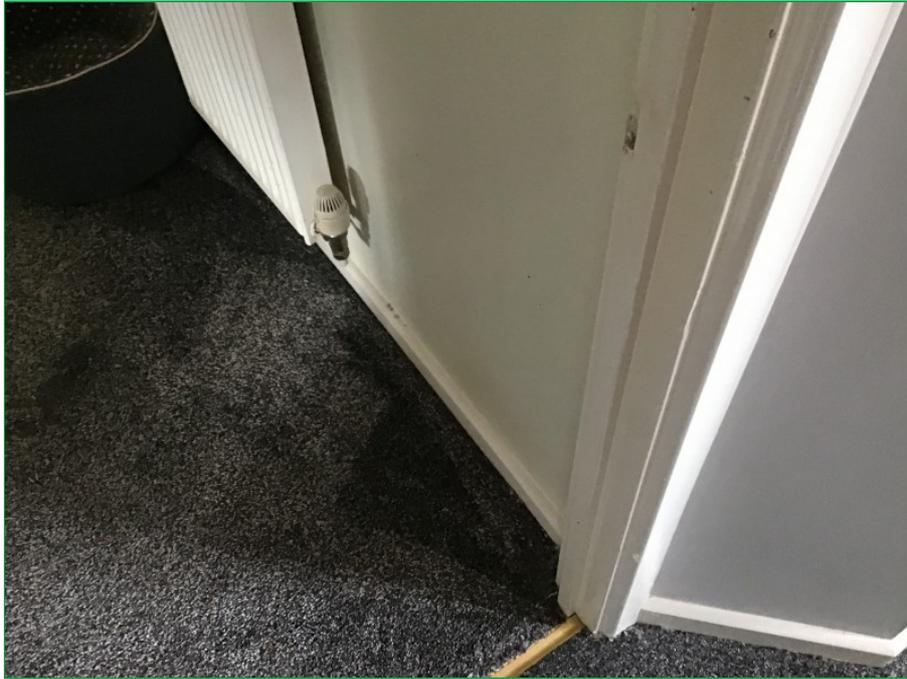
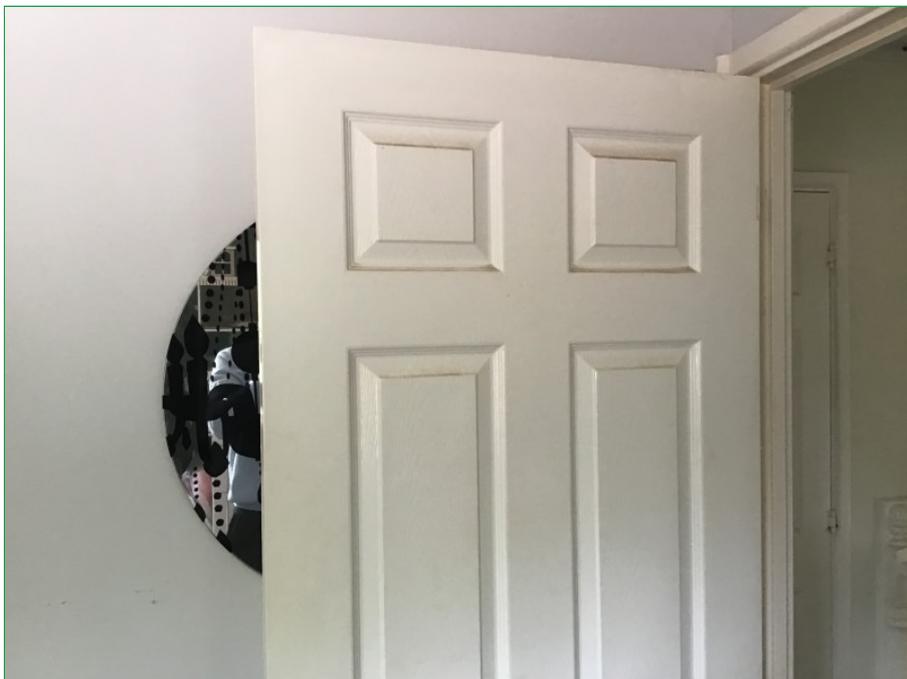
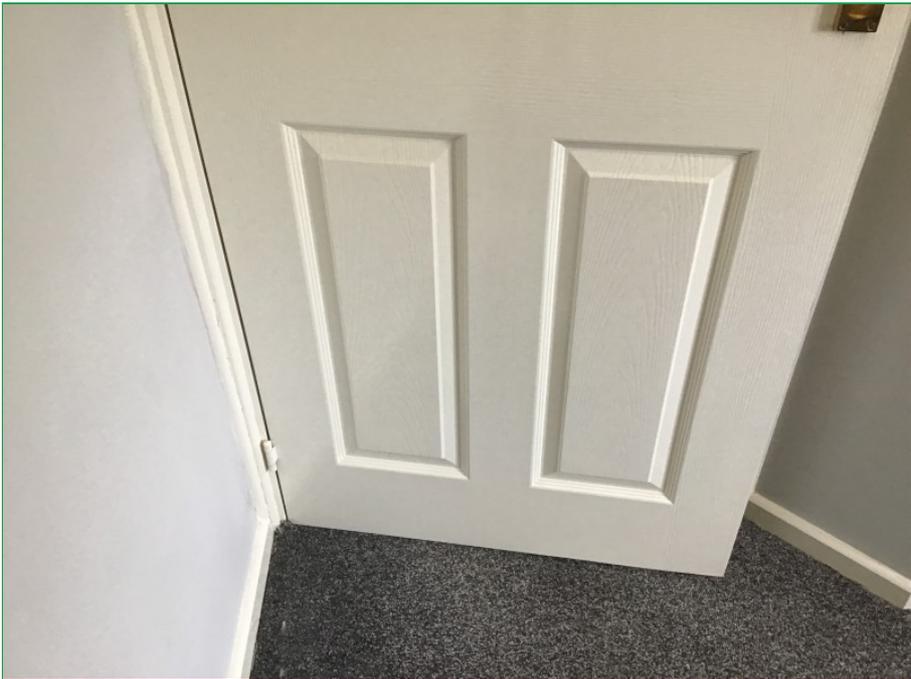
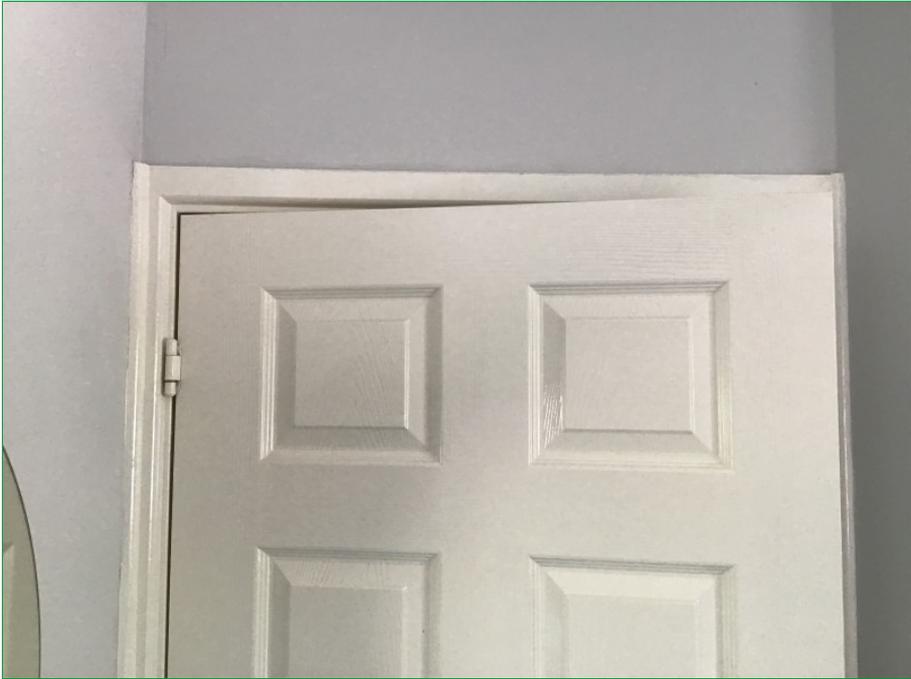
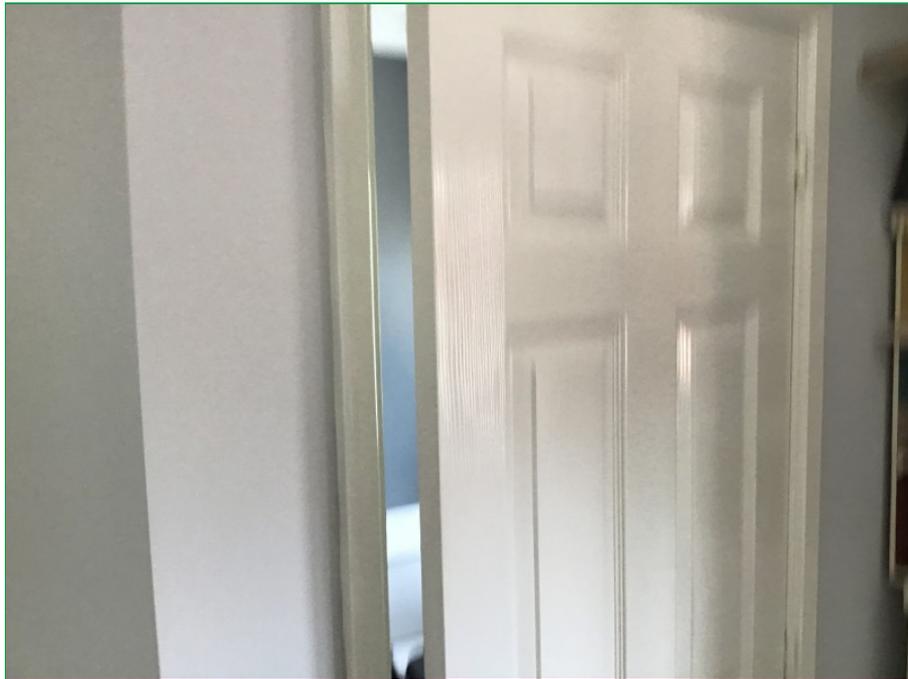
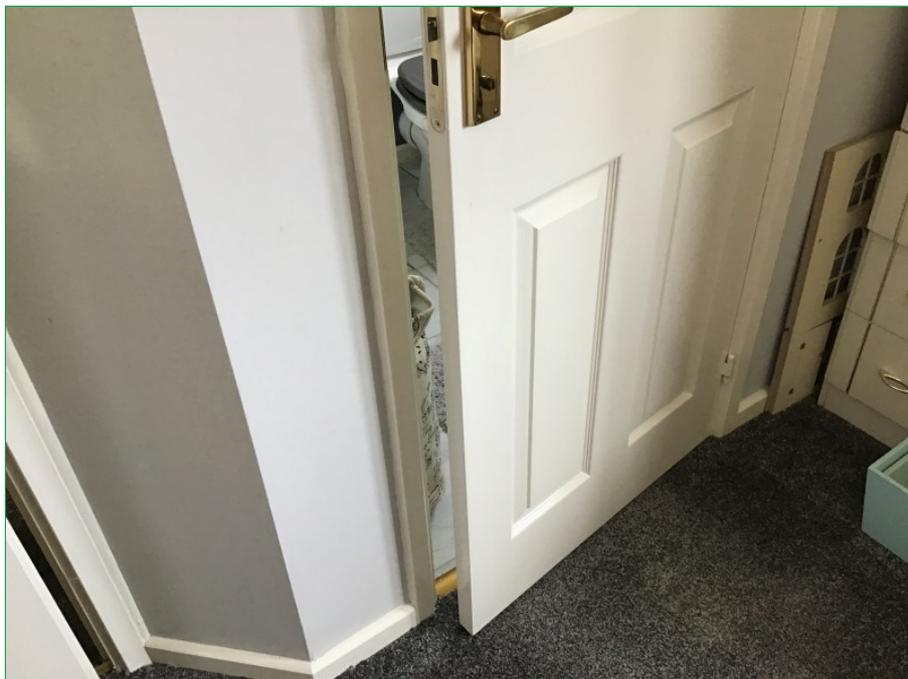
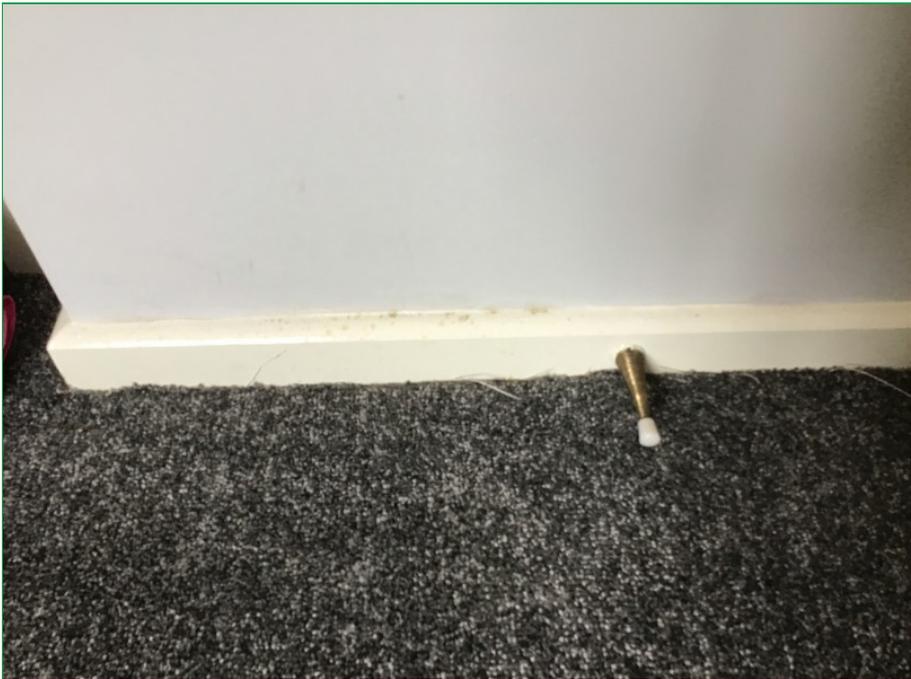
Photo 97

Area	Location	Element	Condition	Description	Photo
Internal	Bedroom 2	Doors and Frames - Softwood Frame & Panelled	Satisfactory	Satisfactory condition, scuff marks noted	[Photos 97 - 104]
Internal	Bedroom 2	Skirting - Softwood	Good	Slight scuffs noted	[Photos 105 - 106]
Internal	Bedroom 2	Window - PVCu	Satisfactory	Slightly begrimed	[Photos 107 - 111]
Internal	Bedroom 2	Radiator - Metal	Good	No damage noted.	[Photo 112]
Internal	Bedroom 1	Ceilings - Plasterboard & Skim	Good	Slight cracking above entrance door leading across to wardrobe. Cracks above window to both left and right hand sides. Marks noted throughout	[Photos 113 - 121]
Internal	Bedroom 1	Internal Walls/ Partitions - Dry Lined	Satisfactory	Scuffed and marked. Vertical crack adjacent the lh side of the radiator Vertical crack above head of window to lh side Hairline crack above door to en suite and entrance door	[Photos 122 - 137]

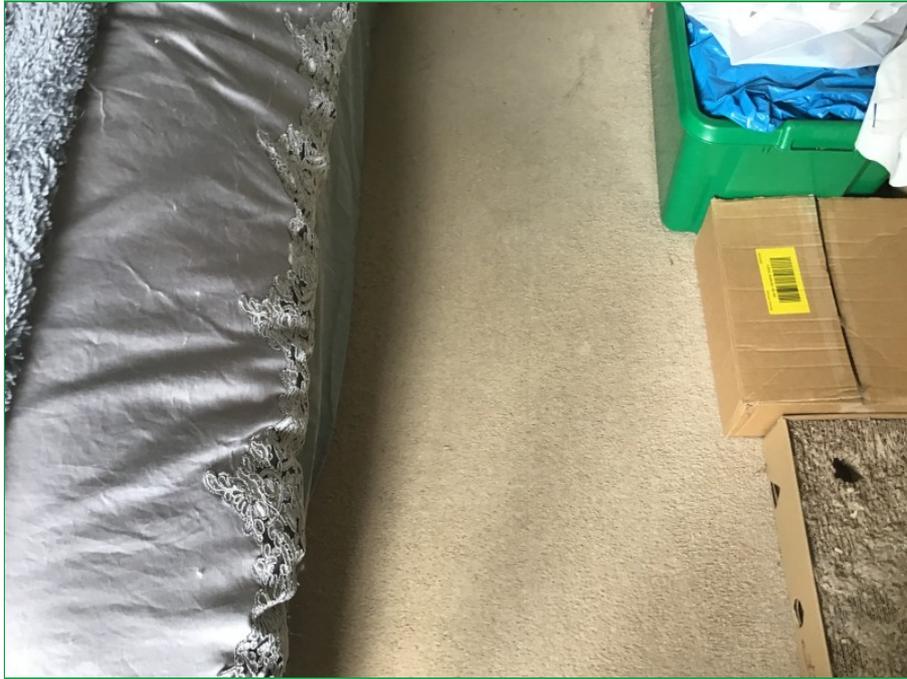
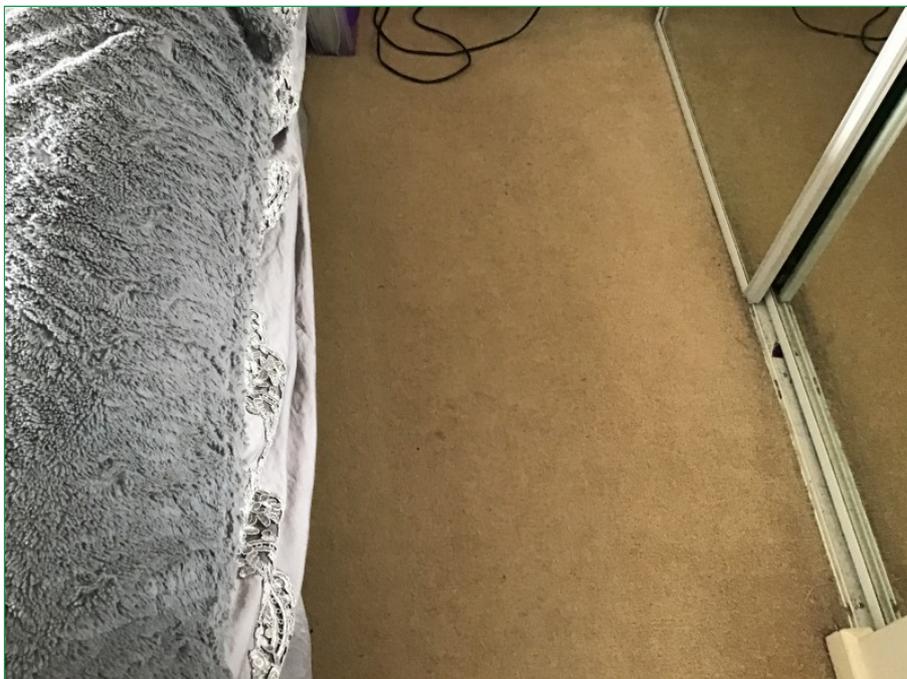
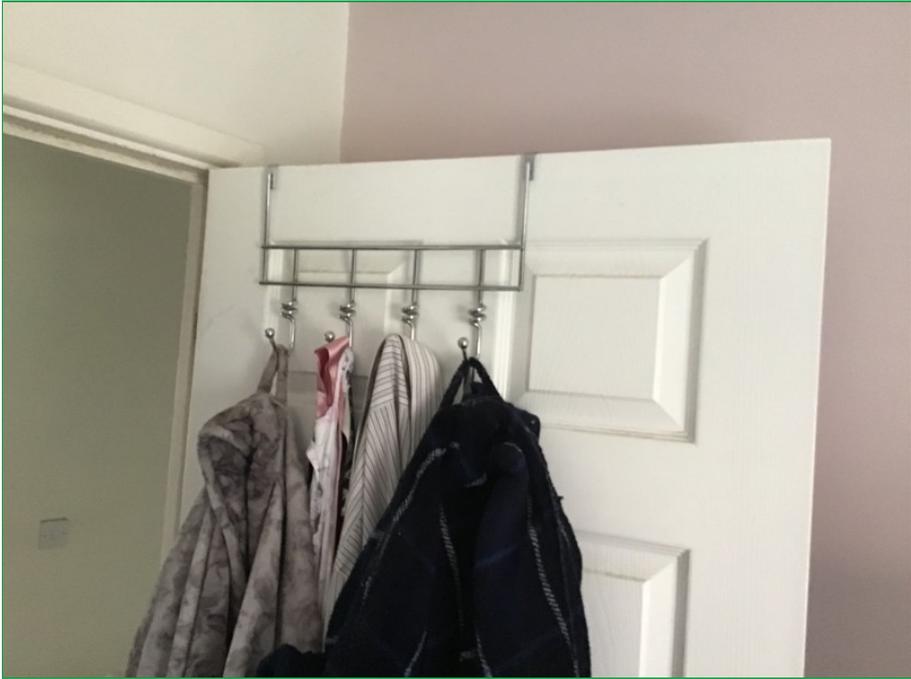
Area	Location	Element	Condition	Description	Photo
Internal	Bedroom 1	Floor Finishes - Carpet	Satisfactory	Slightly stained	[Photos 138 - 140]
Internal	Bedroom 1	Doors and Frames - Softwood Frame & Panelled	Satisfactory	Generally satisfactory, slightly begrimed and damage to the door frame noted	[Photos 141 - 143]
Internal	Bedroom 1	Skirting - Softwood	Satisfactory	The gloss painted softwood timber is scuffed in areas, cracked to the junction with the wall in the above garage area, however generally satisfactory	[Photos 144 - 146]
Internal	Bedroom 1	Radiator - Metal	Satisfactory	No damage noted.	[Photo 147]
Internal	Bedroom 1	Window - PVCu	Satisfactory	Slightly begrimed in good operable condition	[Photos 148 - 151]
Internal	Bedroom 1 En suite	Ceilings - Plasterboard & Skim	Satisfactory	Satisfactory condition, no cracks noted	[Photos 152 - 155]
Internal	Bedroom 1 En suite	Internal Walls/ Partitions - Dry Lined	Good	Floor to ceiling tiling within shower area. Plaster and skim painted finish to the remaining walls no cracks noted Tiling in good condition, no cracks, broken or damaged tiles noted	[Photos 156 - 166]

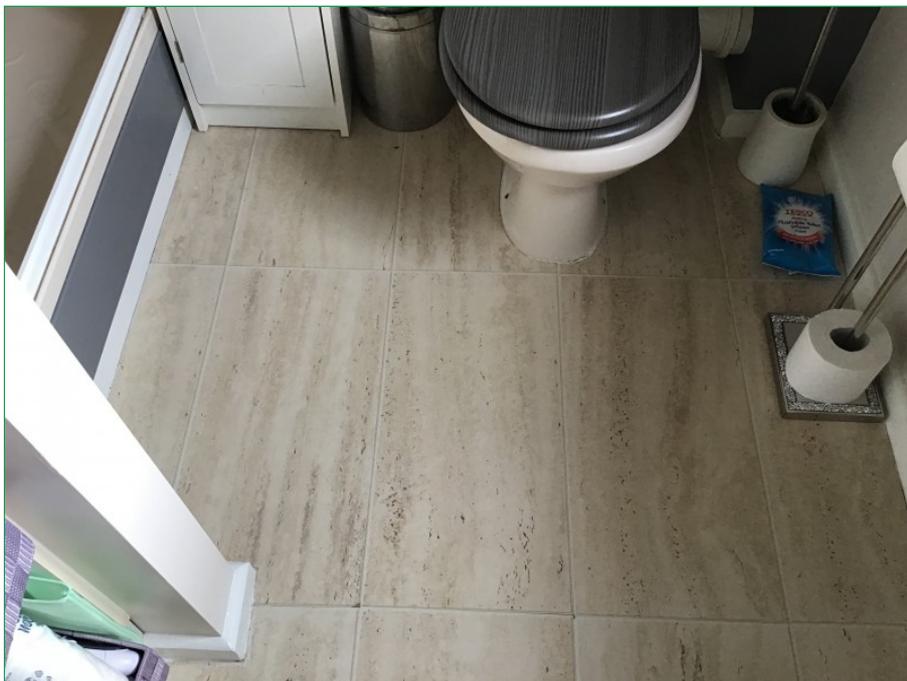
Photo 167

Area	Location	Element	Condition	Description	Photo
Internal	Bedroom 1 En suite	Floor Finishes - Laminate wood flooring	Satisfactory	Slight damage noted to the corner of one board	[Photos 167 - 169]
Internal	Bedroom 1 En suite	Doors and Frames - Softwood Frame & Panelled	Satisfactory	Slight paint damage to door frame and top edge of door	[Photos 170 - 174]
Internal	Bedroom 1 En suite	Sanitary Fittings - Enclosed shower	Satisfactory	generally satisfactory	[Photos 175 - 181]
Internal	Bedroom 1 En suite	Sanitary Fittings - Vanity Wash Basin	Satisfactory	Slight soiling to silicone bead beneath inset sink. Slight water penetration and blowing of the underside of the vanity top	[Photos 182 - 185]
Internal	Bedroom 1 En suite	Sanitary Fittings - Low Cistern WC	Satisfactory	Cracking to silicone bead to base of pan	[Photos 186 - 187]
Internal	Bedroom 1 En suite	Window - PVCu	Satisfactory	Slightly Begrimed	[Photos 188 - 191]

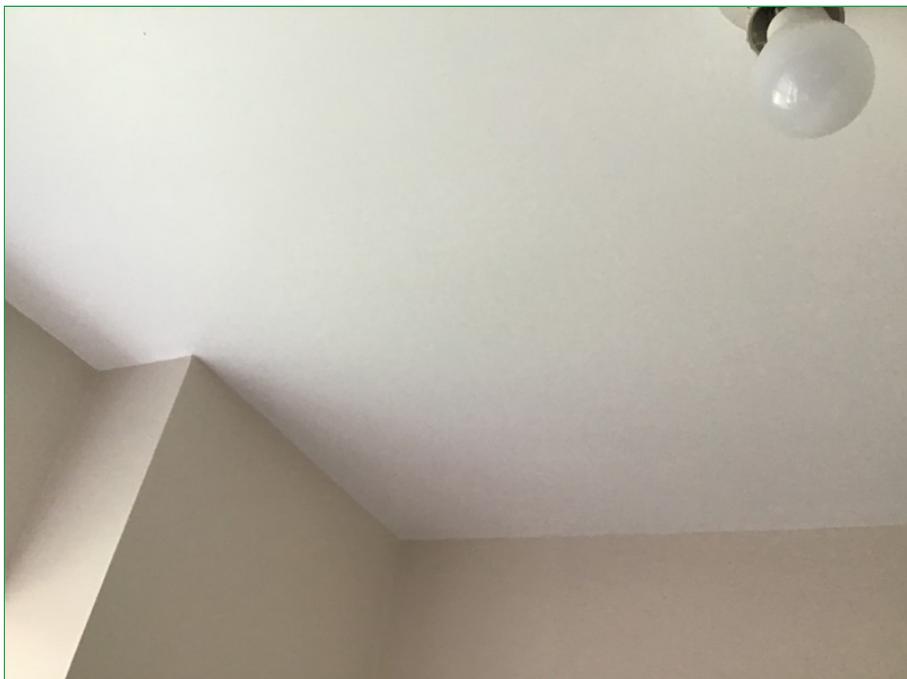
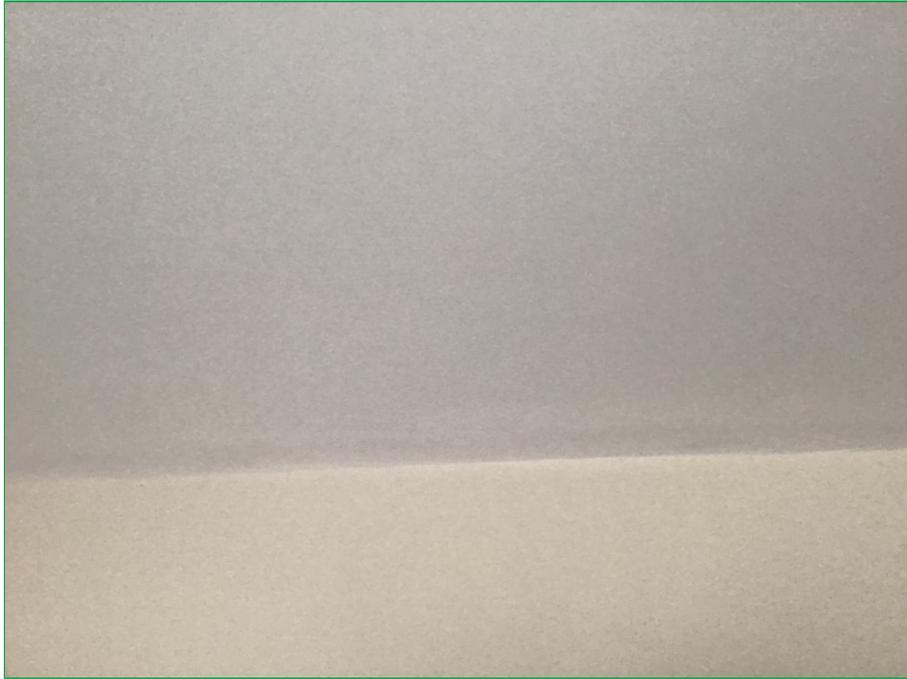
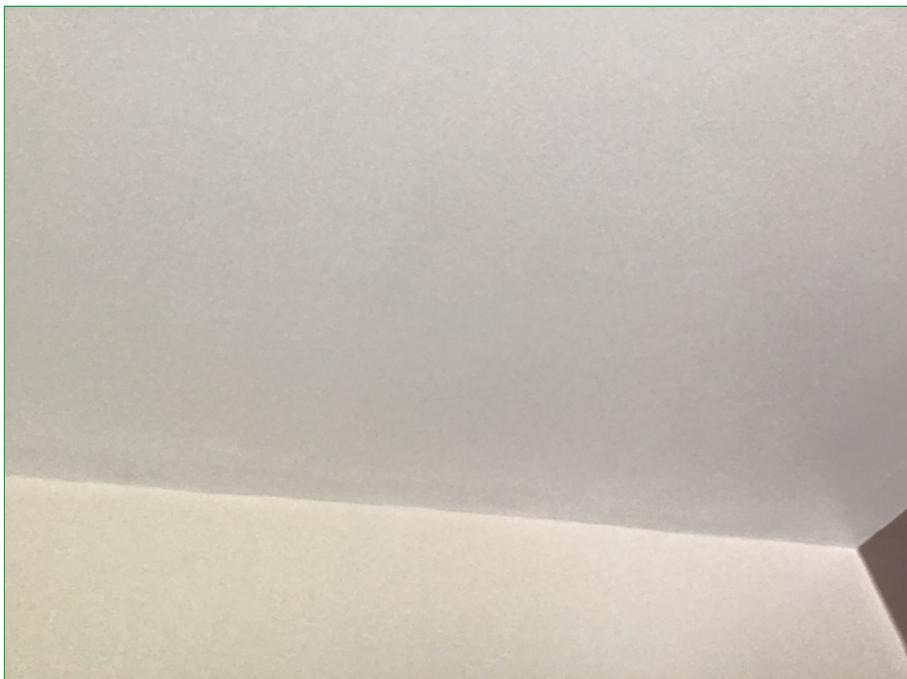
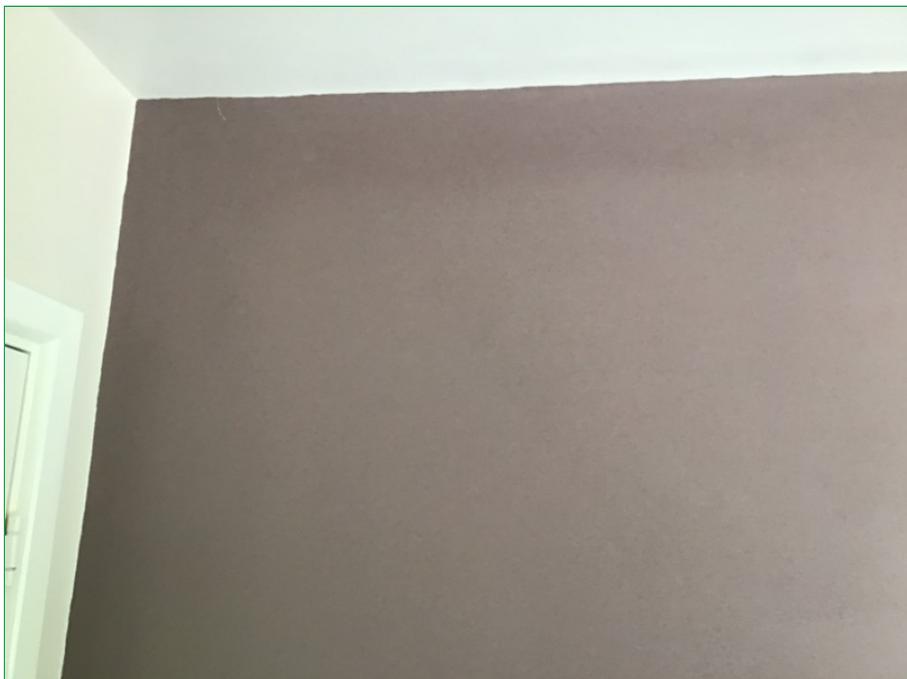
Area	Location	Element	Condition	Description	Photo
Internal	Bathroom	Ceilings - Plasterboard & Skim	Good	No cracks noted	[Photos 193 - 197]
Internal	Bathroom	Internal Walls/ Partitions - Dry Lined	Satisfactory	Generally in satisfactory condition	[Photos 198 - 212]
Internal	Bathroom	Skirting - Softwood	Satisfactory	Blown paint to bottom edge as not sealed to perimeter with the floor finish	[Photos 213 - 214]
Internal	Bathroom	Floor Finishes - Vinyl sheet	Satisfactory	Not sealed to perimeter edge	[Photos 215 - 217]
Internal	Bathroom	Sanitary Fittings - Wall Mounted Wash Basin	Satisfactory	Seal to lh side perishing	[Photos 218 - 220]
Internal	Bathroom	Sanitary Fittings - Low Cistern WC	Good	No damage noted.	[Photos 221 - 222]
Internal	Bathroom	Window - PVCu	Good	No damage noted.	[Photos 223 - 228]
Internal	Bathroom	Sanitary Fittings - Bath	Satisfactory	Soiled grouting Crack to grouting with junction of wall tiling	[Photos 229 - 232]

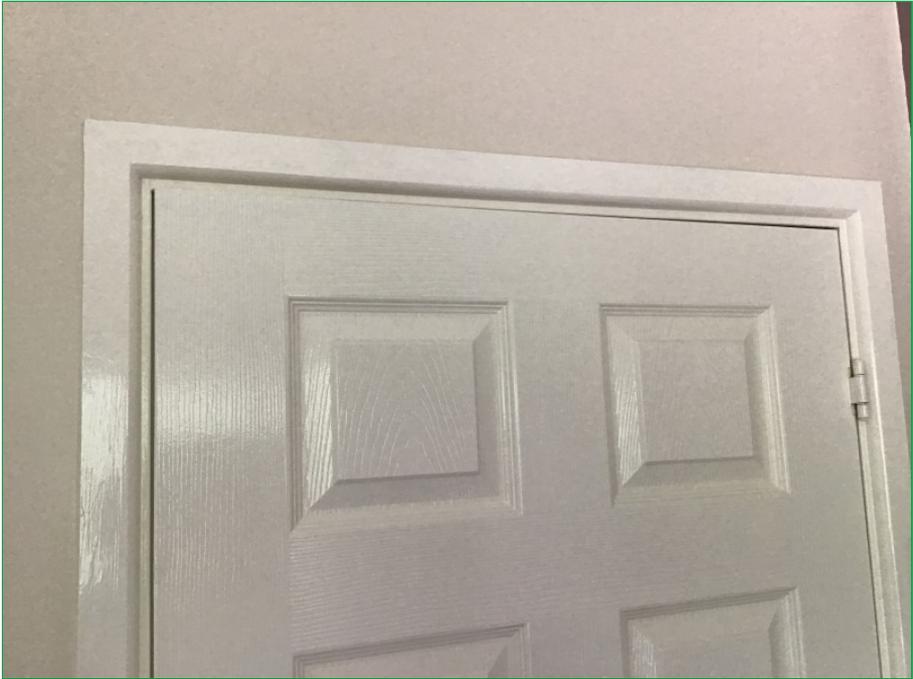
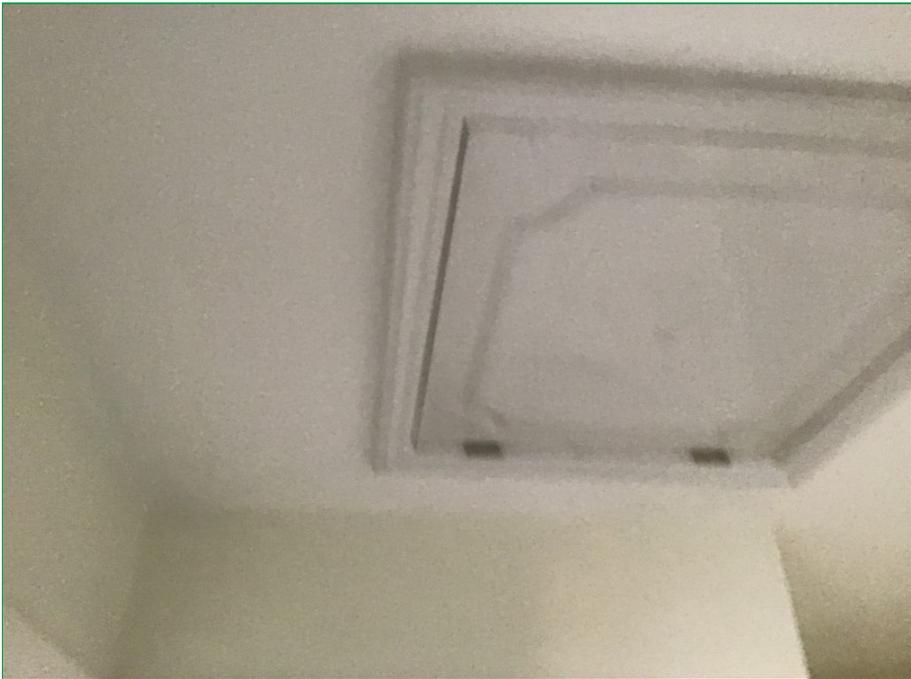
Area	Location	Element	Condition	Description	Photo
Internal	Bathroom	Doors and Frames - Softwood Frame & Panelled	Satisfactory	No damage noted.	[Photos 233 - 234]
Internal	Landing	Ceilings - Plasterboard & Skim	Satisfactory	Slight crack to plaster around loft hatch	[Photos 235 - 240]
Internal	Landing	Internal Walls/ Partitions - Dry Lined	Satisfactory	Minor undulations, scuffed and marked, cracking noted to corners of sloping section above ceiling to staircase. Vertical crack noted above head of doorway to bedroom 1	[Photos 241 - 265]
Internal	Landing	Floor Finishes - Carpet	Good	No damage noted.	[Photos 266 - 268]
Internal	Landing	Skirting - Softwood	Satisfactory	The gloss painted softwood timber is scuffed in areas but generally satisfactory	[Photo 269]
Internal	Stairway	Staircase - Timber	Satisfactory	Paint chipped to handrail and balustrading	[Photos 270 - 273]
Internal	Utility	Ceilings - Plasterboard & Skim	Good	No cracks noted	[Photos 274 - 279]

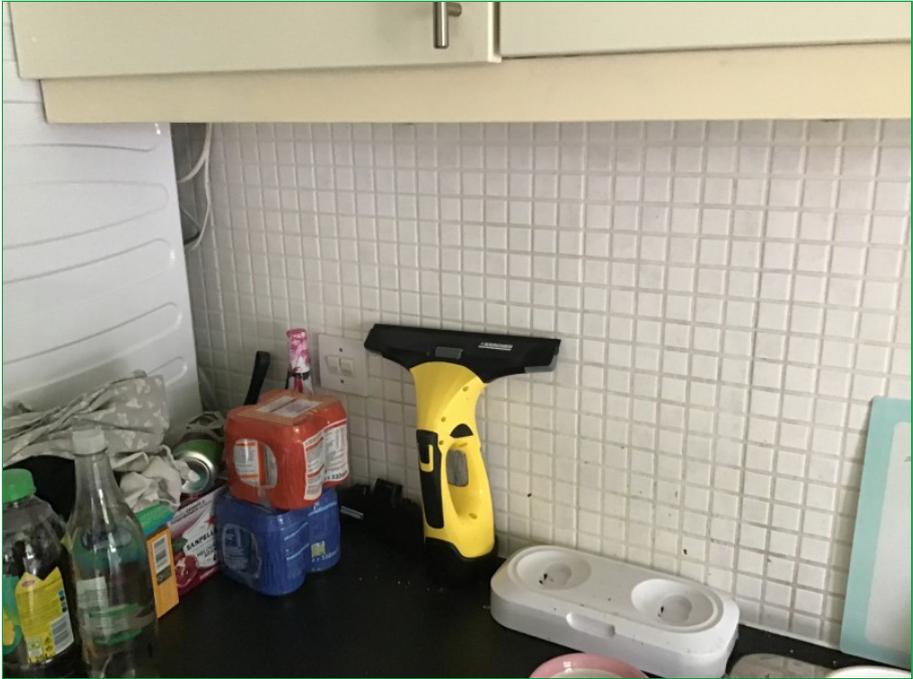
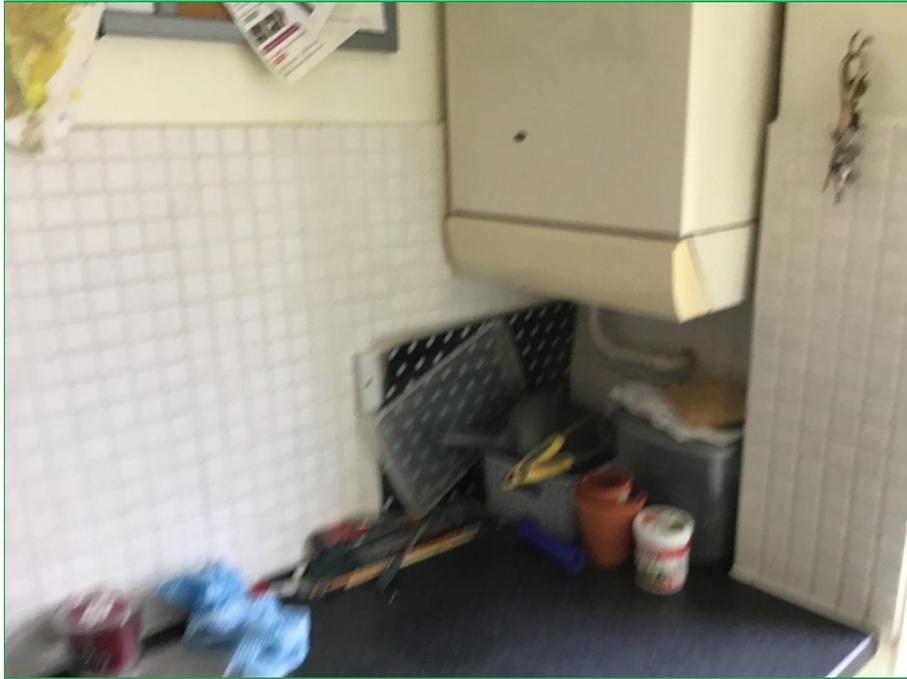
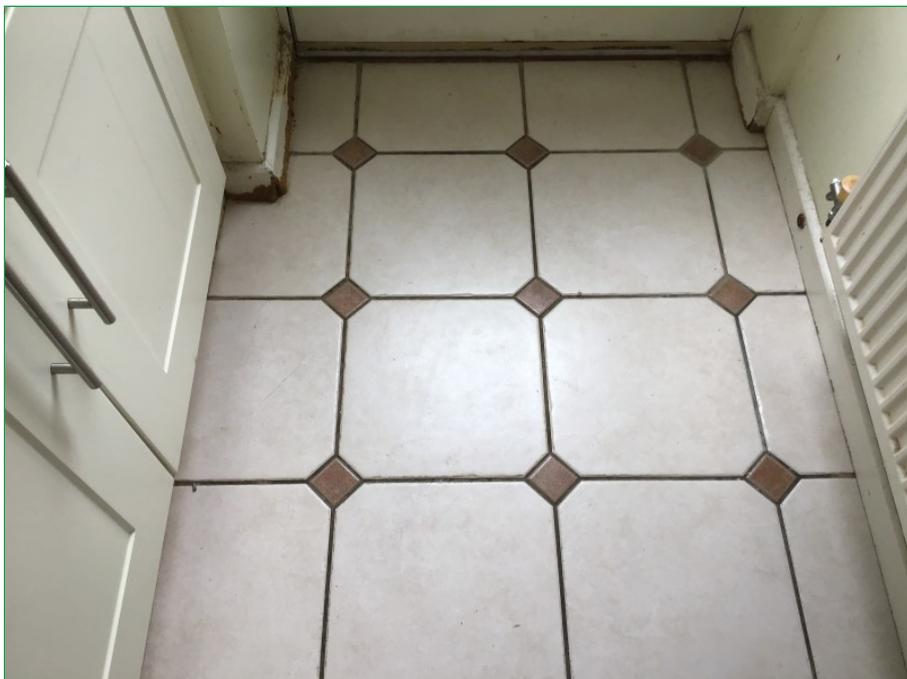
Area	Location	Element	Condition	Description	Photo
Internal	Utility	Internal Walls/ Partitions - Dry Lined	Satisfactory	cracking noted above head of doorway. Historic fixing holes and damage filled.	[Photos 280 - 289]
Internal	Utility	Floor Finishes - Ceramic tiles	Satisfactory	In reasonable condition	[Photos 290 - 291]
Internal	Utility	Doors and Frames - MDF	Fair	No door fitted, MDF door frame blown at low level	[Photos 292 - 295]
Internal	Utility	Skirting - MDF	Fair	Water damaged at low level	[Photos 296 - 298]
Internal	Utility	Doors and Frames - PVCu	Satisfactory	Minor scuffmarks throughout, generally satisfactory	[Photos 299 - 300]
Internal	Utility	Kitchen Fittings - Work Top	Satisfactory	Post formed laminate worktop in satisfactory condition	[Photos 301 - 302]
Internal	Utility	Kitchen Fittings - Base Unit	Satisfactory	Doors to wall units out of alignment	[Photos 303 - 304]
Internal	Kitchen	Ceilings - Plasterboard & Skim	Satisfactory	Minor undulations no cracking noted Damage where light fittings replaced	[Photos 305 - 313]
