Schedule of Condition

Address XXXX **Prepared for** XXXX
Survey Date XXXX
Prepared by Mark Davies
Email m.davies@allcottassociates.co.uk
Telephone 0333 200 7198
Mobile XXXX
Website www.allcottcommercial.co.uk

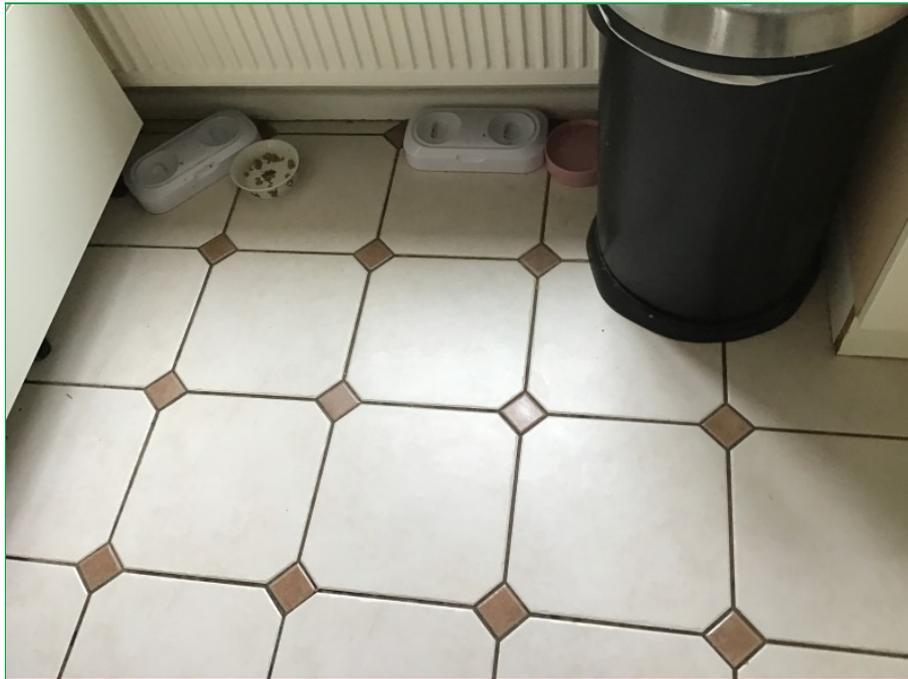
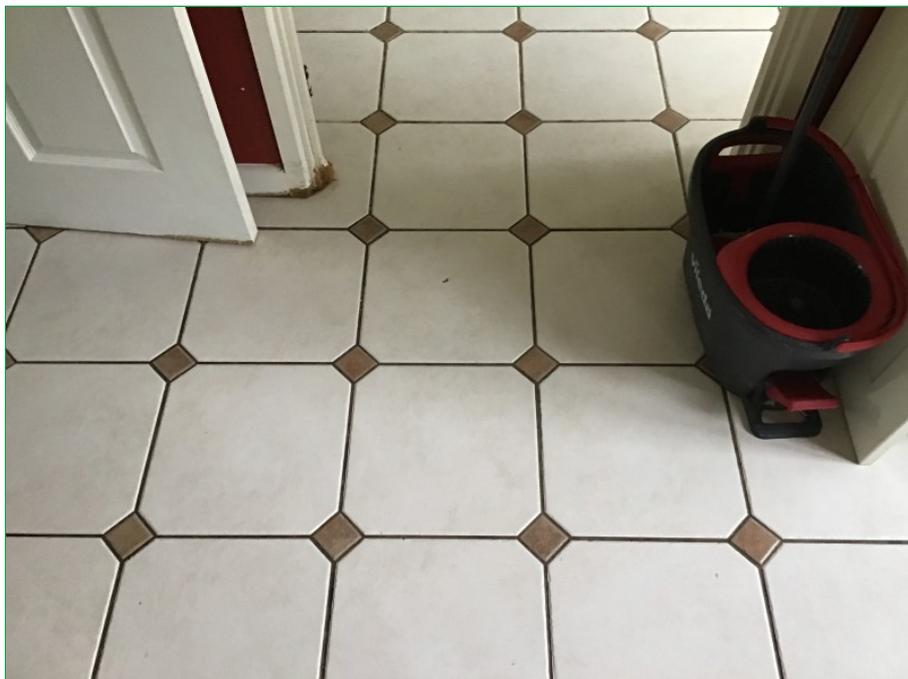
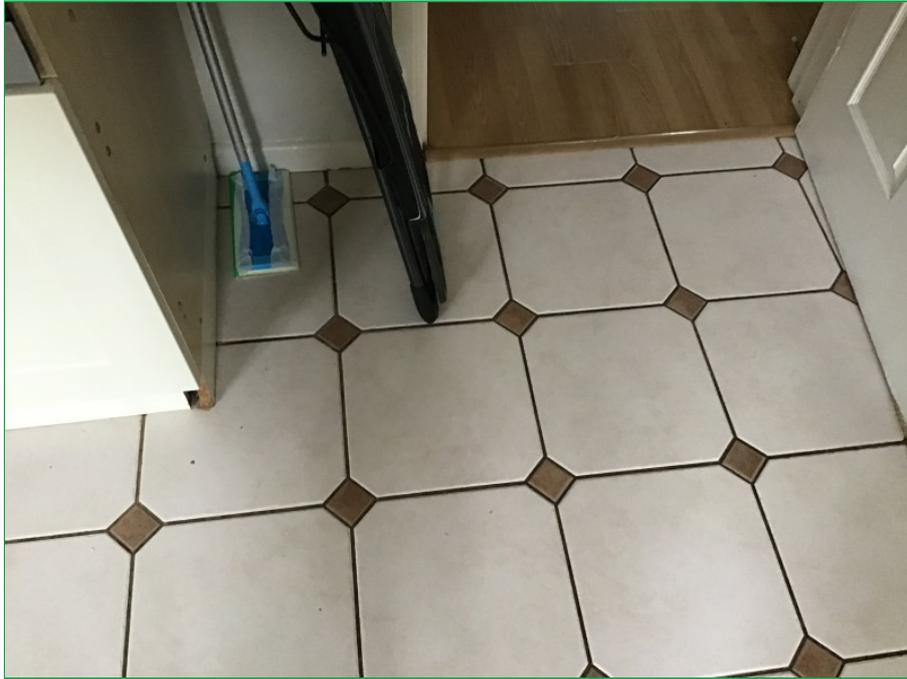
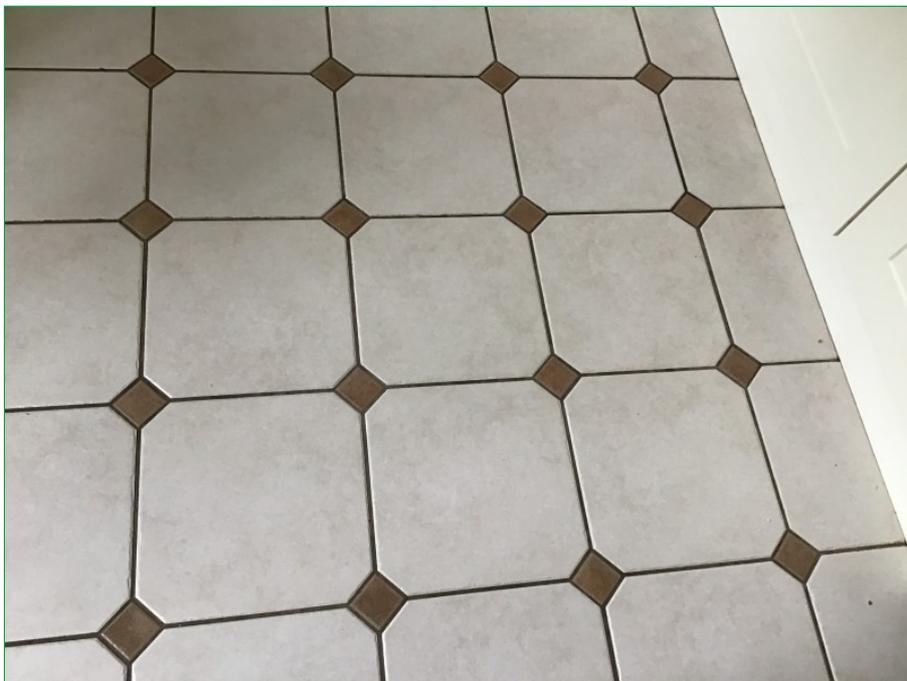
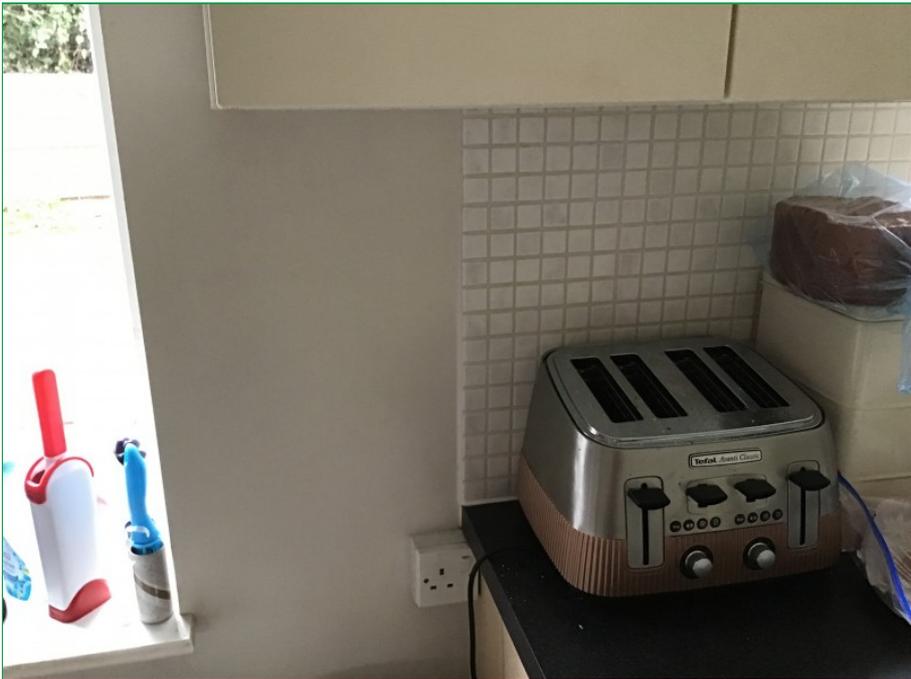
Internal	Kitchen	Floor Finishes - Ceramic tiles	Satisfactory	No cracked or damaged tiles	[Photos 314 - 318]

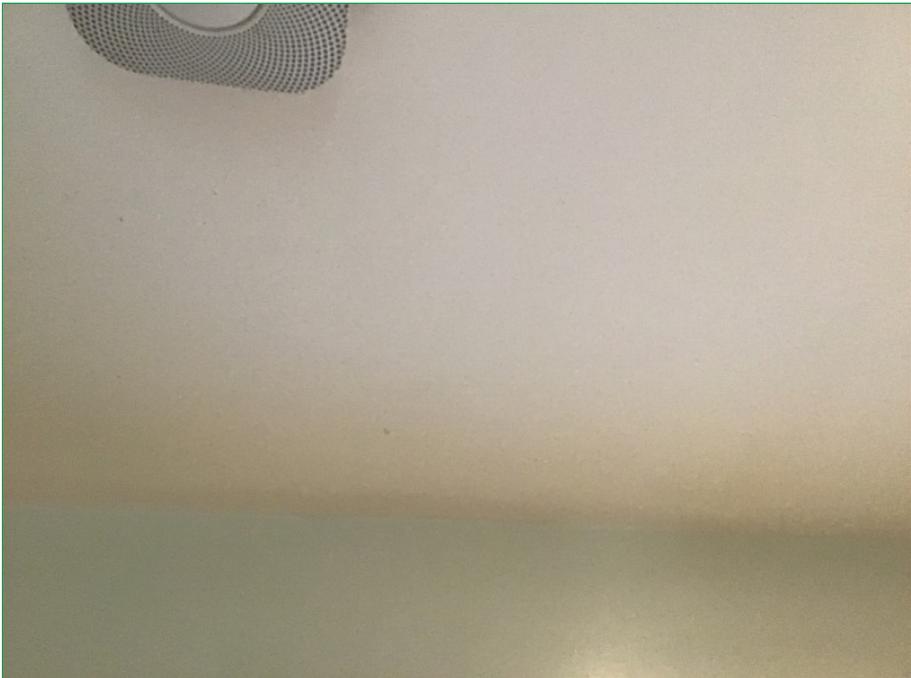
Photo 349

Area	Location	Element	Condition	Description	Photo
Internal	Hallway	Ceilings - Plasterboard & Skim	Satisfactory	Slight undulations and scuff marks no cracking evident	[Photos 349 - 353]
Internal	Hallway	Internal Walls/ Partitions - Dry Lined	Good	Minor scuffs, marks and indentations noted no cracking evident	[Photos 354 - 364]
Internal	Hallway	Floor Finishes - Laminate wood flooring	Satisfactory	No damage noted.	[Photos 365 - 367]
Internal	Hallway	Skirting - MDF	Satisfactory	Minor scuffs and marks noted.	[Photos 368 - 369]
Internal	Hallway	Radiator - Metal	Satisfactory	No damage noted.	[Photo 370]
Internal	Ground Floor wc	Ceilings - Plasterboard & Skim	Satisfactory	Slight undulations no cracks noted	[Photos 371 - 373]
Internal	Ground Floor wc	Internal Walls/ Partitions - Dry Lined	Satisfactory	No cracks noted, generally satisfactory	[Photos 374 - 385]
Internal	Ground Floor wc	Floor Finishes - Ceramic tiles	Good	No damage noted.	[Photos 386 - 387]

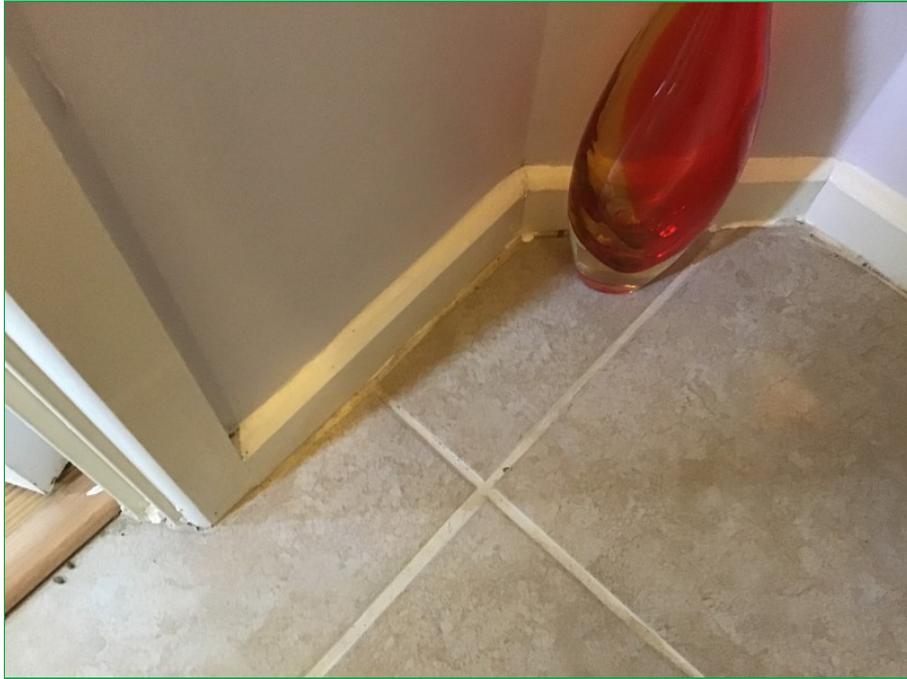
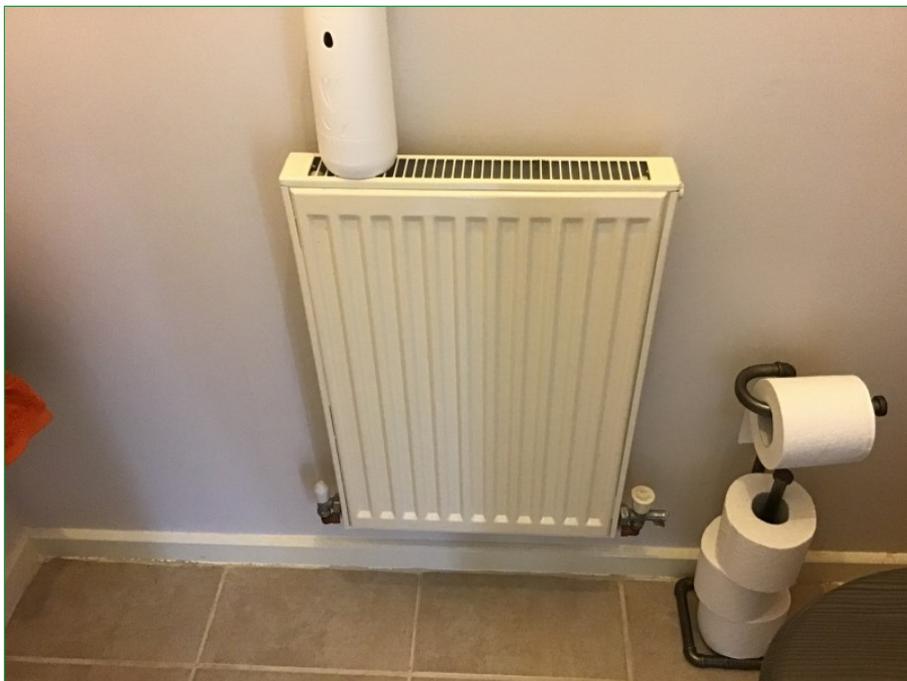
Photo 388

Internal	Ground Floor wc	Skirting - MDF	Satisfactory	The gloss painted softwood timber is scuffed in areas and requires redecoration.	[Photos 388 - 389]

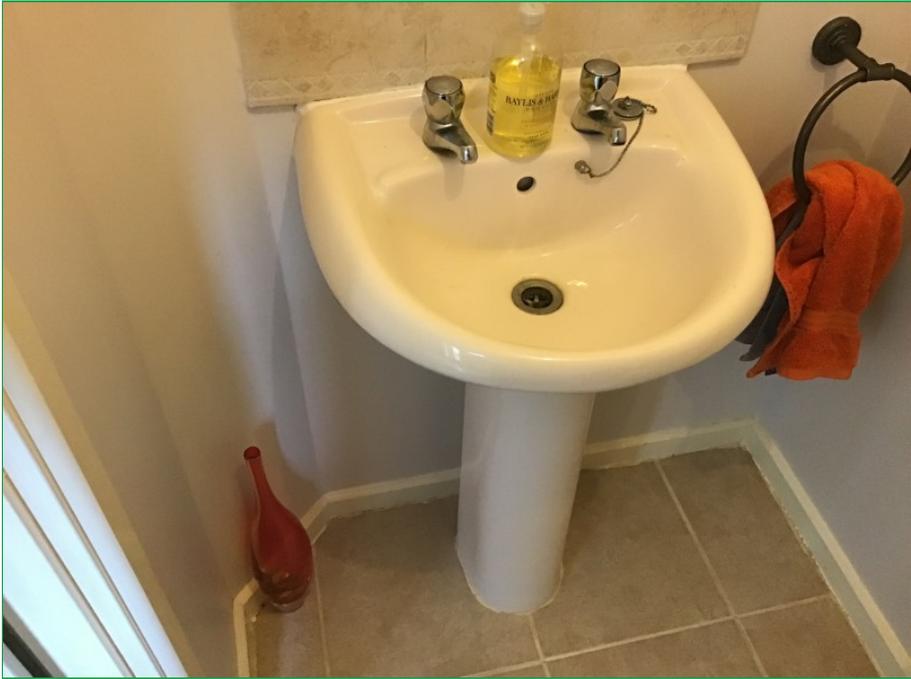
Photo 390

Area	Location	Element	Condition	Description	Photo
Internal	Ground Floor wc	Radiator - Metal	Satisfactory	No damage noted.	[Photo 390]
Internal	Ground Floor wc	Sanitary Fittings - Pedestal Wash Basin	Good	No damage noted.	[Photo 391]
Internal	Ground Floor wc	Sanitary Fittings - Low Cistern WC	Good	No damage noted.	[Photo 392]
Internal	Ground Floor wc	Doors and Frames - Softwood Frame & Panelled	Good	No damage noted.	[Photos 393 - 399]
Internal	Lounge	Ceilings - Plasterboard & Skim	Satisfactory	Minor undulations no cracking evident.	[Photos 400 - 415]
Internal	Lounge	Internal Walls/ Partitions - Dry Lined	Satisfactory	No cracks noted, minor areas of historic filling and minor undulations evident	[Photos 416 - 441]
Internal	Lounge	Floor Finishes - Carpet	Good	No damage noted.	[Photos 442 - 444]
Internal	Lounge	Doors and Frames - Softwood Frame & Panelled	Satisfactory	The paint is flaking on the mdf door frame	[Photos 445 - 448]

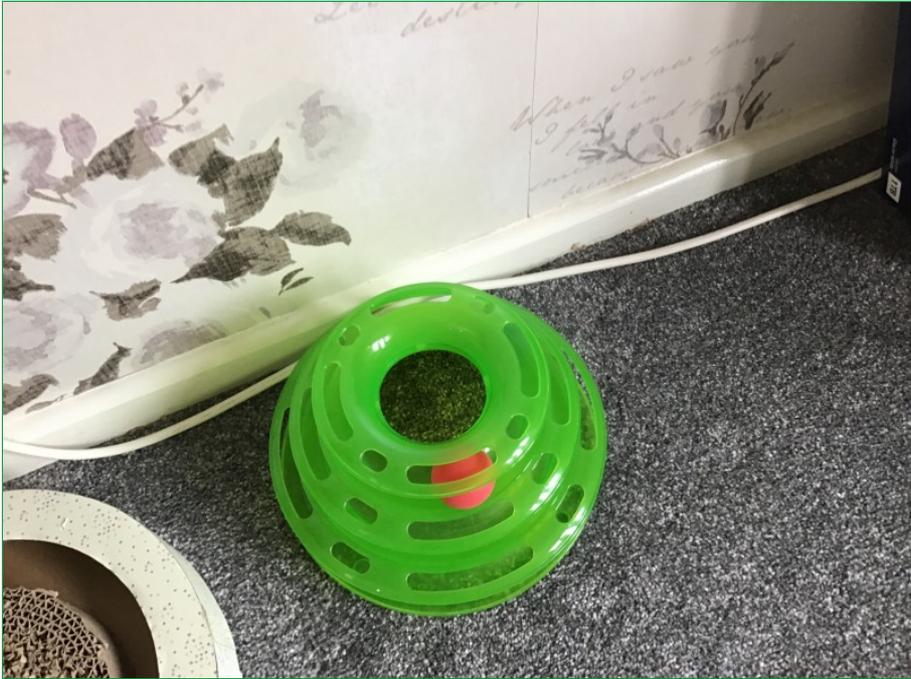
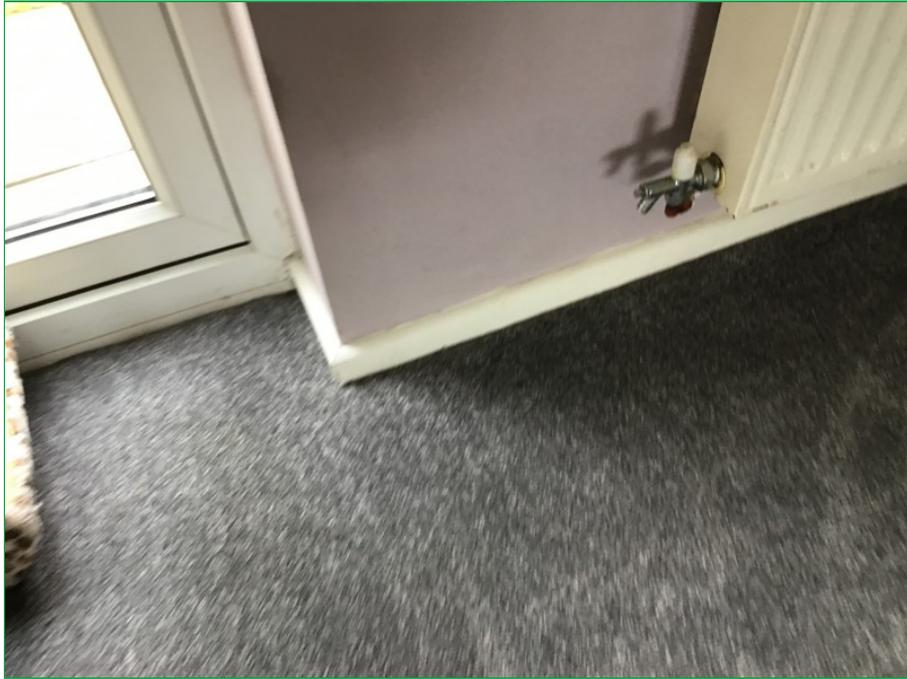
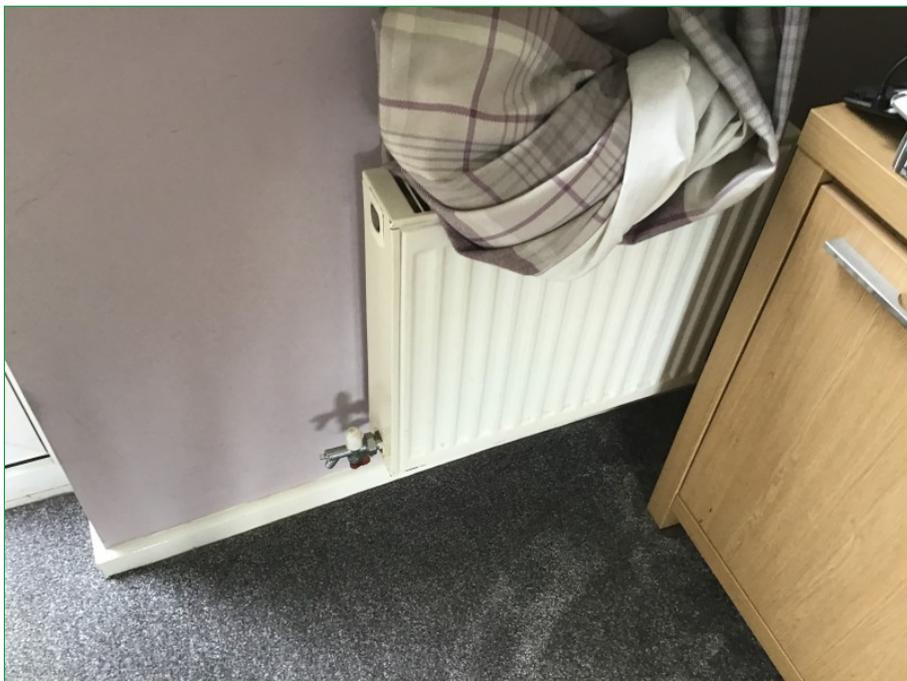
Photo 449

Area	Location	Element	Condition	Description	Photo
Internal	Lounge	Skirting - MDF	Satisfactory	Minor scuffs noted Slight cracking to junction with wall below bay window.	[Photos 449 - 451]
Internal	Lounge	Radiator - Metal	Satisfactory	No damage noted.	[Photos 452 - 453]
Internal	Lounge	Doors and Frames - PVCu	Satisfactory	Minor scuffs and marks noted	[Photos 454 - 461]
Internal	Under stairs	Ceilings - Plasterboard & Skim	Satisfactory	Marks noted	[Photos 462 - 463]
Internal	Under stairs	Internal Walls/ Partitions - Dry Lined	Satisfactory	Scuffs and marks noted	[Photos 464 - 465]
Internal	Under stairs	Floor Finishes - Carpet	Good	No damage noted.	
Internal	Under stairs	Doors and Frames - Softwood Frame & Panelled	Good	No damage noted.	[Photos 466 - 467]
External	Rear Elevation	Roof Structure & Covering - Clay Tile Covering	Good	No damage noted.	[Photos 468 - 470]

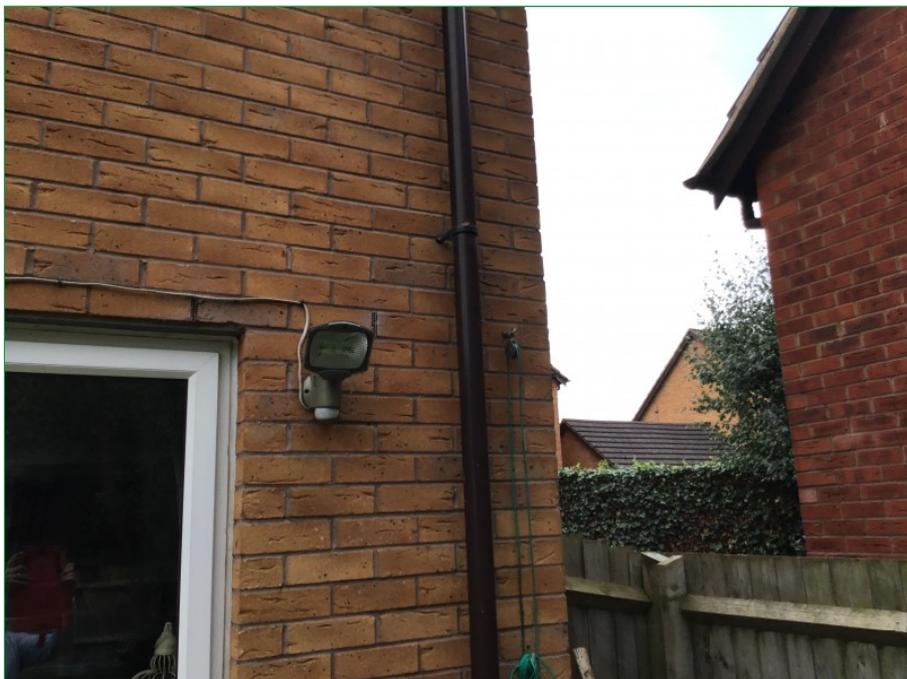
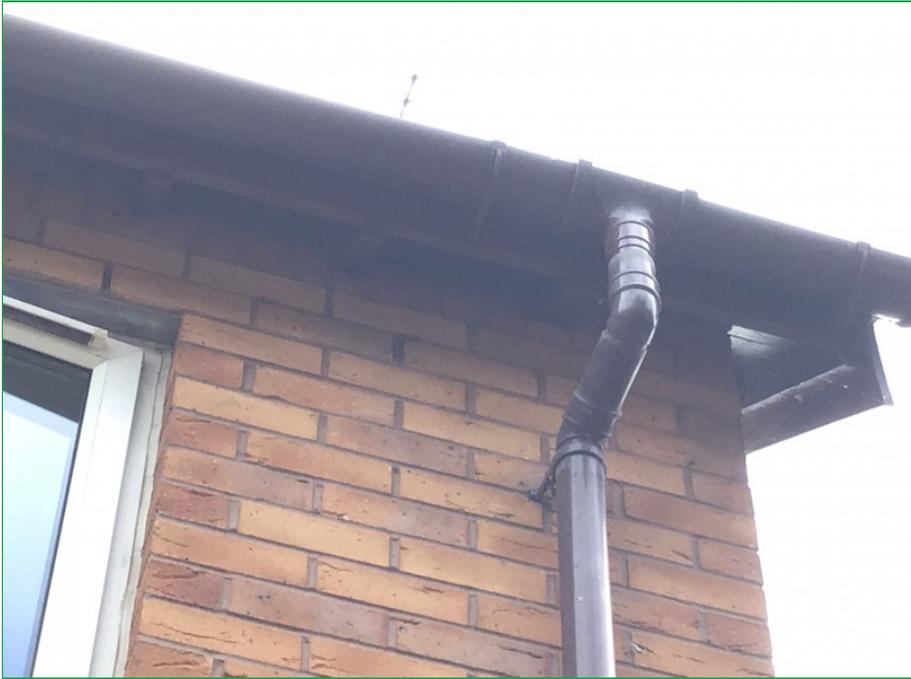
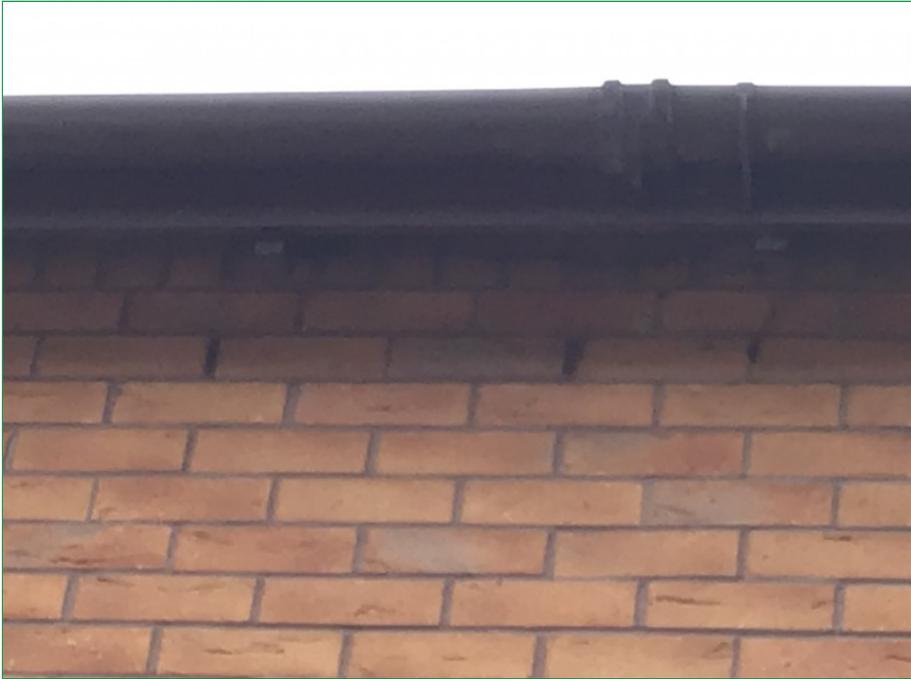
Photo 471

Area	Location	Element	Condition	Description	Photo
External	Rear Elevation	Rainwater Goods - UPVC Gutters	Satisfactory	No damage noted.	[Photos 471 - 473]
External	Rear Elevation	Soffit & Fascia - Timber painted	Satisfactory	Slightly begrimed	[Photos 474 - 475]
External	Rear Elevation	Main Walls - Brick	Satisfactory	Staining at low level 1 brick repainted, generally satisfactory	[Photos 476 - 494]
External	Rear Elevation	Window -	Satisfactory	The UPVC windows are in reasonable condition. No action is required. Stone cills slightly begrimed, generally satisfactory as no cracks noted.	[Photos 495 - 502]
External	Rear Elevation	Doors - PVCu	Good	No damage noted.	[Photos 503 - 512]
External	Rear Garden	Fencing & Boundary Walls - Timber Boarded Fence	Good	No damage noted.	[Photos 513 - 519]
External	Rear Garden	Paving - Stone slabbing	Satisfactory	Minor unevenness, none damaged	[Photos 520 - 525]
External	Front garden	Driveway - Asphalt	Satisfactory	Minor staining no damage noted	[Photos 526 - 533]

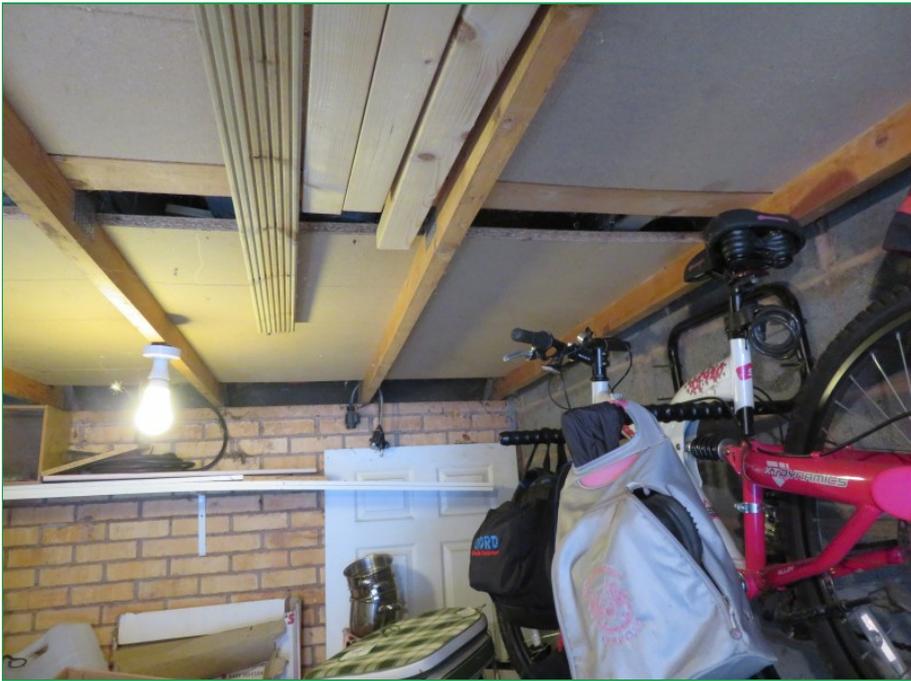
Photo 534

Area	Location	Element	Condition	Description	Photo
Internal	Garage	Ceilings - Plasterboard & Skim	Satisfactory	no cracking noted	[Photos 534 - 538]
Internal	Garage	Walls -	Satisfactory	No damage noted.	[Photos 539 - 548]
Internal	Garage	Floor Structure - Concrete (INSTU)	Satisfactory	No cracking noted slightly uneven	[Photos 549 - 553]
Internal	Garage	Doors and Frames - Metal	Satisfactory	damage noted at low level	[Photos 554 - 555]
Internal	Bedroom 2 en suite	Ceilings - Plasterboard & Skim	Satisfactory	Minor undulations and historic repairs noted Slight crack where the plasterboard butts together. Coving in reasonable condition with no cracking noted	[Photos 556 - 559]
Internal	Bedroom 2 en suite	Internal Walls/ Partitions - Dry Lined	Satisfactory	Generally satisfactory with no cracks noted.	[Photos 560 - 570]
Internal	Bedroom 2 en suite	Floor Finishes - Laminate wood flooring	Satisfactory	Slight opening of the joints noted	[Photos 571 - 573]

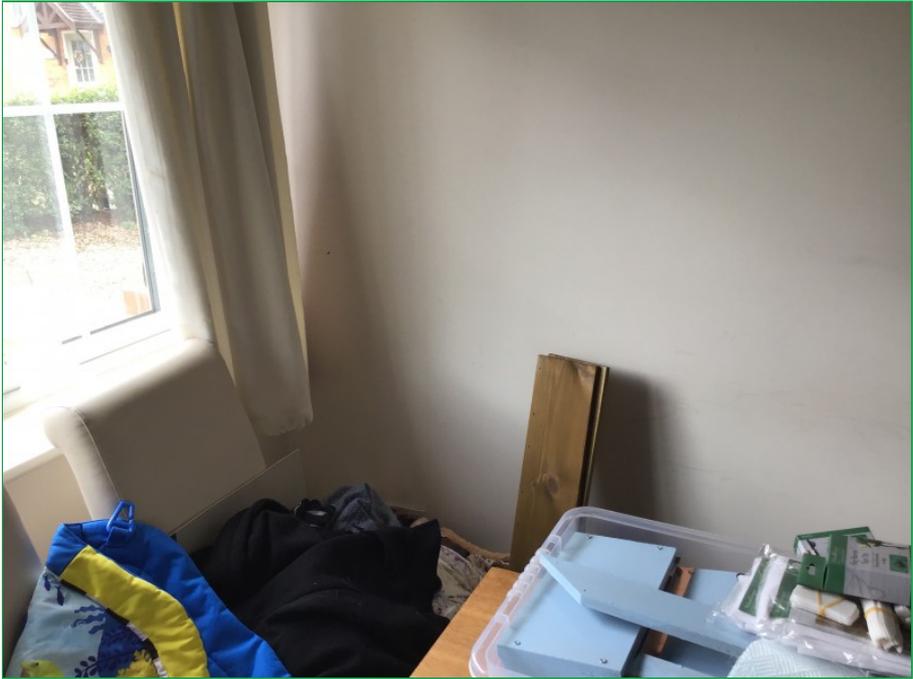
Photo 612

Area	Location	Element	Condition	Description	Photo
Internal	Dining room	Ceilings - Plasterboard & Skim	Good	No cracks noted Minor scuffs and marks evident	[Photos 600 - 603]
Internal	Dining room	Internal Walls/ Partitions - Dry Lined	Good	No damage noted.	[Photos 604 - 616]
Internal	Dining room	Floor Finishes - Carpet	Satisfactory	No damage noted.	[Photos 617 - 618]
Internal	Dining room	Skirting - MDF	Satisfactory	No damage noted.	[Photo 619]
Internal	Dining room	Window - PVCu	Good	No damage noted.	[Photos 620 - 622]
Internal	Dining room	Radiator - Metal	Satisfactory	Chipped to front face	[Photo 623]
Internal	Dining room	Doors and Frames - Softwood Frame & Panelled	Satisfactory	No damage noted.	[Photos 624 - 628]
External	Front garden	Gates -	Satisfactory	No damage noted.	[Photos 629 - 630]
Internal	Airing cupboard	-	Satisfactory	Minor crack to junction of side and rear wall No cracks to ceiling Floor and door satisfactory	[Photos 631 - 637]
