**BRIEF:** To provide structural designs and calculations for the reconstruction and repair of a patio that was suffering subsidence and sliding into the adjacent canal.

**PROPERTY:** Ground floor flats in Kidderminster.

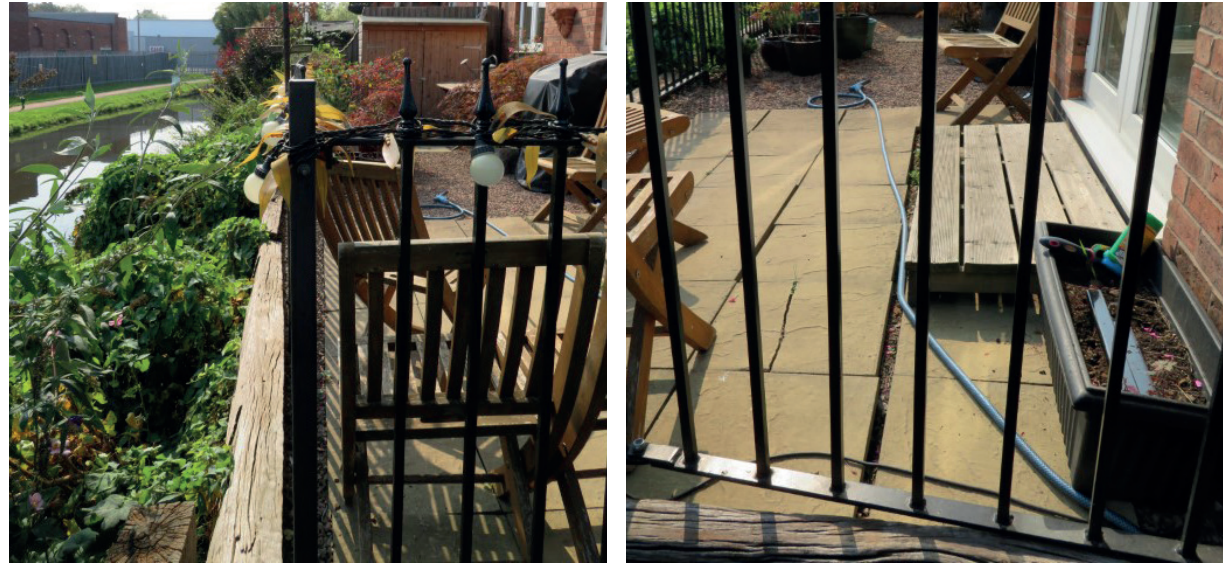
- Timber sleepers supporting the existing patio had rotted and the ground was sloping towards the adjacent canal. This was evident from the cracking to the patio slabs and sloping of the ground towards the canal.
- Our client was keen to minimise disruption and avoid the need for obtaining permits from the canal authority.
- Our structural engineer was therefore tasked with finding a design that would support the patio structure, avoid the need for large scale earth removal and concrete installation, and retain the original timber sleepers in a decorative function.

## SUPPORTS FOR EXISTING PATIO HAD ROTTED, LEADING TO INSTABILITY

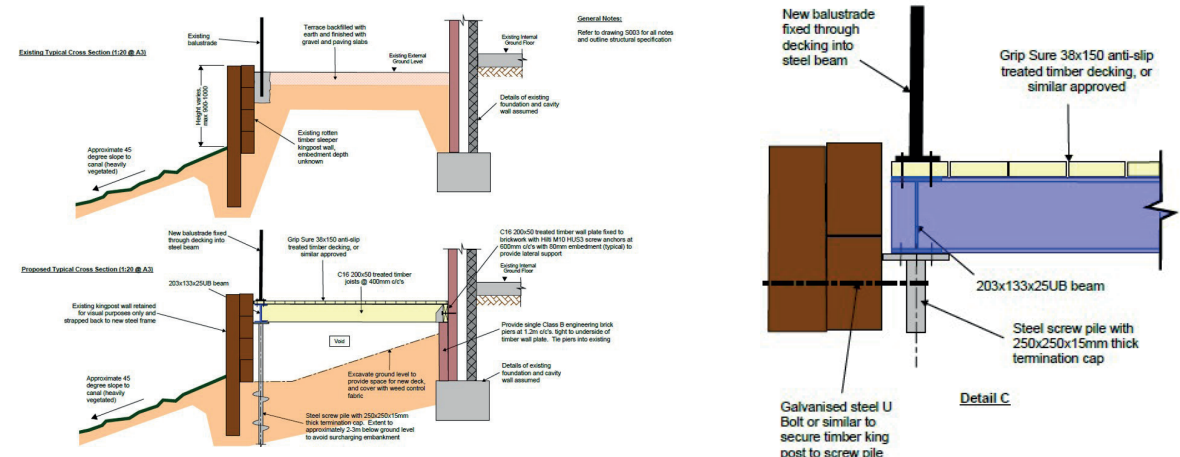
## WE DESIGNED A SCREW PILE SOLUTION

- We designed a screw pile solution to support the patio.
- The design consisted of a steel screw pile with 250x250x15mm thick termination cap extending to approximately 2–3m below ground level to avoid surcharging the embankment.
- The ground was to be excavated to provide space for the new deck and to allow cover with weed control fabric.
- The new patio would consist of treated timber plate supported on treated timber joists, held in place by universal steel beams (I beams).
- The existing fence was to be replaced with a new balustrade fixed through the decking into the steel beam.
- Lateral support was to be provided by fixing a treated timber wall plate to the brickwork with screw anchors, underpinned by single engineering brick piers tight to the underside of the timber wall plate.
- Allcott Commercial is now providing contract administration for the works.
